Relocation behavior of molten fuel to below the core

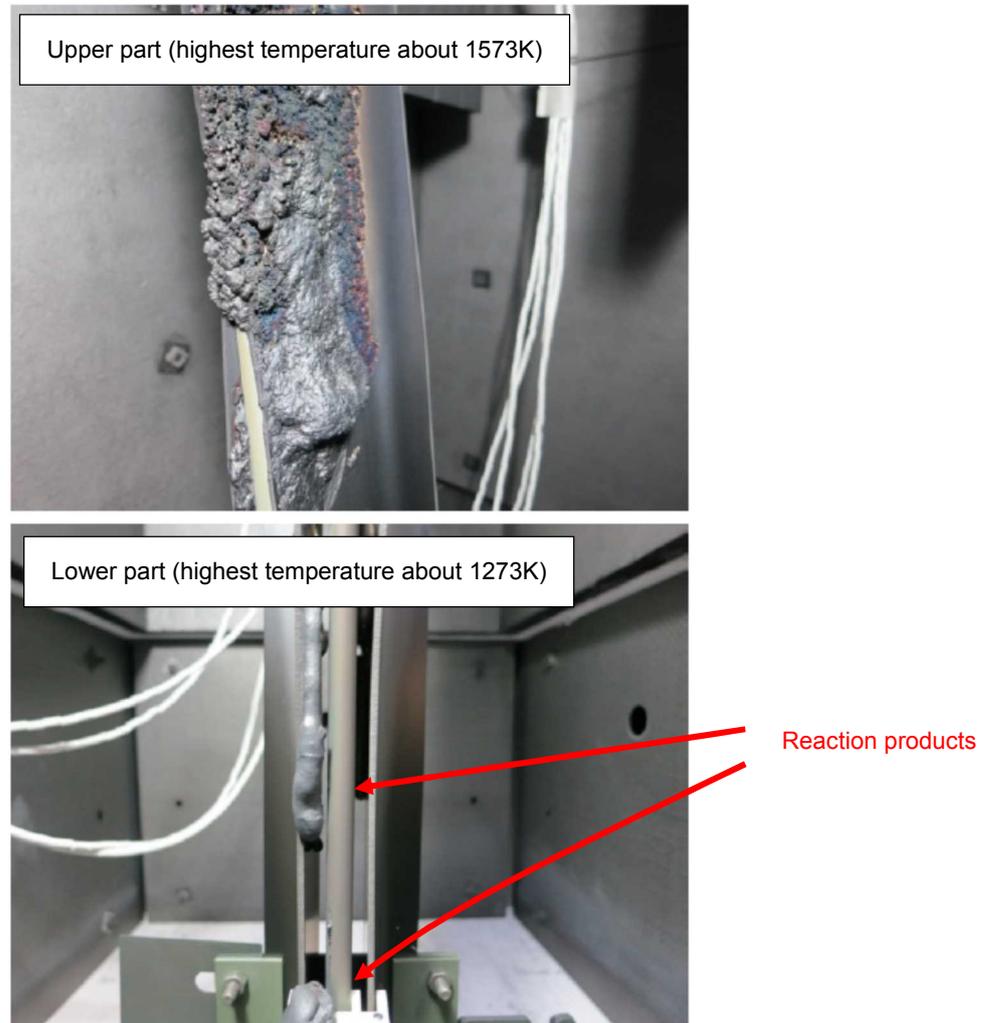
Figure 3.5 Photos of the test piece after the test [7]

Figure 3.5 reproduces photos of the test piece after the test. The test confirmed that the molten reaction products of the control blade and channel boxes flowed down between them. It can be interpreted that Zr-Fe eutectic reactions occurred between SUS316L-made control blade sheaths and the Zircaloy-4 channel boxes when they physically contacted and the

molten reaction products flowed down. The test confirmed the molten reaction products flowed down to the bottom of the test piece.

The test results above indicate a good possibility that reaction products were formed between the control blade and channel boxes upon their mechanical contacts, and the molten objects of control blades themselves would drop right into the bottom along the gap (flow path) next to them in their normal arrangement. That means the reaction products would likely flow down directly to the CRGT. But if the reaction products blocked the flow path by

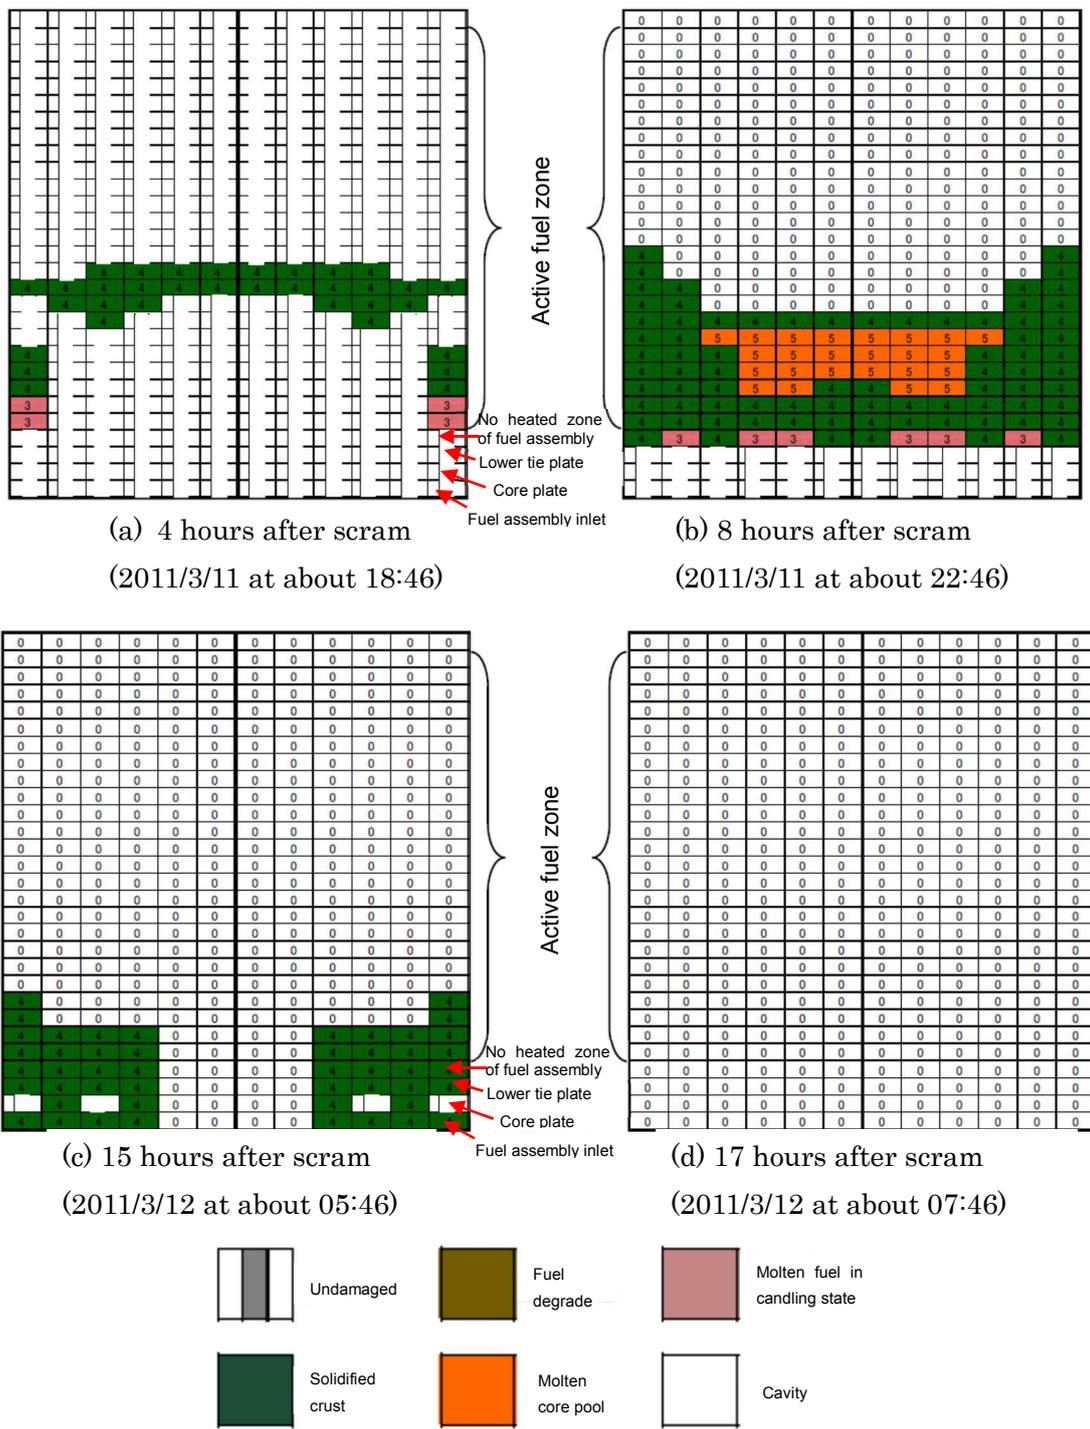
Figure 4.1 Conditions of damaged core (Unit-1)

After the molten fuel pool was formed, the shroud was damaged. Further, molten fuel relocated to below the core upon the central part of core plate being damaged. Afterward, the molten fuel left in the peripheral area of the core relocated to the paths via the inlet orifice of the fuel supports and control rod velocity limiters. Eventually, the whole core plate was degraded and no more molten fuel was left in the core region.

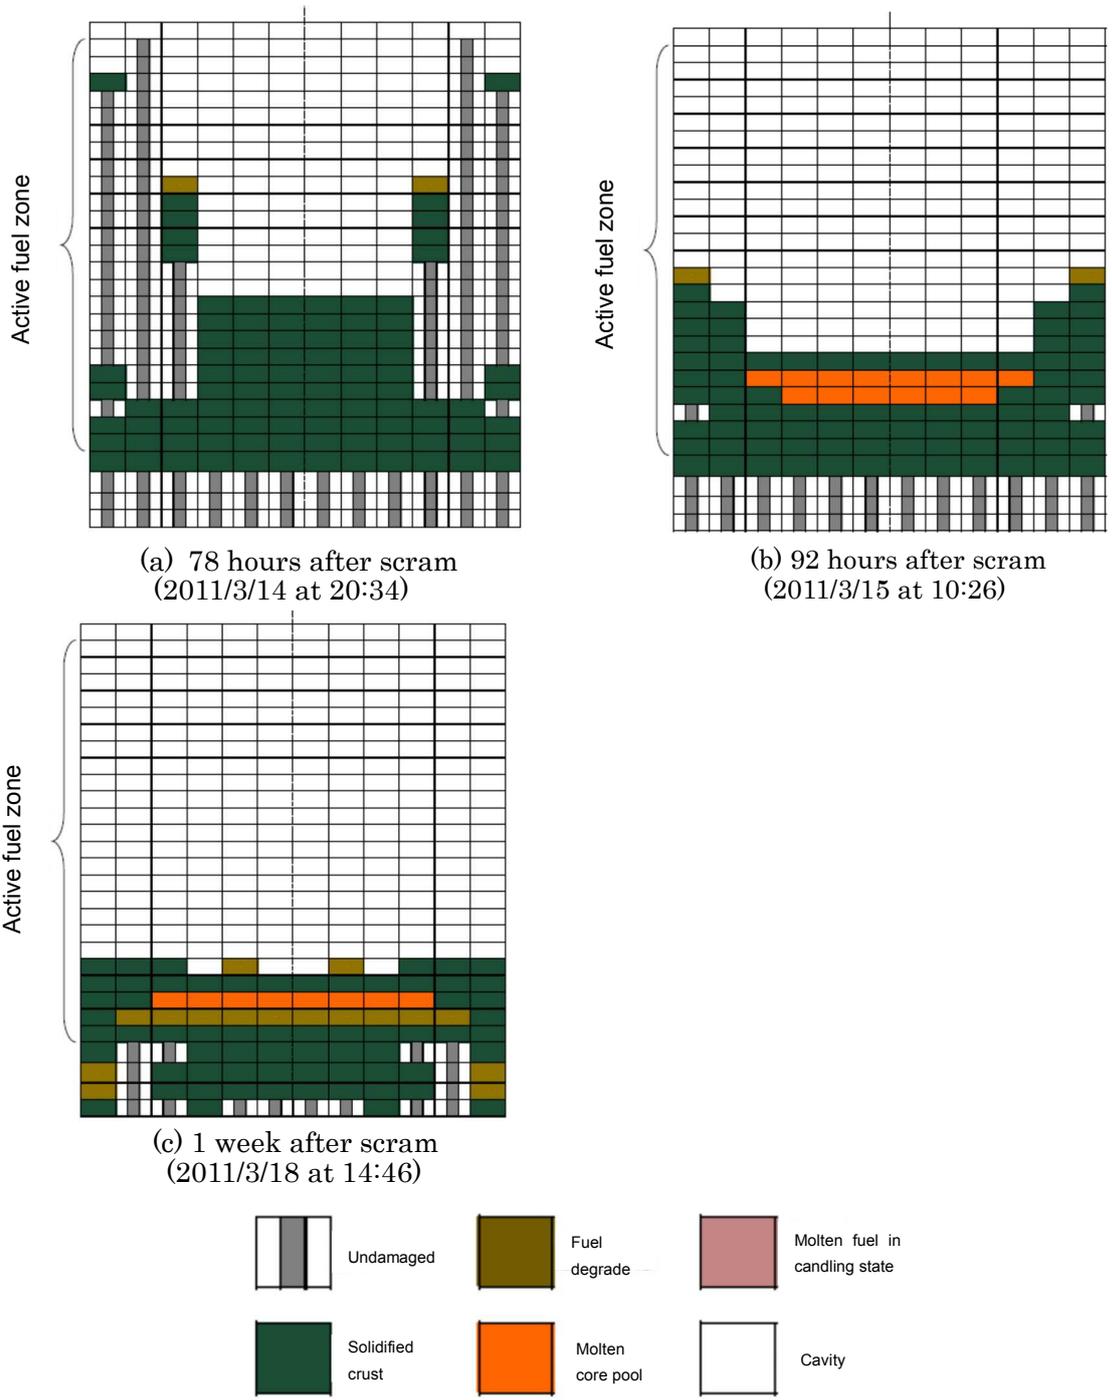
Figure 4.2 Conditions of damaged core (Unit-2)

After the molten fuel pool was formed, molten fuel flowed out to below the core via the inlets to fuel assemblies. Molten fuel also relocated to the path via the control rod velocity limiters. The shroud damage seen in Unit-1 did not occur and the core plate had no degradation. The molten fuel was left in crust forms on the lower fuel tie plates, core plate, fuel supports and other parts of the lower core structure.

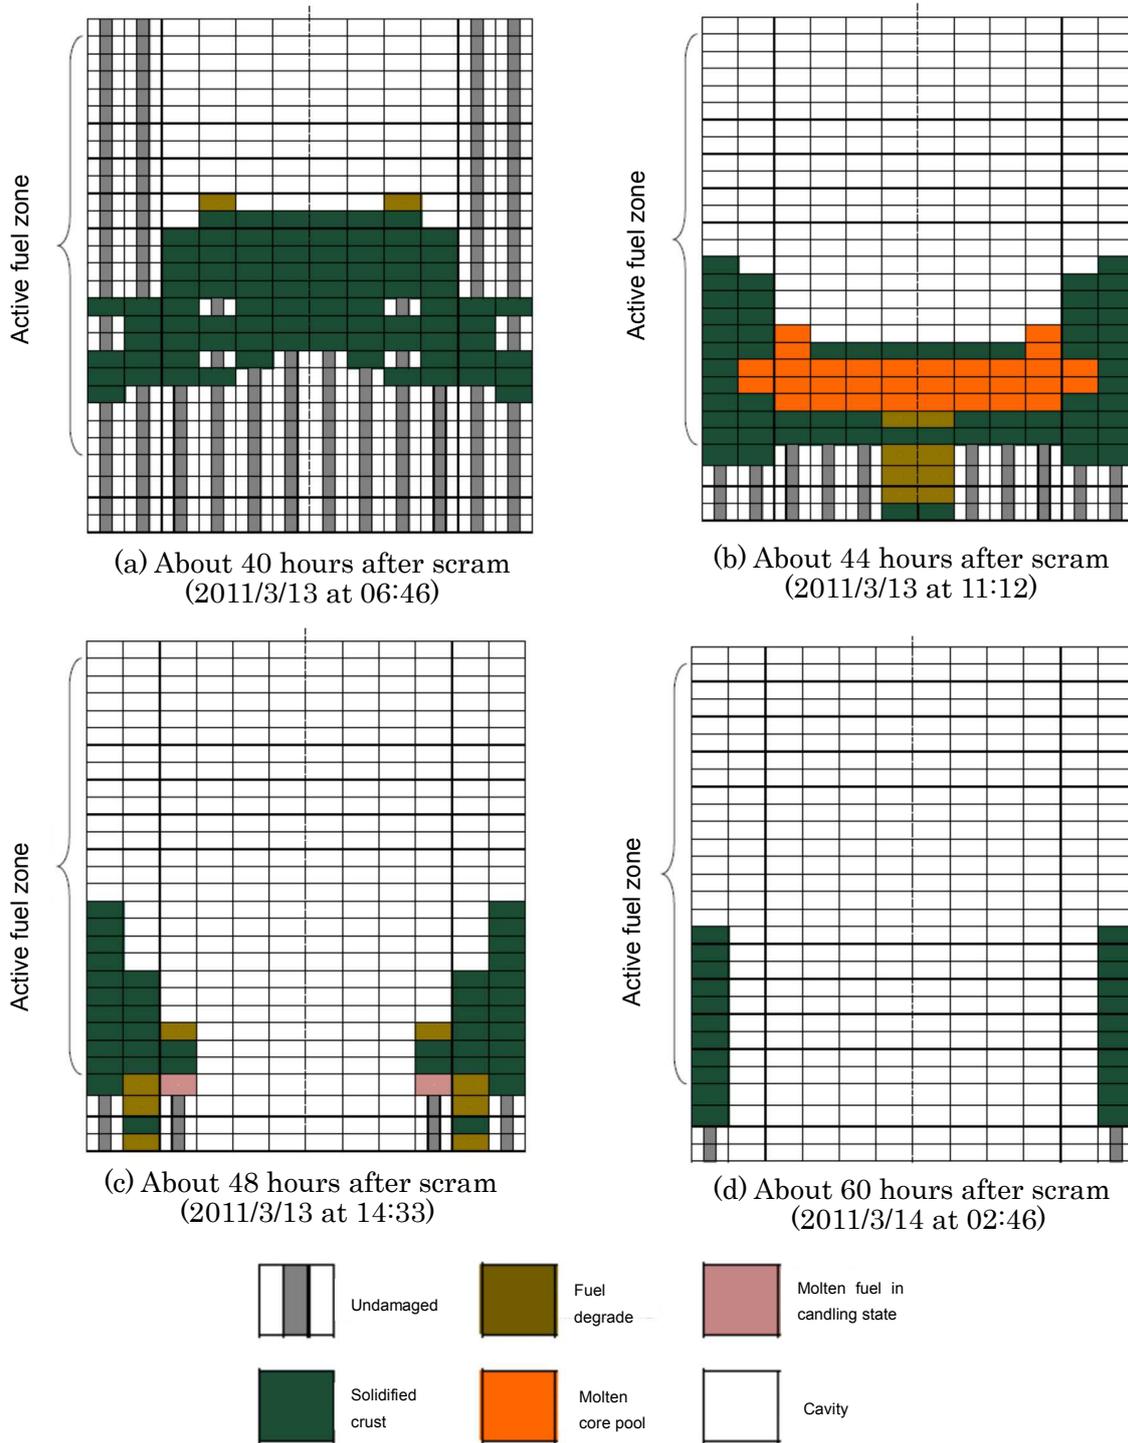
Figure 4.3 Conditions of damaged core (Unit-3)

After the molten fuel pool was formed, molten fuel flowed out to below the core via the inlets to fuel assemblies in the central area of the core. The molten fuel that flowed out to below the core melted CRGT and control rod drive housings, damaging the core plate positioned above them and destroying its core support functions. The molten fuel and other molten objects accumulated on the central area of the core plate fell down step by step to

below the core. Eventually, no more molten fuel was left in the core region. The shroud was not damaged.

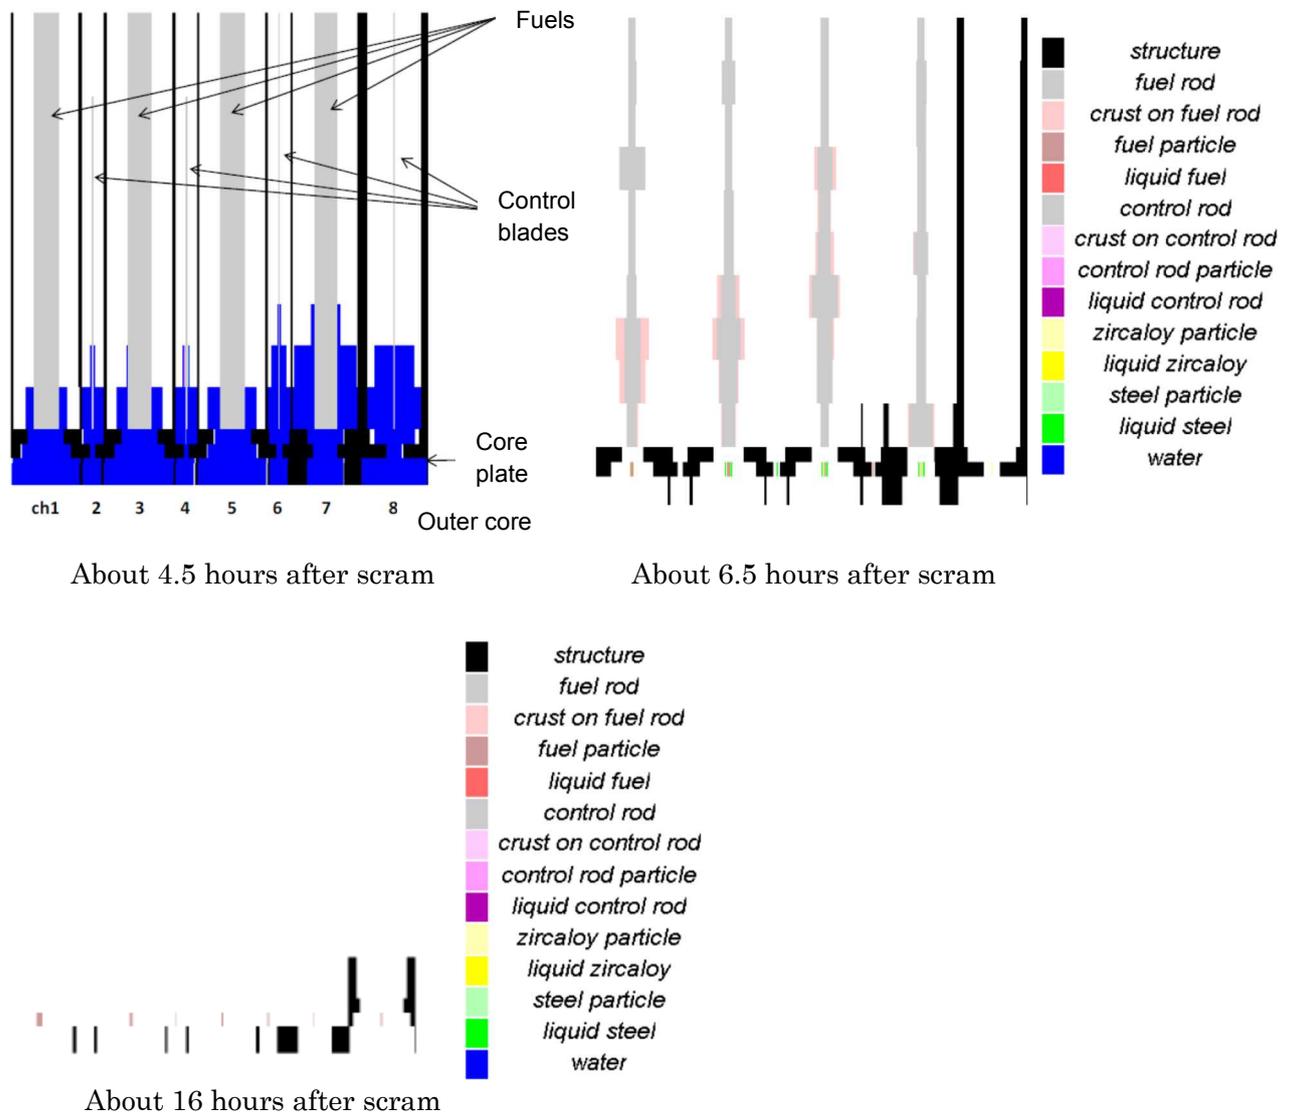
Figure 4.4 Conditions of damaged core of Unit-1 (Volume fractions)

The core plate was melted when it contacted with part of the molten fuel and all structures in the core region dropped to below the core. The molten fuel which relocated to the CRGT melted the control rod velocity limiters. Eventually, no molten fuel was left in the core region. The lower part of the shroud was also melted.

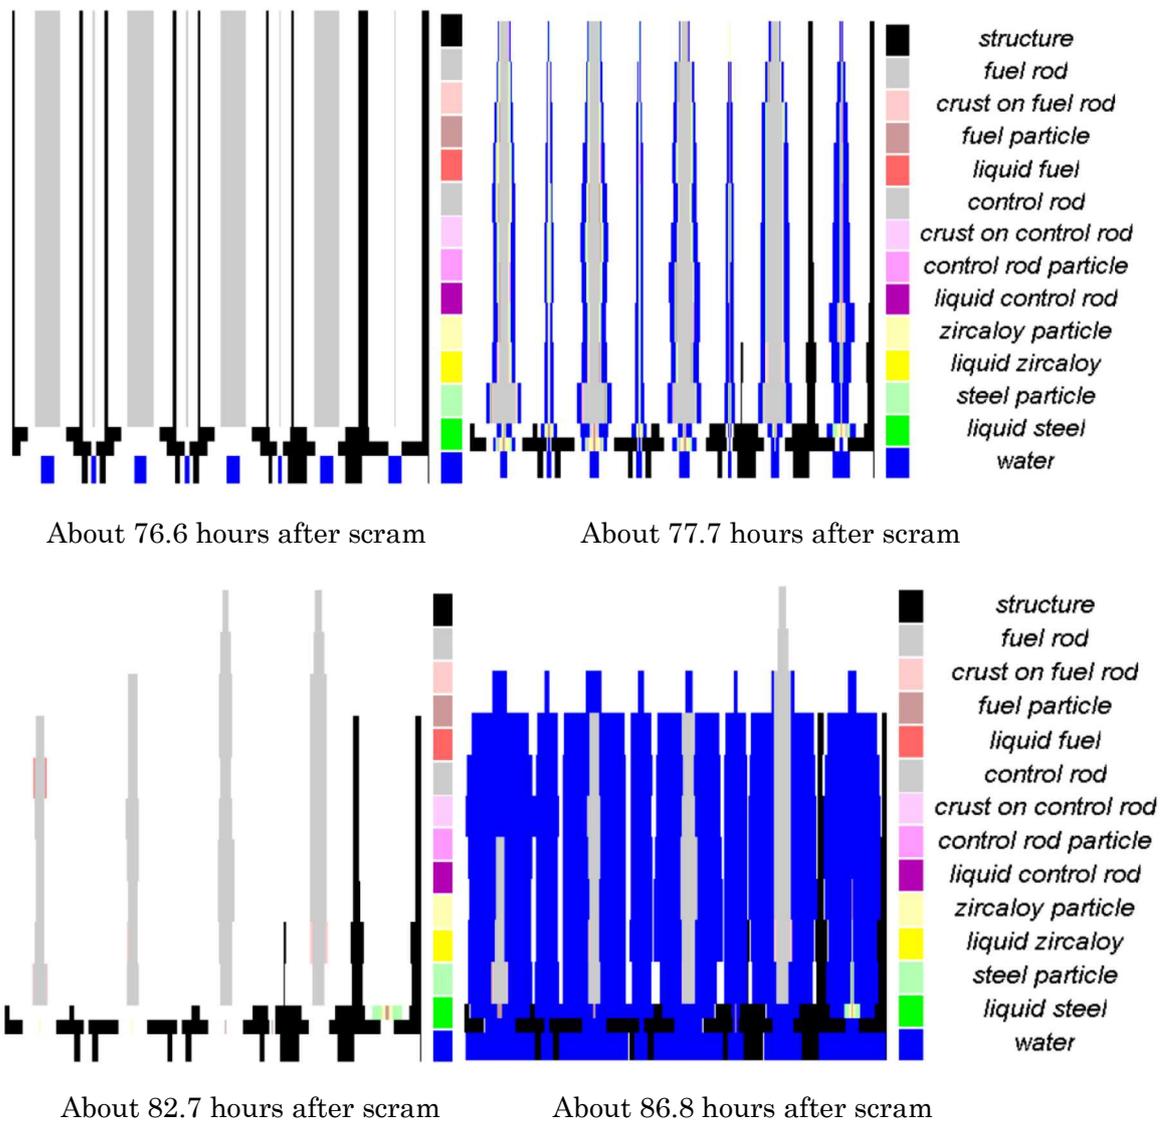
Figure 4.5 Conditions of damaged core of Unit-2 (Volume fractions)

The core plate and control rod velocity limiters were not completely damaged by the molten fuel. Molten fuel was left in crust forms on the lower structures such as the lower fuel tie-plates, core plate and fuel supports. Part of the upper shroud was damaged.

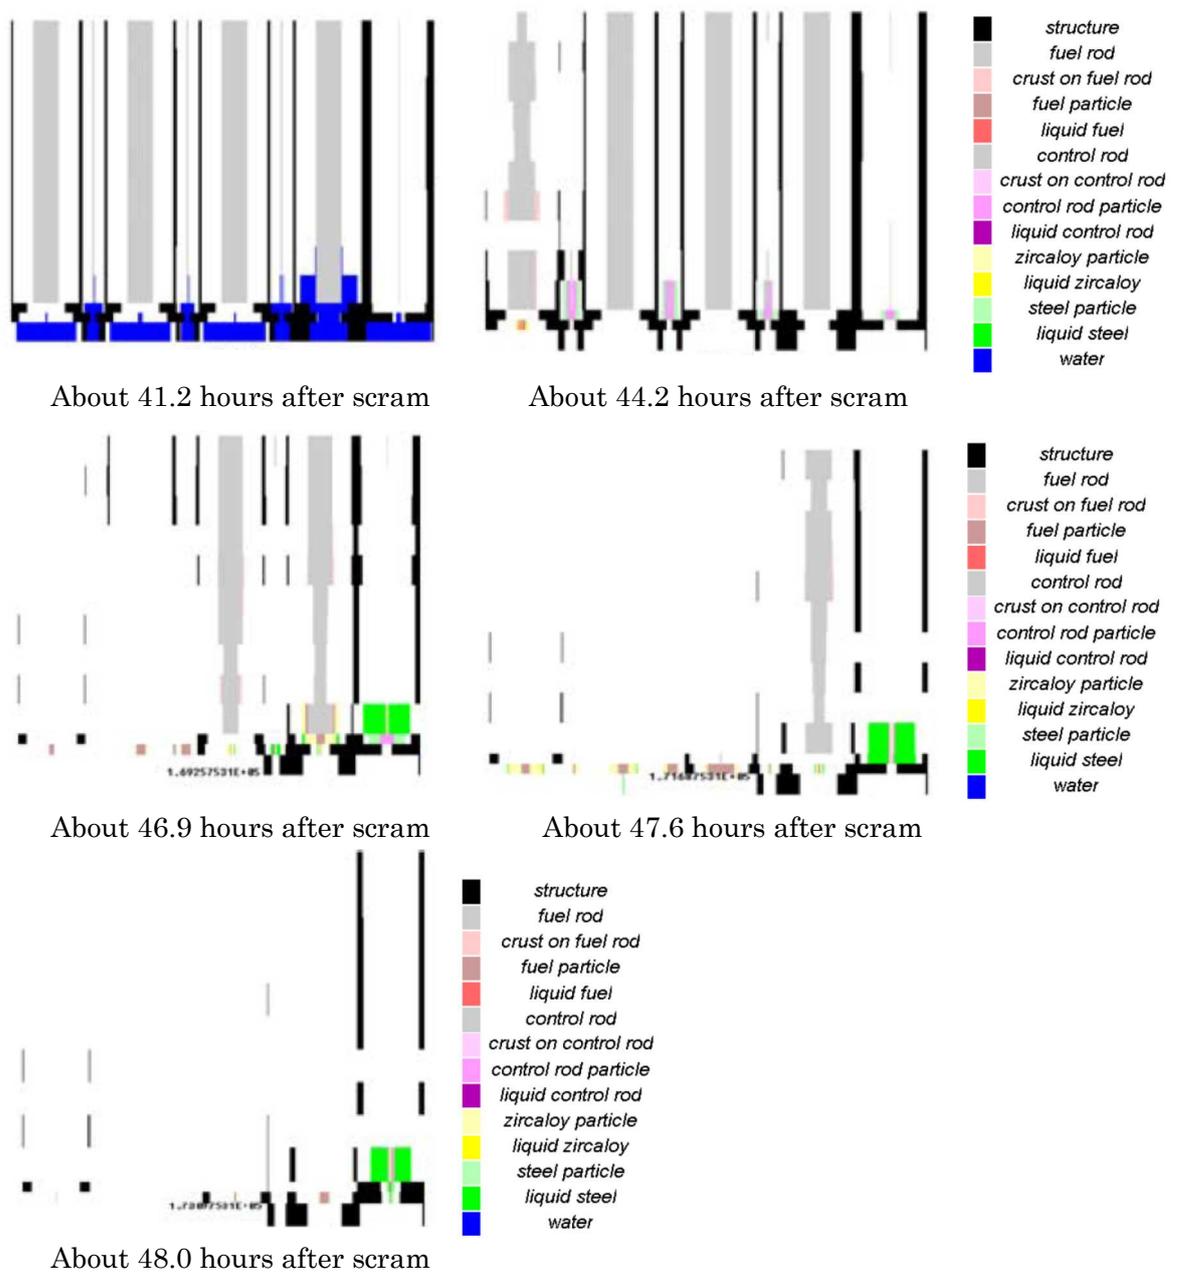
Figure 4.6 Conditions of damaged core of Unit-3 (Volume fractions)

The core plate was melted when it contacted with part of the molten fuel and all structures in the core region dropped to below the core. The molten fuel which relocated to the CRGT melted the control rod velocity limiters. Eventually, almost no molten fuel was left in the core region. The lower part of the shroud was also melted.
