Estimation of causes of high contamination of RCW piping at Unit-1

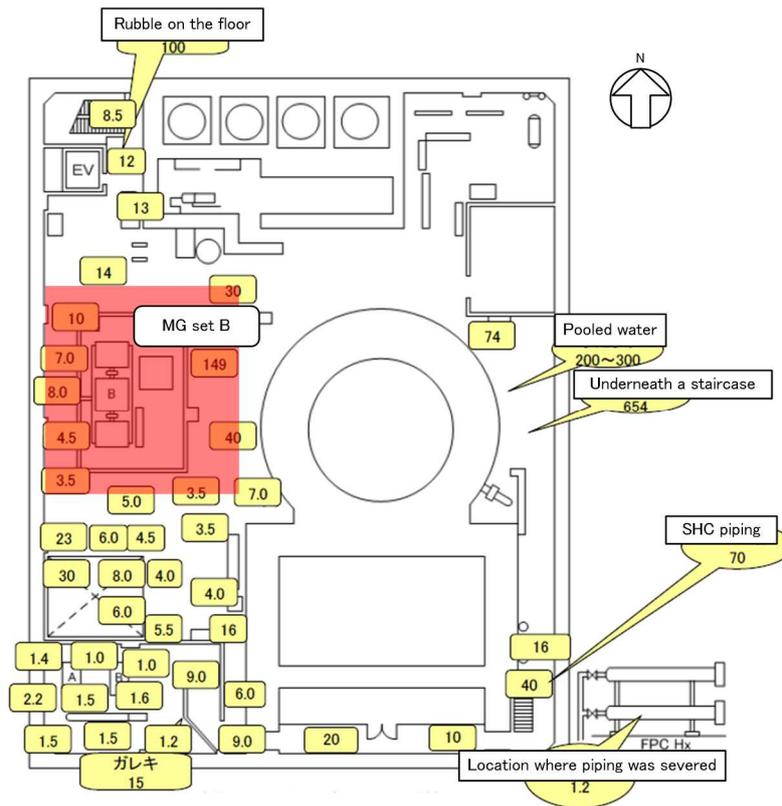
Figure 4 Air dose rates measured on Floor 3 of Unit-1 R/B (mSv/h) [1]

On Floor 3, high dose rates were measured in the west area (149mSv/h) (Figure 4). A possible cause is the MG set oil cooler (B) in the area, but other causes may be possible because the air dose rates in the surrounding area were low (3.5 to 40mSv/h). On Floor 4, dose rates in several tens of mSv/h were measured in the west and southwest areas, the highest value being 90mSv/h measured in the southwest area (Figure 5). The RCW surge tank which adjusts the RCW water inventory was installed in this area.

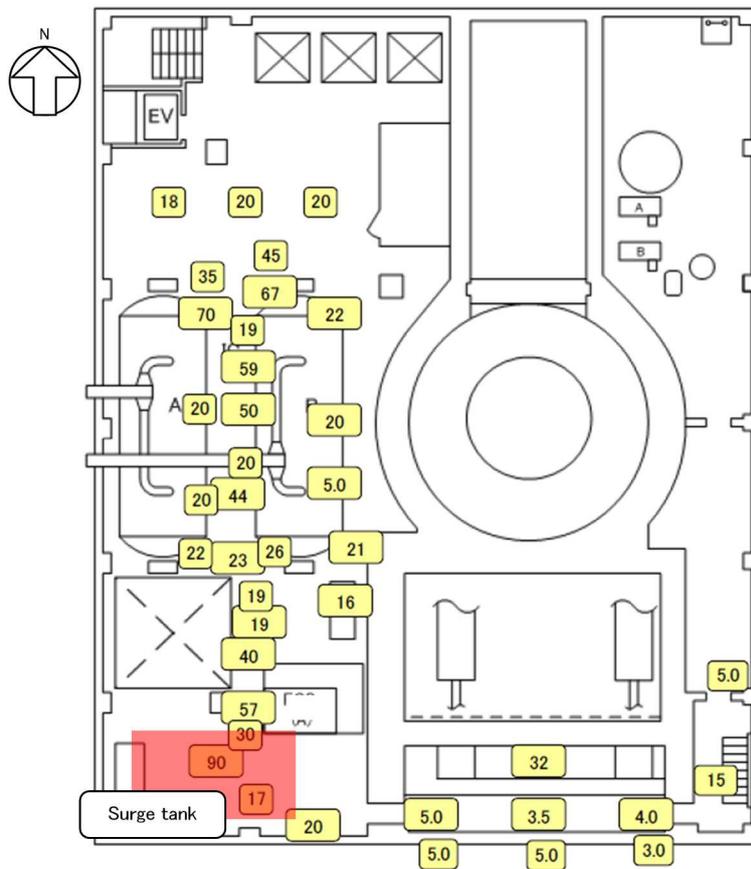
Figure 5 Air dose rates measured on Floor 4 of Unit-1 R/B (mSv/h) [1]

The RCW piping ② has four branch lines. The line to the surge tank is likely to be at about atmospheric pressure at its end and therefore the radioactive materials could have tended to migrate in the direction of the surge tank. This is consistent with the high dose rates observed

around the surge tank on the R/B Floor 4 (Figure 5). Migration to other lines depends on the distance and paths to the destination equipment or on the elevational relations with the surge tank, which is an easier destination for migration. But all downstream lines return to the heat exchanger outlet line in a closed circuit. Therefore, the line pressures are considered close to the RCW pressures and it can be considered to have been hard for radioactive materials to migrate to these lines. It should be noted that the relatively high dose rates observed in the vicinity of the MG set (A) could have been affected by the RCW heat exchanger, as mentioned in Section 2, and they could have been caused not only by the contamination in the piping.

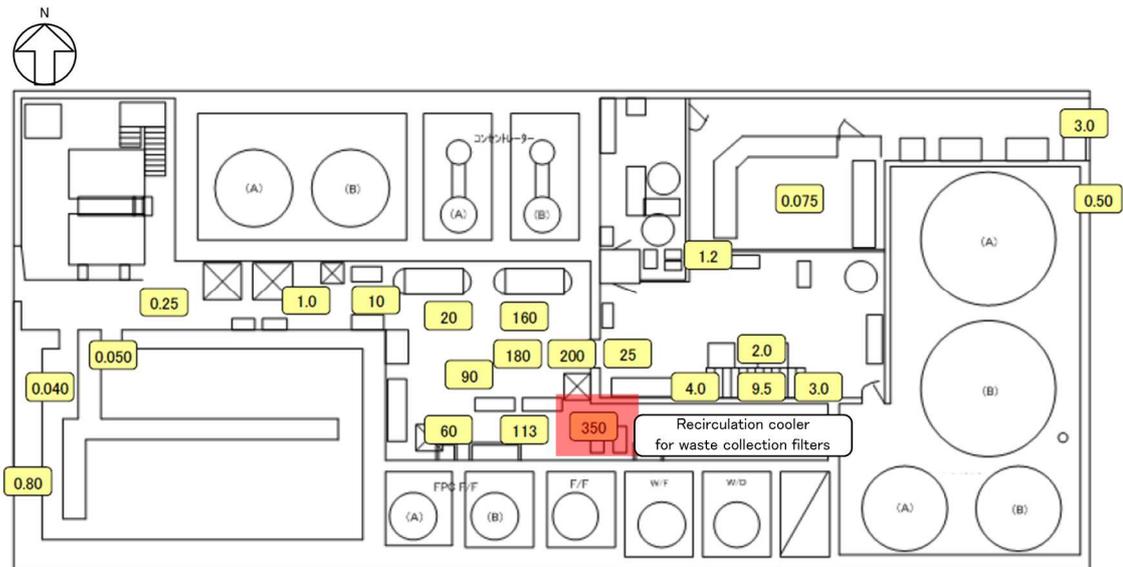
Figure 6 Air dose rates measured on Floor 1 of Unit-1 Rw/B (mSv/h) [1]

On the R/B Floor 1, a high dose rate (350mSv/h) was measured in the south area (Figure 6). In this area, a recirculating cooler for waste collection filters was installed, which was one piece of equipment to be cooled by the RCW system.

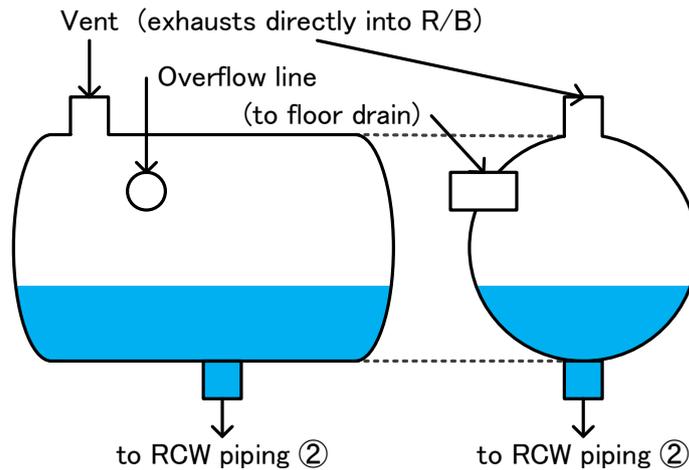
Figure 7 Structure of RCW surge tank (image)

The RCW system discharged its surge tank vent exhaust directly to the air in the R/B (Figure 7). Therefore, the pressure distribution in the RCW lines is considered to have been in a distribution with the pressure at the surge tank at 1 atmospheric pressure (about 0.1MPa[abs]). On the other hand, it has been confirmed that the PCV pressures of Unit-1 in the accident progression were kept high after the DW pressure of 0.6MPa[abs] had been measured at about 23:50 on March 11th until the PCV wet well venting (W/W venting) was successfully carried out, and then decreased over the period from 14:30 to 14:50 on March 12th when the W/W venting was implemented. Since it is probable that the migration behavior of radioactive materials in the RCW piping depended on the PCV pressures, investigation was made in Sections 4.1 and 4.2 concerning the destination of radioactive materials in the respective cases of high PCV pressures and low PCV pressures.

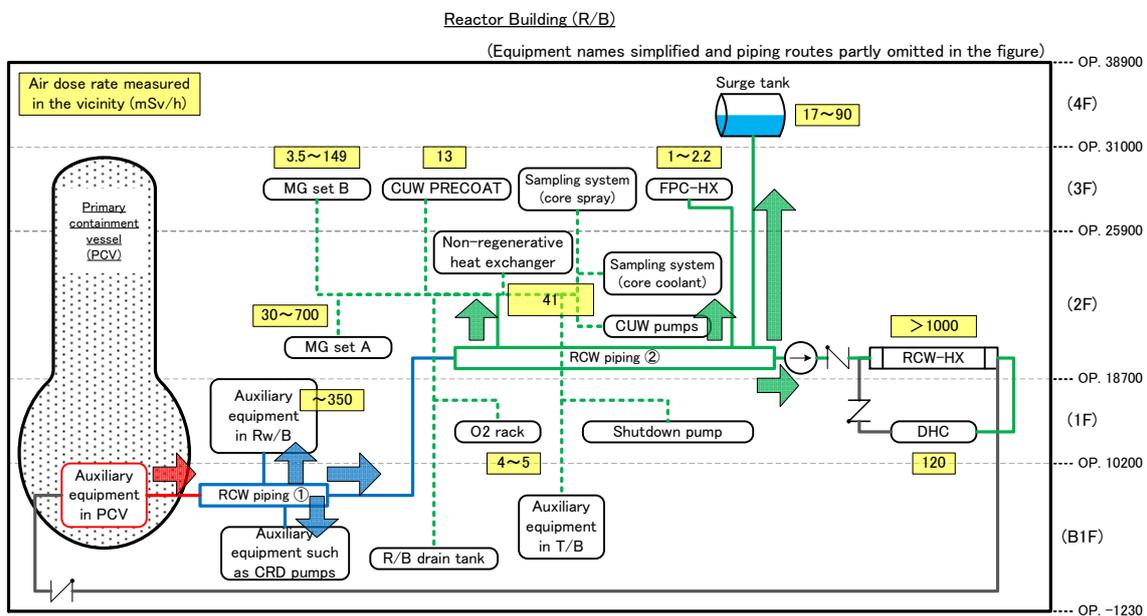
Figure 8 Migration of radioactive materials in the case of high PCV pressures

Radioactive materials migrate from the PCV to the RCW piping, since the PCV pressure at the location of damage (of the RCW piping) is higher than the pressure at the surge tank with the elevation difference and other factors being taken into account. Figure 8 shows the evaluation results of radioactive material migration in the RCW piping for the high PCV pressure situation, based on the RCW piping routes shown in Section 2 (Figure 1). When the RCW piping in the PCV pedestal is damaged, radioactive materials migrate into the RCW piping ① in Figure 8. The other side of the piping (upstream) was excluded in the evaluation, because it has a check valve near the inlet to the PCV and therefore the radioactive migration was considered to be insignificant. The RCW piping ① has three branch lines: the junction to the R/B is located closer to the PCV; the line goes to the CRD pumps and other auxiliary equipment in the Basement Floor 1; and the last line, the RCW main piping ② has a surge tank downstream. None of these three lines would have presented particular difficulties for radioactive materials to migrate through, although it is difficult to show this quantitatively. It should be noted that the high dose rates observed on the R/B Floor 1 could be due to the radioactive materials migrating to the R/B. The situation in the R/B Basement Floor 1 has not yet been investigated; it is the installed location of CRD pumps and other auxiliary equipment.

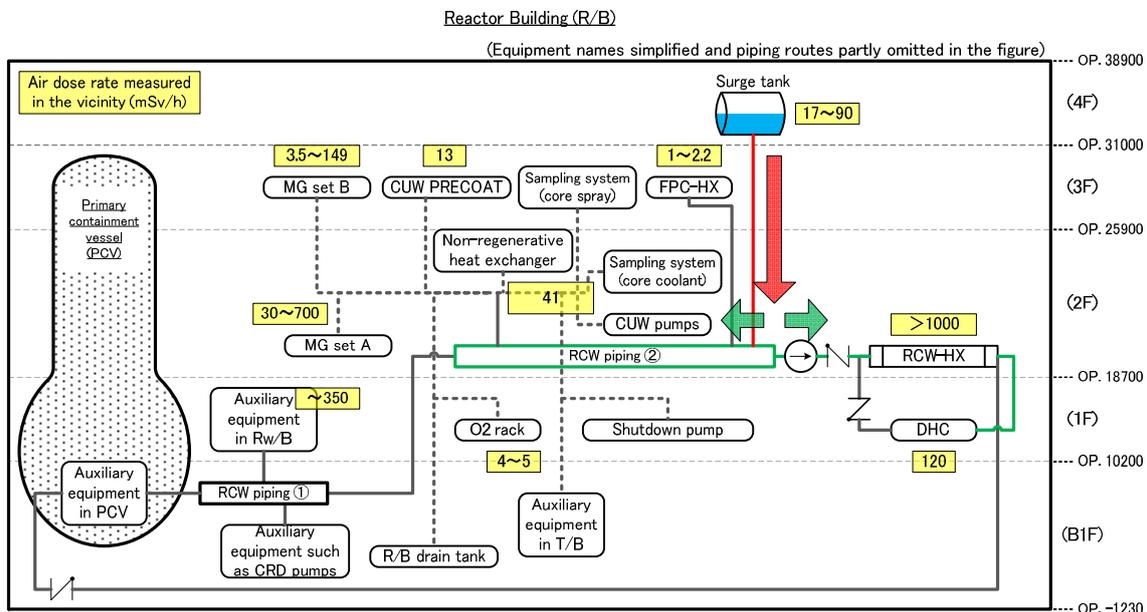
Figure 9 Migration of radioactive materials in the case of low PCV pressures

At Unit-1, the PCV pressures decreased from 14:30 to 14:50 on March 12th on the occasion of W/W venting. The radioactive materials which migrated to the surge tank when the PCV pressures were high would come down to the level where the pressures balanced with the PCV pressures. Figure 9 shows feasible migration paths for the radioactive materials accumulated in the surge tank.

When the radioactive materials being accumulated in the surge tank migrated to the RCW piping ②, they would proceed to the RCW piping ① (to the left in Figure 9) or the RCW heat exchanger (to the right). The heat exchanger had a large surface area and a large amount of

radioactive materials could be deposited therein. This estimation is consistent with the high dose rates observed around the RCW heat exchanger on R/B Floor 2 (Figure 3). It is also consistent with the high dose rates near DHC on R/B Floor 1 (Figure 2).
