The cause of RCIC shutdown in Unit 3

Attachment 3-5-11

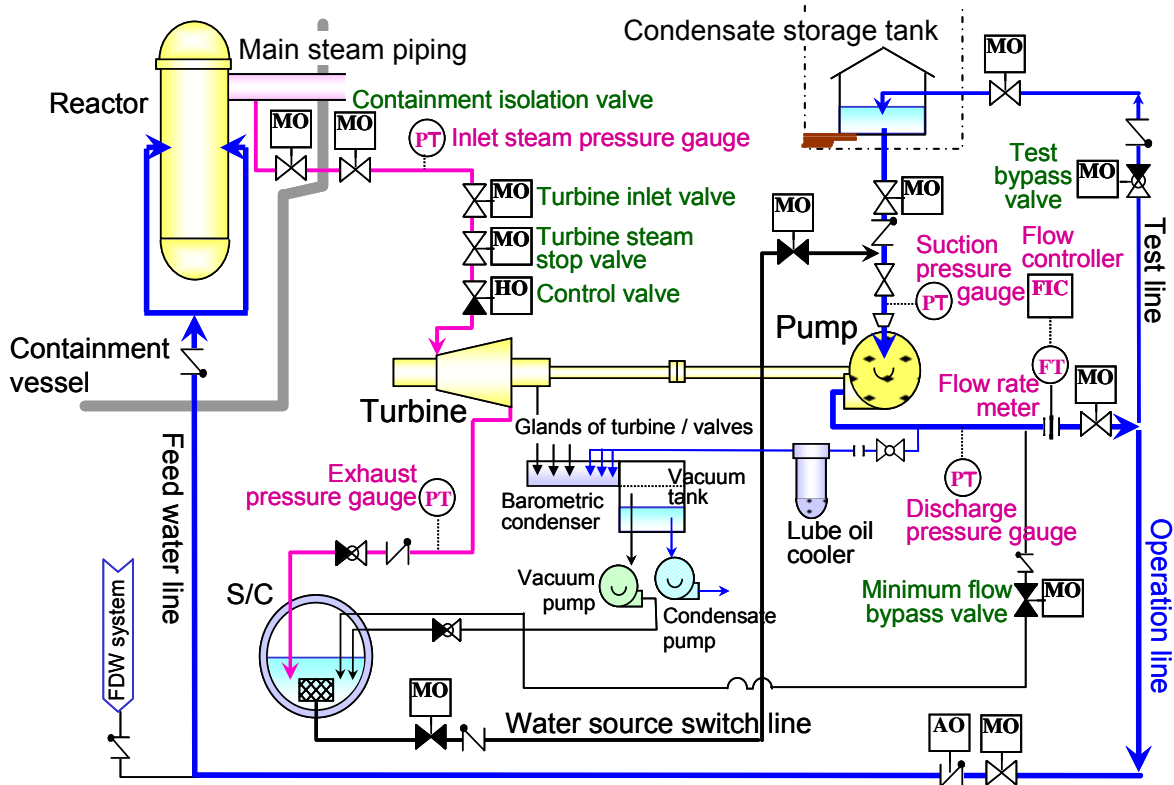
Figure 1 RCIC system diagram

Under these circumstances, the operators configured the water injection line through both the RCIC injection line and its test line by valve operations on the RCIC control panel. This was done to avoid battery depletion due to RCIC startup and shutdown, and to maintain the stable reactor water level by using the condensate storage tank (CST) as the water source. In order to ensure moderate transition of the reactor water level, the flow rate was controlled within a predefined range by adjusting the test line valve apertures and the flow indicator and controller (FIC). Figure 1 shows the RCIC diagram and the operational status.

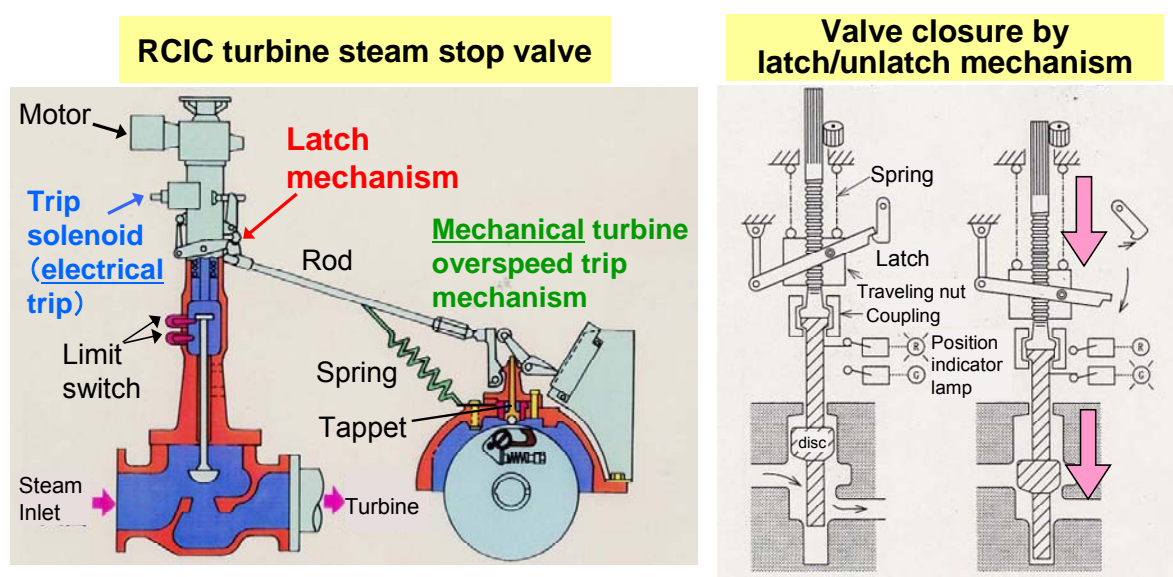
Figure 2 Schematics of RCIC turbine steam stop valve and its trip mechanisms

The RCIC turbine can be tripped by two different mechanisms: electrical trip and mechanical overspeed trip. In an unusual situation, the turbine trip stop valve is closed to cut the steam flow. Figure 2 shows a schematic diagram of the turbine steam stop valve and trip mechanisms.

A latch mechanism is built in the upper part of the valve where its stem is driven. In the electrical trip mechanism, the trip signal (an automatic trip signal from the interlock or manual trip signal) excites the trip solenoid and releases the latch. When unlatched, the spring in the valve cylinder expands and the steam stop valve is fully closed.

In the mechanical trip mechanism, the tappet in the overspeed trip mechanism is pushed upward, which works on the rod connected to the latch mechanism by spring forces, leading to the unlatching. The electrical mechanism needs a DC power source just as the RCIC needs it for operation and control, while the mechanical mechanism can work even if no DC power source is available.

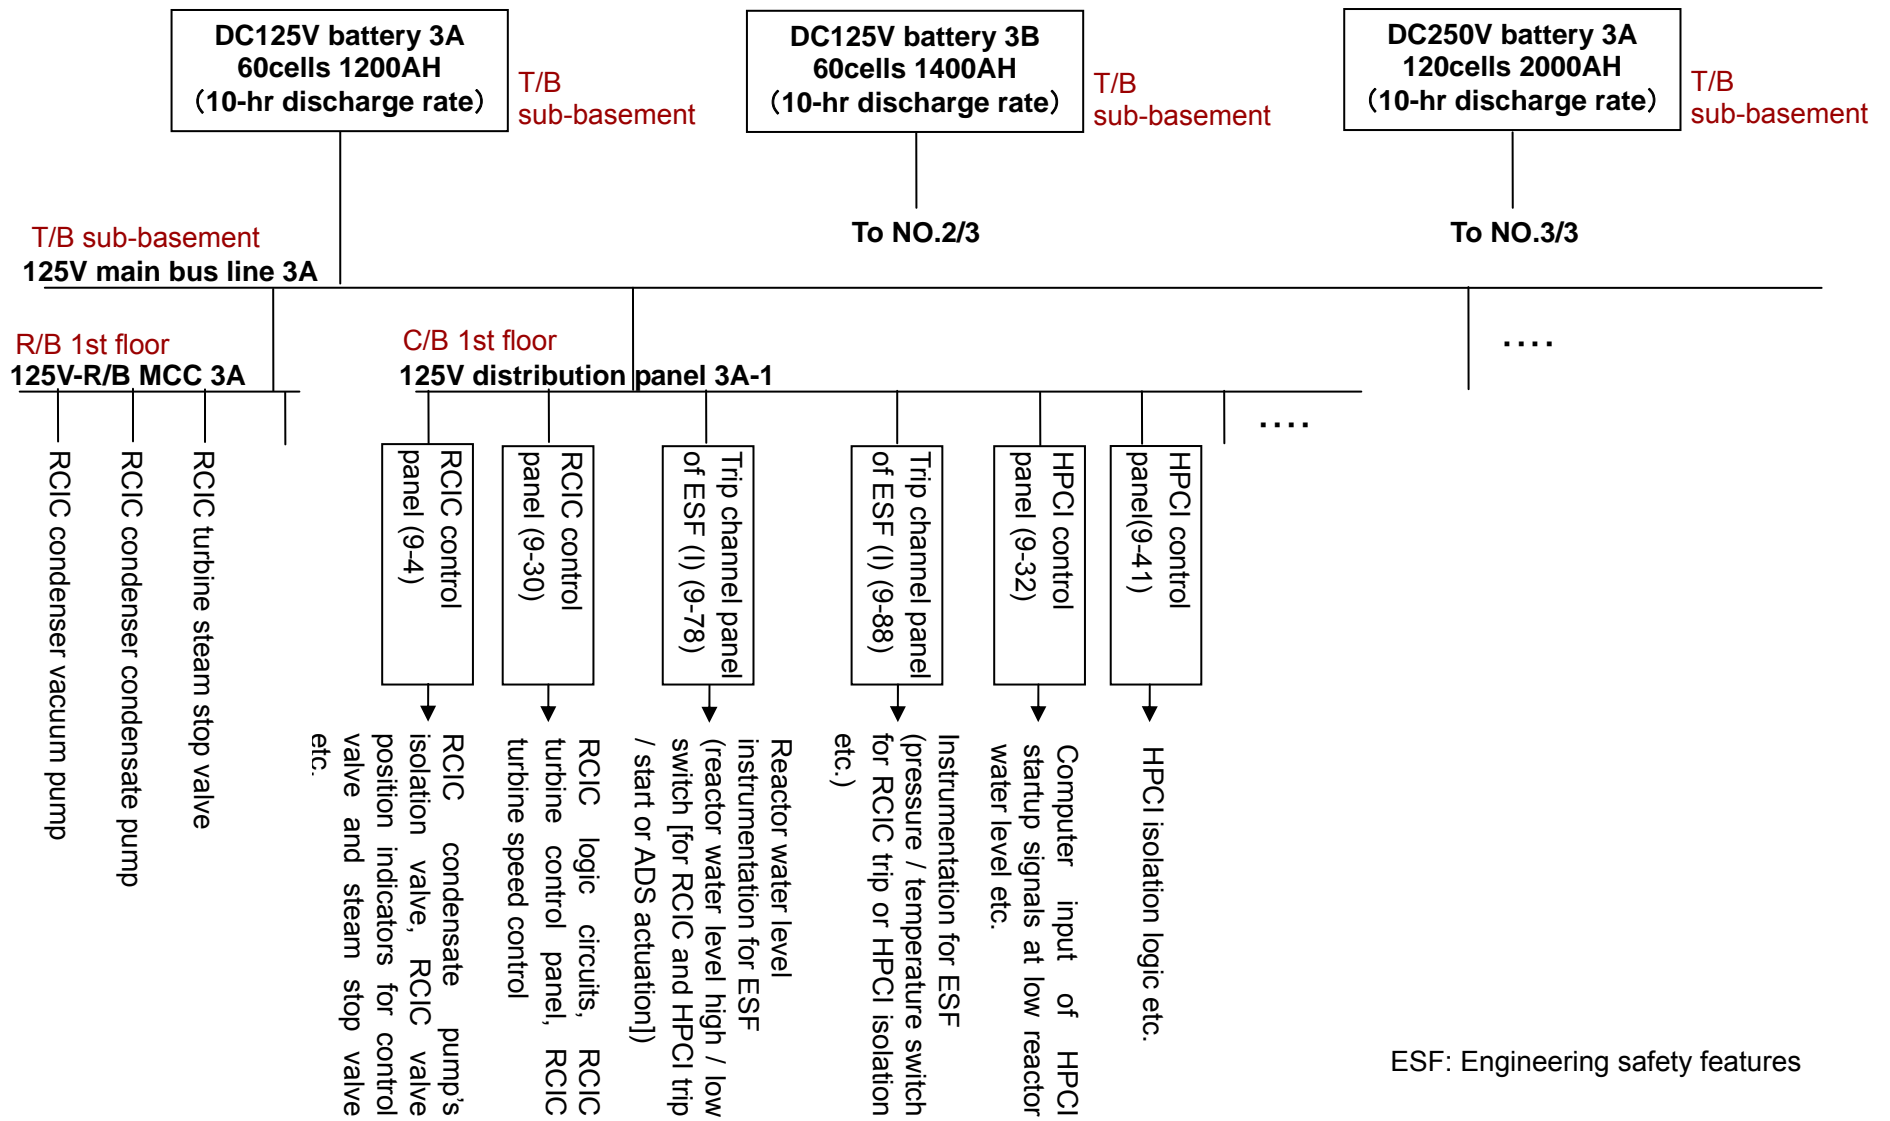
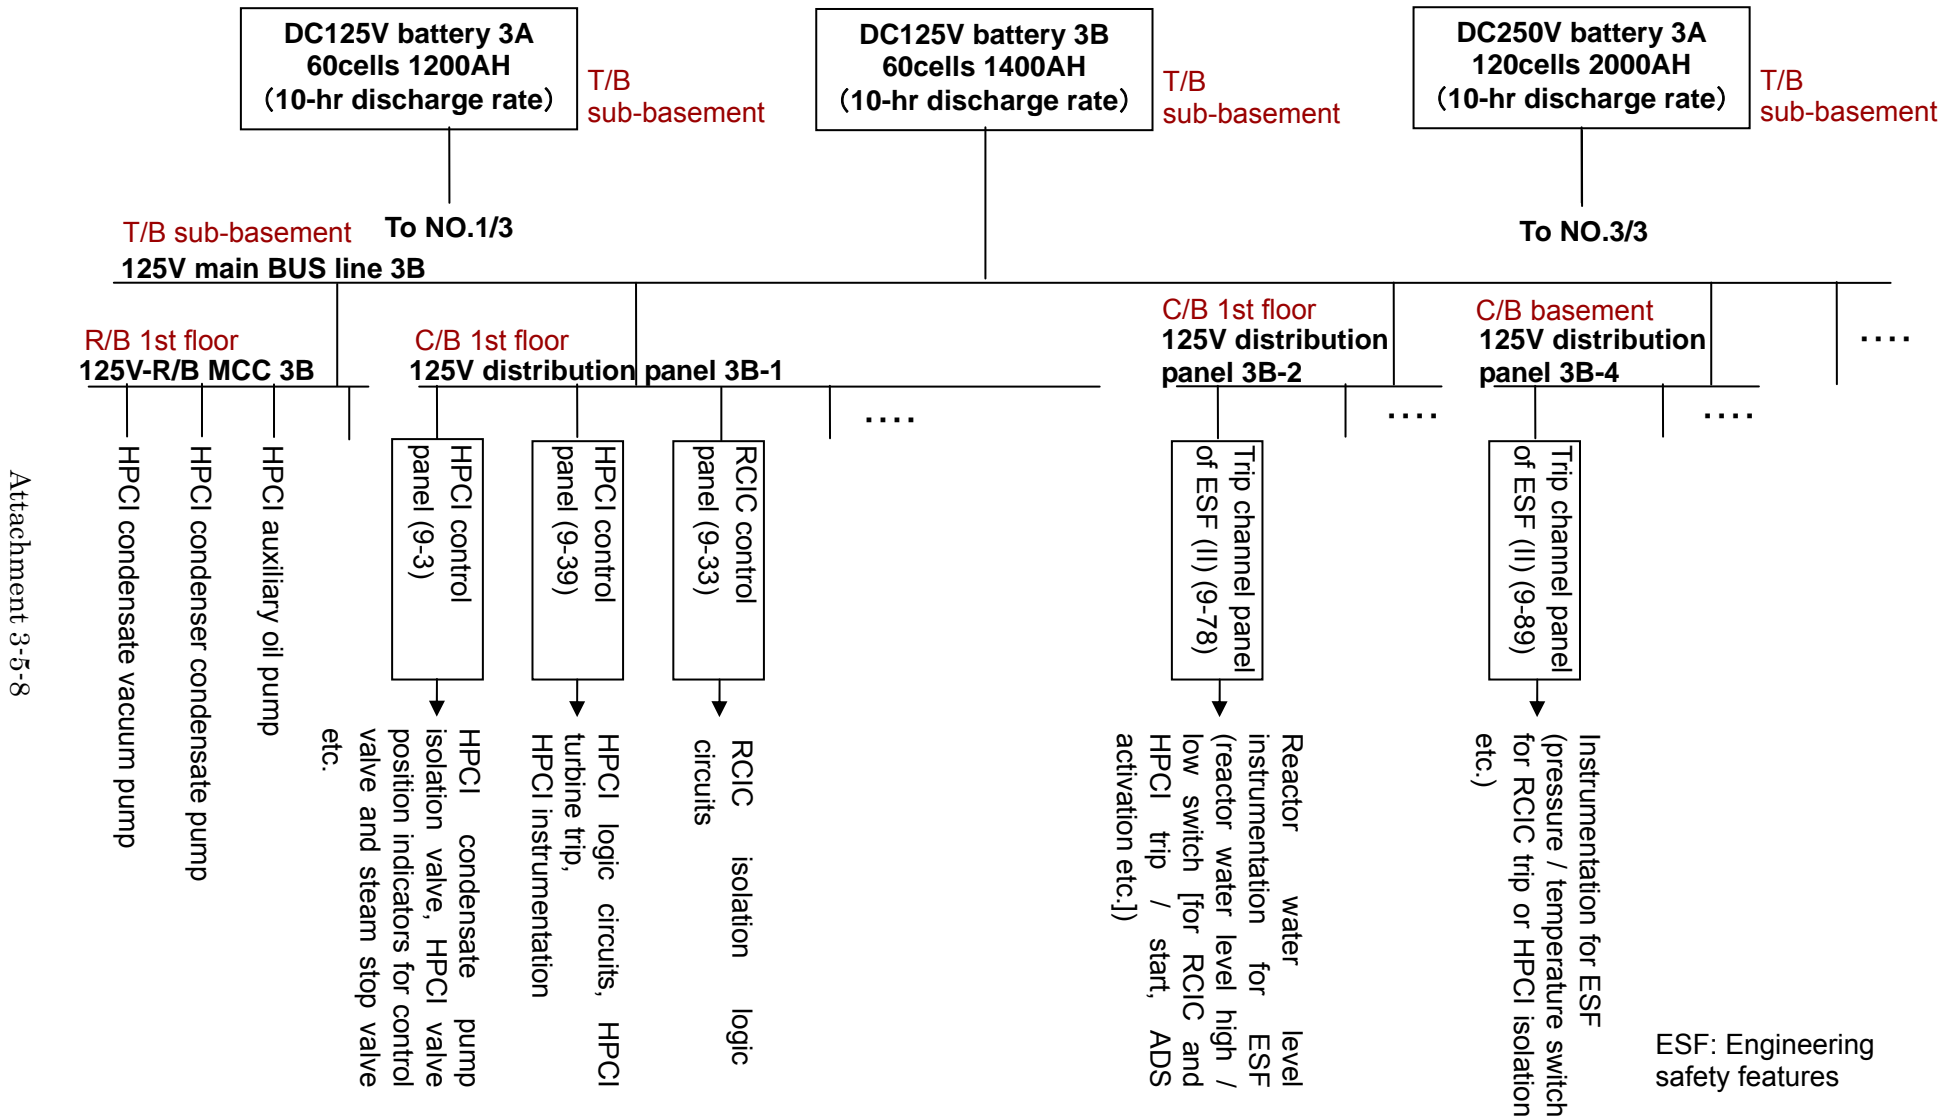
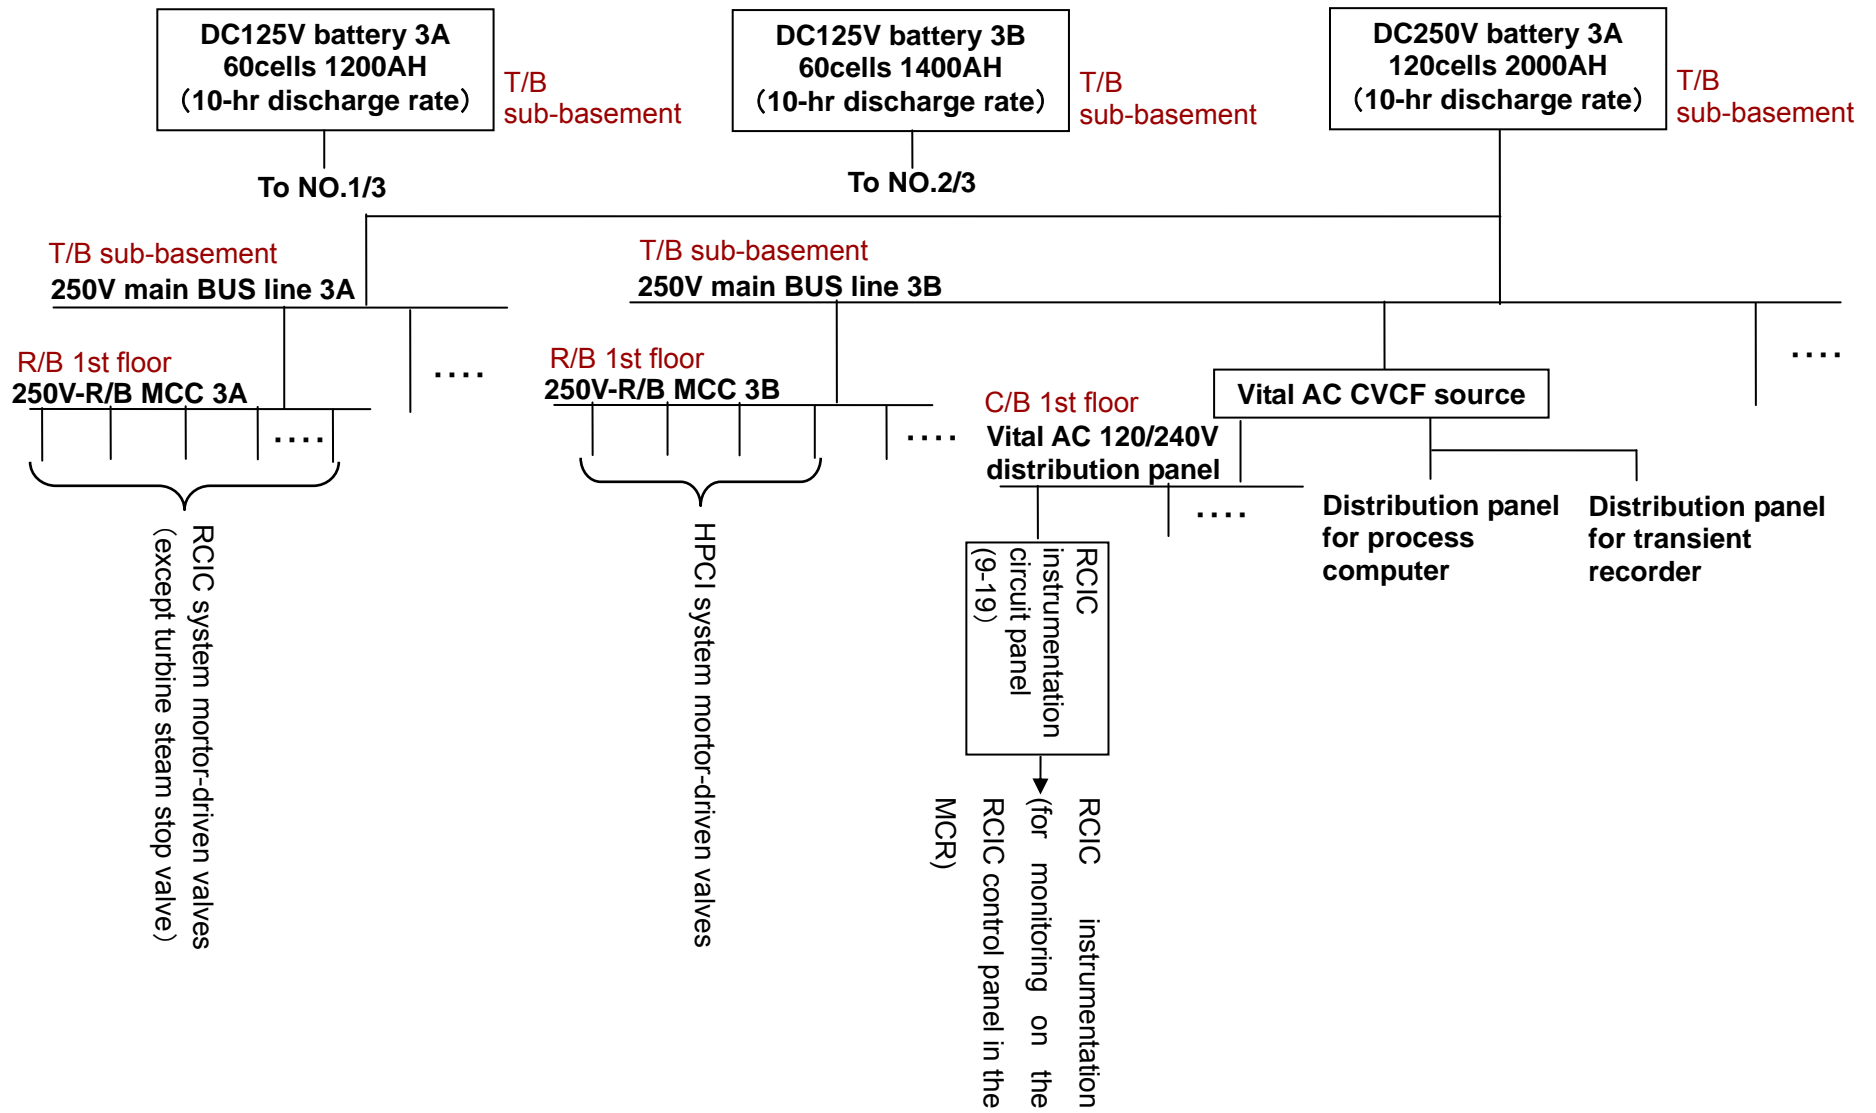
Figure 4 shows schematics of DC power distributions and loads relevant to the RCIC and HPCI of Unit 3. Batteries and DC power supply panels of Unit 3 were not destroyed by the tsunami, since they had been installed in a sub-basement of the turbine building, differing from the situation of Unit 1 and Unit 2.

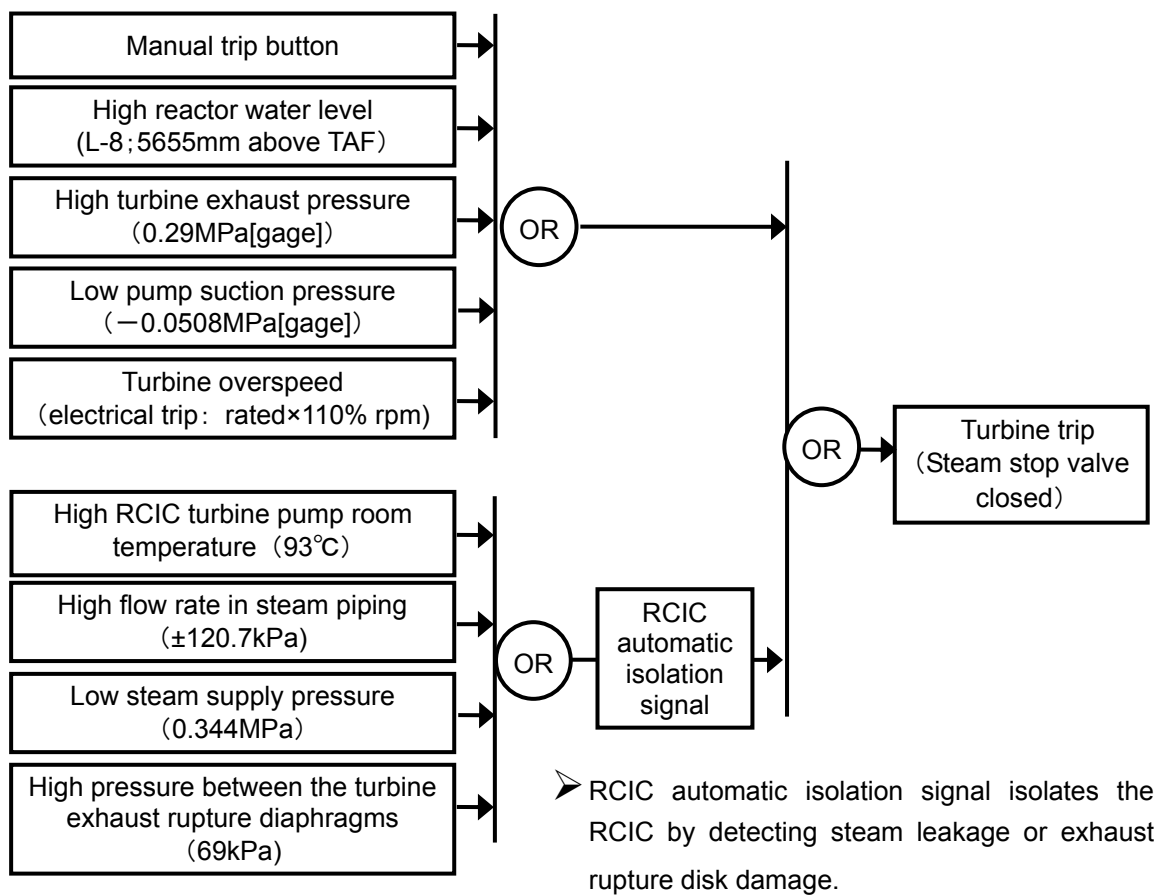
Figure 6 The interlock logic of RCIC electrical trips

Figure 6 shows the interlock logic of RCIC electrical trips.

The following subsections describe the feasibility conditions of each interlock logic, among which the highest likelihood is for high turbine exhaust pressure.

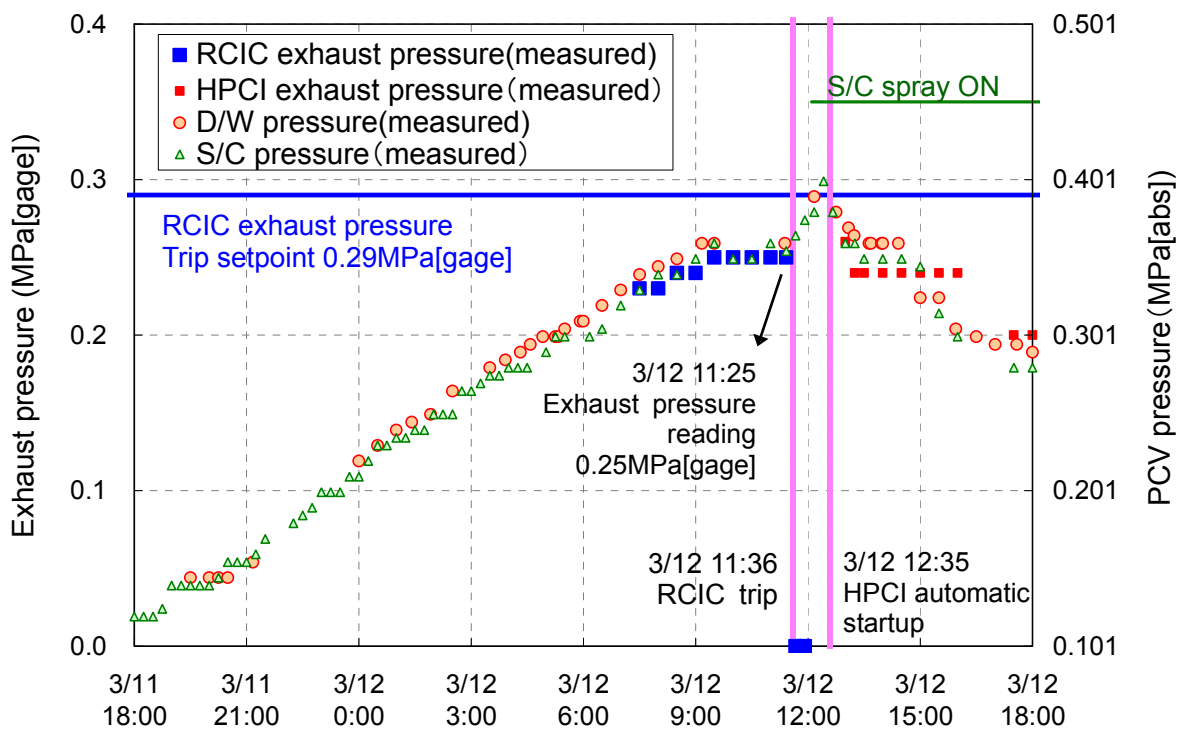
Figure 7 RCIC exhaust pressure change and PCV pressure change

Figure 7 shows the RCIC turbine exhaust pressure changes observed by the operators. Due to loss of heat removal functions, the exhaust pressure was increasing with the increase in both the D/W and S/C pressures, and as of 11:36 on March 12th, when the RCIC tripped, they were at a level very close to the preset high exhaust pressure trip level. The exhaust pressure reading was 0.25MPa[gage] as of 11:25 on March 12th, and had not reached the preset trip level (0.29MPa[gage]). Further, there is no record on the exhaust pressure at the very instant of the RCIC trip, and so no direct evidence of observation exists concerning the RCIC trip due to high exhaust pressure.

It should be noted, however, that the D/W and S/C pressures showed an increasing trend again, after remaining stable at one level for almost 3 hours before the RCIC trip, in the particular circumstance in which the PCV pressure should have simply increased under the situation of no final heat sink. Consequently, it is possible to consider that the turbine exhaust pressure reached the trip level at 11:36 on March 12th, based on the following.

As was shown in Figure 7, the turbine exhaust pressure reading was about 0MPa[gage] after the RCIC trip at 11:36 on March 12th. This is because the steam in the exhaust piping was condensed and because the S/C pressure (back pressure) was blocked by the check valve in the downstream side of the exhaust piping.

In the development of tsunami accident management procedures under station blackout conditions for the Kashiwazaki-Kariwa Nuclear Power Station, a procedure to bypass the high RCIC turbine exhaust pressure interlock is being developed to continue water injection using the RCIC even when the S/C pressure increases. This is based on a concept to prioritize continuing the RCIC operation for flexibility even if the turbine exhaust pressure exceeds the trip level, since such an operation will not damage the RCIC equipment immediately.

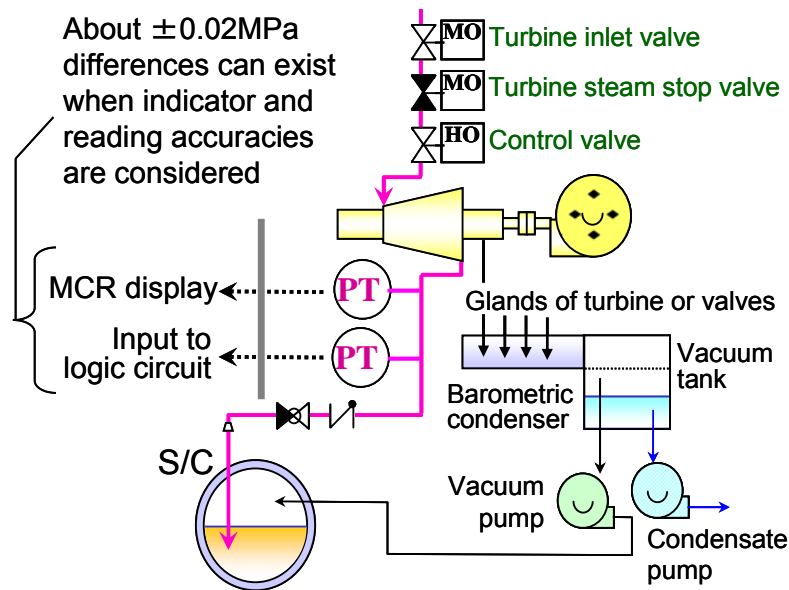
Figure 8 Positional illustration of RCIC exhaust pressure gauges

As is shown in Figure 8, exhaust pressure gauges for the MCR indicator and the logic circuit input are different, and about 0.02MPa difference could exist in these two instrumentations due to instrumentation accuracies and reading errors. Even taking these inaccuracies into account, the

pressure reading of 0.25MPa[gage] at 11:25 on March 12th is considered not to have reached the trip level (0.29MPa[gage]).

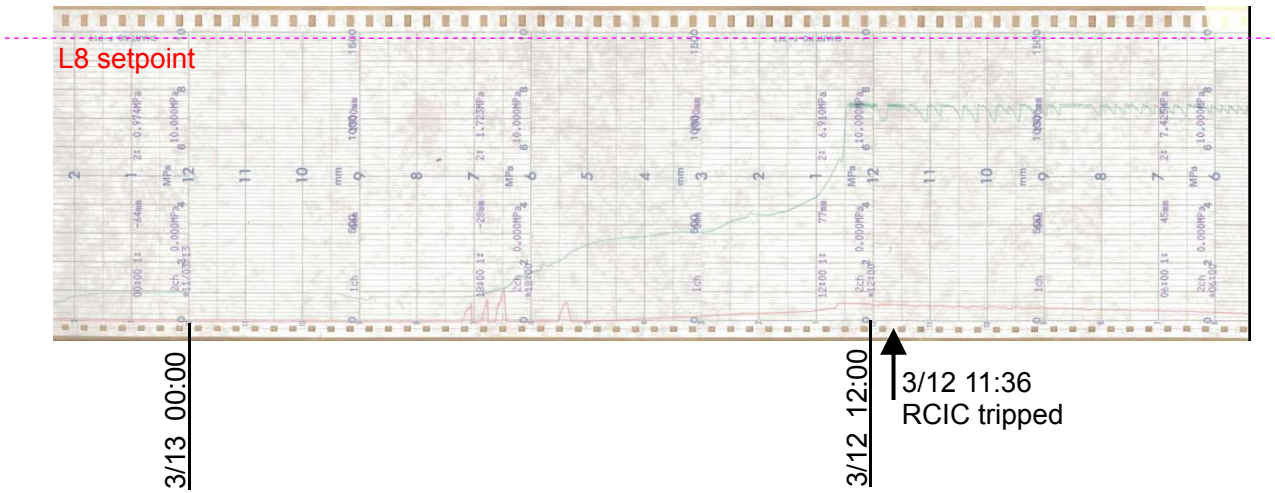
Figure 9 Chart record of reactor water level/pressure

Figure 9 shows the chart record of reactor water level (narrow range) and Figure 10 shows the measured water level changes which operators read in the indicators. The RCIC flow rate was being controlled by the FIC while monitoring the reactor water level, and as of 11:36 on March 12th, when the RCIC tripped, the reactor water level had not reached the level L-8. An RCIC trip due to high reactor water level interlock is not possible.
