Dose increase around March 20th, 2011

1. Background

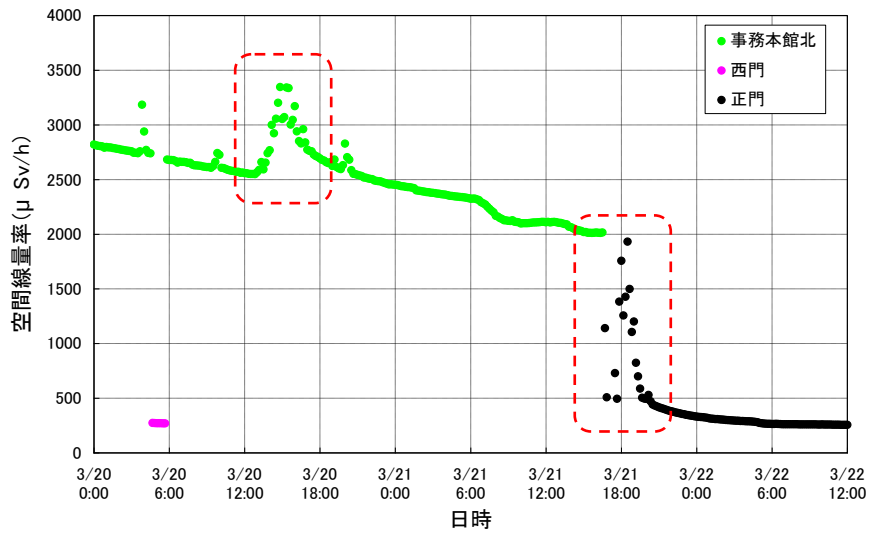
Figure 1 Dose increase on March 20th and 21st, 2011

Figure 1 shows the dose level change observed during March 20th and 21st in the area surrounding the Fukushima Daiichi NPS. The dose increase in question is described by the data enclosed within the dotted red lines. On March 20th the dose rose about 800 μ Sv/h in two hours from 12:50 to 14:50 in the north area of the main administration building. The dose remained above 3000 μ Sv/h till about 16:00, then began to decrease. On March 21st the dose jumped to about 1400 μ Sv/h in 100 minutes from 16:50 to 18:30 near the main gate. The dose decreased thereafter and returned to the level before the dose increase.

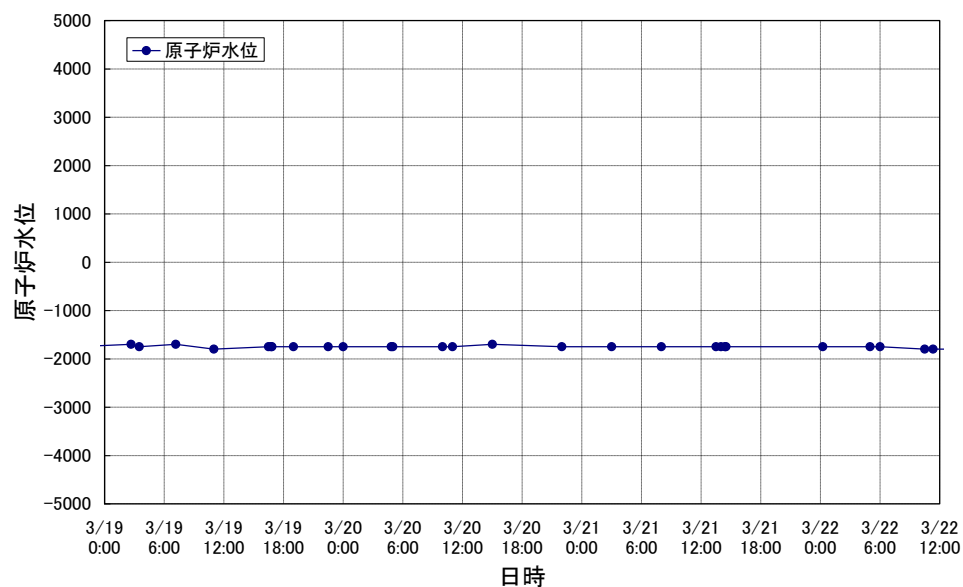
Figure 3 Reactor water level of Unit-1

Concerning Unit-1, Figure 3 and Figure 4 have no noticeable significant changes in the reactor water level, reactor pressure and PCV pressure during the time period when dose increase was observed, although the data points are limited. In Figure 5 CAMS (D/W) readings show a big drop after 12:00 on March 20th, which might indicate a possible release of radioactive materials from the containment vessel. But the PCV pressure shows no changes and the CAMS (S/C) data show no big changes during the period of interest. All in

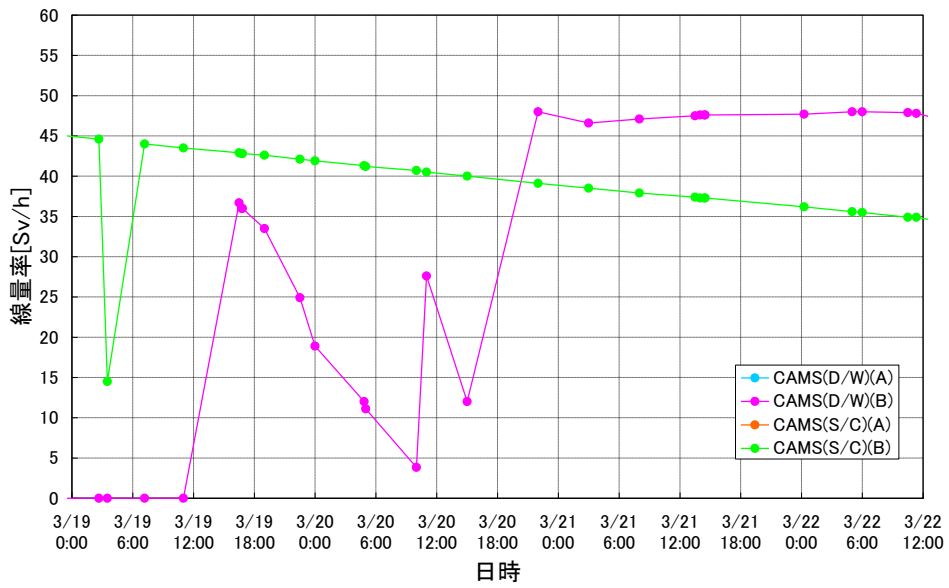
Figure 5 CAMS readings of Unit-1

all, the change in the CAMS (D/W) readings is reasonably attributed to defective individual readings.

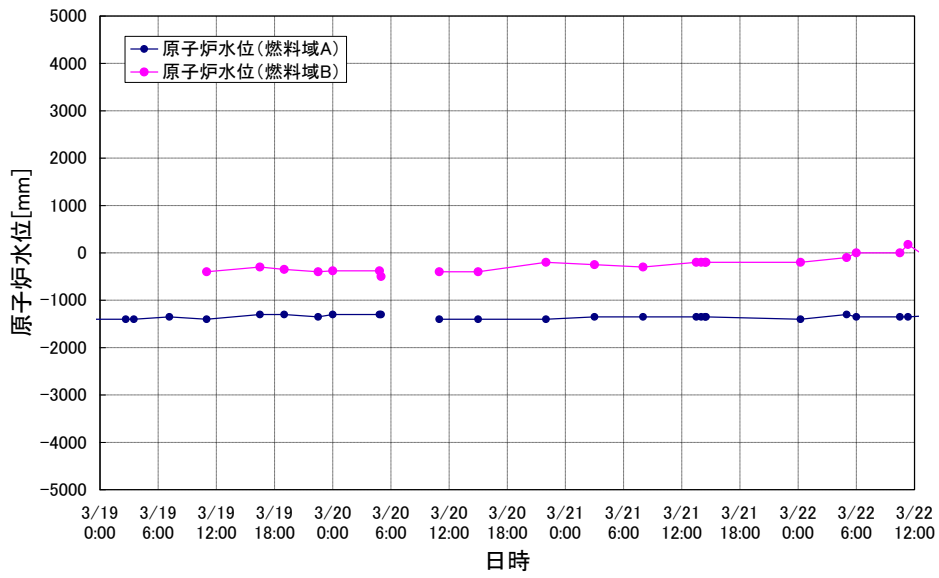
Figure 6 Reactor water level of Unit-2

Concerning Unit-2, Figure 6 and Figure 7 have no noticeable significant changes in the reactor water level, reactor pressure and PCV pressure during the time period when the dose increase was observed, although the data points are limited. In Figure 8 CAMS (D/W) readings show a lower value at 11:00 on March 20th than those before and after. But again the change in the CAMS (D/W) readings is reasonably attributed to defective individual readings, because of a discontinuity in particular readings and the CAMS (S/C) data show no changes over the same time period.

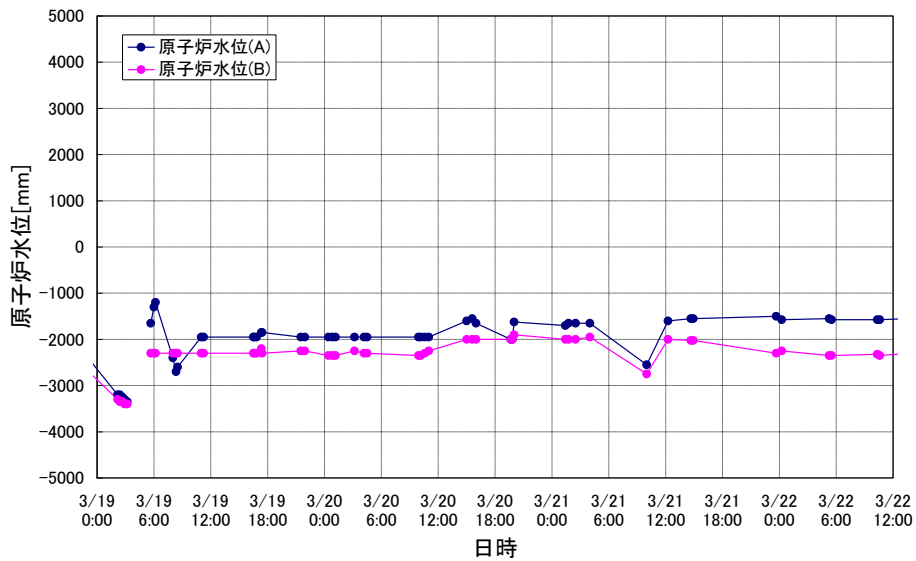
Figure 9 Reactor water level of Unit-3

Concerning Unit-3, Figure 9 and Figure 10 show a slight increase in the reactor water level and a slight decrease in the reactor pressure and D/W pressure during the time period when the dose increase was observed on March 20th. During this time period, the reactor temperature and PCV temperature showed a decreasing tendency [1]: the temperature of the feedwater nozzle (N4B) decreased from 210 deg C (at 11:00) to 140 deg C (at 15:00), that of reactor vessel bottom head from 244 deg C (at 11:00) to 220 deg C (at 15:00), and that of D/W HVH return line from 220 deg C (at 11:00) to 187 deg C (at 15:00). This leads to the understanding that the temperature decrease caused the pressure decrease of the reactor and PCV. In Figure 11 CAMS readings show no changes during the period of interest. From these considerations a new incident releasing radioactive materials during this time period of interest at Unit-3 seems unlikely to have occurred.

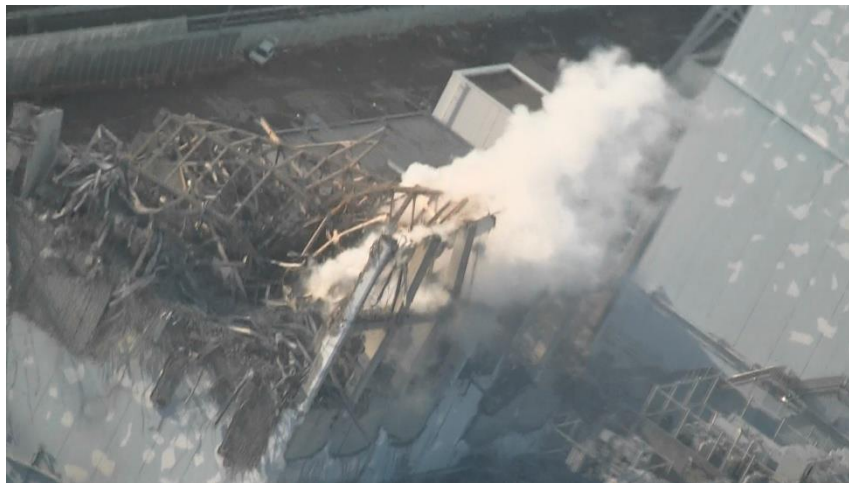
Figure 12 Aerial photo of Unit-3 (March 16th, 2011)

have been more or less continuously released from the containment vessel of Units-1 to 3. For example, steam and other gases rose from the Unit-3 containment vessel as white smoke that passed from the upper side of the building after it had been damaged by the hydrogen explosion. This situation can be seen in an aerial photo taken on March 16th (Figure 12).

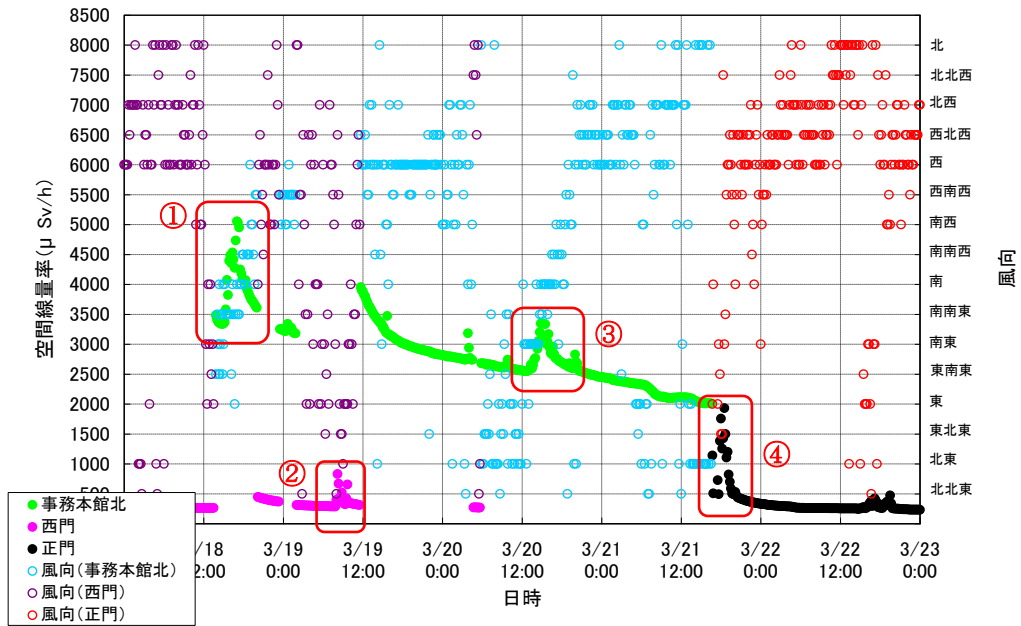
Figure 13 Air dose changes and wind direction

To assess this possibility, the car position at the time of the dose increase was checked as to whether it was downwind. Figure 13 shows the correlation between wind direction and air dose during the period of March 18th to 23rd [2]. The relation between the monitoring car position and wind direction was reviewed, especially at the time points ① to ④ in Figure 13, when the air dose increase had been observed. The monitoring car was positioned at these times at the north side of the main administration building, the west gate or the main gate.

As a general observation from Items 5.1 to 5.3 above, more measurement points seemed to have been downwind when the dose increase was observed, and on the contrary they seemed to have been in other wind directions when the dose decrease was observed. Consequently, the wind directions might have been relevant to the dose increase on March 20th and 21st.
