Status of investigation on estimating situation of cores and containment vessels

1. Introduction

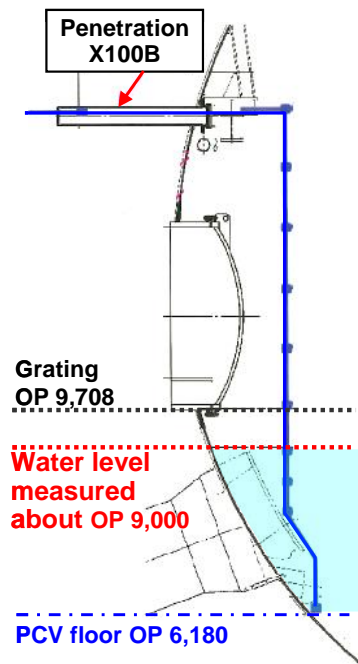
Figure 2-1 Measured level of water retained in Unit-1 PCV

The level of water retained was measured by lowering the CCD camera cable down to the water surface through the grating above in the PCV. The water level was found to be about 2.8m above the D/W floor (as of October 10, 2012) (Figure 2-1).

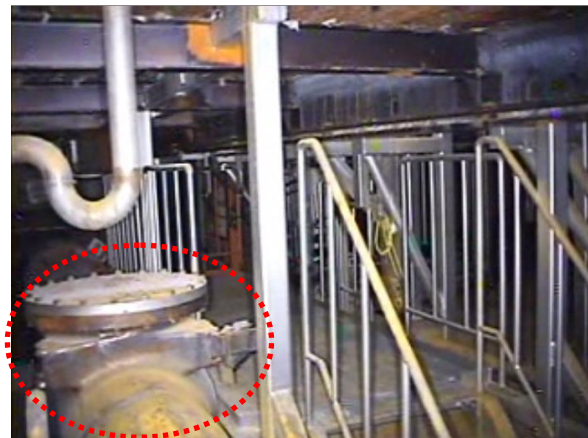
Figure 2-3 Camera photo of an S/C vacuum breaker in the torus room of Unit-1

No water leaking position in the S/C has been located yet. At least, no leak was confirmed on the flange of one of the eight vacuum breakers, as far as the camera photos showed (Figure 2-3).

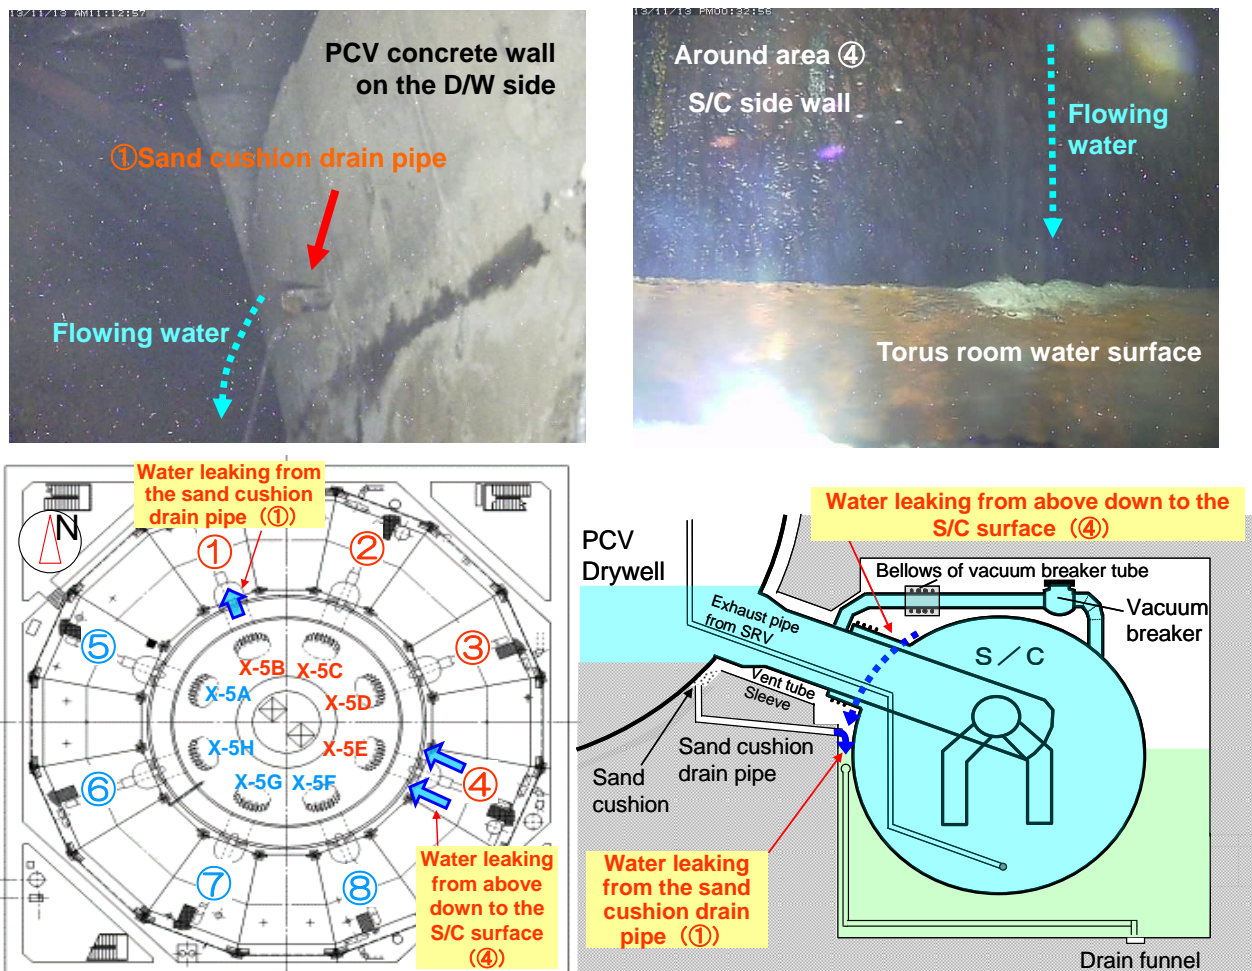
Figure 2-4 Camera images taken below the vent tubes in Unit-1 torus room (part)

Camera imaging confirmed water leaks at the following locations (Figure 2-4).

\*Water leaks at ① were confirmed since the vinyl chloride pipe (connecting the sand cushion drain tube and drain funnel with an insertion-type joint) had been displaced. Water leaks could not be confirmed at locations ② to ⑧, since the drain tubes had not been displaced. The concrete seams (joints) below the sand cushion drain piping were observed to be wet all around on the concrete wall.

Water leaks into the sand cushion occur only when water leaks directly from the drywell. The leakage is probably from a low position of the drywell below the water level (for example, the containment vessel shell, pipe penetrations, etc.). The low location of the water leaks in the drywell would indicate the possible influence of molten fuel that fell to the PCV bottom. This information is of critical significance in estimating the conditions of the core and PCV.

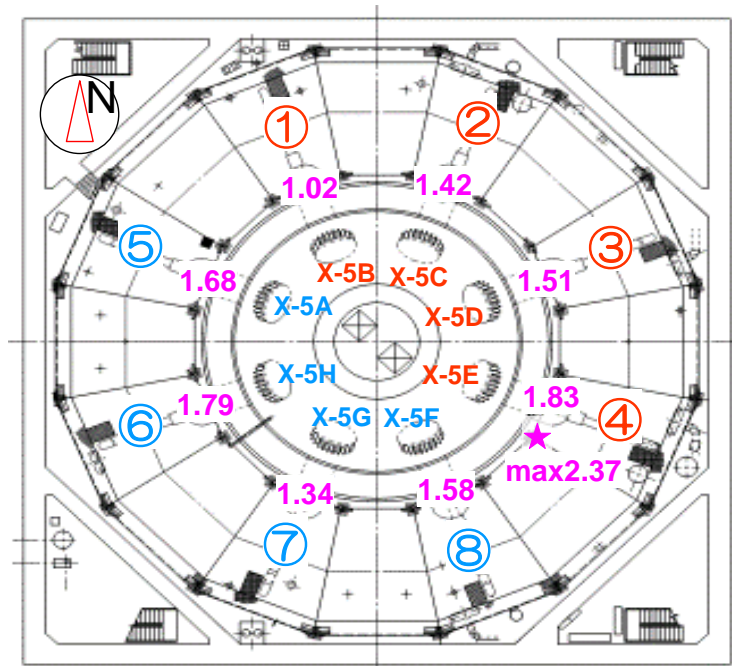
Figure 2-6 Dose distribution measured during the torus room investigation underneath vent tubes of Unit-1

The vertical distribution of radiation doses measured when lowering the instrumentation boat in November 2013 was similar to that measured in February 2013 (in the area surrounding the torus). Dose distribution along the boat traveling route was about 1 to 2 Sv/h, and the highest spots were in the southeast area (Figure 2-6).

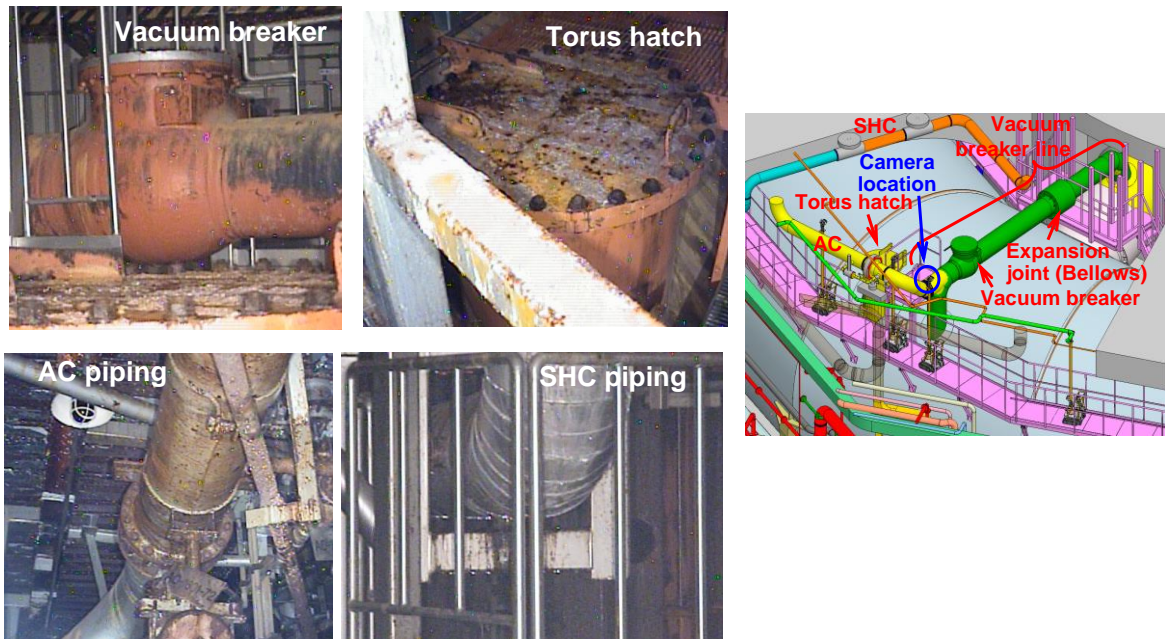
Figure 2-7 Camera images of Unit-1 S/C top area exploration (around vent tube X-5E) (Part)

In May 2014, survey instrumentation robot was introduced through a drilled hole in the northwest area of the first floor of the Unit-1 reactor building to explore the S/C top area in order to locate the leak source near the vent tube X-5E, where leaking had been confirmed. By using the outer catwalk, the instrumentation robot made a camera survey around the vent tube X-5E, and the water leak was confirmed to be from the protective cover of the expansion joint on the vacuum breaker line. No leaks were noticed from the vacuum breaker valve, torus hatch, shutdown cooling system (SHC) piping or atmospheric control system (AC) piping (Figure 2-7) [7].

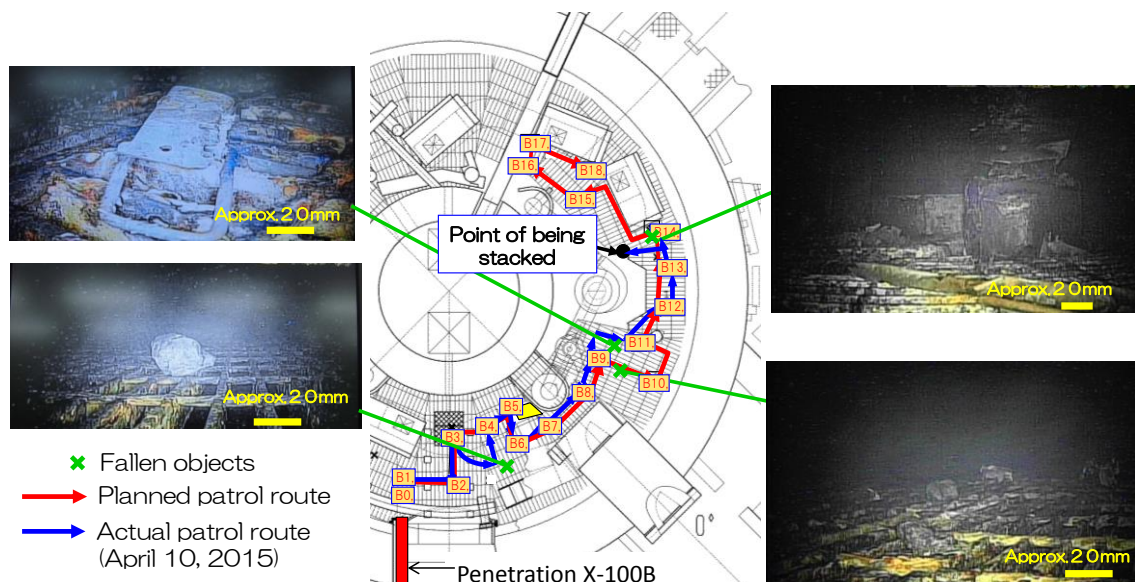
Figure 2-9 Photos taken during the anti-clock-wise patrol [9]

The grating floor on the ground level outside the pedestal of Unit-1 was investigated from April 10 to 18, 2015. A running robot machine was sent through the PCV penetration X-100B. The robot patrolled clock-wise and anti-clock-wise by about 180 degrees for investigating damaged conditions of existing structures and presence of obstacles. Figure 2-9 and Figure 2-10 present a part of the photos taken during the anti-clock-wise and clock-wise patrols, respectively. As seen in Figure 2-9, no big damage was recognized on the HVH (heating ventilating handling unit), PLR piping, pedestal walls, PCV inner walls, etc., although fallen objects were noticed on the patrol path.

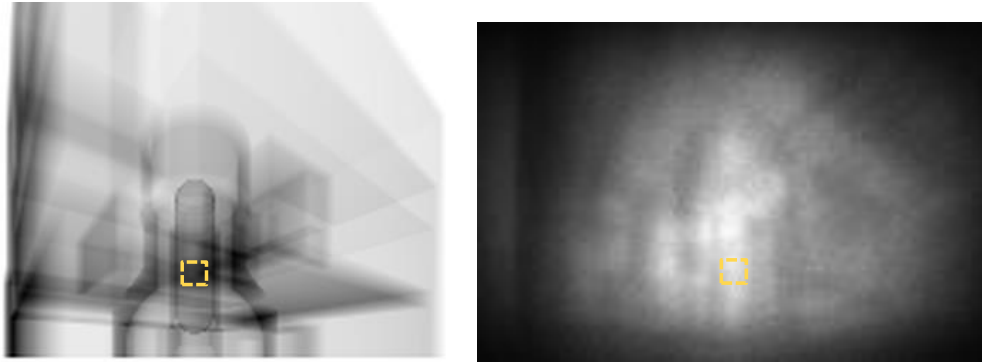
Figure 2-12 Muon image of the reactor predicted from the design (left) and that of the actual reactor based on measurements for 96 days (right) [11]  
(dotted region corresponds to the original core position)

Figure 2-12 shows the image of the reactor predicted from the design (left) and the image of the actual reactor obtained by muon measurements for 96 days (right), both at Point 1. The basic principle of measurements by the muon transmission method is the same with that of

X-ray (Roentgen) photography. High density objects absorb more muons and are photographed in black. In the image of the reactor as designed with intact fuel, a black portion is recognized corresponding to the position of the core. In the image of the actual reactor, on the other hand, some recognizable equipment such as the spent fuel pool and isolation condensers are found, but there is no high density object (fuel) at the core position.

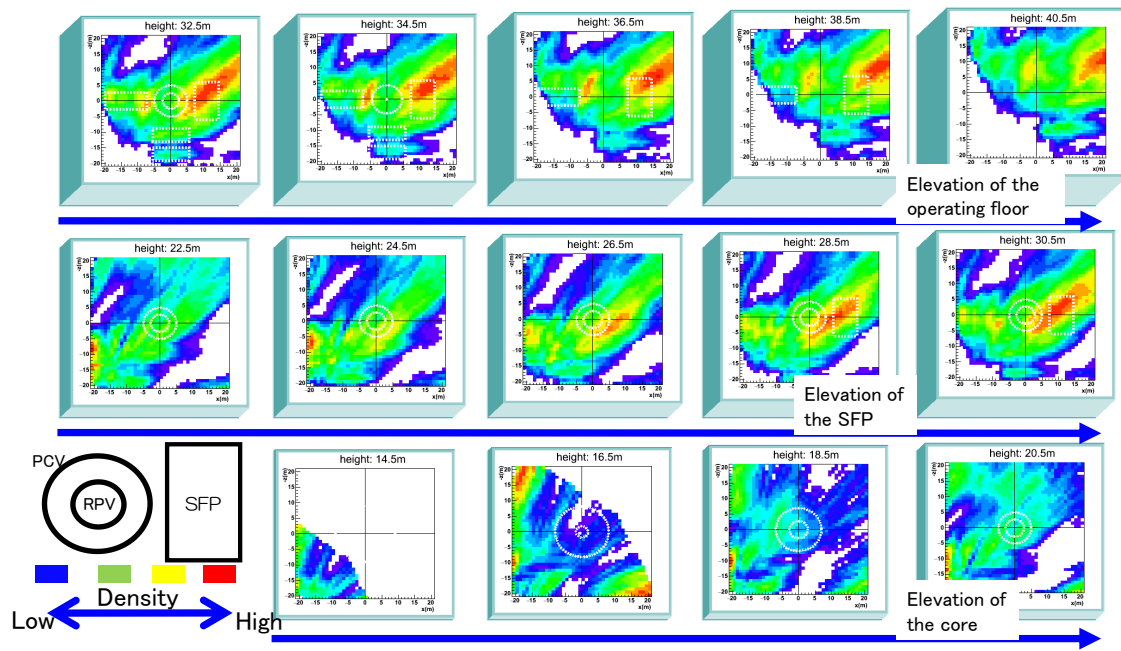
Figure 2-13 High density material distribution maps at three separate elevations

From these considerations, no fuel is thought to be left at the core position. This is consistent with the estimated conditions of the core and PCV previously announced by TEPCO.

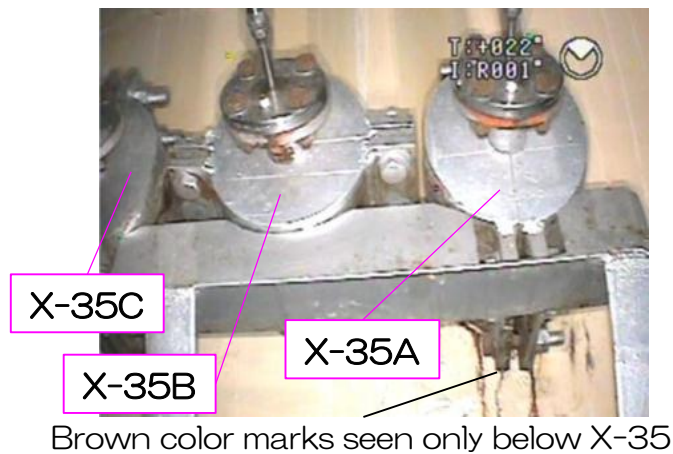
Figure 2-16 Optical camera photo taken at the penetration X-35 [12]

Exterior appearances of PCV penetrations, piping and other objects in the TIP room were surveyed by an optical camera. Some brown-colored specks hinting at flow lines were noticed around PCV penetration X-35A (Figure 2-16). But, as mentioned above, no radiation source was noticed around the area of penetrations X-35A to X-35D. No other marks hinting at leaks were recognized at any places around the penetrations, piping and other objects in the TIP room including the penetrations X-31, -32 and -33.

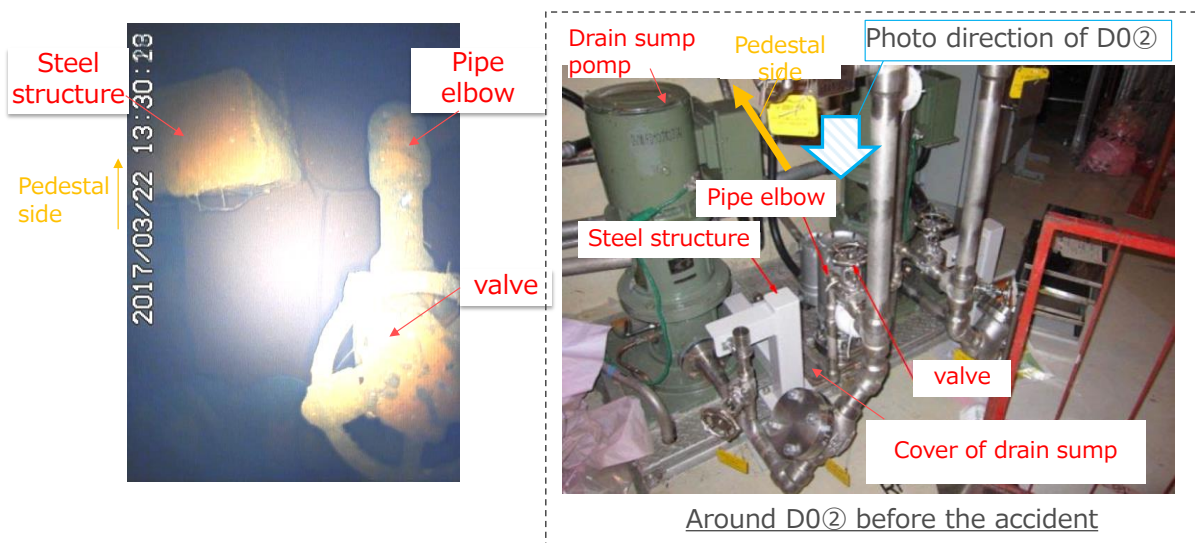
Figure 2-19 Observation from Point D0 [14]

Figure 2-19 presents the observation results by cameras from Point D0 near the drain sump outside the pedestal. No big damage or collapse of structures around the drain sump can be confirmed.

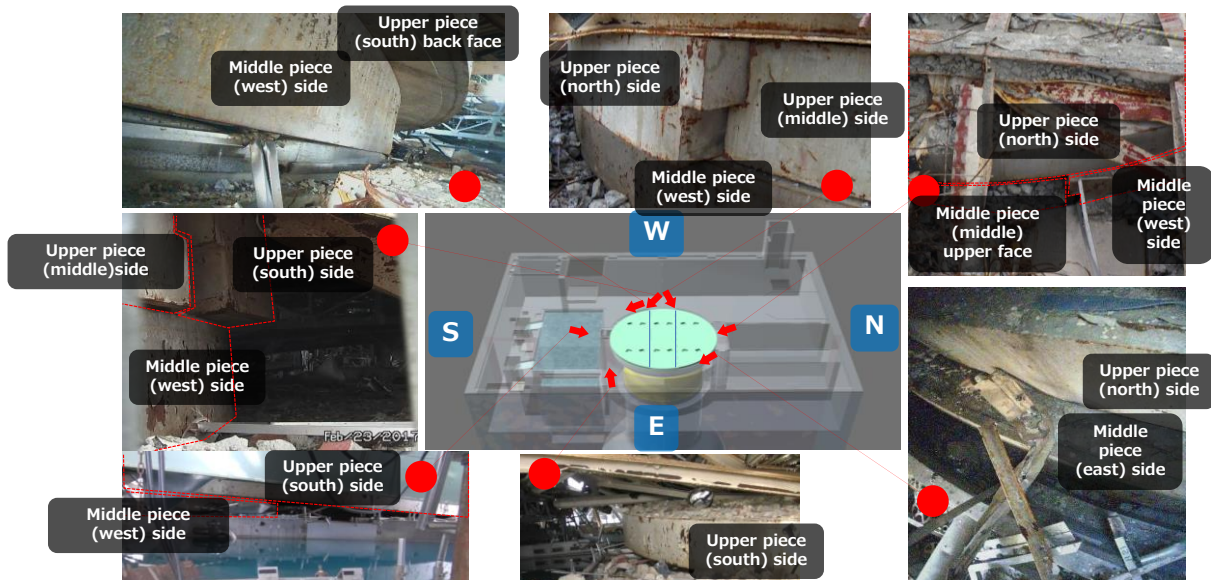
Figure 2-23 Well-plug pieces as they were on the operating floor [16]

Figure 2-23 shows the well-plug damage conditions observed on the operating floor. The position of each well plug is estimated to have moved, as shown in Figure 2-24. The north piece of the upper well-plug was found to have moved to the west by about 720 mm. The center and north pieces of the upper well-plug were found to have been deformed downward by a maximum of 155 mm and 84 mm, respectively.

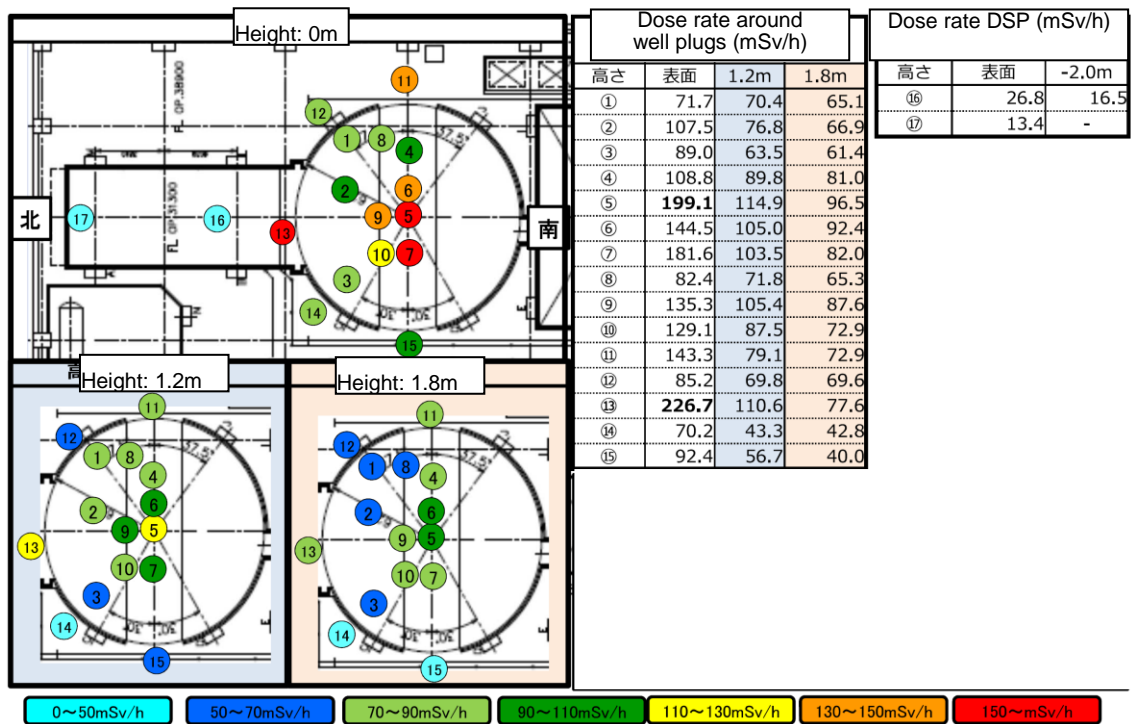
Figure 2-26 Dose rates on the operating floor [18]

Figure 2-26 shows the results of dose measurement. Dose rates were found higher at the central part on the well-plugs and in the north side around the well-plugs.

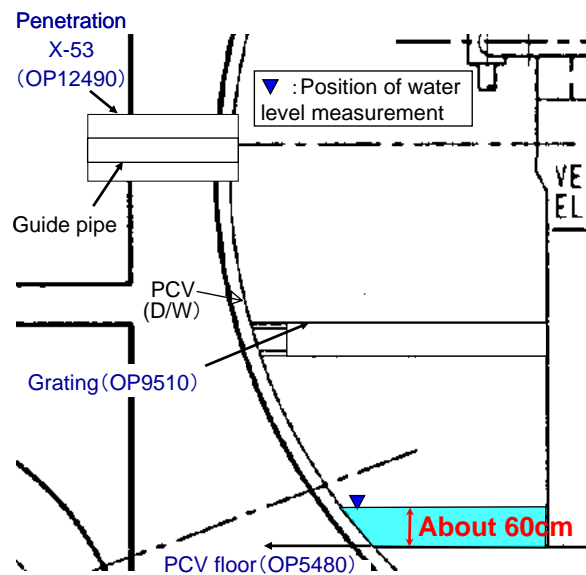
Figure 3-1 Measured level of retained water in Unit-2 PCV

The level of water retained was confirmed to be about 60 cm above the D/W floor by the video image scope (as of March 26, 2012) (Figure 3-1).

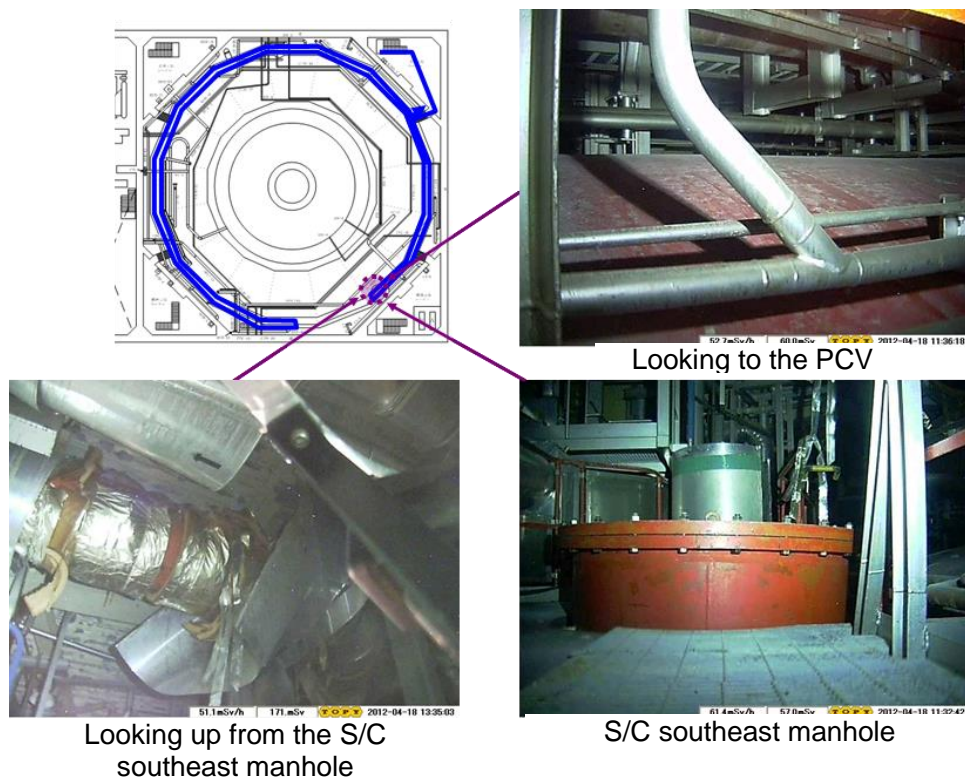
Figure 3-5 Camera photos in the torus room of Unit-2 (part)

No water leaking position in the S/C has been located yet. At least, no leak was confirmed on the flange, etc. of the S/C manholes, as far as the camera photos show (Figure 3-5).

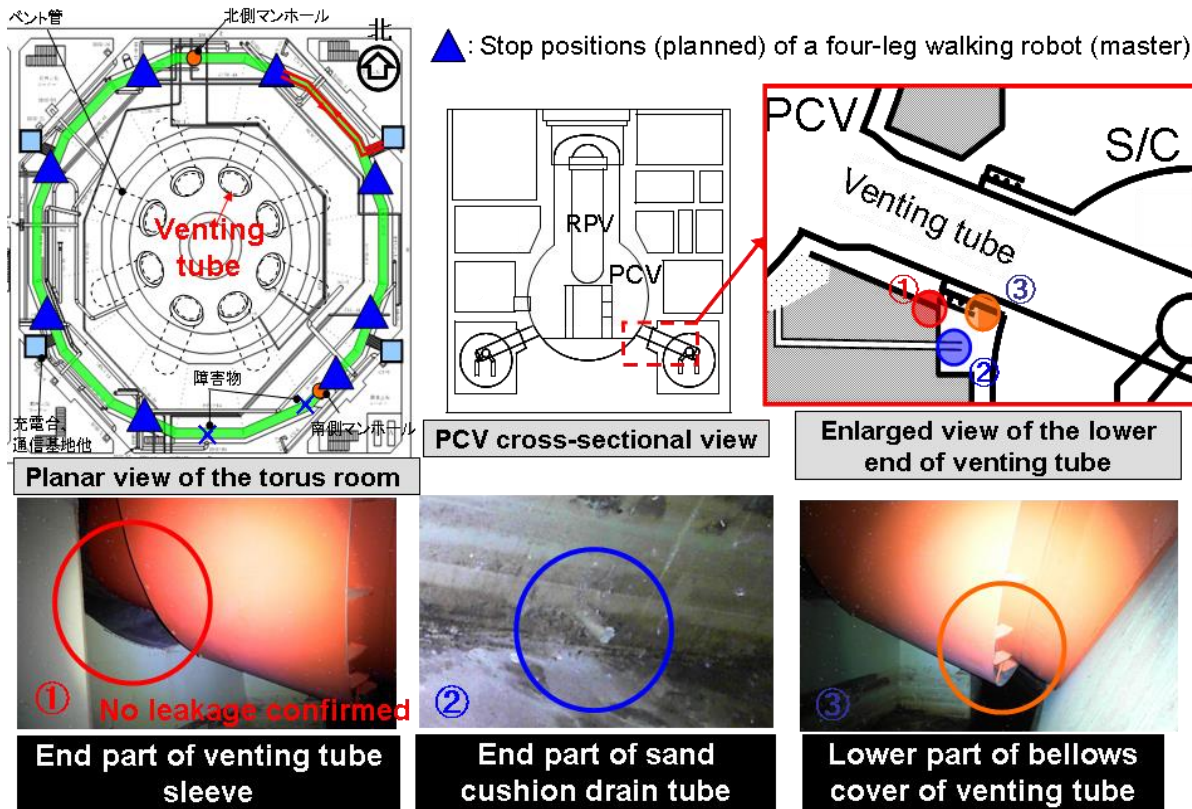
Figure 3-6 Camera photos around the lower end of the venting tubes in the torus room of Unit-2 (part)

No water leaking position in the S/C has been located yet. At least, no leak was confirmed from the lower end of venting tubes within the visible range (Figure 3-6).

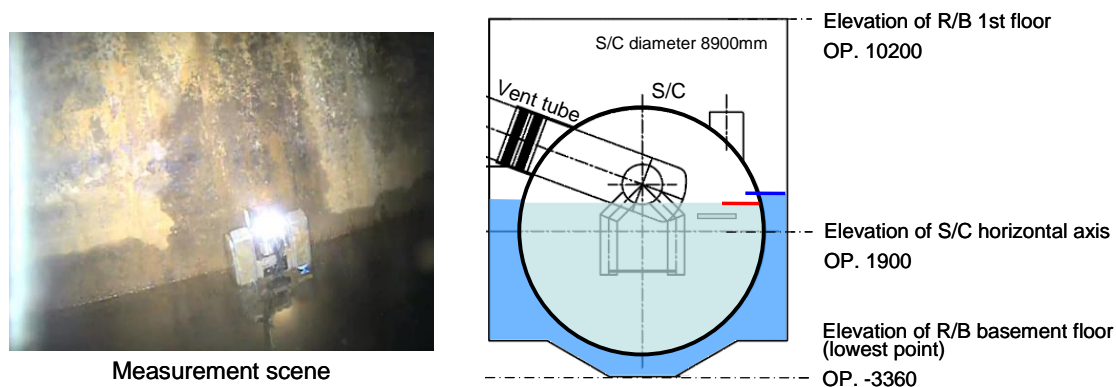
Figure 3-7 S/C water level measurements of Unit-2

The S/C water level is in correspondence with the level of water retained in the torus room. This is consistent with the water level estimated earlier by the nitrogen gas injection tests. This information confirms that water leaks occurred at the S/C lower position (including piping).

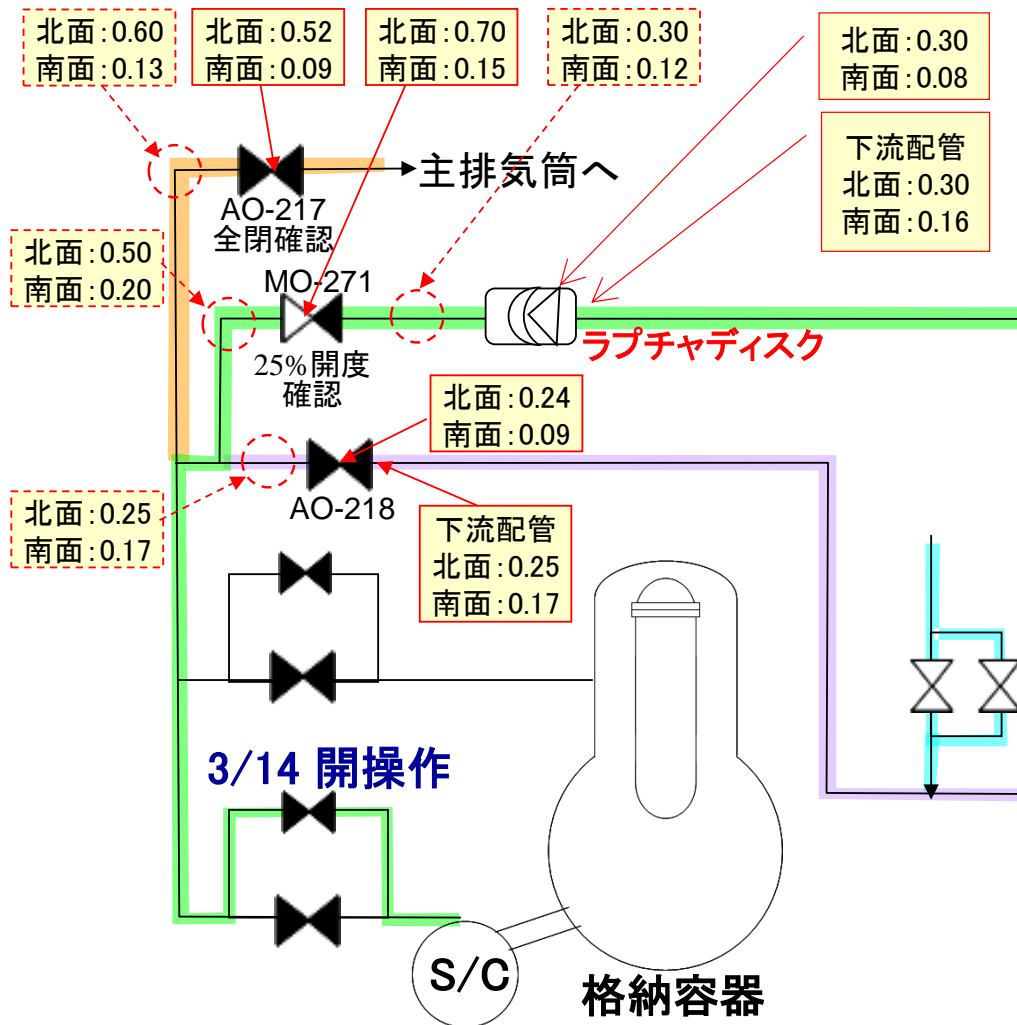
Figure 3-9 Radiation levels observed around the rupture disk (mSv/h)

Figure 3-9 shows the results of radiation measurement around the rupture disk. The measurement was done on October 8, 2014. The radiation level measured was 0.30 mSv/h from the north face, while it was 0.08 mSv/h from the south face. Both were at about the same level of 0.30 mSv/h (north face) and 0.12 mSv/h (south face) before the rupture disk on the venting line, or 0.30 mSv/h (north face) and 0.16 mSv/h (south face) after the disk. These values indicate that the area is not contaminated to the extent predictable for such lines as the Unit-1 venting line, through which gas containing a large amount of radioactive materials went.

Furthermore, there exists a consistent tendency in the surrounding area that the levels on the north face are higher than those on the south face. This may indicate that the observed radiation levels were influenced by some unknown high level radioactive source existing on the north side of

the rupture disk area, i.e., the radiation levels observed on the north face of the venting line and the rupture disk were actually measurements of radiation coming from that unknown high level radioactive source on the north side without the shielding effect of the piping, while the radiation levels obtained on the south face were actually measured after being shielded by the piping. Therefore, it is highly likely that the rupture disk and the piping around the disk are the least contaminated.

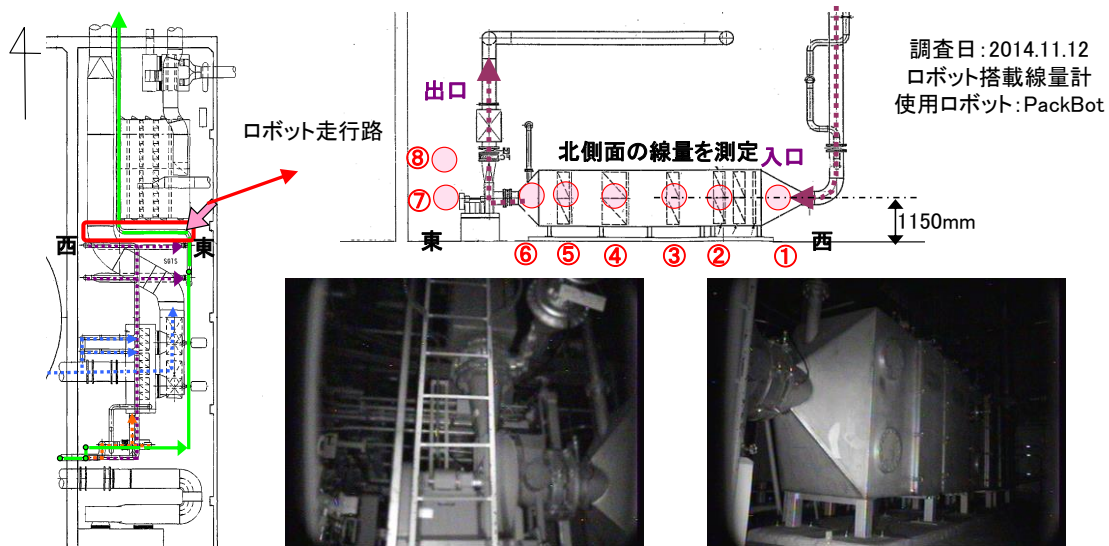
Figure 3-10 Radiation level observed (SGTS filter (A))

Figures 3-10 and 3-11 show the radiation measurement results around the SGTS filters (A) and (B), respectively. For both filters (A) and (B), radiation levels as high as about 1Sv/h were obtained. The maximum contamination has been observed on the HEPA filter at the SGTS filter outlet. Generally, the SGTS filter captures radioactive materials from its inlet side, which means that the results observed may indicate the gas containing the radioactive materials flowed into the SGTS filter from the opposite direction (backward flow). As clearly recognizable from Figure 3-8, there are two possible paths for this backward flow: from the Unit-2 venting line and the Unit-1 venting line (this is the same situation as having occurred when hydrogen gas flowed backward from Unit-3 to Unit-4).

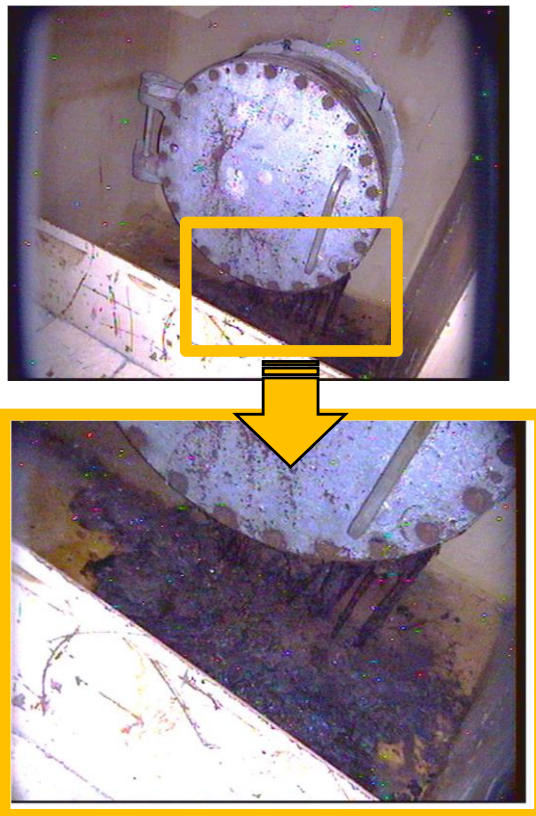
Figure 3-13 Melted matter at the penetration flange [27]

Figure 3-13 shows a photo of the melted matter. The melt hung from the penetration flange and lay spread on the floor. It is thought to be materials that had covered cables of the CRD replacement machine or O-ring materials of the penetration flange seals. The melt on the floor was solidified and confirmed to be easily removable by spatulas or similar tools.

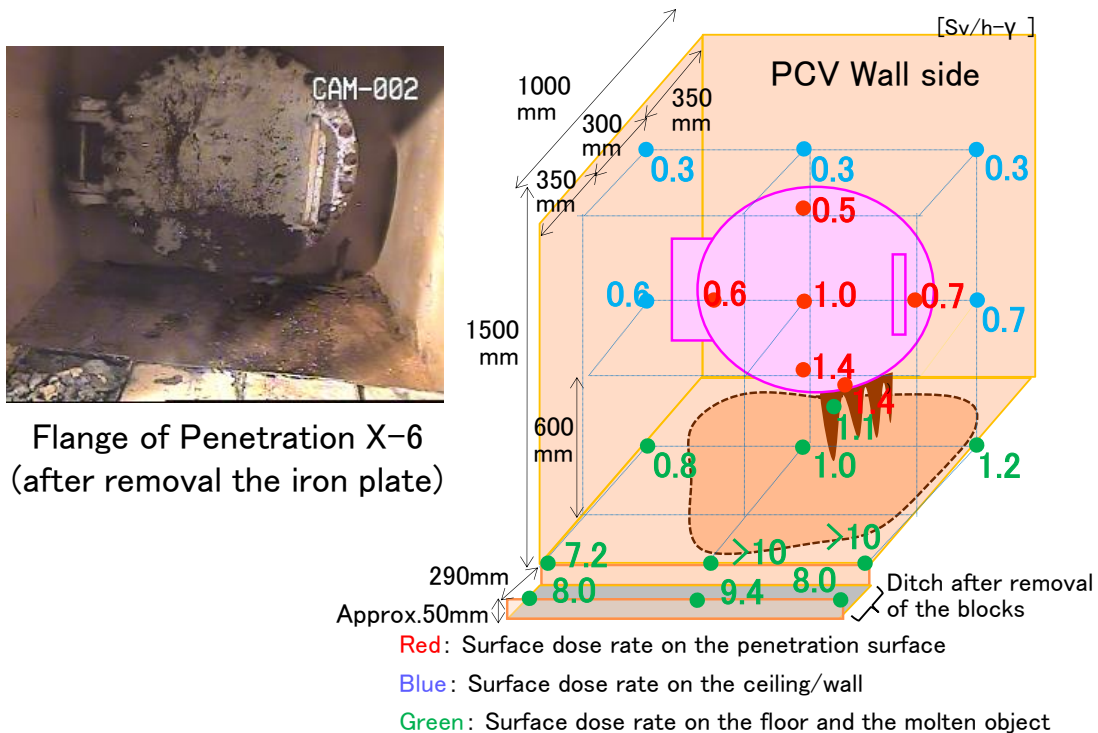
Figure 3-14 Measurement results of surface radiation dose rate [28]

Figure 3-14 gives the radiation dose rate measured on the surface. An increasing tendency for the surface dose is noticed in the order: “on the ceiling < in the middle < on the floor”; and especially a high dose rate is observed in the ditch after the shield blocks had been removed. The contamination might have spread from the area where the melt lay to the ditch. If the radiation dose difference between the locations of “at the penetration” and “on the wall” comes from the contribution of a radiation source inside the penetration X-6, it is estimated to be approximately 1 Sv/h at the maximum.

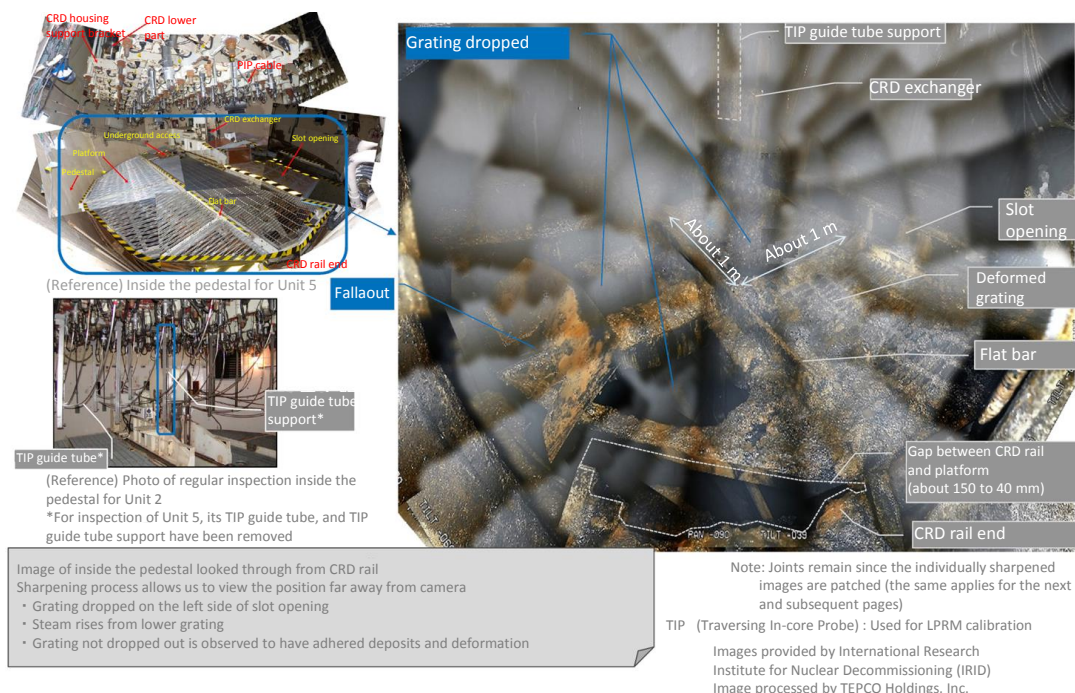
Figure 3-20 Conditions in the pedestal [30]

a guide pipe, as a preparatory survey for the investigation using the self-propelled investigation device. Figure 3-20 presents an integrated photo combining pieces of images taken by the camera after image processing for clarification. When referred to the similar arrangement at Unit-5 shown in the figure (left), the grating of Unit-3 can be found to be missing. At and above the place, cable-shaped fallen objects, and other fallen objects looking like TIP guide-tubes have been identified.

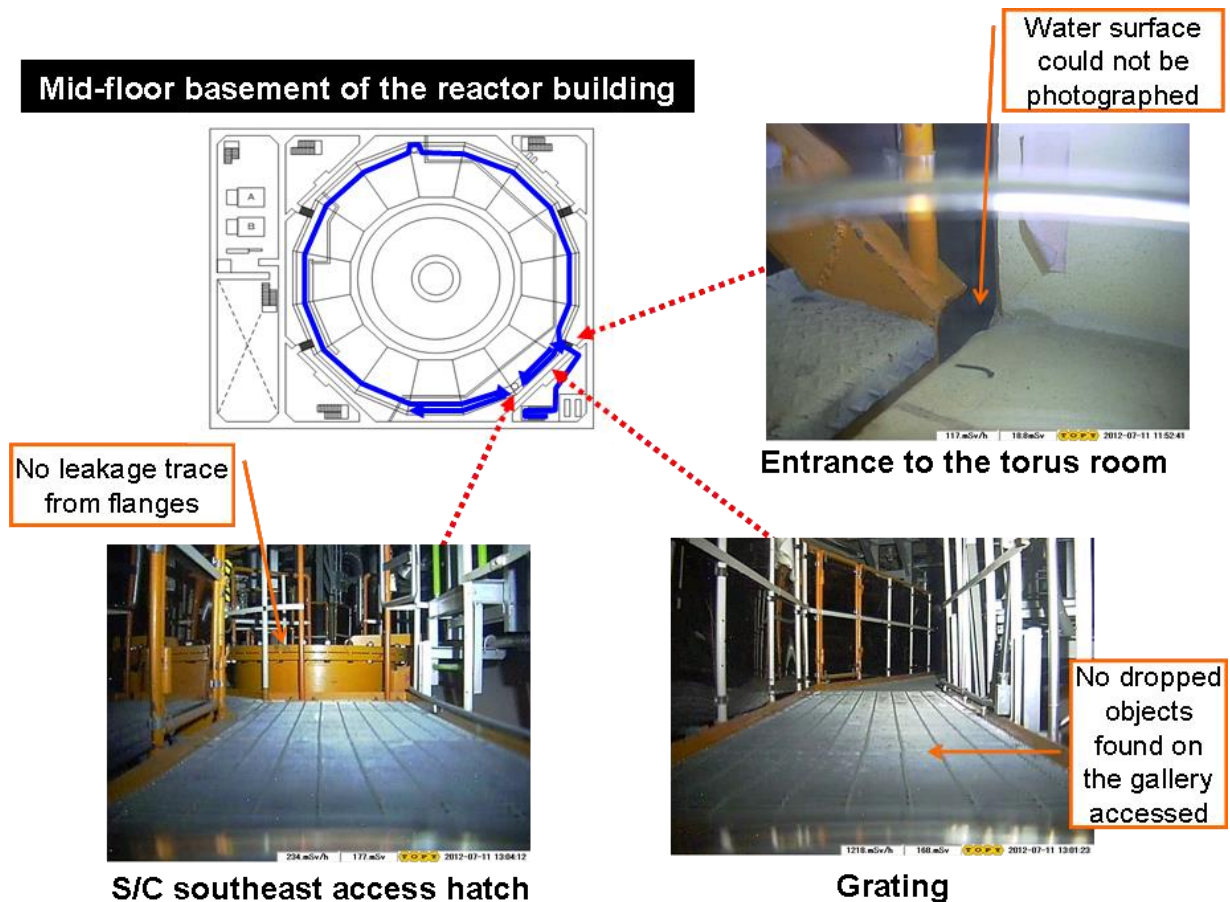
Figure 4-1 Camera photos in the torus room of Unit-3 (part)

No water leaking position in the S/C was located yet. At least, no leak was confirmed on the flange, etc. of the S/C manholes, as far as the camera photos show (Figure 4-1).
