Additional examination of station black-out due to tsunami

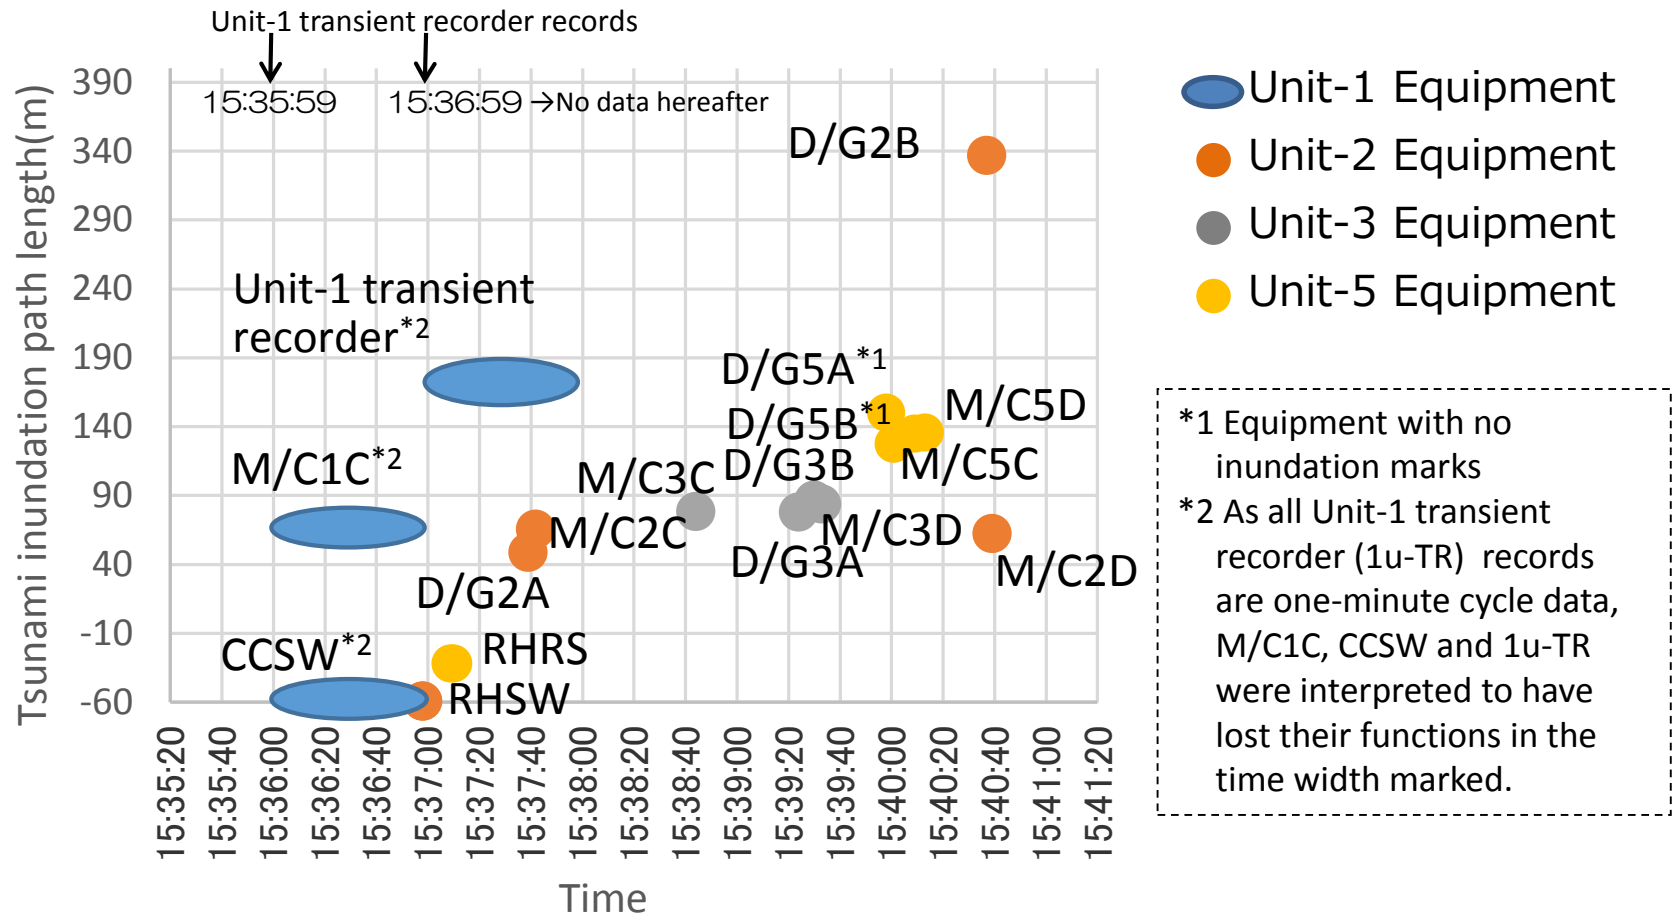
Figure 3 Relations between tsunami inundation path lengths to power equipment and timings of loss of functions

Figure 3 illustrates correlations between the tsunami inundation path lengths to power equipment and function loss timings of power supply systems. Function loss timings at Unit-1 were derived from the transient recorder records. Since all the records at the time were one-minute cycle data, power supply functions are considered to have been lost during the time width of marks in the figure. The D/G1A, 1B and M/C1D are not marked in the figure, because their function loss timings could not be specified: their voltages were kept at the value at 15:36:59, just before the transient recorder stopped recording and no more data are available after that. But the transient recorder records indicate that the emergency power equipment of Line A was lost first due to trouble in the M/C (the loss of emergency AC power equipment at Unit-1 is analyzed in detail in the NRA report “Interim Report on the Analyses of Nuclear Accidents at the Fukushima Daiichi Nuclear Power Station of Tokyo Electric Power Company” (hereafter the “Interim Report on Accident Analysis”) [3]). The function loss timing could not be specified for the Unit-2 M/C2E housed in the CP/B, either, since no alarm records are available. Although function loss timings were partly not specifiable, as mentioned above in this paragraph, correlations were analyzed between the tsunami inundation path lengths and function loss timings, because the overall trend between them could have been grasped based on the function loss timings mostly specified.

Figure 3 shows that seawater pumps lost their functions first followed by power equipment of D/G and M/C. The overall trend in the figure of “upper right to lower left” indicates the trend “the longer the inundation path lengths, the later the function loss timings.” From these observations, function losses of power equipment are estimated to have been caused by the tsunami run-ups and inundation one after another.

Meanwhile, when the figure is read in more detail, power supply functions of Unit-1 were generally lost fairly early and the function loss timings of Unit-2 seem somewhat inconsistent with the overall trend. Thus, the behaviors of each unit were analyzed in more detail mainly for the discussion of these causes.

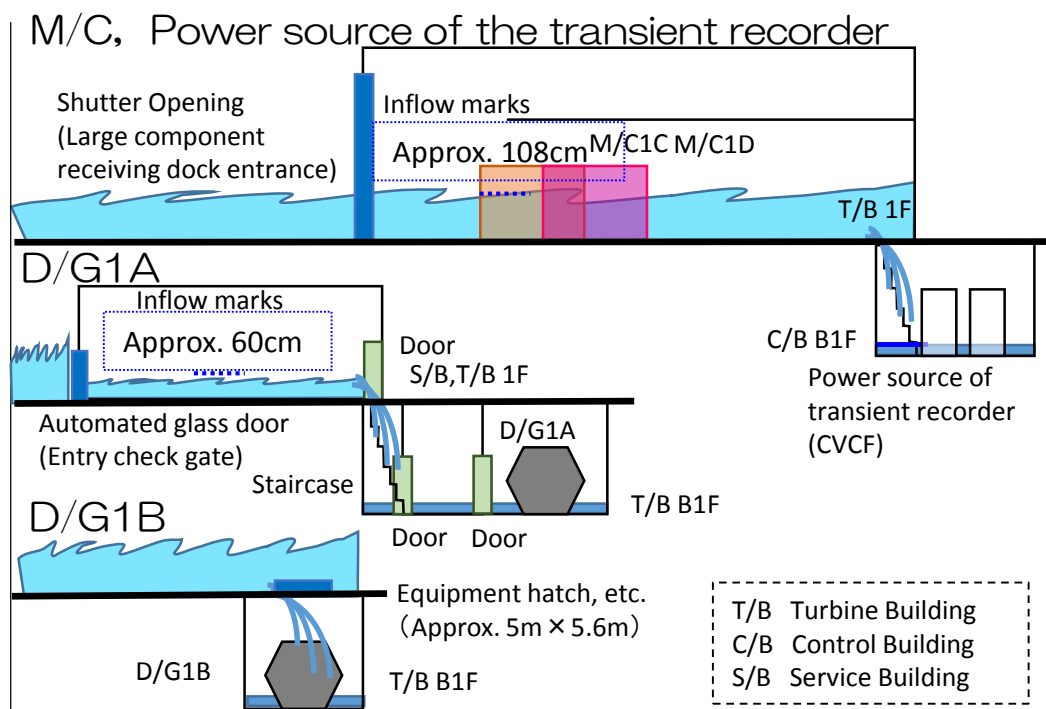
Figure 4 An image of tsunami inflow into Unit-1 turbine building

Figure 4 illustrates a tsunami inundation image for Unit-1 T/B. The drawing depicts the tsunami inflow from the reference position to the power equipment along the inundation path assumed.

The upper part of the figure shows that the large component receiving dock entrance stands just before the M/C. The entrance had a protection door and shutter. Usually, they both would be closed, but the door of Unit-1 was open at the time of the tsunami arrival [2]. On that day, the protection door had been opened for scheduled work. The door was left open, upon evacuation of the workers immediately after the earthquake, until the time of the tsunami arrival. If the protection door had been closed, the tsunami flooding might have been controlled to a certain degree, but with the door being left open, the shutter was deformed and broken by the tsunami and drifting wreckage, and inflow of a large amount of seawater was allowed. Consequently, the M/C located near the large component receiving dock is considered to have been inundated at an earlier timing in the overall trend between the tsunami inundation path lengths and function loss timings.

As seen above, the reason that the power equipment of Unit-1 lost their functions at an earlier timing in the overall trend can be considered that, because the protection door had been kept open at the large component receiving dock, the shutter had been greatly deformed and broken by the tsunami and drifting wreckage, allowing a large amount of tsunami inflow.

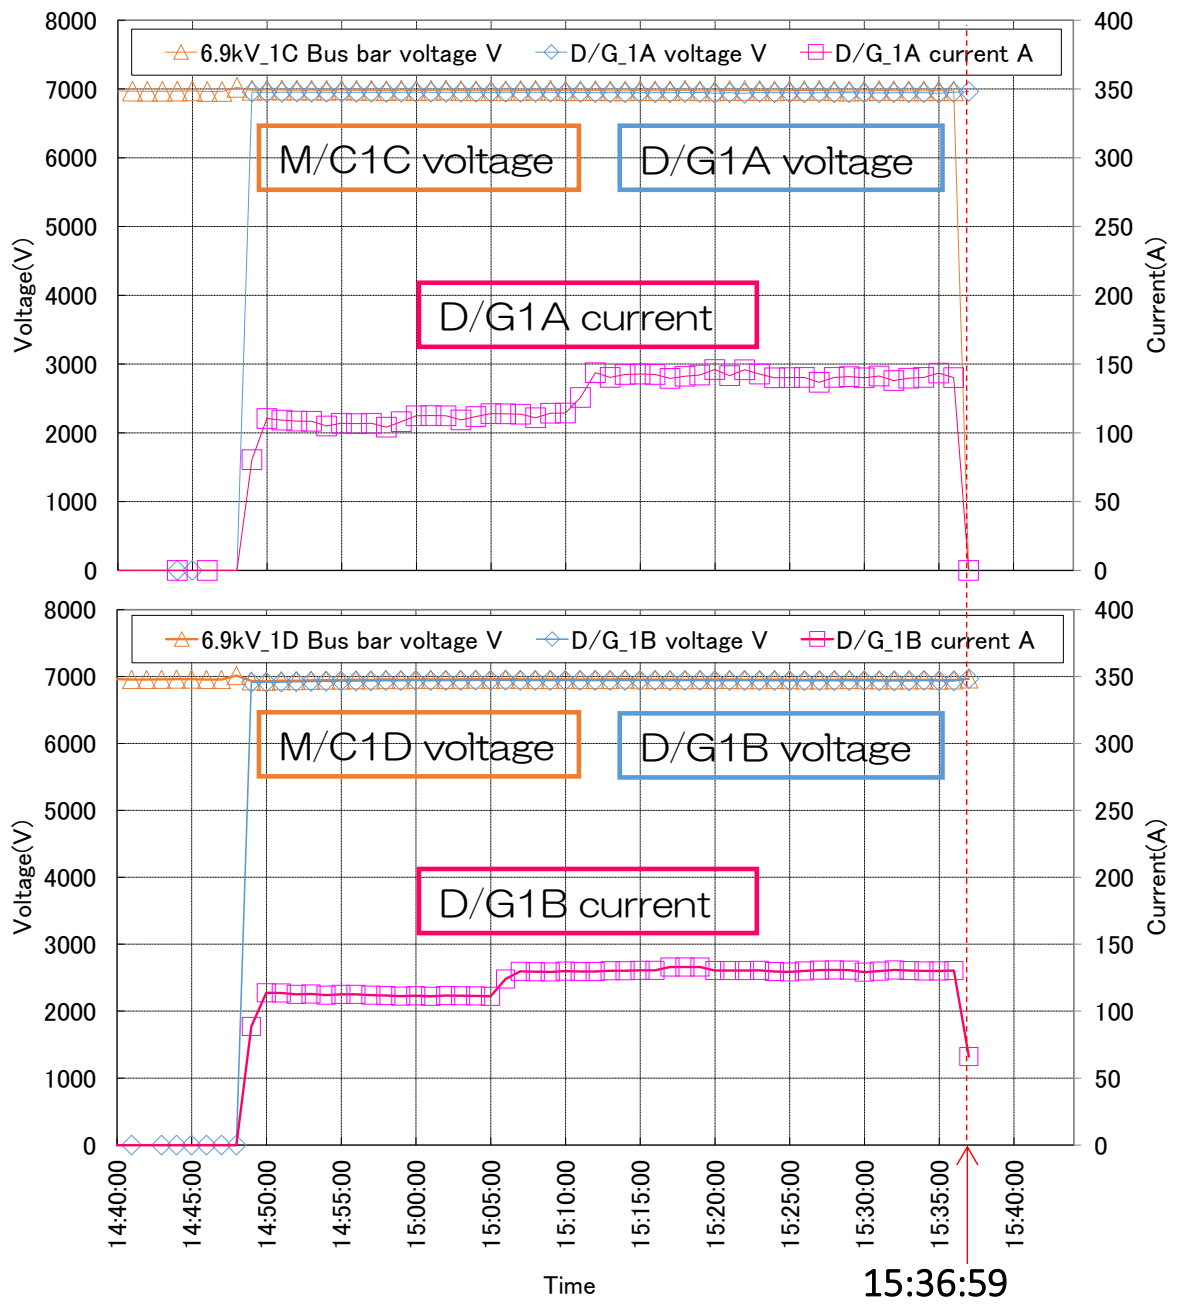
Figure 5 Transient recorder records of Unit-1 power supply systems (Top: Line A, Bottom: Line B)

Figure 5 gives the transient recorder data of Unit-1 power supply systems. No problems would have occurred to the D/G control system, because the D/G1A and 1B kept their voltages at the value at 15:36:59, just before the time when the transient recorder stopped recording (Possible Cause ③ excluded). Further, no electrical accident would have occurred to the bus bars, because the bus bars of M/C1C and 1D were not flooded (Possible Cause ① excluded). On the other hand, concerning the M/C1C an auxiliary relay contact located below the inundation mark might have been flooded and energized, thus the D/G circuit breaker is considered to have been activated (Possible Cause ② cannot be excluded). The M/C1C is considered to have lost its functions at an earlier timing.

The transient recorder received its power from a constant voltage constant frequency (CVCF) unit housed in the Control Building B1 floor. It is estimated that this CVCF unit was flooded, lost its functions and caused the function loss of the transient recorder. The transient recorder is considered to have lost its functions at an earlier timing in the overall trend, since no barriers had existed to prevent a large amount of tsunami inflow on the path from the large component receiving dock entrance to the cell housing the UPS unit.

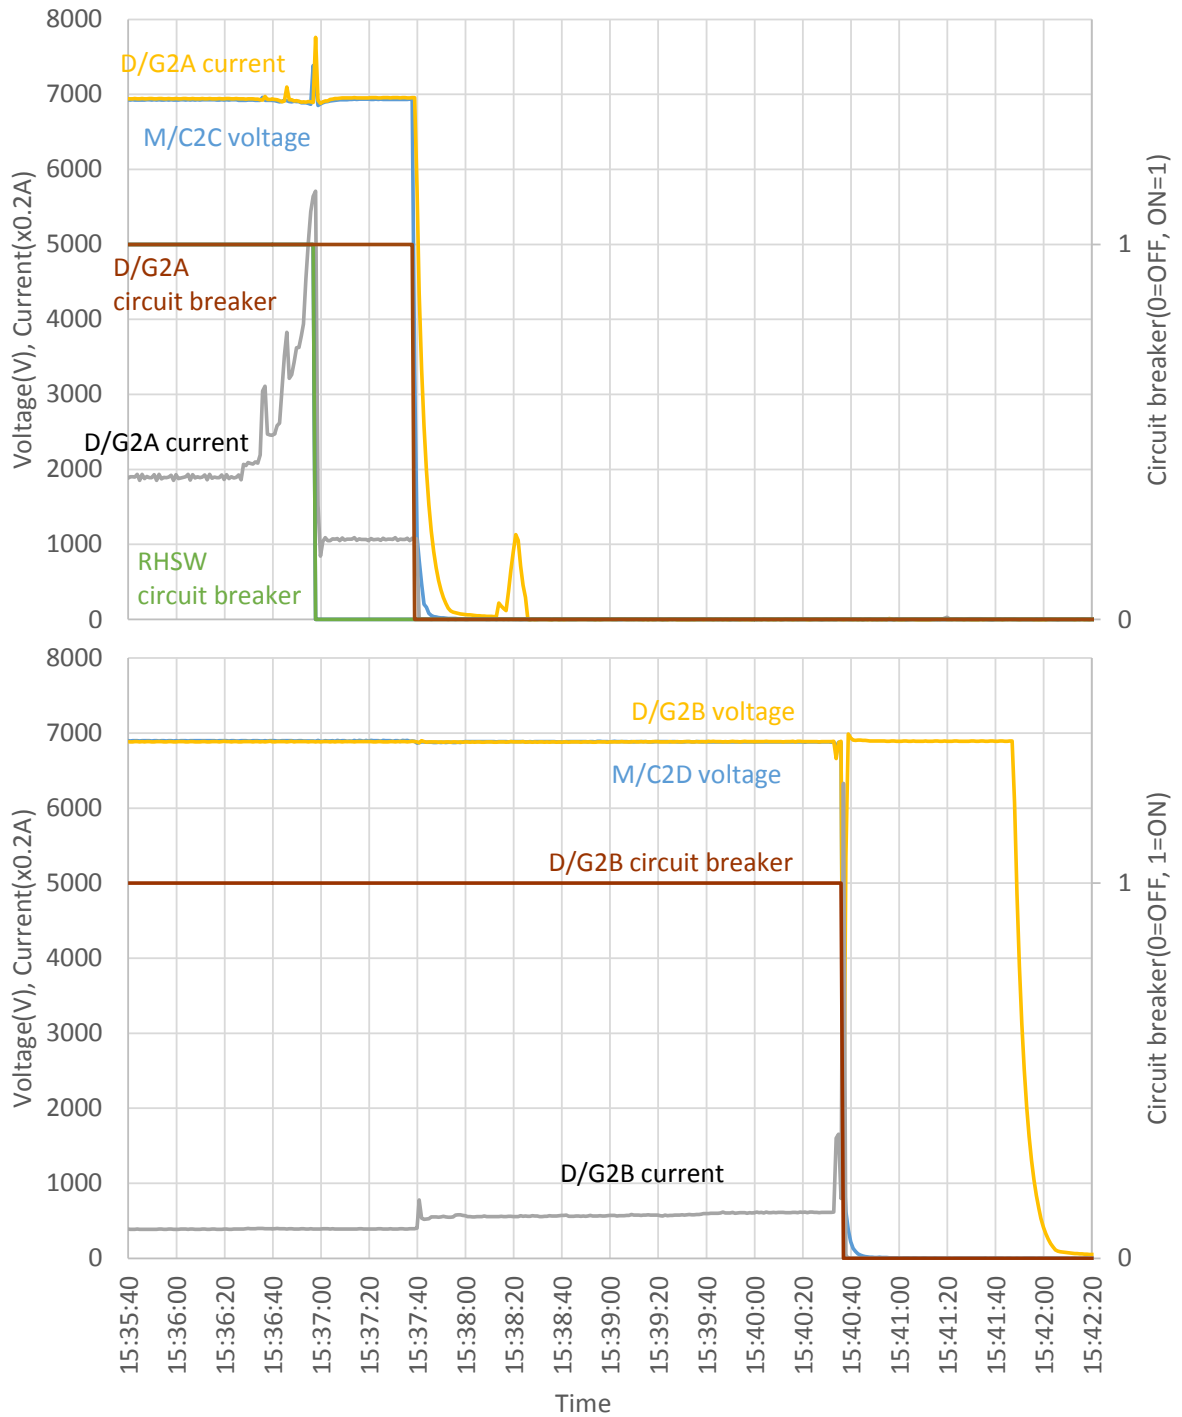
Figure 7 Unit-2 Process computer records (Top: Line A, Bottom: Line B)

Figure 7 gives the process computer data of Unit-2 systems. On Line A, the RHSW circuit breaker opened at about 15:37:00 and the current of D/G2A dropped sharply. The D/G2A circuit breaker opened at about 15:37:40 and the D/G2A current and D/G2A and M/C2C voltages dropped sharply down to zero (Possible Cause ③ excluded). If the D/G supplied an electrical accident-caused current, it should be a spike-shape current, but no such spike-shape currents are noticeable. Therefore, no electrical accident occurred to the D/G or M/C (Possible Cause ① excluded). On the other hand, the D/G2A showed a rise in its current from about 15:36:20 to about 15:37:00, and the RHSW circuit breaker opened at about 15:37:00. This is presumed to indicate that the RHSW pump was overloaded by the tsunami inflow and tripped. Consequently, it is highly possible the DGSW pump, which had been installed at the same seawater pump area, tripped at a similar timing. When the DGSW pump trips, the D/G lockout relay is activated 60 seconds later by the pump discharge pressure “low” signal and the D/G circuit breaker opens (the air-cooled D/G2B has no such trip logic). The D/G2A circuit breaker opened at about 15:37:40. If the DGSW pump is assumed to have tripped sometime between about 15:36:20 and about 15:37:00 when a rise is observed in the D/G2A current, the sequence is roughly consistent with the trip logic. This means, it is highly probable that the DGSW pump trip led to the D/G trip, thus losing the Line A power source (Possible Cause ② cannot be excluded). In this situation, the timing of function loss becomes earlier than the timing derived from the inundation path length. A different scenario of Possible Cause ② may hold, in which terminals in the D/G control panel are energized upon flooding, activating the lockout relay (Possible Cause ② cannot be excluded). In this situation, the function loss timing should have coincided with the timing derived from the inundation path length. It is not possible to specify which scenario actually took place because no direct records are available to identify the D/G trip cause. But it seems probable that the DGSW pump trip caused the D/G trip, losing the Line A power source, because the RHSW pump actually tripped and the timing of function loss was early.

On Line B, the D/G2B circuit breaker opened at about 15:40:40, and the D/G2B current and the M/C2D voltage dropped sharply down to zero. The D/G2B voltage kept its normal value for some time after the quick recovery from a short drop at the time of the D/G2B circuit breaker being opened. This shows that the D/G2B itself kept its functions for some time even after its circuit breaker had opened (Possible Causes ② and ③ excluded). At about 15:40:40, the D/G2B recorded a spike-shape current, showing that the D/G supplied an electrical accident-caused current at that timing. It was presumed therefore that the function loss of Line B was attributable to M/C trouble, in particular to an electrical accident at the suspected accident point in Figure 5 on the side of the M/C2E or M/C2D, which had opened the D/G circuit breaker (Possible Cause ① holds). It should be noted that the M/C2D housed in the T/B is likely to have been flooded, from the viewpoint of the tsunami inundation path length in the current study. As is shown in Figure 8, an image of tsunami inflow into Unit-2 T/B, there is a zone-isolation door that must be passed through by the tsunami inflow entering the building from the D/G louvers and other openings to reach the M/C2D cell. The function loss timing due to this tsunami inflow path will be delayed more than the timing assumed from the inundation path lengths.

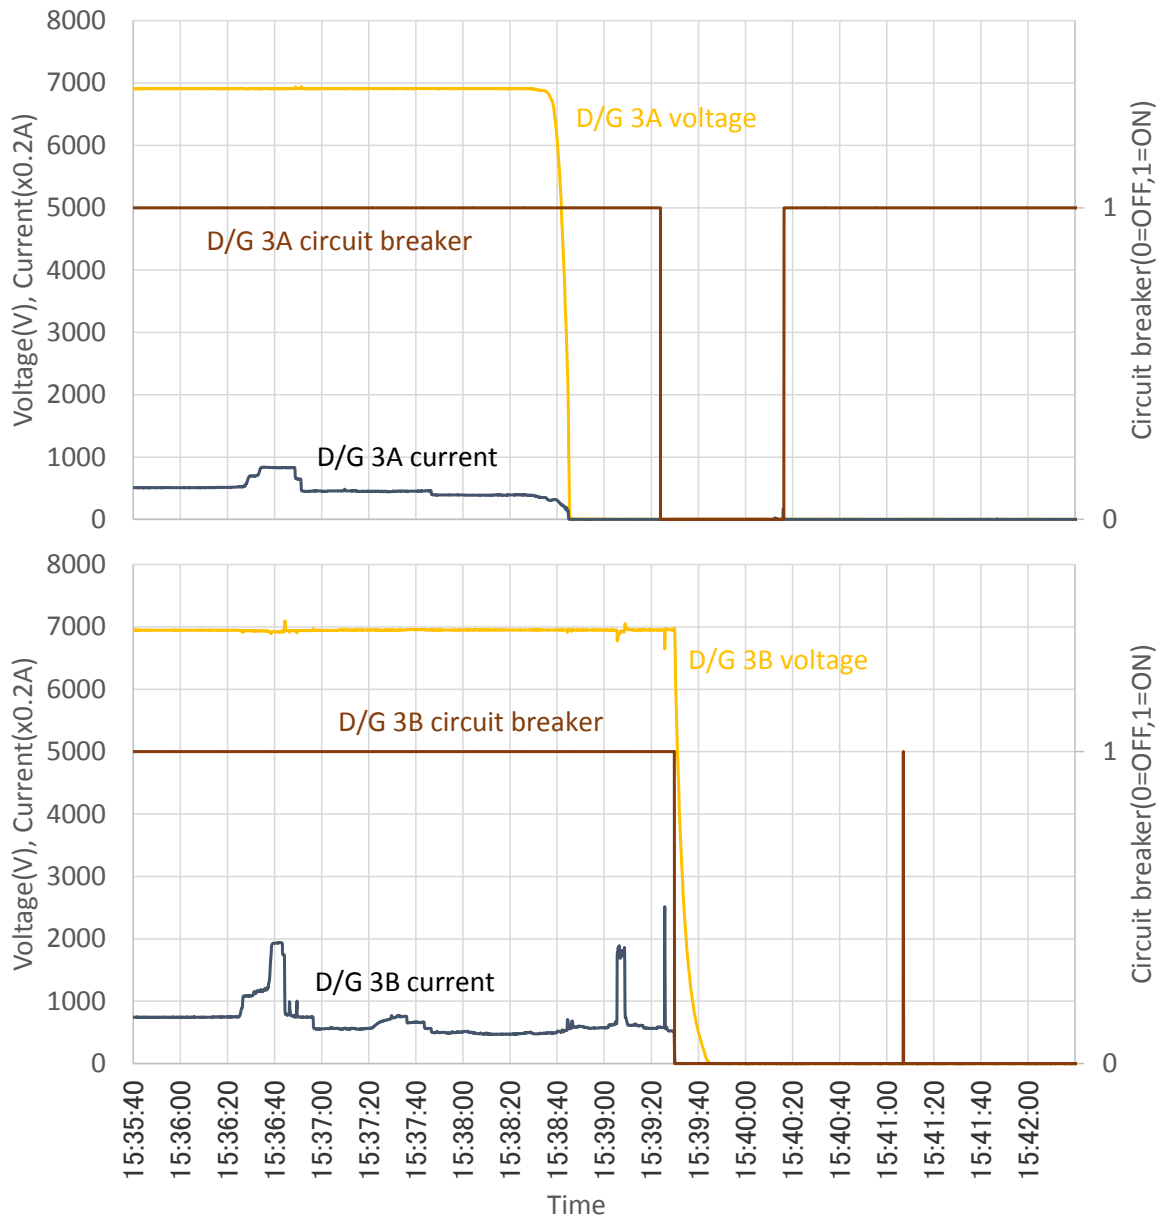
Figure 9 Unit-3 Process computer records (Top: Line A, Bottom: Line B)¹

As shown in Figure 2 and Figure 3, the tsunami inundation path lengths to D/G3A, 3B, M/C3C and 3D are not very different, although they are installed at different locations and their assumed tsunami inundation paths are different. Nevertheless, Line A lost its power supply several tens of seconds earlier than Line B. Possible scenarios behind this difference were examined. Figure 9 provides the transient recorder records of Unit-3 power supply systems. The time was so calibrated that the timing of “D/G Circuit Breaker OFF” recorded by the transient recorder coincided with the timing of “Diesel Generator OFF” recorded in the Unit-3 alarm records, which had been calibrated against the Unit-2 process computer.

On Unit-3 Line B, the D/G3B circuit breaker opened at about 15:39:30 and the D/G3B current and voltage dropped sharply to zero (Possible Cause ③ excluded). No electrical accidents occurred to the D/G and M/C, since no spike-shape currents are recorded (Possible Cause ① excluded). It is presumed, therefore, that the terminals in the D/G control panel had been energized by the DGSW pump trip or inundation, as having occurred to Unit-2 Line A, and the D/G lockout relay had been activated.

On Unit-3 Line A, on the other hand, the D/G3A current and voltage dropped first sharply to zero at about 15:38:40 and then the D/G circuit breaker opened at 15:39:24, that is, the D/G stopped before its circuit breaker opened. It is unlikely that the lockout relay caused the loss of functions (Possible Cause ② excluded). No electrical accidents occurred to the D/G and M/C, since no spike-shape currents are recorded (Possible Cause ① excluded). Consequently, some unknown anomaly occurred to the D/G control system, terminating power supply to the bus bars (Possible Cause ③ cannot be excluded).

¹ D/G circuit breaker signals show changes after 15:40. It is understood that these changes do not represent the actual working conditions of the system, because the signals of the circuit breaker of the RHSWs also changed in the same time span, albeit they were not in service.

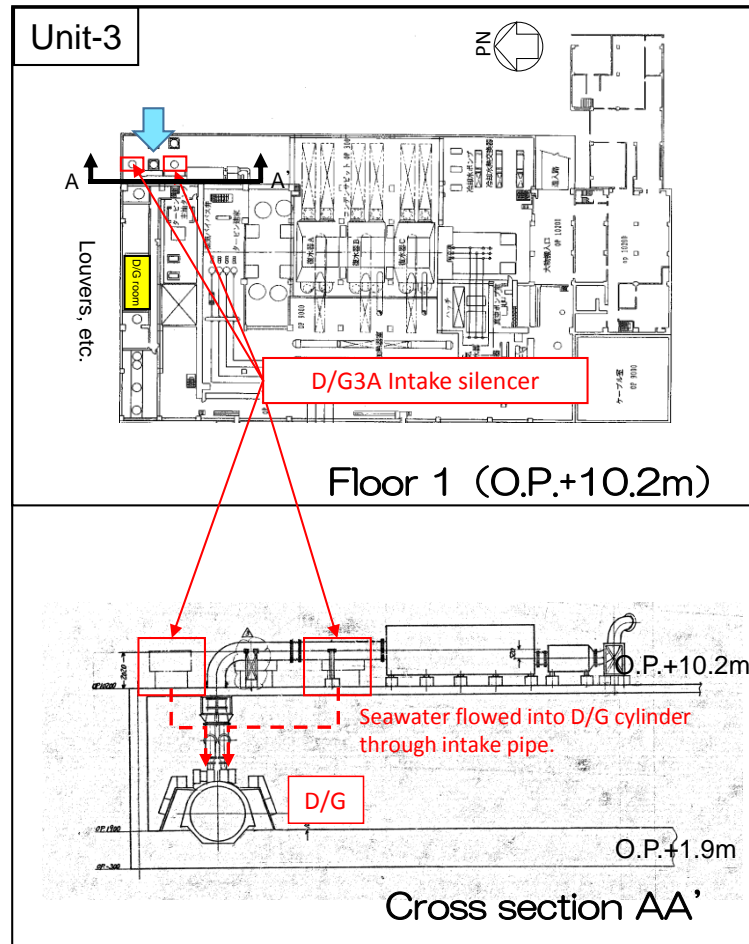
Figure 10 D/G3A Silencer position
(Top: T/B Plan view, Bottom: AA Cross-sectional view)

A possible scenario of the D/G3A having stopped is that seawater flowed into the D/G cylinder through the intake silencer. Figure 10 shows the installation location of the

silencer, and Figure 11 illustrates the operation of a 4-cycle diesel engine. The D/G3A silencer was installed on the seaside at a lower elevation, as can be seen in Figure 10. It is possible seawater flowed to the inside of the D/G engine through the silencer. If this seawater reached the cylinder via the intake pipe, as shown in Figure 11, it would have caused insufficient combustion in the diesel engine. Furthermore, if the seawater reached other cylinders, the D/G rotating speed would have gradually dropped, the voltage would have dropped and eventually the D/G would have stopped. It should be noted that silencers of Unit-1 D/G1A and 1B, and Unit-2 D/G2A were also installed on the seaside at lower elevations, like Unit-3 D/G3A. The inundation path lengths to all these silencers are not very different. Therefore, the tsunami could have eventually flowed into the D/G cylinders of Units-1 and -2 as well. But it is unlikely that seawater, having flowed into the cylinders, stopped Unit-1 D/Gs and Unit-2 D/Gs, because their power supply was stopped earlier than Unit-3 Line A, and their voltage and current drop behavior is different from the unique behavior of Unit-3 Line A. It should also be noted that no seawater would have flowed into the silencers of Unit-3 D/G3B, Unit-5 D/G5A and 5B, because the silencer of Unit-3 D/G3B was installed at an elevated position, and those of Unit-5 D/G5A and 5B were enclosed by side-walls.

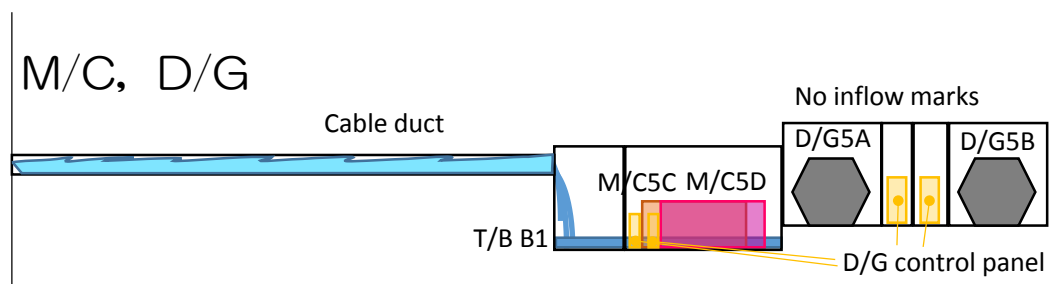
Figure 12 An image of tsunami inflow into Unit-5 turbine building

Figure 12 is an image of tsunami inflow into the Unit-5 T/B. The M/C5C and 5D were installed in the electrical equipment room of Floor B1, while the D/G5A and 5B were in the D/G cell on a slightly higher floor level than that of the electrical equipment room. D/G control panels were partly in the electrical equipment room. As shown in Figure 3, there is not much difference in tsunami inundation path lengths to the above power supply systems. It is unlikely that the power was lost by the flooded D/Gs, because no tsunami marks were left in the D/G cell. To reach the electrical equipment room, the tsunami is estimated to have flowed from cable penetrations via underground cable ducts, since tsunami marks could be recognized on the cable penetrations in the electrical equipment room. Even if the M/C main circuits were not flooded and did not lose bus bar voltages, the D/Gs could have lost their functions due to energized terminals in the D/G control panel when flooded.

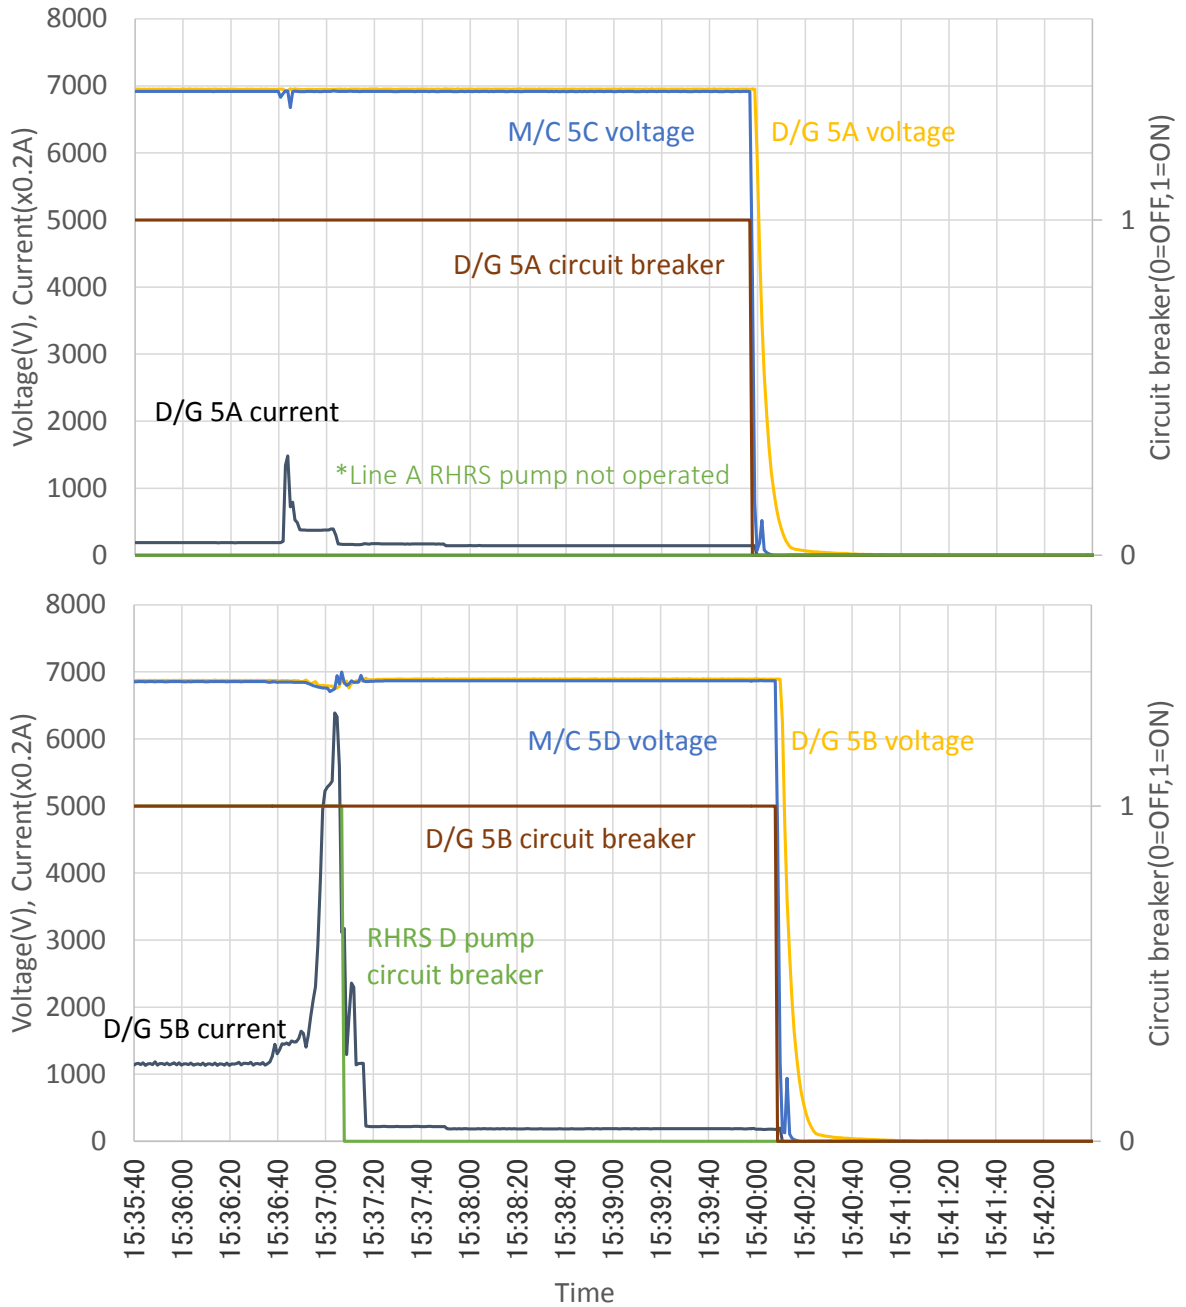
Figure 13 Unit-5 process computer records (Top: Line A, Bottom: Line B)

Figure 13 gives the process computer data of Unit-5 power supply systems. Both on Line A and Line B, the D/G circuit breakers opened at about 15:40:00, and D/G currents, D/G and M/C voltages sharply dropped to zero (Possible Cause ③ excluded). No electrical accidents occurred to the D/G and M/C, since no spike-shape currents are recorded (Possible Cause ① excluded). Consequently, it is likely that the power was lost due to the activated lockout relay when the DGSW pump tripped or the terminals in the D/G control panel were energized upon flooding, as was the case in Unit-2 Line A and Unit-3 Line B (Possible Cause ② holds).

Thus, both Line A and Line B lost power due to the tsunami.
