## Relocation behavior of molten fuel to below the core

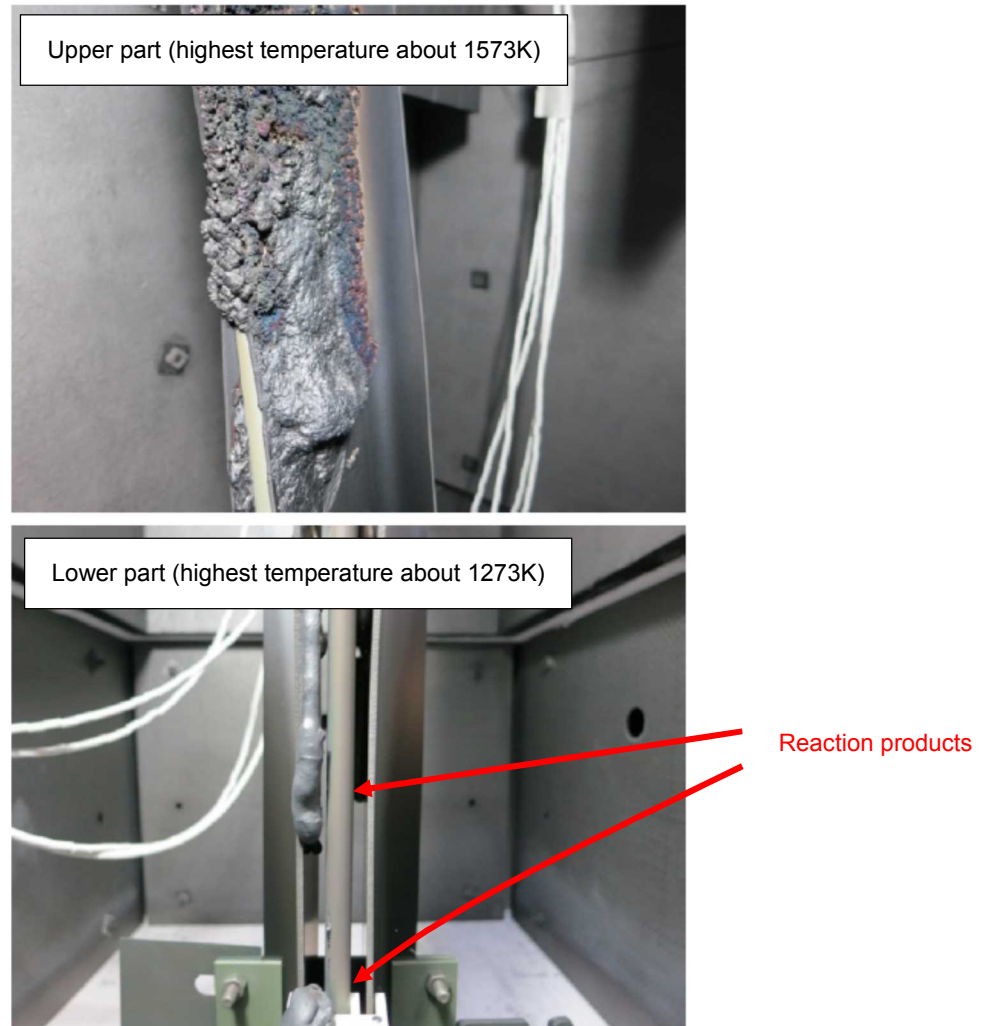
Figure 3.5 Photos of the test piece after the test [7]

Figure 3.5 reproduces photos of the test piece after the test. The test confirmed that the molten reaction products of the control blade and channel boxes flowed down between them. It can be interpreted that Zr-Fe eutectic reactions occurred between SUS316L-made control blade sheaths and the Zircaloy-4 channel boxes when they physically contacted and the

molten reaction products flowed down. The test confirmed the molten reaction products flowed down to the bottom of the test piece.

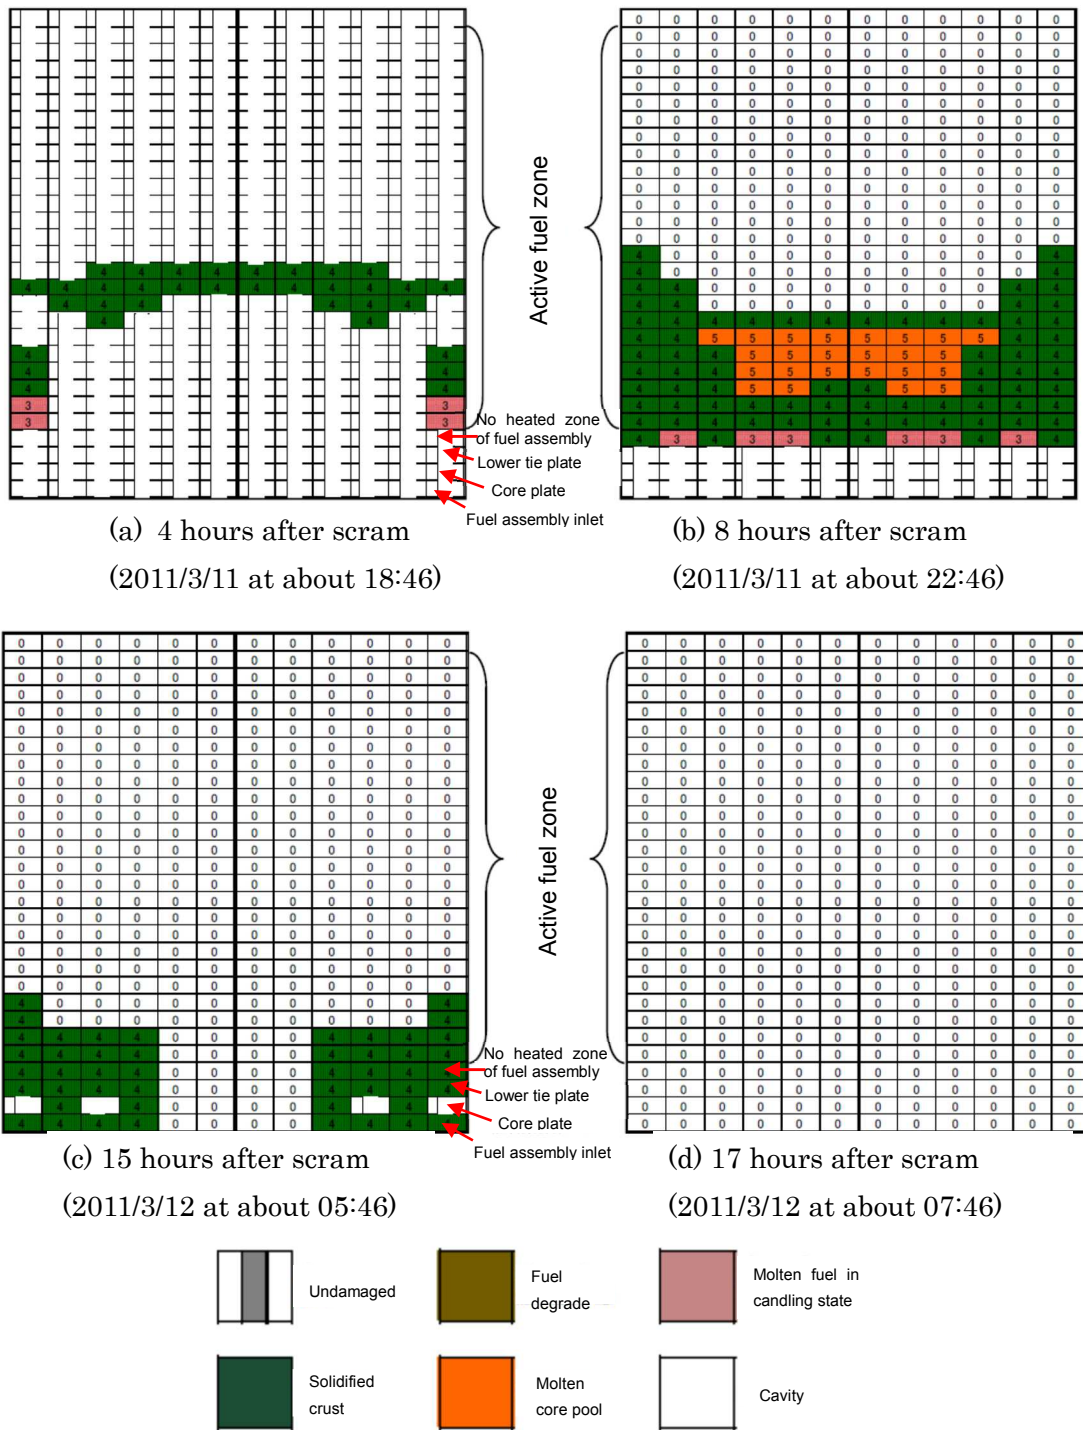
Figure 4.1 Conditions of damaged core (Unit-1)

After the molten fuel pool was formed, the shroud was damaged. Further, molten fuel relocated to below the core upon the central part of core plate being damaged. Afterward, the molten fuel left in the peripheral area of the core relocated to the paths via the inlet orifice of the fuel supports and control rod velocity limiters. Eventually, the whole core plate was degraded and no more molten fuel was left in the core region.

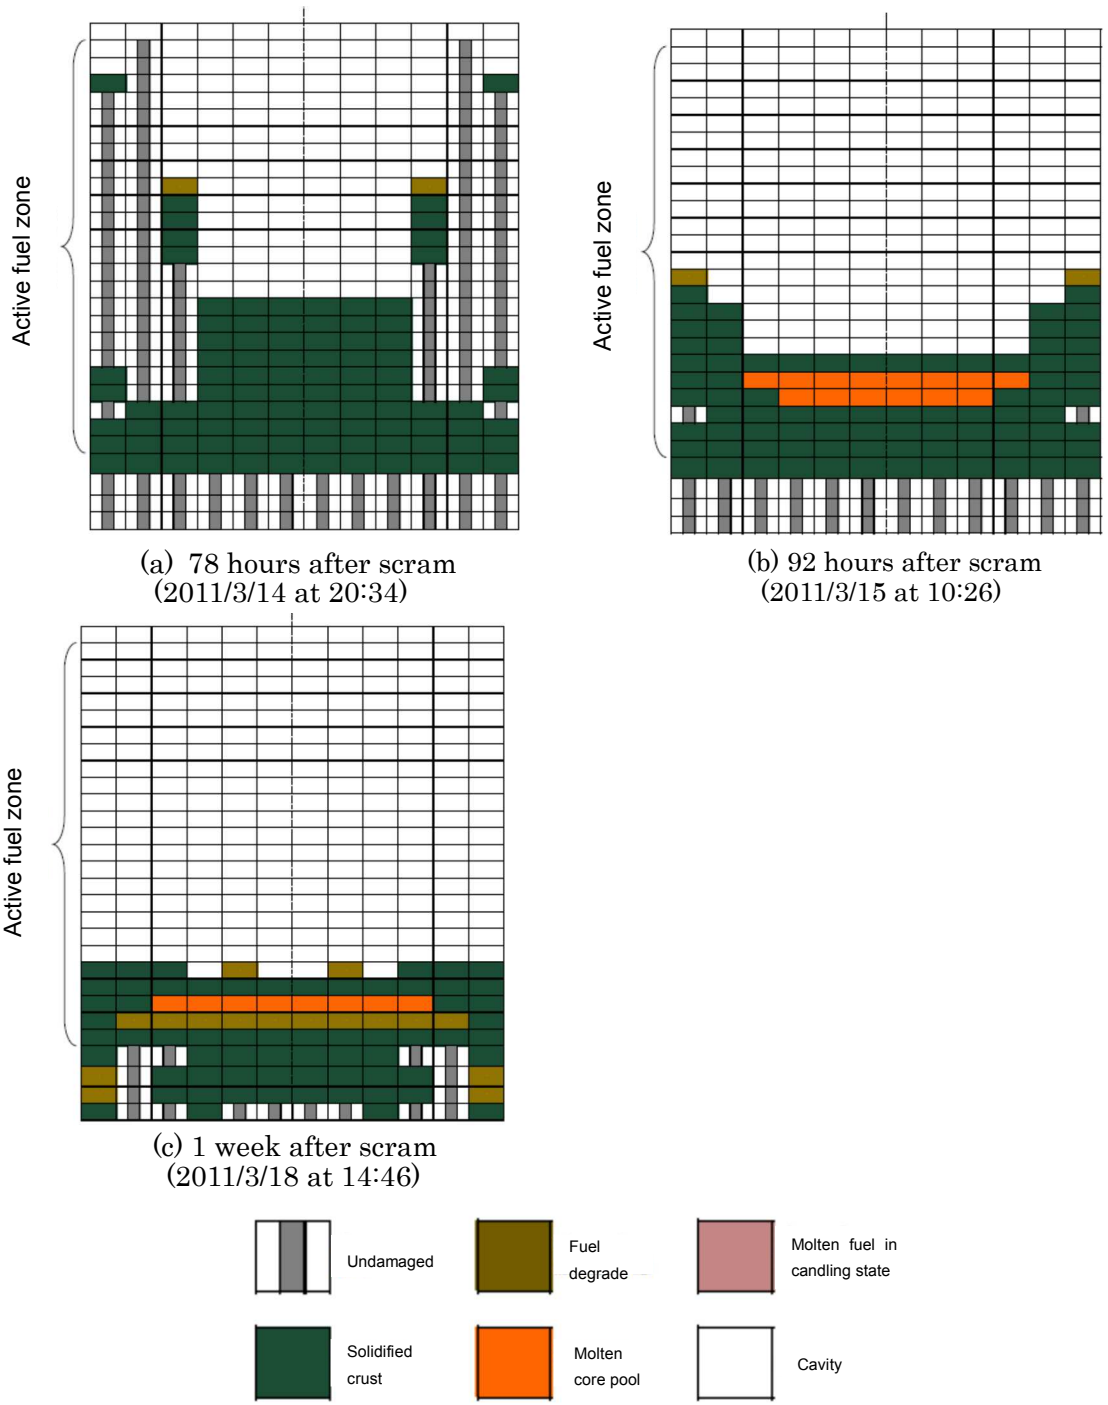
Figure 4.2 Conditions of damaged core (Unit-2)

After the molten fuel pool was formed, molten fuel flowed out to below the core via the inlets to fuel assemblies. Molten fuel also relocated to the path via the control rod velocity limiters. The shroud damage seen in Unit-1 did not occur and the core plate had no degradation. The molten fuel was left in crust forms on the lower fuel tie plates, core plate, fuel supports and other parts of the lower core structure.

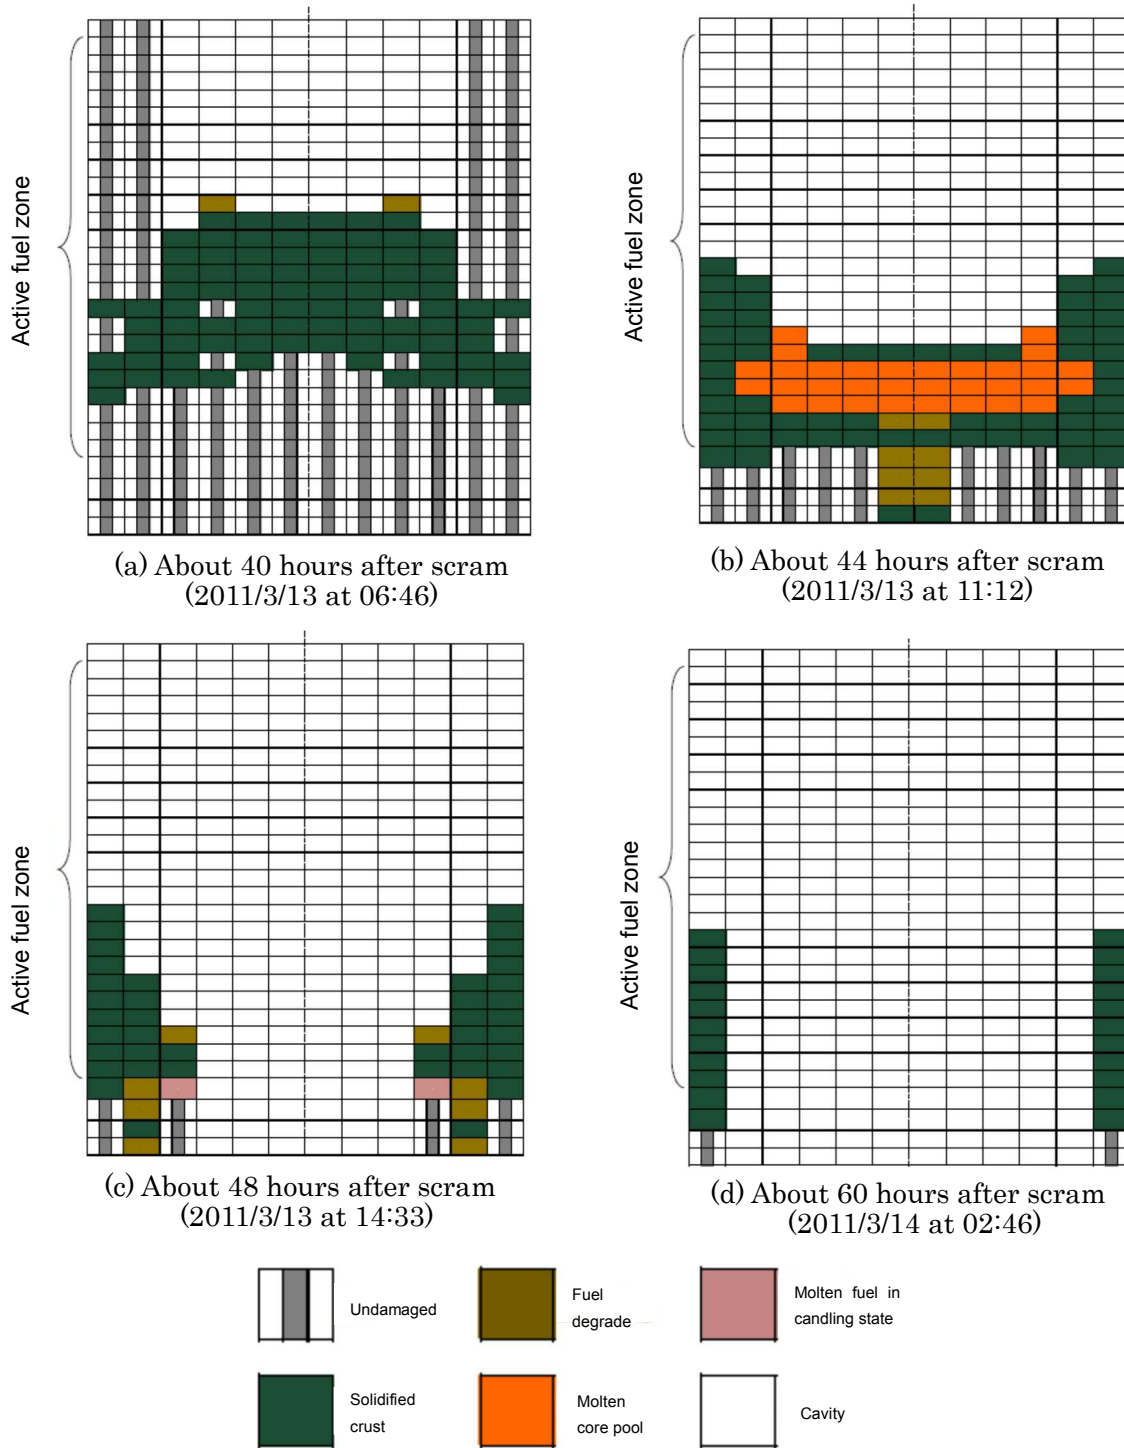
Figure 4.3 Conditions of damaged core (Unit-3)

After the molten fuel pool was formed, molten fuel flowed out to below the core via the inlets to fuel assemblies in the central area of the core. The molten fuel that flowed out to below the core melted CRGT and control rod drive housings, damaging the core plate positioned above them and destroying its core support functions. The molten fuel and other molten objects accumulated on the central area of the core plate fell down step by step to

below the core. Eventually, no more molten fuel was left in the core region. The shroud was not damaged.

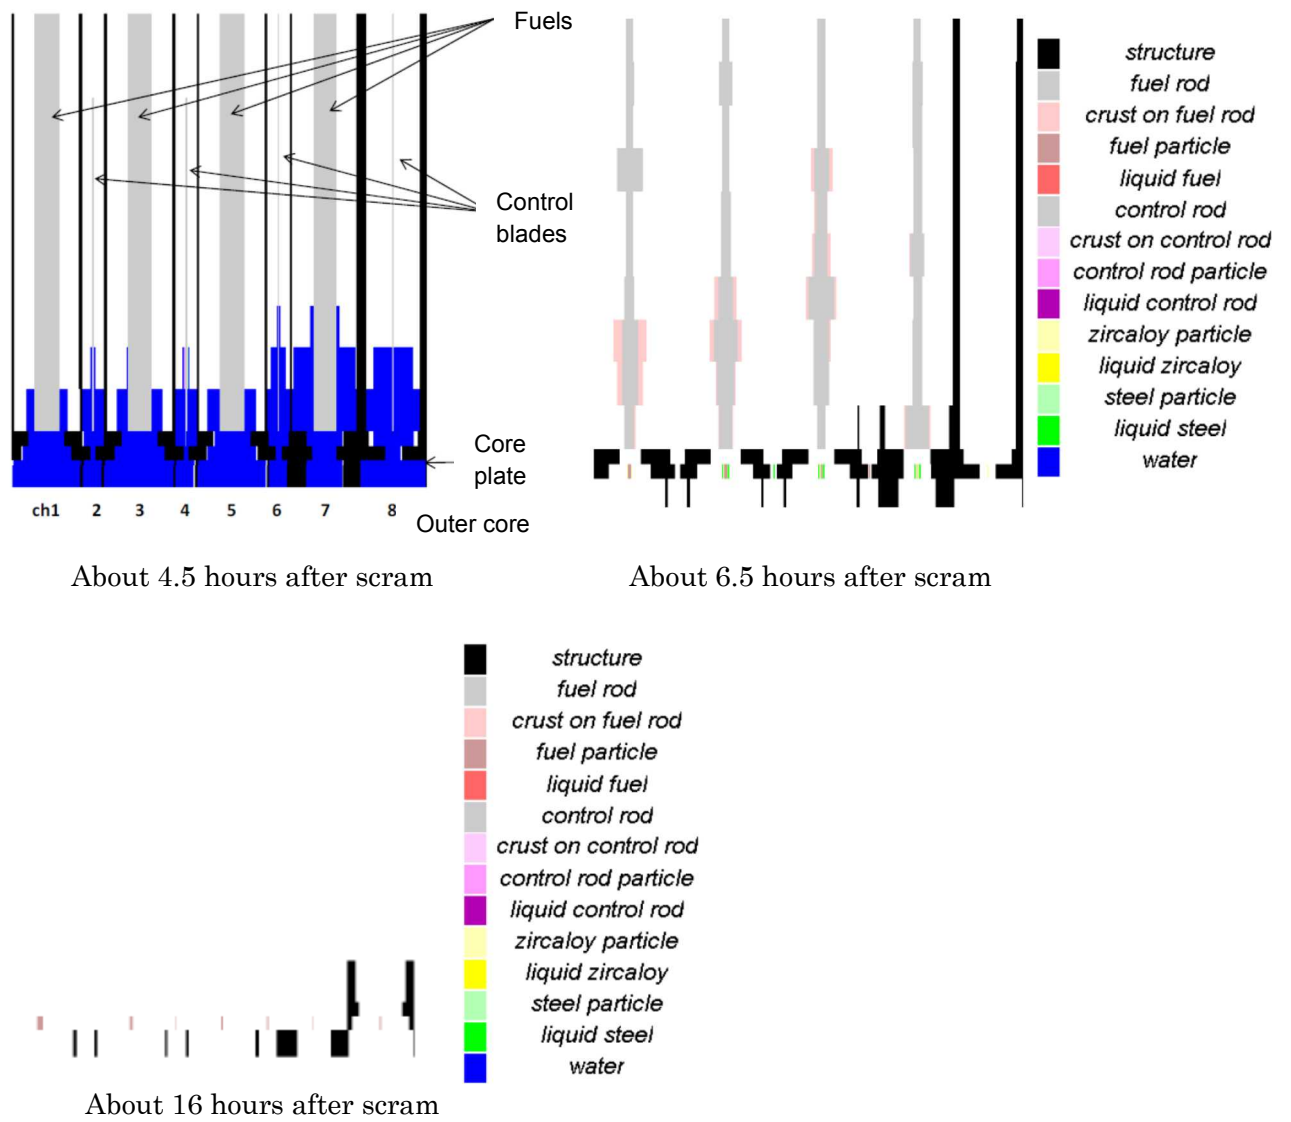
Figure 4.4 Conditions of damaged core of Unit-1 (Volume fractions)

The core plate was melted when it contacted with part of the molten fuel and all structures in the core region dropped to below the core. The molten fuel which relocated to the CRGT melted the control rod velocity limiters. Eventually, no molten fuel was left in the core region. The lower part of the shroud was also melted.

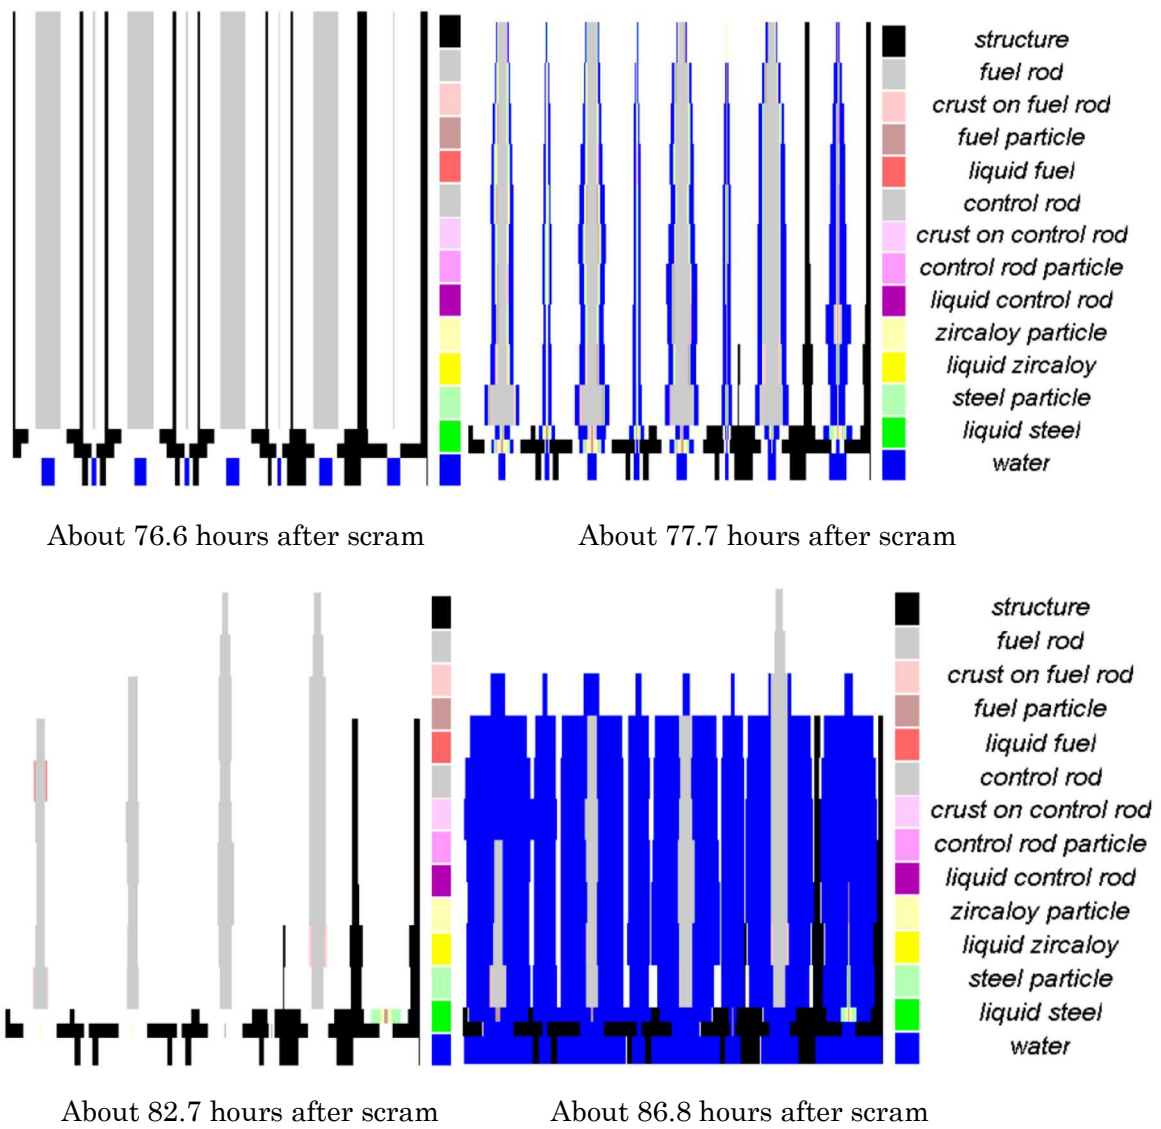
Figure 4.5 Conditions of damaged core of Unit-2 (Volume fractions)

The core plate and control rod velocity limiters were not completely damaged by the molten fuel. Molten fuel was left in crust forms on the lower structures such as the lower fuel tie-plates, core plate and fuel supports. Part of the upper shroud was damaged.

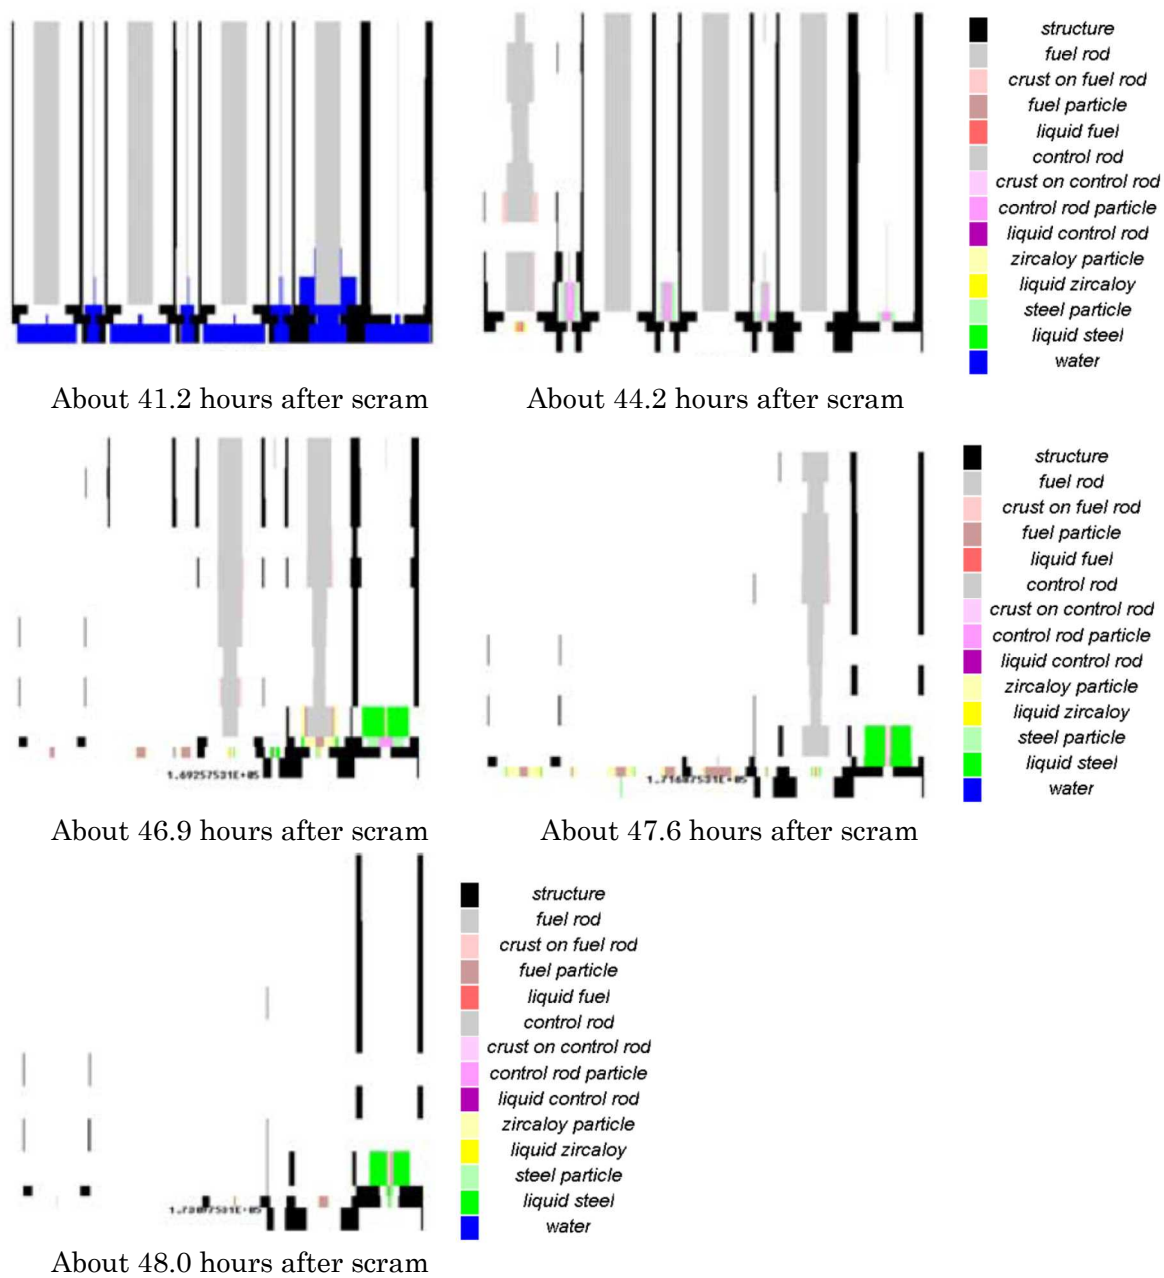
Figure 4.6 Conditions of damaged core of Unit-3 (Volume fractions)

The core plate was melted when it contacted with part of the molten fuel and all structures in the core region dropped to below the core. The molten fuel which relocated to the CRGT melted the control rod velocity limiters. Eventually, almost no molten fuel was left in the core region. The lower part of the shroud was also melted.
