Analysis of the hydrogen explosion at the Unit-1 Reactor Building

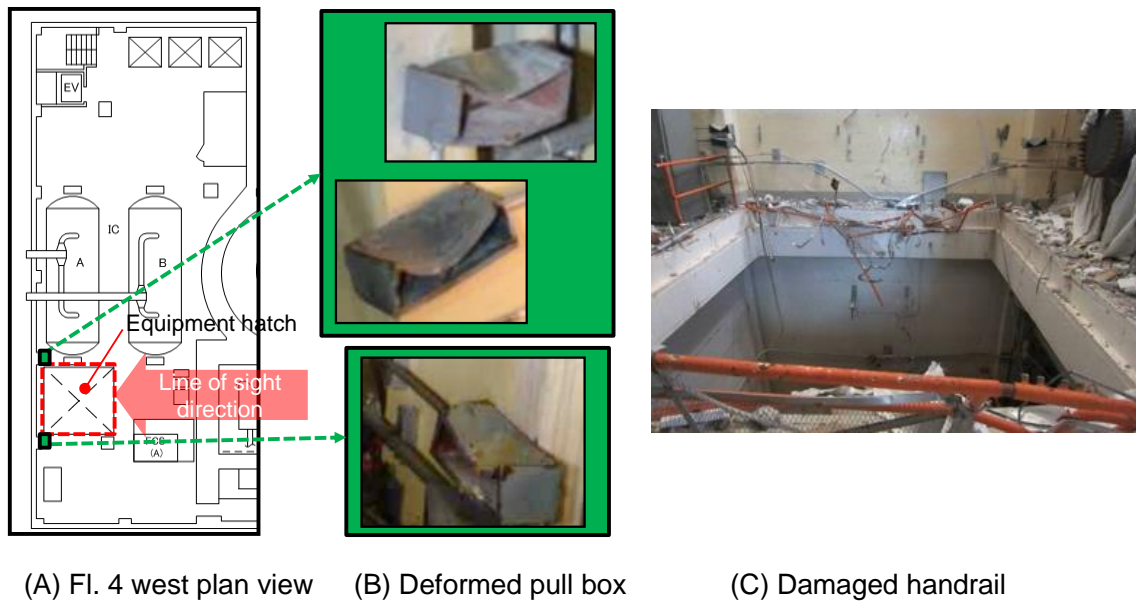
Figure 16 shows the damage conditions near the equipment hatch. The pull box in (B) seems crushed from above.

Figure 16 Deformed pull box and damaged handrail near equipment hatch

Figure 18 shows the blast analysis results in Case ② and Case ③, indicating that, in these cases, strong horizontal blasts collided against the pull box, after the high concentration hydrogen on Floor 4 had been ignited. The damage condition of the pull box shown in Figure 16 (B) indicates no marks of horizontal blasts.

From these comparisons, it is concluded that: the deformed shape of the pull box near the equipment hatch on Floor 4 is consistent with the blast directions in Case ① and Case ④ when hydrogen leaks on Floor 5 were assumed; whereas, it is inconsistent with the blast directions in Case ② and Case ③ when hydrogen leaks on Floor 5 and Floor 4 were assumed.

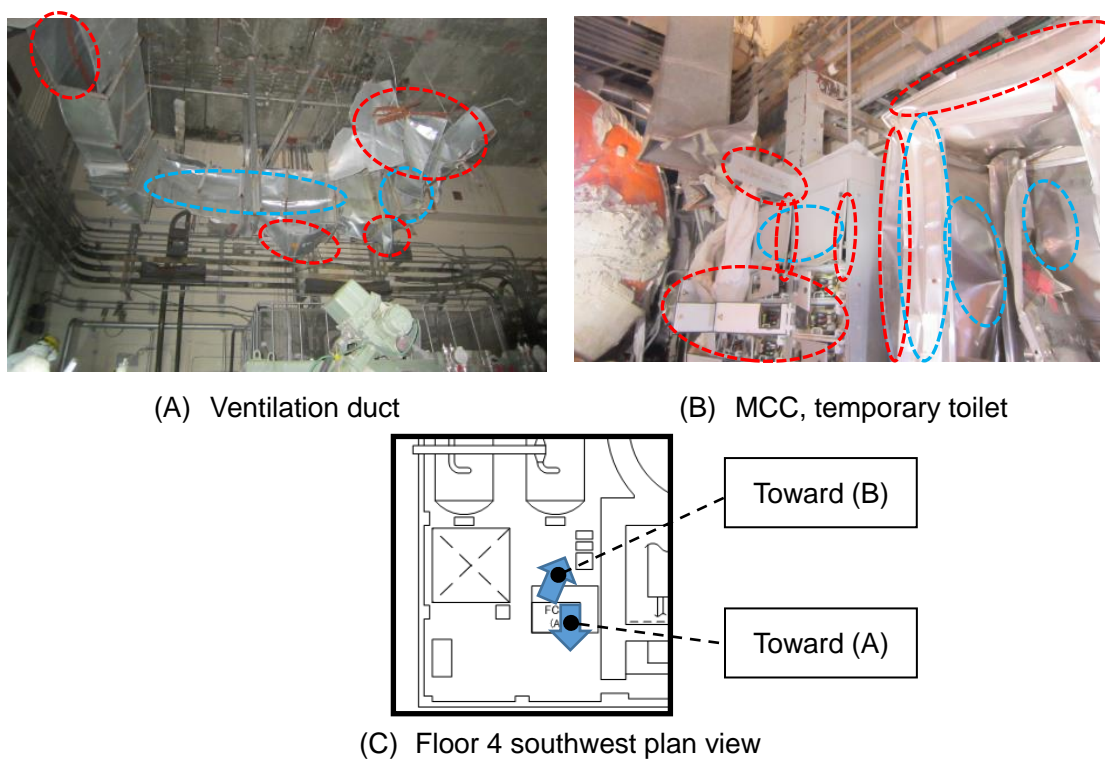
Damaged conditions of the MCC, temporary toilet and ventilation duct, are shown in Figures 21 (A) and (B). Figure 21 (C) gives the directions in which the camera was pointed. Locations encircled in red in the figure are deformed outward and those encircled in blue are deformed inward.

A similar pressure difference could have been generated in hollow structures of the ventilation ducts, MCC and temporary toilet, and consequently inward and outward deformations as was seen in Figure 21 might have been caused in the course of the R/B pressure increase and decrease. Figure 22 shows the results in Case ① as an example, but the above correlation (pressure difference between inside and outside the ventilation duct) is commonly observed in all cases and none of them is considered inconsistent with the damage conditions.

Figure 21 Deformed ventilation duct, MCC and temporary toilet

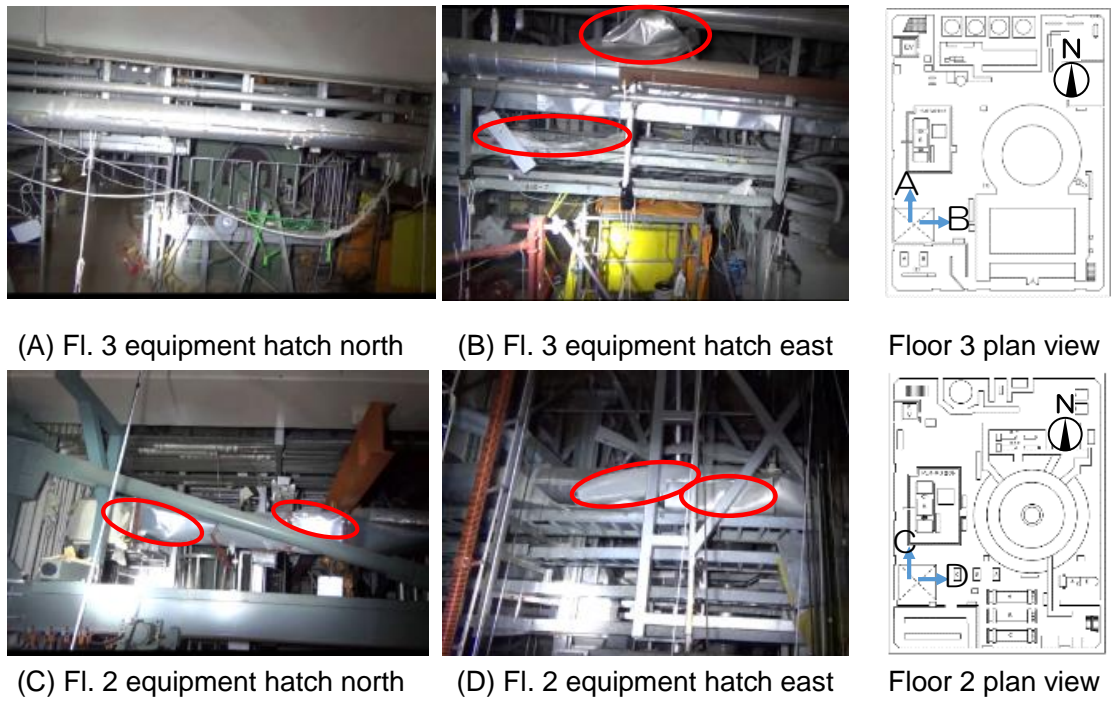
Figure 24 shows conditions around the equipment hatch on Floor 3 and below. Some damage can be noticed (encircled in red) on relatively thin structures. But almost no damage is noticeable on other structures. The damage is less than that on Floor 4 in the west side area discussed in Section 3.2 and no strong blast marks are noticeable.

Figure 24 Conditions around equipment hatch on Floor 3 and below

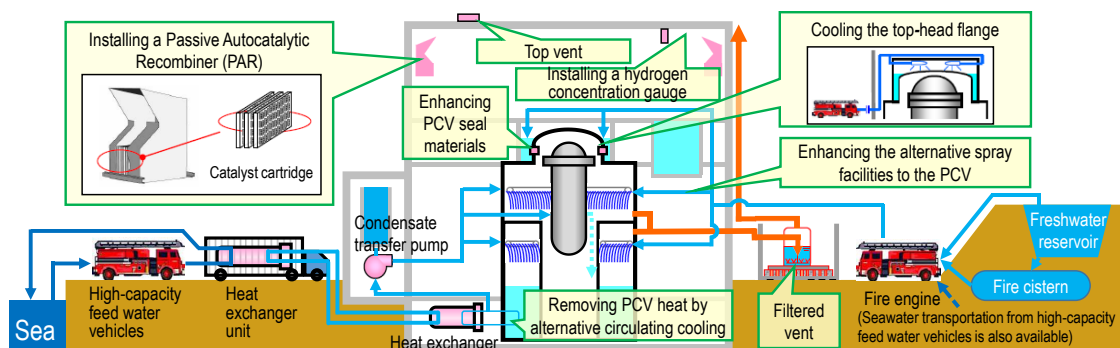
Figure 26 Preventive measures against PCV leaks and hydrogen explosions at Kashiwazaki-Kariwa Nuclear Power Station

As preventive measures against PCV leaks, the following steps will be taken at the Kashiwazaki-Kariwa Nuclear Power Station in order to prevent PCV damage due to overheating and overpressure: strengthening PCV seal materials, strengthening alternative means of PCV spray, implementing top flange cooling, implementing alternative circulation cooling and a filtered vent, etc. It should be noted that pipes penetrating the PCV are designed to be automatically isolated by the isolation valves, as soon as anomalies in accident conditions are detected.

As preventive measures against hydrogen explosions, hydrogen concentration measuring instruments are being installed for early leak detection at locations where leaks can occur (R/B top floor above the PCV top head, and at a small cell for the equipment hatch or airlock). Measures will be taken to control excessive hydrogen leaks to the R/B by depressurizing the PCV through implementation of a filtered vent as soon as a set hydrogen concentration limit is exceeded on the R/B top floor. Further, installation of passive autocatalytic recombiners (PARs) on the R/B top floor, hydrogen discharge from the R/B via the top vent, and other means are being considered. Figure 26 outlines the concept of these measures. Even when hydrogen leaks from the equipment hatch or airlock, hydrogen is led to the top floor via ventilation ducts and others. With these measures, it is estimated the hydrogen concentration in the R/B will not reach the combustion limit.
