Dose increase around March 20th, 2011

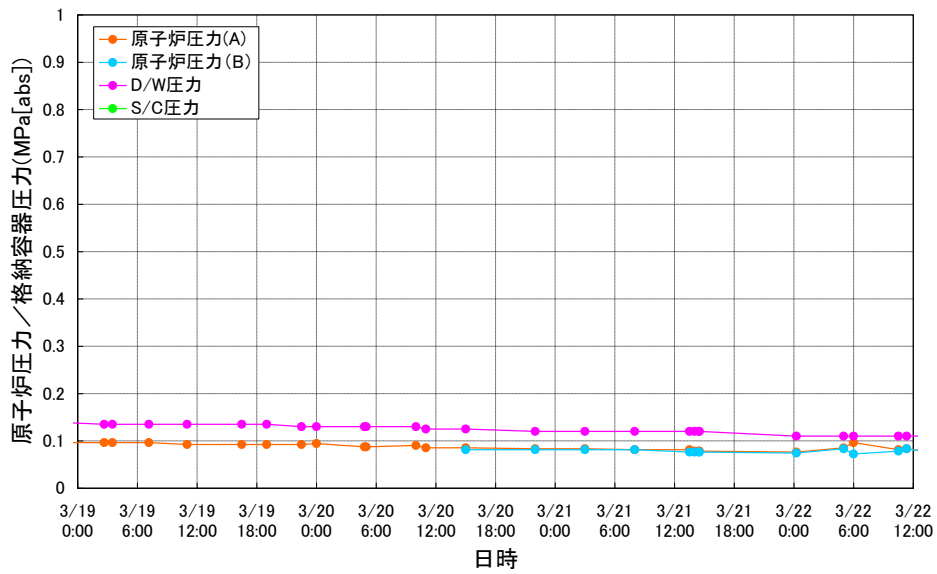
Concerning Unit-2, Figure 6 and Figure 7 have no noticeable significant changes in the reactor water level, reactor pressure and PCV pressure during the time period when the dose increase was observed, although the data points are limited. In Figure 8 CAMS (D/W) readings show a lower value at 11:00 on March 20th than those before and after. But again the change in the CAMS (D/W) readings is reasonably attributed to defective individual readings, because of a discontinuity in particular readings and the CAMS (S/C) data show no changes over the same time period.

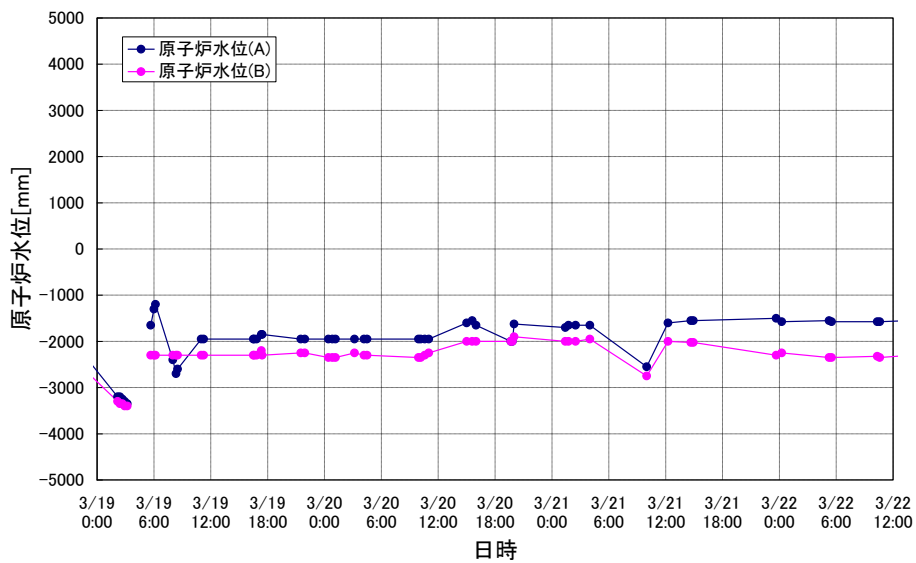
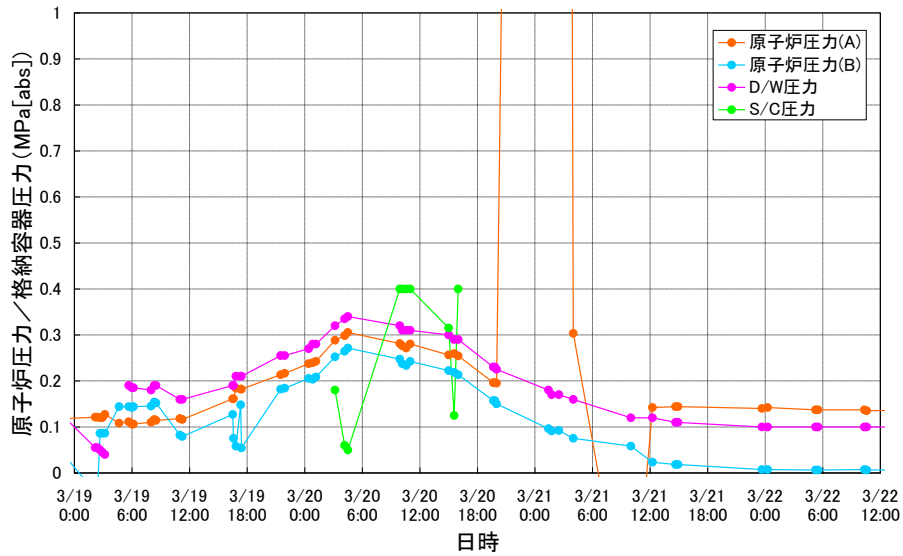
Concerning Unit-3, Figure 9 and Figure 10 show a slight increase in the reactor water level and a slight decrease in the reactor pressure and D/W pressure during the time period when the dose increase was observed on March 20th. During this time period, the reactor temperature and PCV temperature showed a decreasing tendency [1]: the temperature of the feedwater nozzle (N4B) decreased from 210 deg C (at 11:00) to 140 deg C (at 15:00), that of reactor vessel bottom head from 244 deg C (at 11:00) to 220 deg C (at 15:00), and that of D/W HVH return line from 220 deg C (at 11:00) to 187 deg C (at 15:00). This leads to the understanding that the temperature decrease caused the pressure decrease of the reactor and PCV. In Figure 11 CAMS readings show no changes during the period of interest. From these considerations a new incident releasing radioactive materials during this time period of interest at Unit-3 seems unlikely to have occurred.

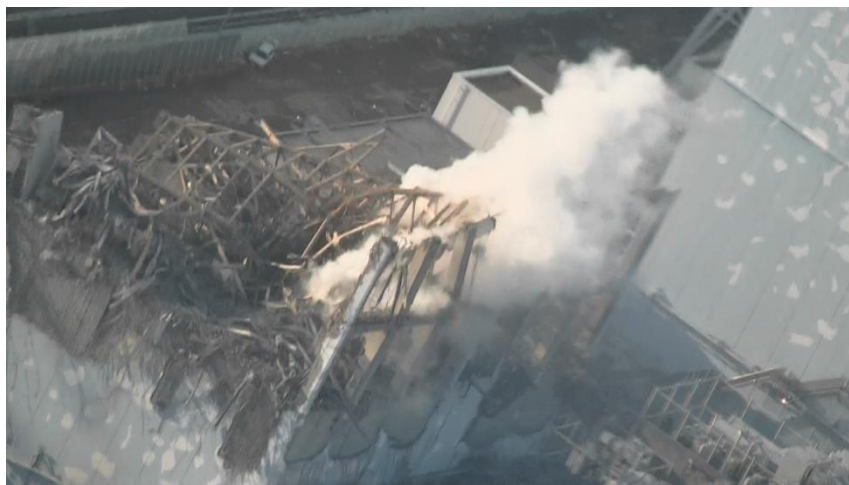
Figure 12 Aerial photo of Unit-3 (March 16th, 2011)

have been more or less continuously released from the containment vessel of Units-1 to 3. For example, steam and other gases rose from the Unit-3 containment vessel as white smoke that passed from the upper side of the building after it had been damaged by the hydrogen explosion. This situation can be seen in an aerial photo taken on March 16th (Figure 12).
