**The 5th Progress Report**  
on the Investigation and Examination of  
Unconfirmed and Unresolved Issues  
on the Development Mechanism  
of the Fukushima Daiichi Nuclear Accident

December 25, 2017

Tokyo Electric Power Company Holdings, Inc.

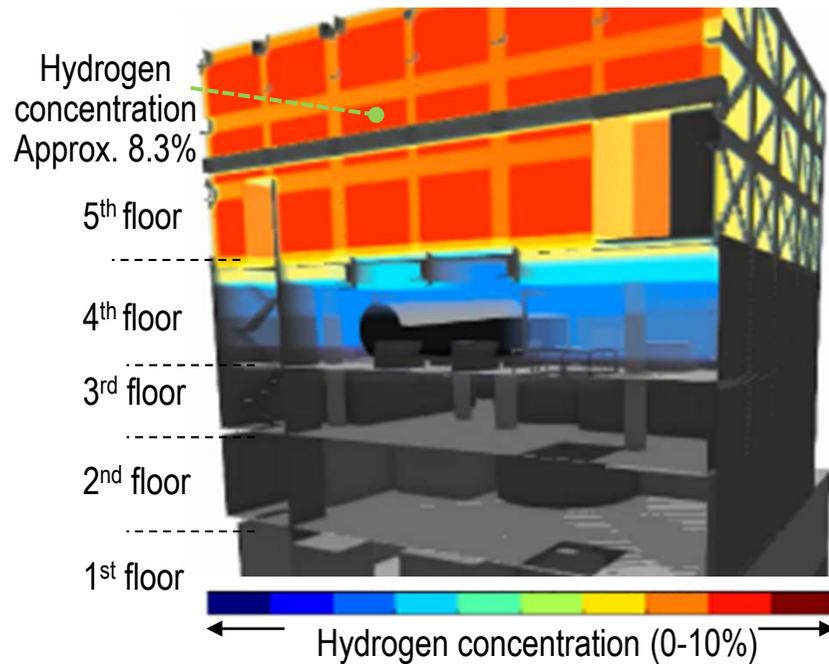
Figure 1: Distribution of hydrogen concentration immediately before explosion

- Hydrogen was distributed mainly on the 5<sup>th</sup> floor. Part of the hydrogen went from the 5<sup>th</sup> floor to the 4<sup>th</sup> floor via stairs, etc., though the concentration was low (Figure 1).
- The fire developed on the 5<sup>th</sup> floor and increased pressure on the 5<sup>th</sup> floor forced the equipment hatch\* lid open.
- Through the opened equipment hatch, a downward blast was generated on the 4<sup>th</sup> floor and below due to pressure difference. The horizontal blast inflow from the equipment hatch was small on the 3<sup>rd</sup> floor and below (Figure 2).

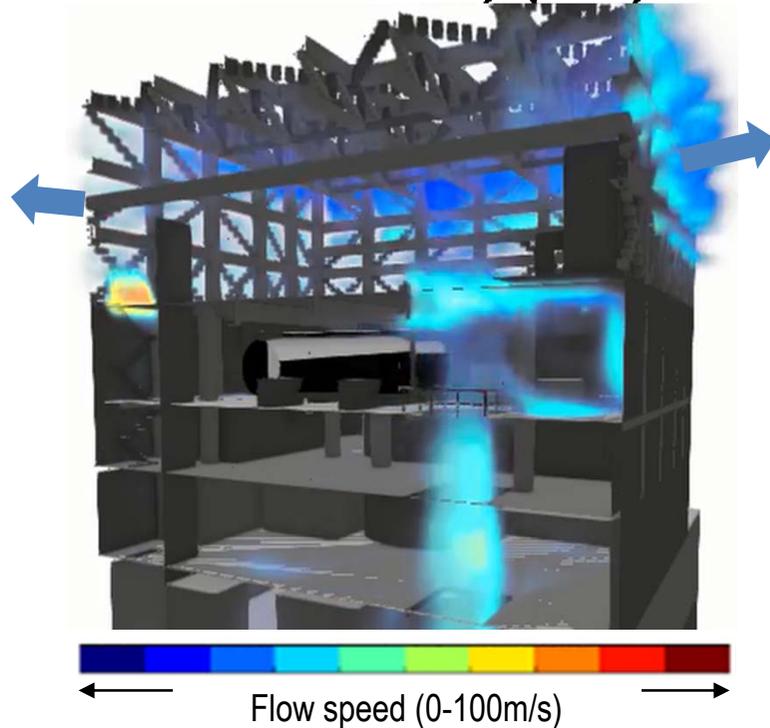
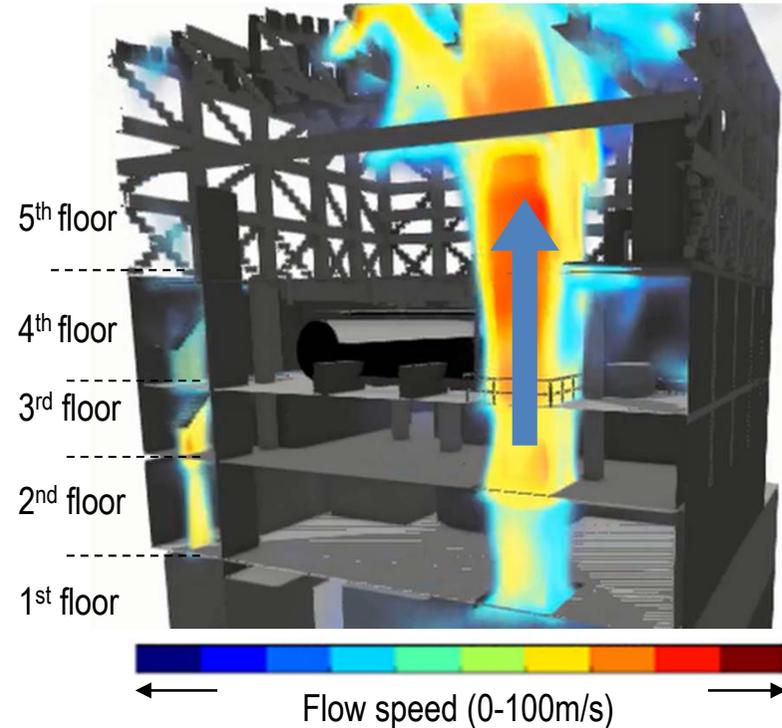
- Increased pressure on the 5<sup>th</sup> floor subsequently broke the side wall on the 5<sup>th</sup> floor, which was the weakest load-bearing wall and a horizontal blast was generated (Figure 1).
- After the side wall was broken, pressure on the 5<sup>th</sup> floor declined, pressure on the 4<sup>th</sup> floor and below relatively increased and later an upward flow was generated through the equipment hatch (Figure 2).

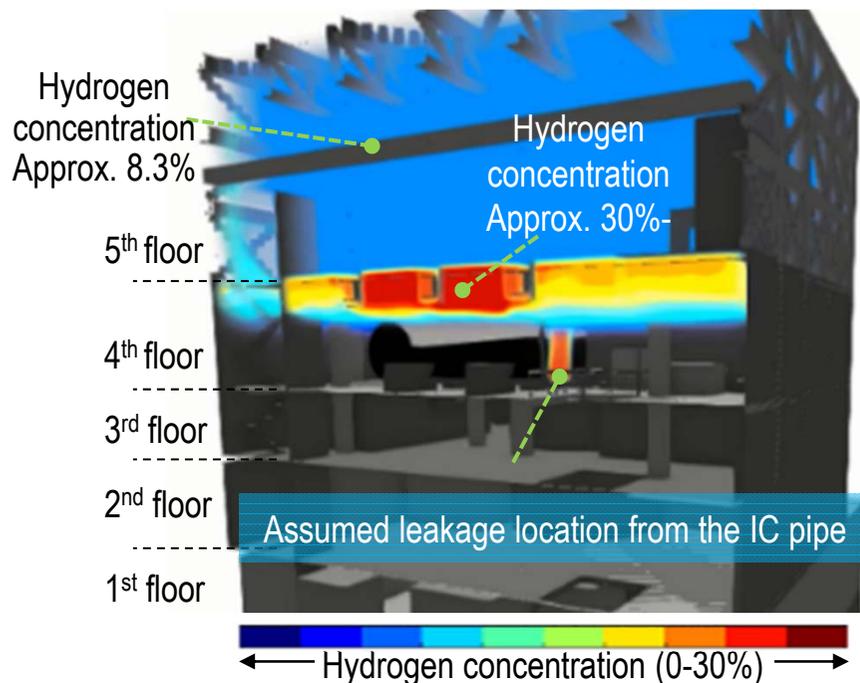
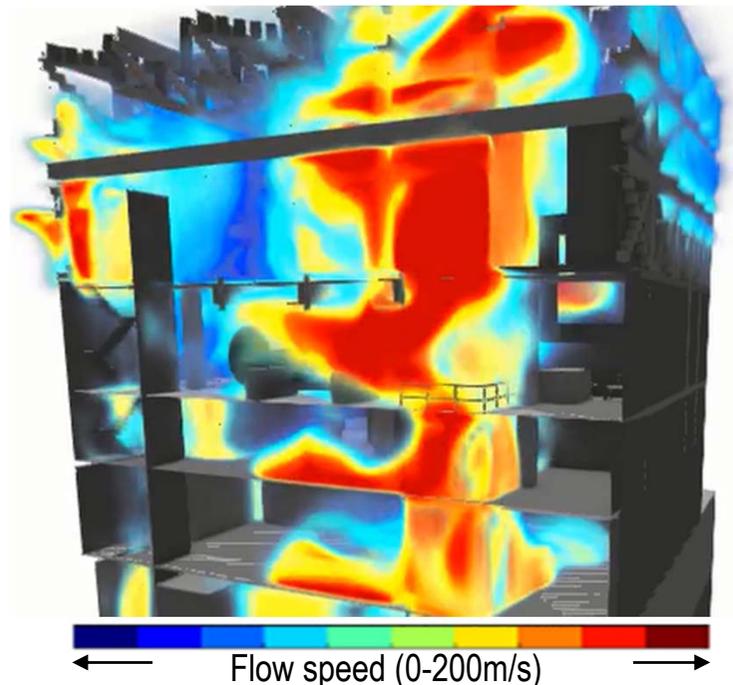
- High hydrogen concentration around the ceiling near the leakage point on the 4<sup>th</sup> floor. Hydrogen distribution on the 5<sup>th</sup> floor was similar to that in the leakage case on the same floor (Figure 1).
- A significant fire took hold on the west side of the 4<sup>th</sup> floor, where a high hydrogen concentration was recorded, which caused pressure to soar. Consequently, the blast speed exceeded that in Case 1 (Figure 2).

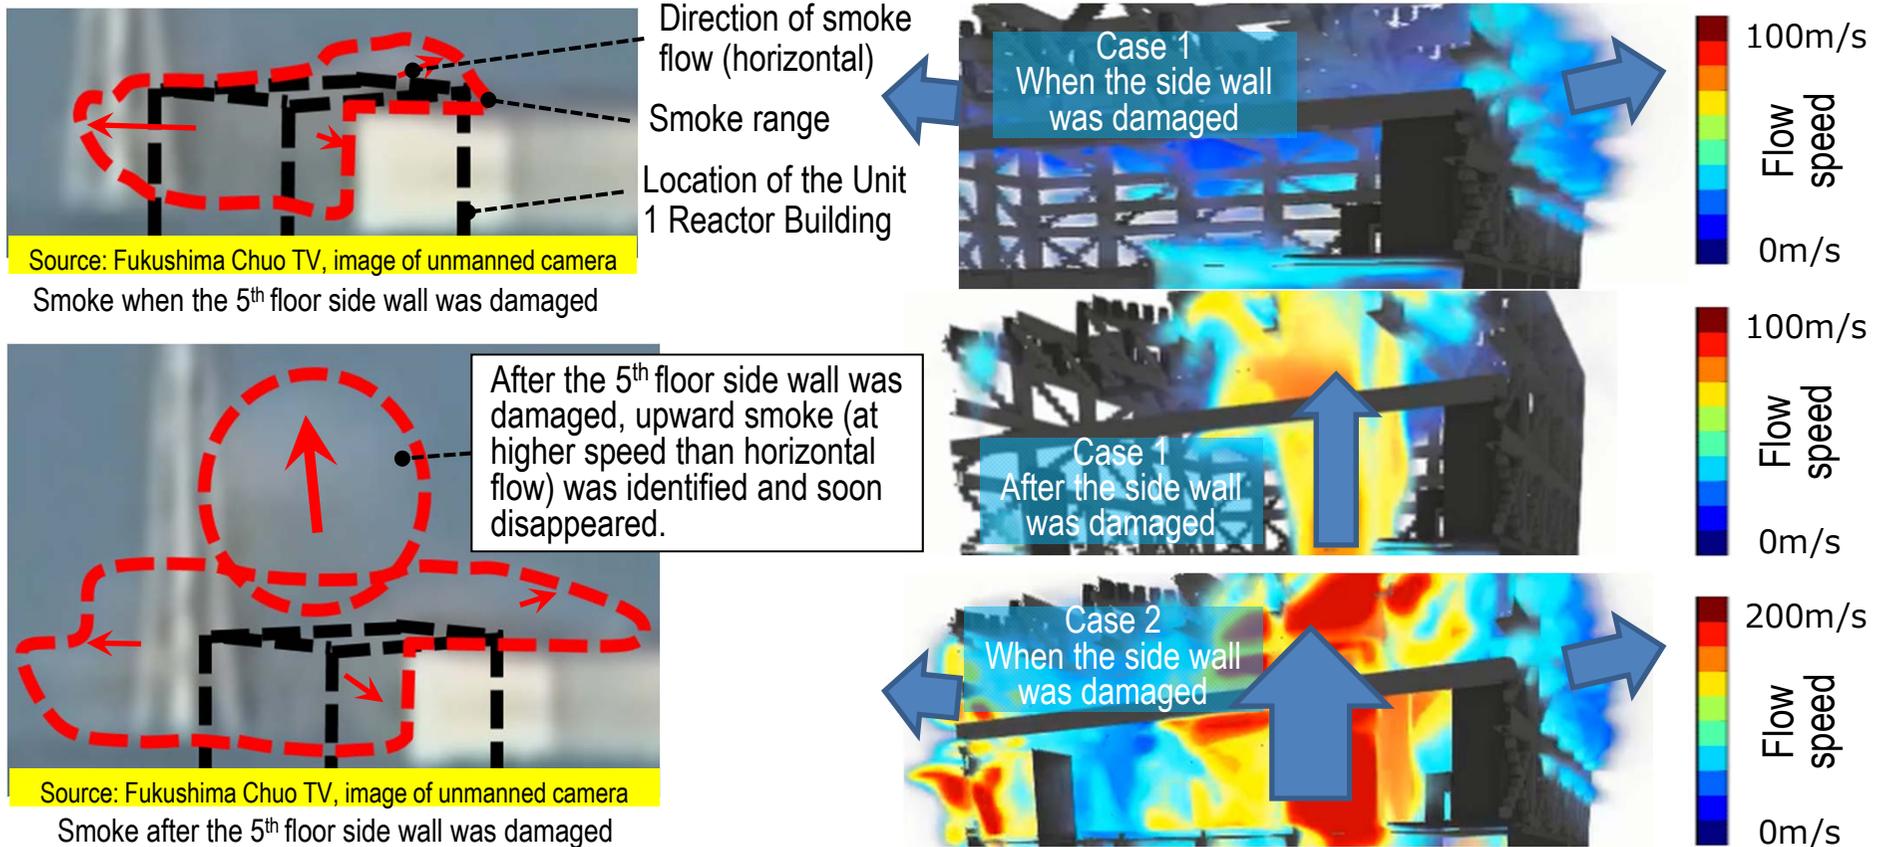
- Images of the unmanned camera showed a horizontal blast when the 5<sup>th</sup> floor side wall was damaged and later, an upward high-speed blast.
- The analytical results showed that following damage to the 5<sup>th</sup> floor side wall, a horizontal flow followed by a subsequent upward high-speed flow were generated in Case 1 (the same tendency in the images), while horizontal and upward flows were generated simultaneously in Case 2.

The images captured the potential upward flow after the side wall was broken, which was indicated in the case of the leakage on the 5<sup>th</sup> floor.

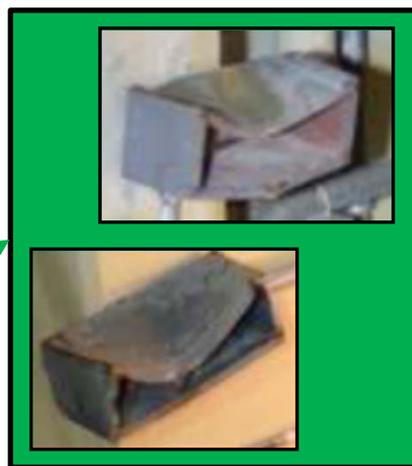
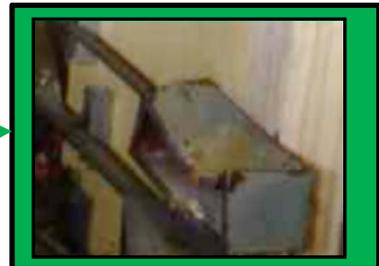
Distorted pull box (downward distortion)

- An inspection of pull boxes (metal boxes that integrate and split cables) around the equipment hatch on the west side of the 4<sup>th</sup> floor identified distortion which was likely due to downward crushing.
- The analytical results concluded that a downward blast was generated at the above point in Case 1 (correlating with the damage status) while a strong horizontal blast was generated in Case 2.

The distortion direction of the pull boxes around the 4<sup>th</sup> floor equipment hatch was consistent with the direction of the blast in the case of leakage onto the 5<sup>th</sup> floor. The blast direction in the case of leakage onto the 4<sup>th</sup> and 5<sup>th</sup> floors differed from the distortion direction of the pull boxes.

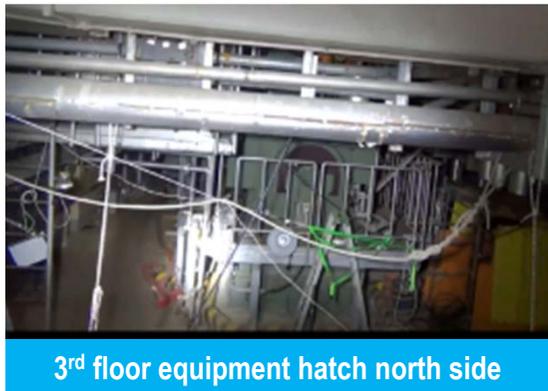
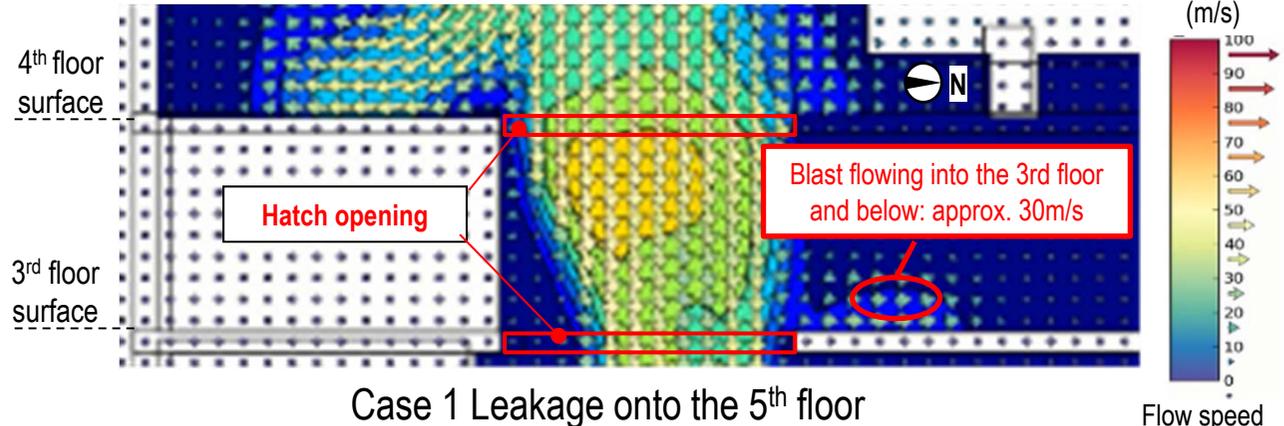
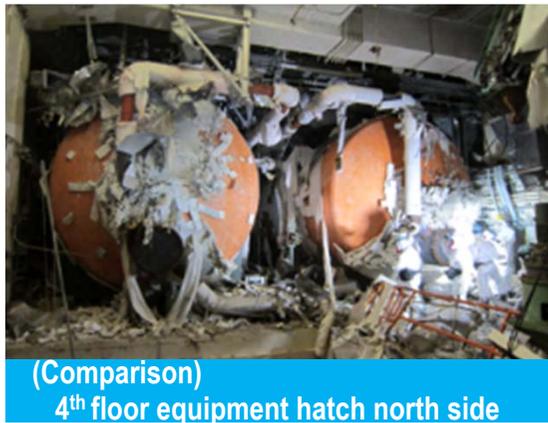
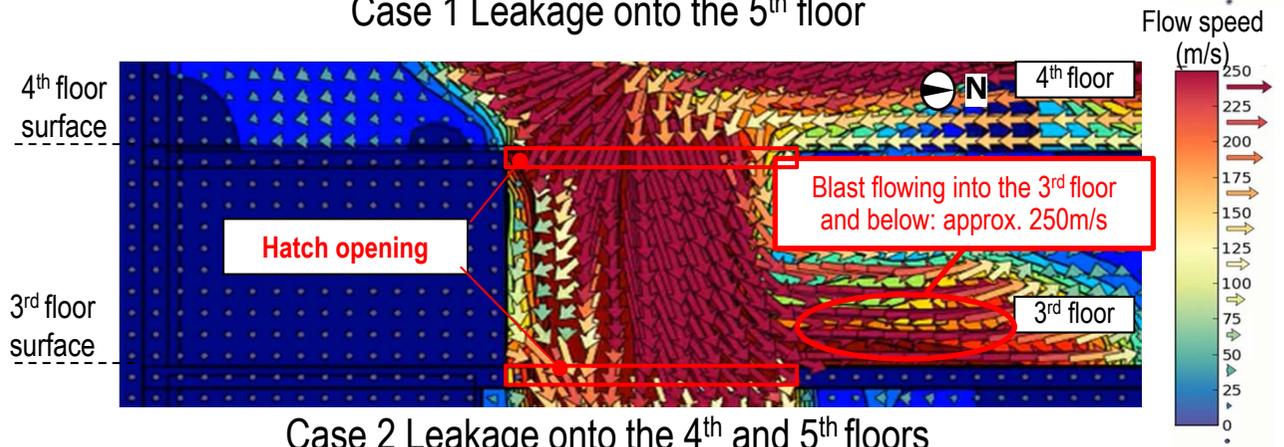
- Minor damage was identified on the 3<sup>rd</sup> floor and below compared to the 4<sup>th</sup> floor, with no sign of damage from the strong blast.
- Analytical results showed that the maximum blast speed flowing into the 3<sup>rd</sup> floor and below was relatively low in Case 1, but significantly high in Case 2.

Minor damage was identified on the 3<sup>rd</sup> floor and below and in terms of the inflow blast speed, it was consistent with the case of leakage onto the 5<sup>th</sup> floor. The blast in the case of leakage onto the 4<sup>th</sup> and 5<sup>th</sup> floors was likely to be excessive.

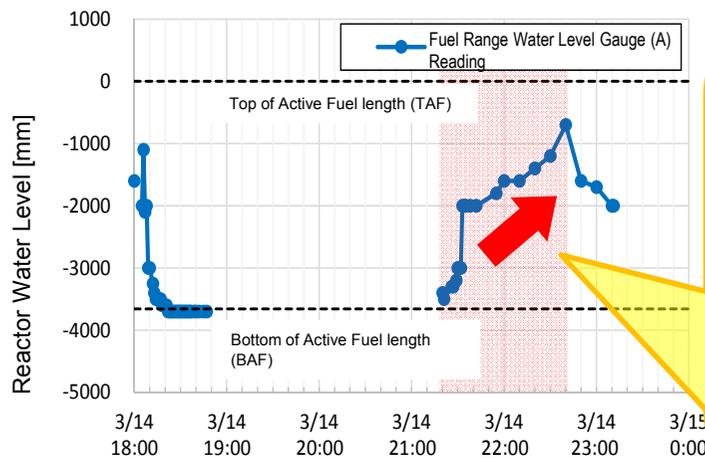
Figure Water Level Gauge Readings of Unit 2

The reactor water level is a key benchmark to determine the accident progression. Although the water level gauge may have failed to indicate an accurate value in the process where the accident caused the temperatures in the reactor and containment vessel to soar, the actual reactor water levels can be estimated by analyzing the indicated values based on the features of the water level gauge. Here, we have estimated how the reactor water level actually changed based on the water level gauge readings during the period of progressive core damage and meltdown (the night of March 14, 2011), on which we have focused to date.

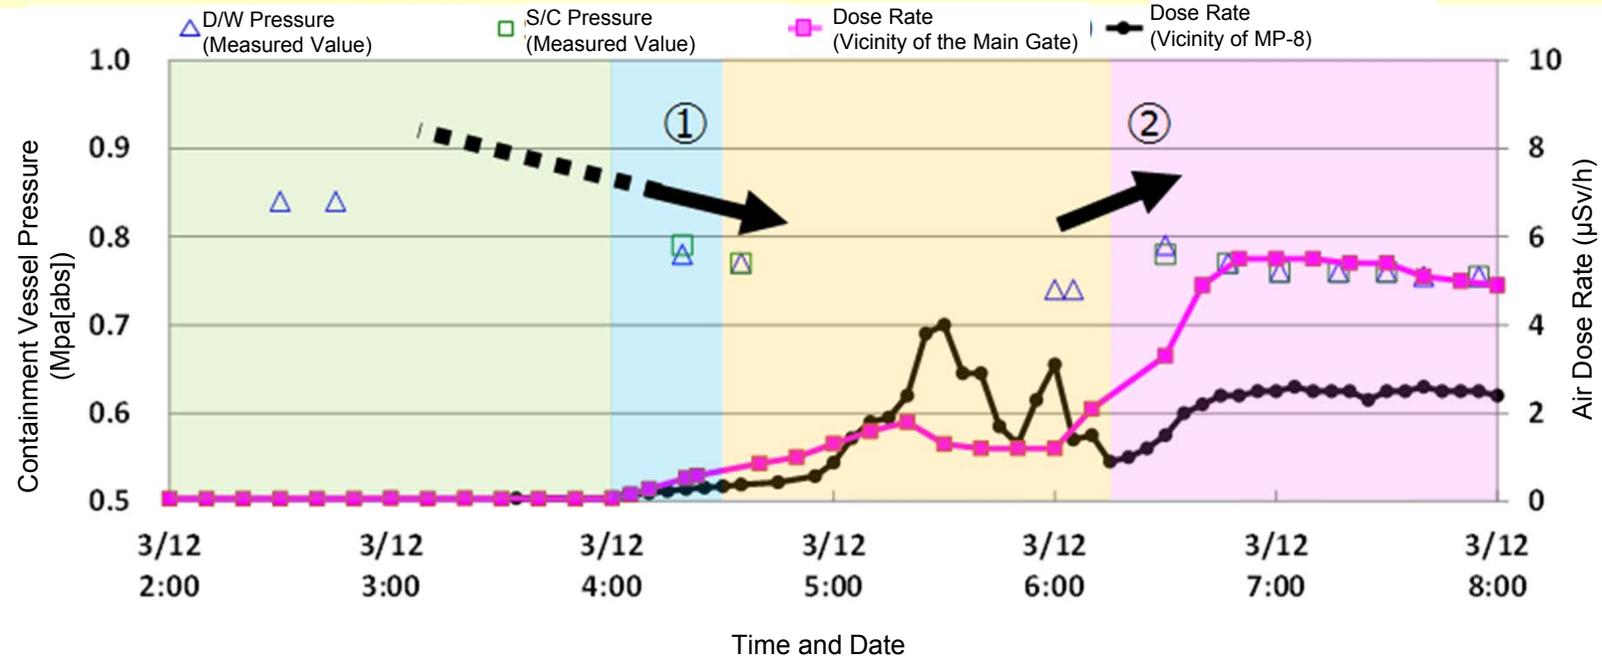
Relationship between the Measured Values of the Containment Vessel Pressure of Unit 1 and the Air Dose Rate Monitoring Data in the Power Plant Site

- The air dose rate increased during both ① and ② shown in the figure, in which the containment vessel pressure changes. Therefore we deduced that radioactive material was transferred from the containment vessel to the reactor building.
- Conversely, the containment vessel pressure showed different behavior; it decreased shortly before 4:30 a.m. (① in the figure) and increased shortly after 6:00 a.m. (② in the figure).
