Welded Tank Internal Surface Inspection Results and Future Tank Plan in light of the Detection of Hydrogen Sulfide

April 25, 2019

Tokyo Electric Power Company Holdings, Inc.

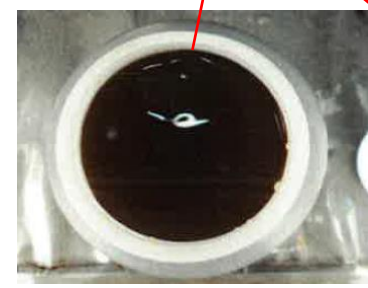
External appearance of water at the bottom of the D-C1 tank sampled on February 12, 2019

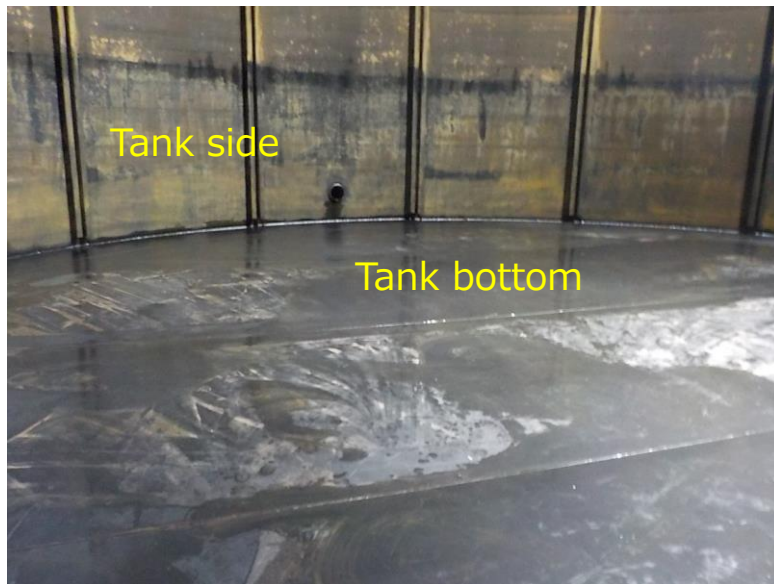
- Sludge recovered from the bottom of the G3-E5 tank and a visual inspection of the inner surface conducted
 - Scratches/gouges (maximum depth: 1.7 mm) and paint chipping assumedly caused during construction found on the bottom. No paint chipping, etc., was found on the side surfaces.

Internal surface conditions

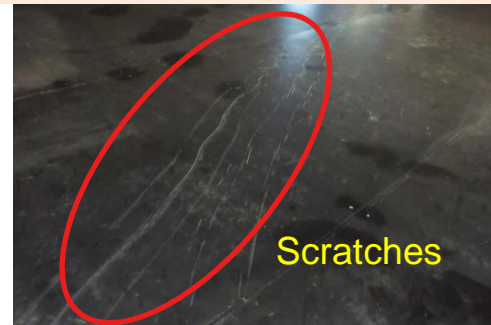
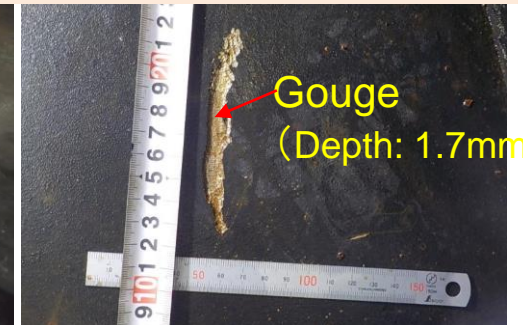
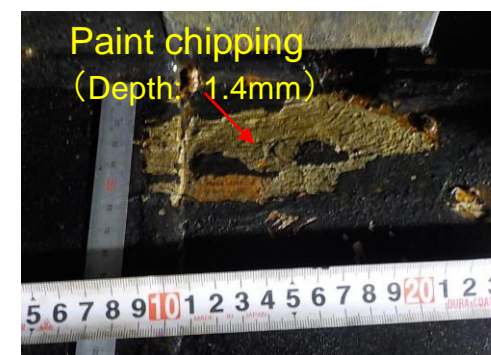
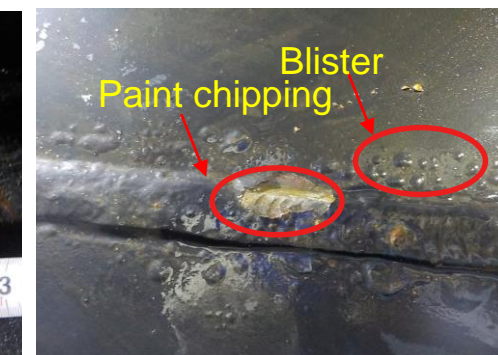
- No large discrepancies with inspection results from neighboring tanks (G3-F4) in which hydrogen sulfide was not found.
 - Inspection of areas where paint is chipping (locations of corrosion) found that there was no black iron sulfide film, so it was determined that the paint chipping was not caused by sulfate-reducing bacteria. Furthermore, the rate of corrosion of locations of paint chipping assumedly caused during construction is 0.26 mm/year, which is approximately the same as the normal speed of corrosion of carbon steel (less than 0.3 mm/year).

Scratches, etc., found at the bottom of the tank

- Scratches with a depth of 1.7mm on the bottom that were found during internal surface inspections of the G3-E5 tank are not problematic because the plate thickness allowance is 9mm (nominal plate thickness: 12mm-required plate thickness: 3mm), but they will be repaired and painted just to be safe.
- The plate thickness allowance of the bottom plate of other welded tanks (stored water: Sr-treated water, ALPS-treated water) is:
 - 9 mm → G3, G1 south, H1~H6, H8, B, J1~J9, K1 area
 - 19mm → G1 south, H4 south area
 - 22mm → D, G7, H4 south, K2~K4 area

In light of the above inspection results we will continue to use other welded tanks in which Sr-treated water is being stored after draining them to perform internal surface inspections and repair/paint scratches.

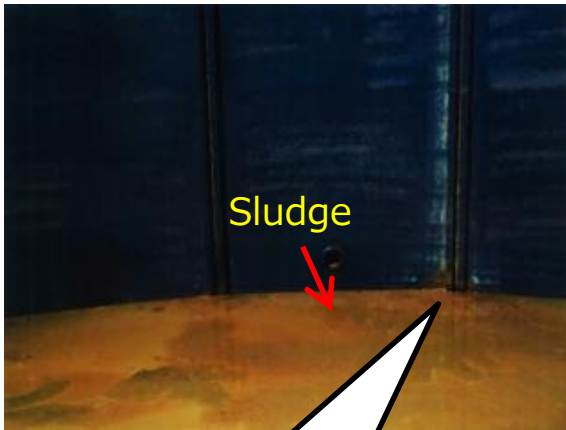
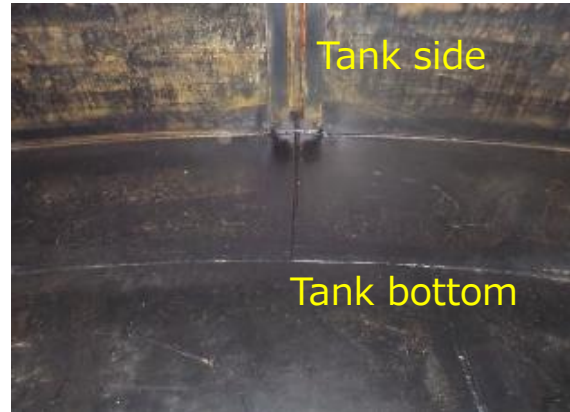
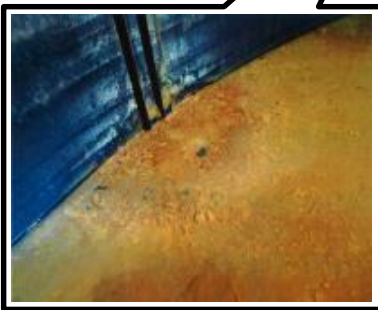
- After sludge at the bottom of the G3-F4 tank was removed, a visual inspection of the inside was conducted and it was found that the paint was intact throughout. However, scratches, blisters and paint chipping on welded surfaces was found. Going forward the aforementioned locations will be repaired and repainted.

Prior to sludge removal

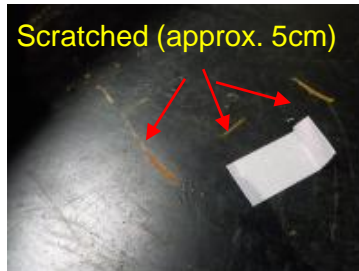
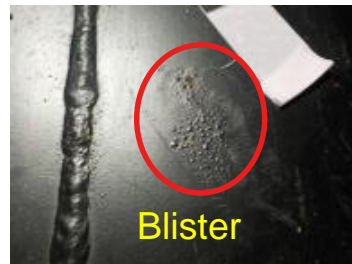
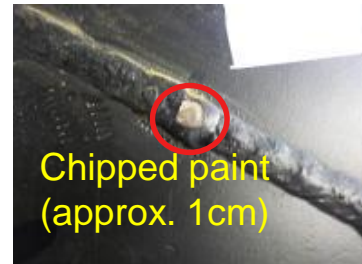
After sludge removal
