# Results of Internal Inspection of ALPS-Treated Water Storage Tanks

October 31, 2019

Tokyo Electric Power Company Holdings, Inc.

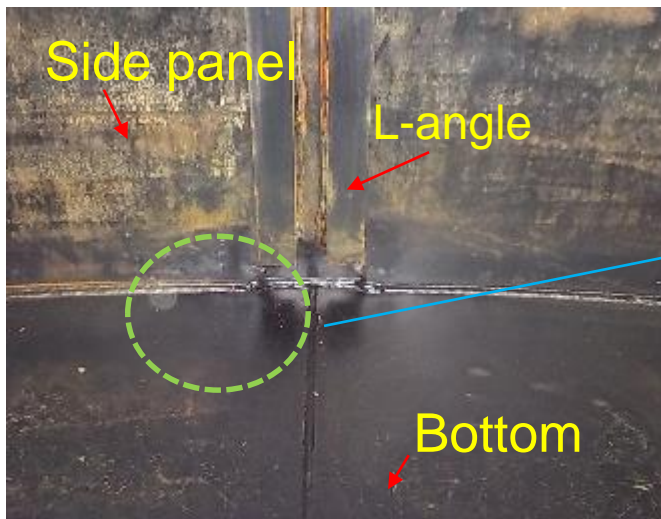
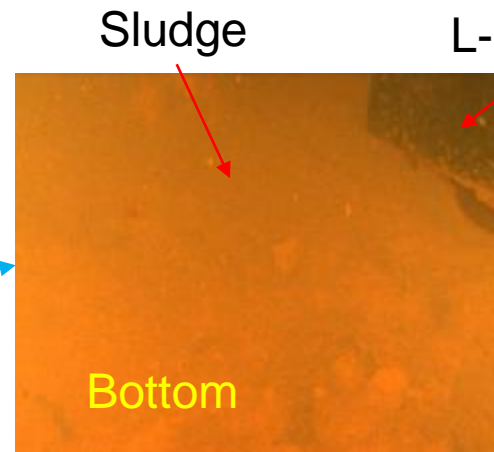
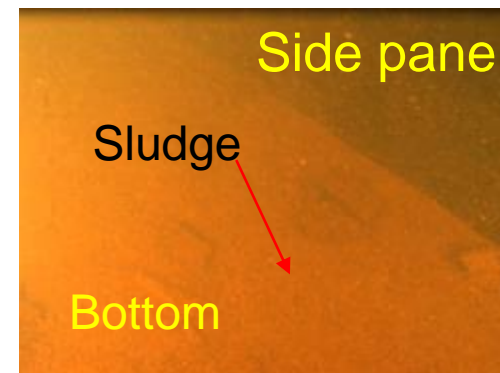
- An internal surface inspection of the G3-D1 tank conducted using an ROV found the following.
  - Sludge has accumulated over the entire bottom surface of the tank
  - The bottom surface of the tank could not be seen even when the ROV was lowered to the bottom and slid sideways to push some of the sludge out of the way.
- Furthermore, it is assumed that the primary reason why sludge has formed in mixed-water tanks is because, "ferric chloride injected into the RO treatment equipment to protect the RO membrane has coagulated and settled to form crud that has adhered to the multimedia filter (hereinafter referred to as, "MMF"), and some of the crud was transferred to the Sr-treated water tanks via the RO condensed water side during backwashing to eliminate MMF clogs."

Conditions at the bottom of tanks (photographed during internal surface inspections conducted using an ROV)

- The internal inspection conducted using an ROV revealed that the bottom of the tanks cannot be observed due to accumulated sludge. The accumulated sludge is, as mentioned above, assumed to be caused by residual Sr-treated water. Therefore, we shall deliberate removing the sludge from the aforementioned 36 tanks to prevent the generation of hydrogen sulfide and also because an internal inspection using an ROV is impossible. (The detailed timeframe for removal of this sludge shall be determined after completion of the treatment of Sr-treated water with ALPS, which is underway at current time.)
- In regards to ALPS-treated water tanks not mentioned above, 24 tanks in the G3 area will be subject to internal inspections using an ROV in October 2020, and inspection plans for other areas shall be created based on the status of these inspections.

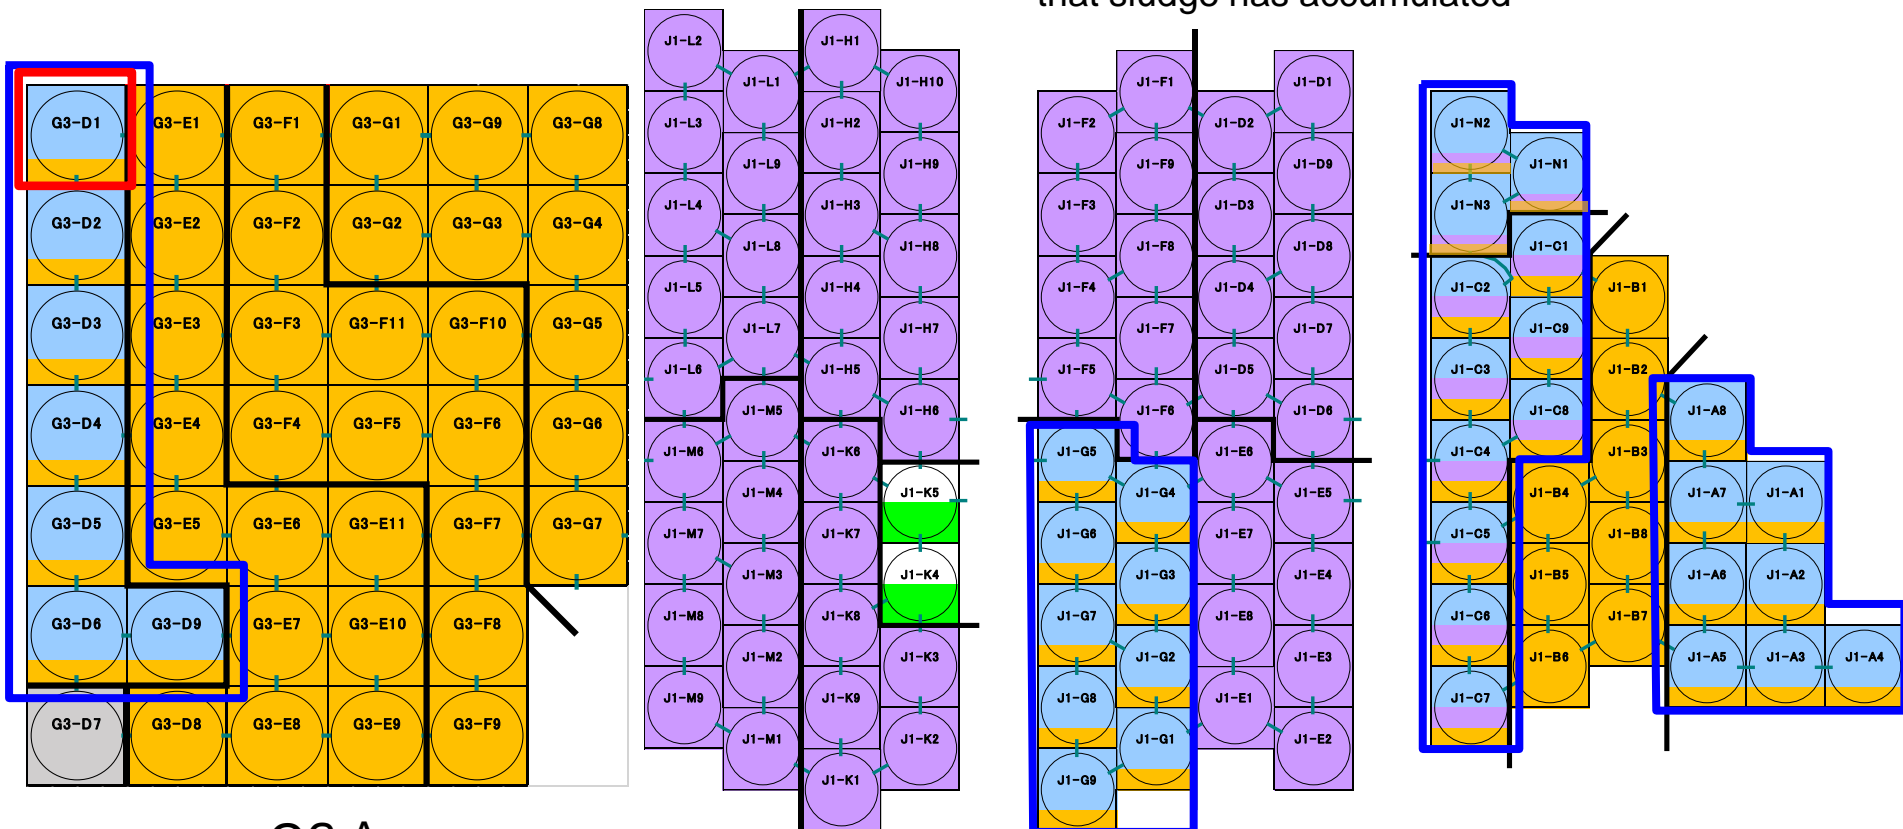
- As shown in the chart below, the concentration of radioactive substances in the 36 ALPS-treated water storage tanks (G3 west area (Group D)/J1 area (Groups A,C,G,N)) was higher compared to other ALPS-treated water storage tanks due to water that was left over from when the aforementioned tanks were previously used to store RO concentrated brine and Sr-treated water (data released on TEPCO website).  
An ROV (submersible robot) was used to inspect the bottom of the inside of the tanks due to the possibility of accumulated sludge (one reference tank (G3-D1))

[Reference] ALPS-treated water tanks in which sludge has accumulated

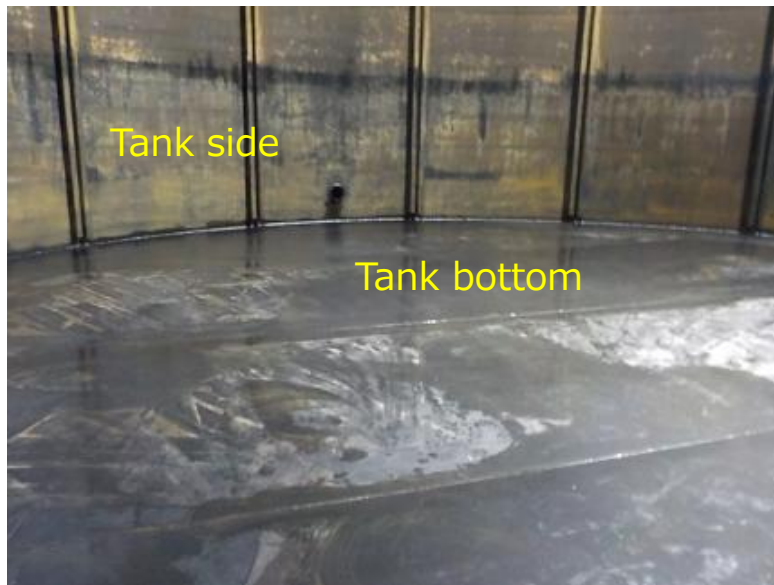
- Sludge recovered from the bottom of the G3-E5 tank and a visual inspection of the inner surface conducted
  - Scratches/gouges (maximum depth: 1.7 mm) and paint chipping assumedly caused during construction found on the bottom. No paint chipping, etc., was found on the side surfaces.

- No large discrepancies with inspection results from neighboring tanks (G3-F4) in which hydrogen sulfide was not found.
  - Inspection of areas where paint is chipping (locations of corrosion) found that there was no black iron sulfide film, so it was determined that the paint chipping was not caused by sulfate-reducing bacteria. Furthermore, the rate of corrosion of locations of paint chipping assumedly caused during construction is 0.26 mm/year, which is approximately the same as the normal speed of corrosion of carbon steel (less than 0.3 mm/year).

Internal surface conditions

In light of the above inspection results we will continue to use other welded tanks in which Sr-treated water is being stored after draining them to perform internal surface inspections and repair/paint scratches.

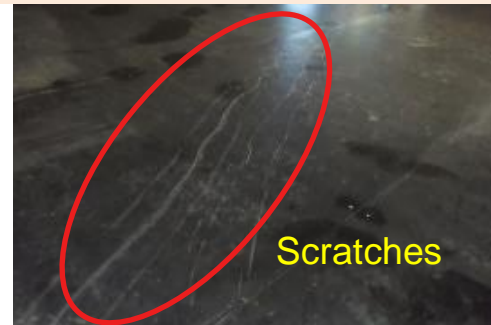
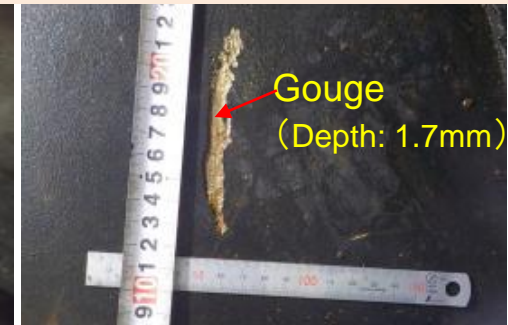
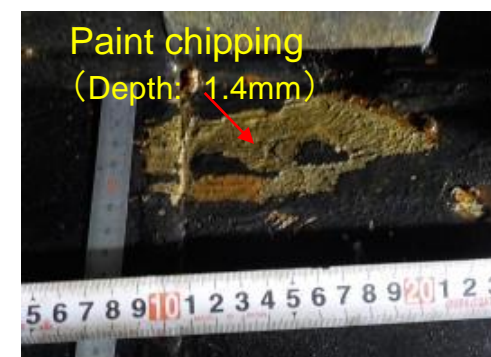
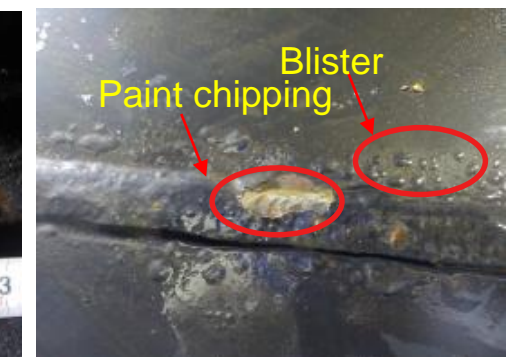
Scratches, etc., found at the bottom of the tank

- Scratches with a depth of 1.7mm on the bottom that were found during internal surface inspections of the G3-E5 tank are not problematic because the plate thickness allowance is 9mm (nominal plate thickness: 12mm-required plate thickness: 3mm), but they will be repaired and painted just to be safe.
- The plate thickness allowance of the bottom plate of other welded tanks (stored water: Sr-treated water, ALPS-treated water) is:
  - 9 mm → G3, G1 south, H1~H6, H8, B, J1~J9, K1 area
  - 19mm → G1 south, H4 south area
  - 22mm → D, G7, H4 south, K2~K4 area

The smallest plate thickness allowance is 9 mm, which is the same as the G3-E5 tank, so there is no problem if there are similar scratches

- At current time there are no leaks from scratches
- Welded tanks in which Sr-treated water is being stored will be drained and the internal surface inspected in conjunction with future ALPS treatment plans
- Welded tanks in which ALPS-treated water is being stored will be subject to internal surface inspections after being drained, or will be inspected using submersible cameras, as part of future long-term inspection plans
