Completion of the Internal Investigation of the Unit 2 Spent Fuel Pool (SFP) at the Fukushima Daiichi Nuclear Power Station

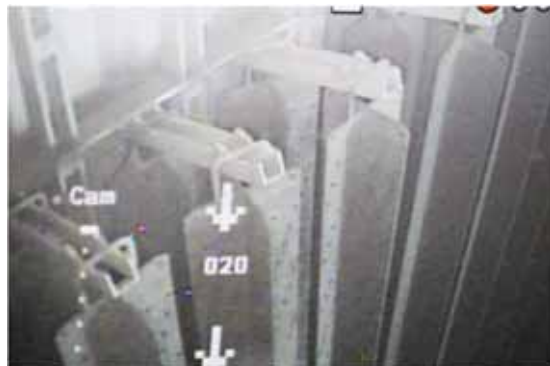
【Control rods and control rod hangers】

- In regards to ①, we confirmed that the control rods are hanging on control rod hangers as normal. In regards to ②, sandy deposits were found at the bottom of the cask pit. However, no large obstructions, nor damage to the beams or bolts, were found.

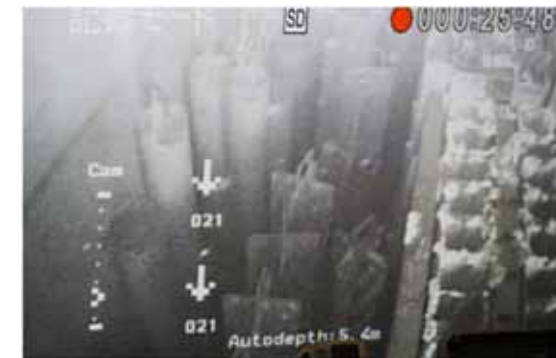
【Control rod racks and filters】

- During today's portion of the investigation we did not encounter any circumstances that have the potential to interfere with fuel removal.
- In addition, we also checked the condition of channel boxes that have been stored in the SFP since before the disaster, and filters from regular inspections, but have not encountered any circumstances that have the potential to interfere with fuel removal.
