Tank Displacement Caused by the Earthquake on February 13 and Countermeasures

February 25, 2021

Tokyo Electric Power Company Holdings, Inc.

March 1, 2021 Partially revised
(P2, P4 ,P5)

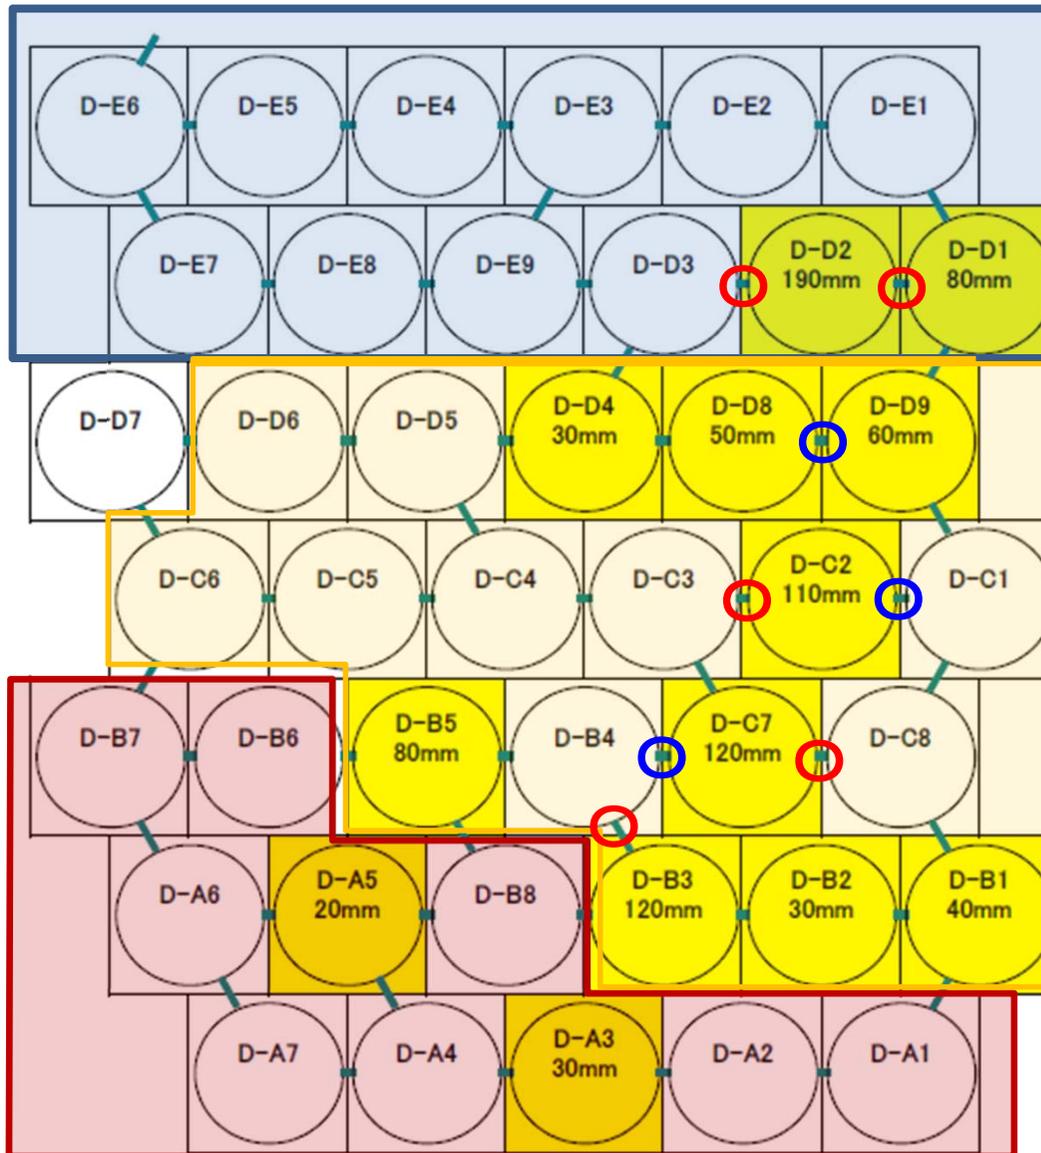
4. Area D tank displacement

- In Area D, coupling pipes were found in **eight** locations to have been displaced to a degree that exceeds the recommended amount of displacement by the manufacturer during inspections prior to the removal of protective coverings. And, in the six other areas tanks were found to have been displaced to a degree that is lower than manufacturer's recommended amount of displacement. (**Eccentricity : two, Elongation : four, Shrinkage : three (One was confirmed to have eccentricity and elongation in a same pipe.)**)

- : Locations where displacement exceeds manufacturer's recommendations
- : Locations where displacement exceeds manufacturer's recommendations (Additional)

Tanks found to have been displaced

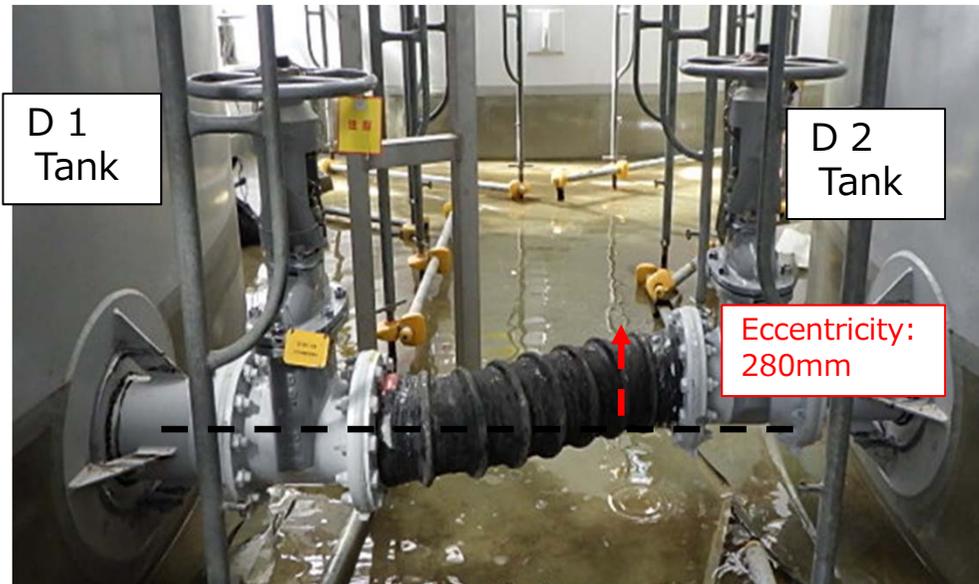
Coupling pipe (Connecting D1-D2)
(A small amount of rain water has accumulated inside the dyke)

Manufacturer recommended displacement※ Eccentricity: 150mm
Elongation/Shrinkage: ±50mm

※ : Minimum for guaranteeing stable functionality. The pipes will not immediately break/rupture if the amount of displacement exceeds the amount of displacement mentioned above.

- Coupling pipes that were displaced will be replaced as soon as preparations are completed.
- Going forward, the necessity for earthquake countermeasures will be examined, procedures for responding to earthquakes will be revised, and securing an inventory of spare parts will be reexamined based upon the data obtained from seismometers on site.

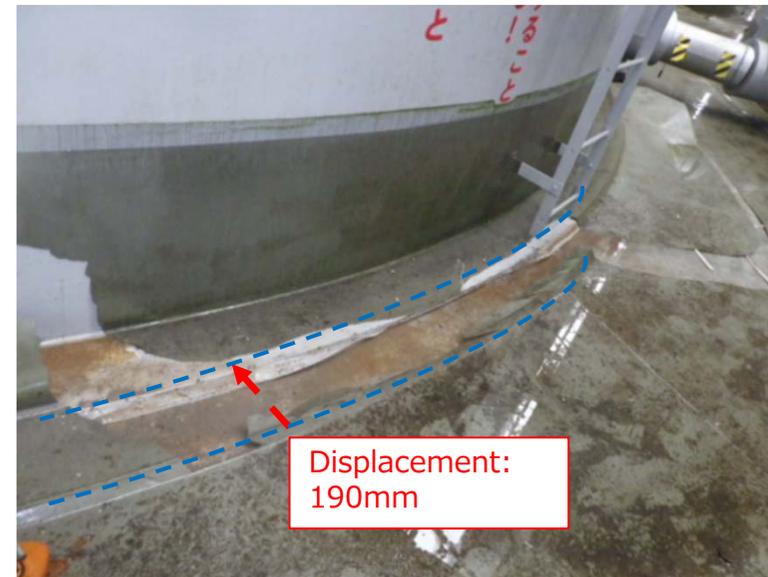
Tanks displacement and waterproof paint
(Polyurea) damage (D2 Tank)
(A small amount of rain water has accumulated inside the dyke)
