Handling of the PCV Water Level Drops at Units 1 and 3

March 25, 2021

Tokyo Electric Power Company Holdings, Inc.

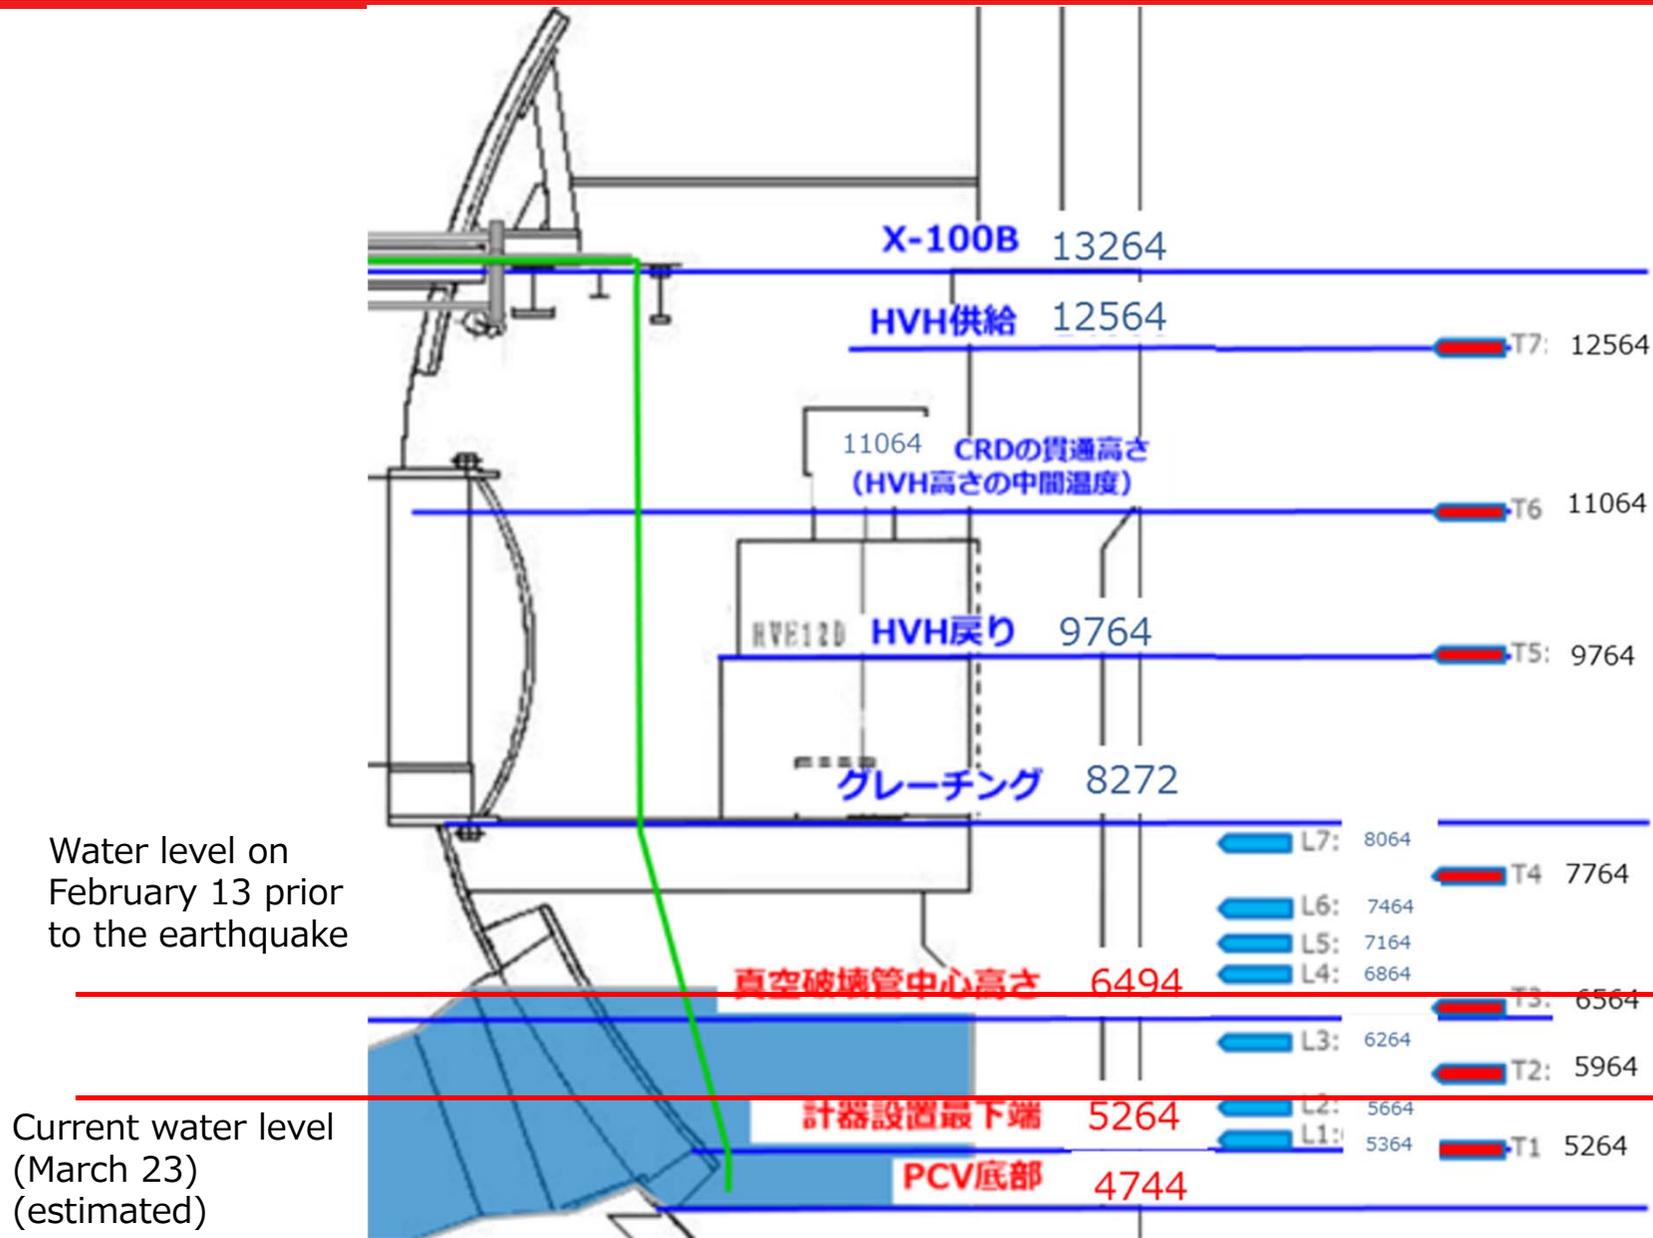
2-1. Trends in parameters related to the Unit 1 PCV water level drop

- When plant parameters were checked on February 18, 2021, the Unit 1 PCV water level gauge was showing a drop in water level.
- Confirmation/assessment of other parameters thereafter revealed that some of the newly installed PCV temperature gauges were showing dropping trends, so it was determined on February 19 that the PCV water levels at Units 1 and 3 were dropping.

- At Unit 1, the PCV water level fell below water level gauge L2 ※ at 8:24 PM on March 22, so at 10:42 PM on the same day the amount of cooling water injection was increased (Approx. 3.0m³/h→Approx.4.0m³/h). As a result, the water level rose above L2 at 3:57 AM on the next day (March 23).

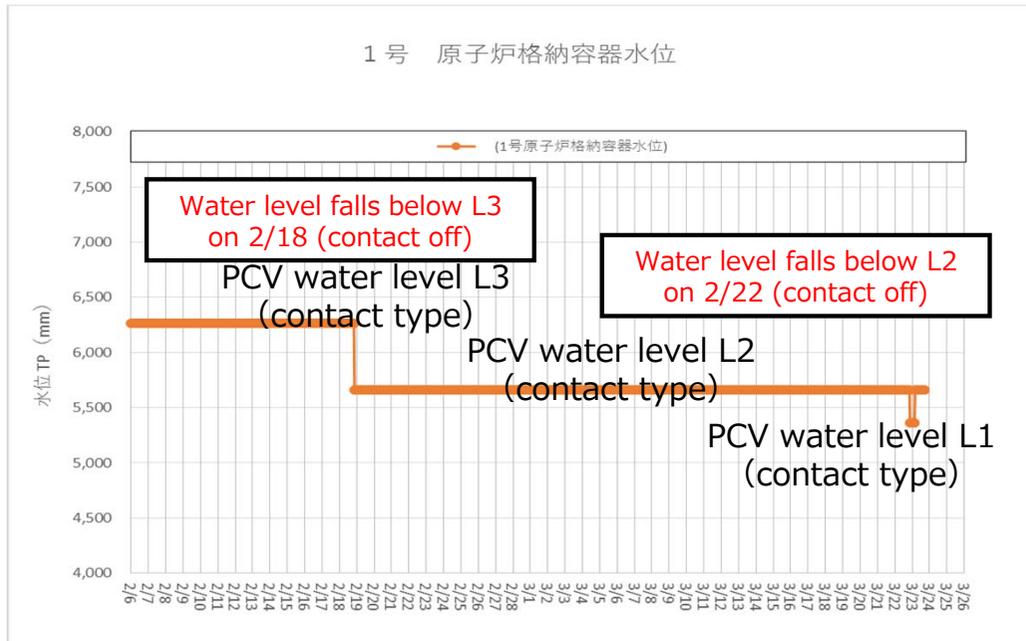
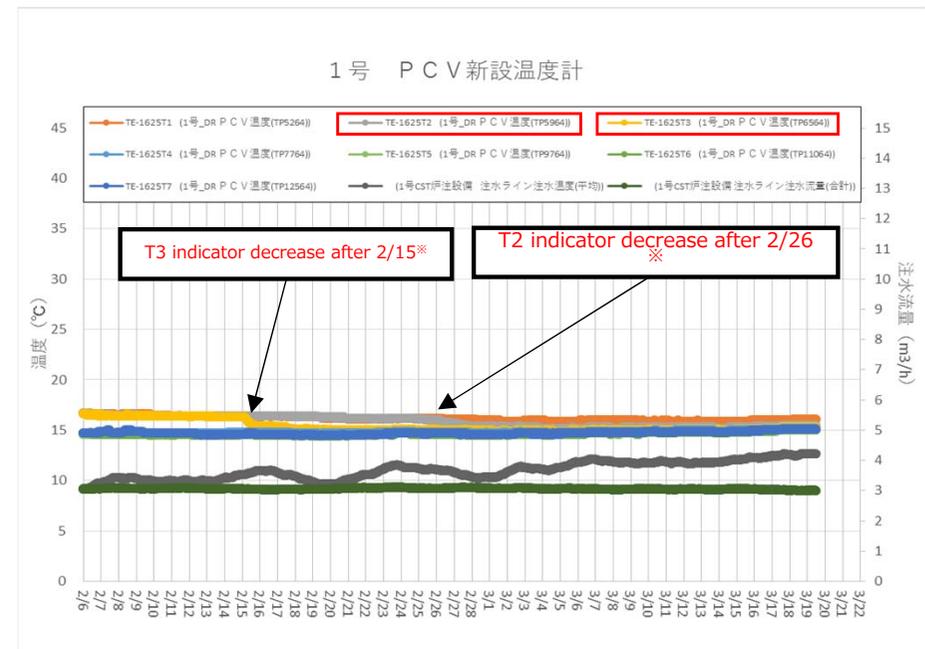
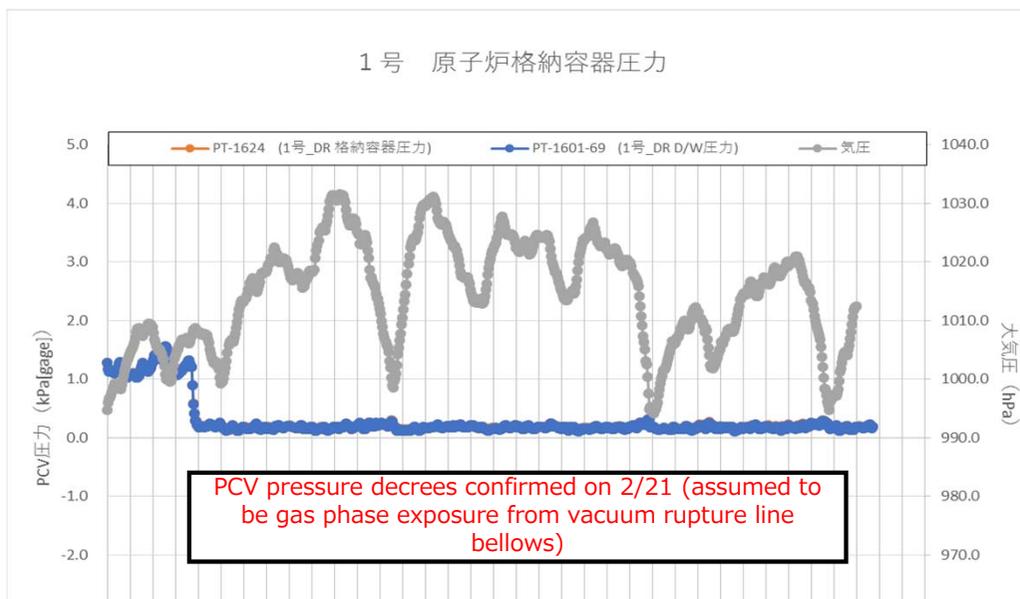
2-1. Trends in parameters related to the Unit 1 PCV water level drop

※ From past data we know that temperature gauges inside the PCV read a few degrees Celsius higher amidst gases (exposed) then when submerged in liquids, so we assume that the temperature gauge is exposed.

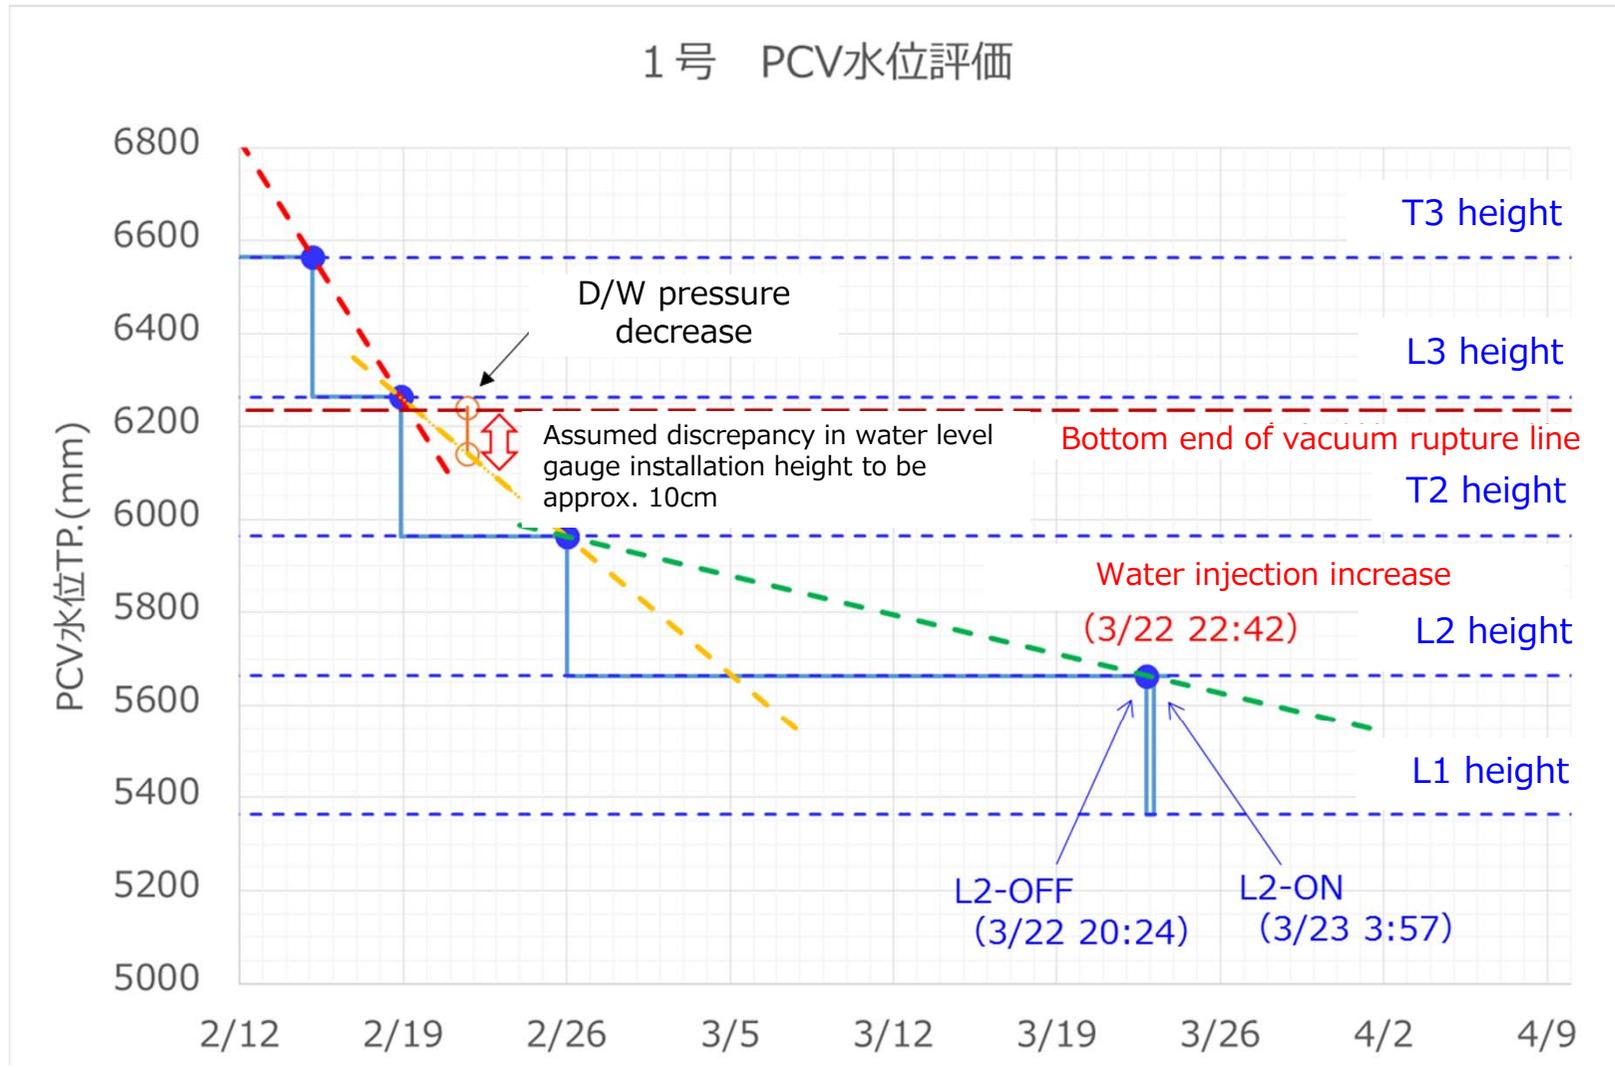
2-1. Trends in parameters related to the Unit 1 PCV water level drop

- On March 22 the PCV water level fell below water level gauge L2 so the amount of cooling water injection was increased (Approx. 3.0m³/h→Approx.4.0m³/h). As a result, the water level rose above L2 on March 23.

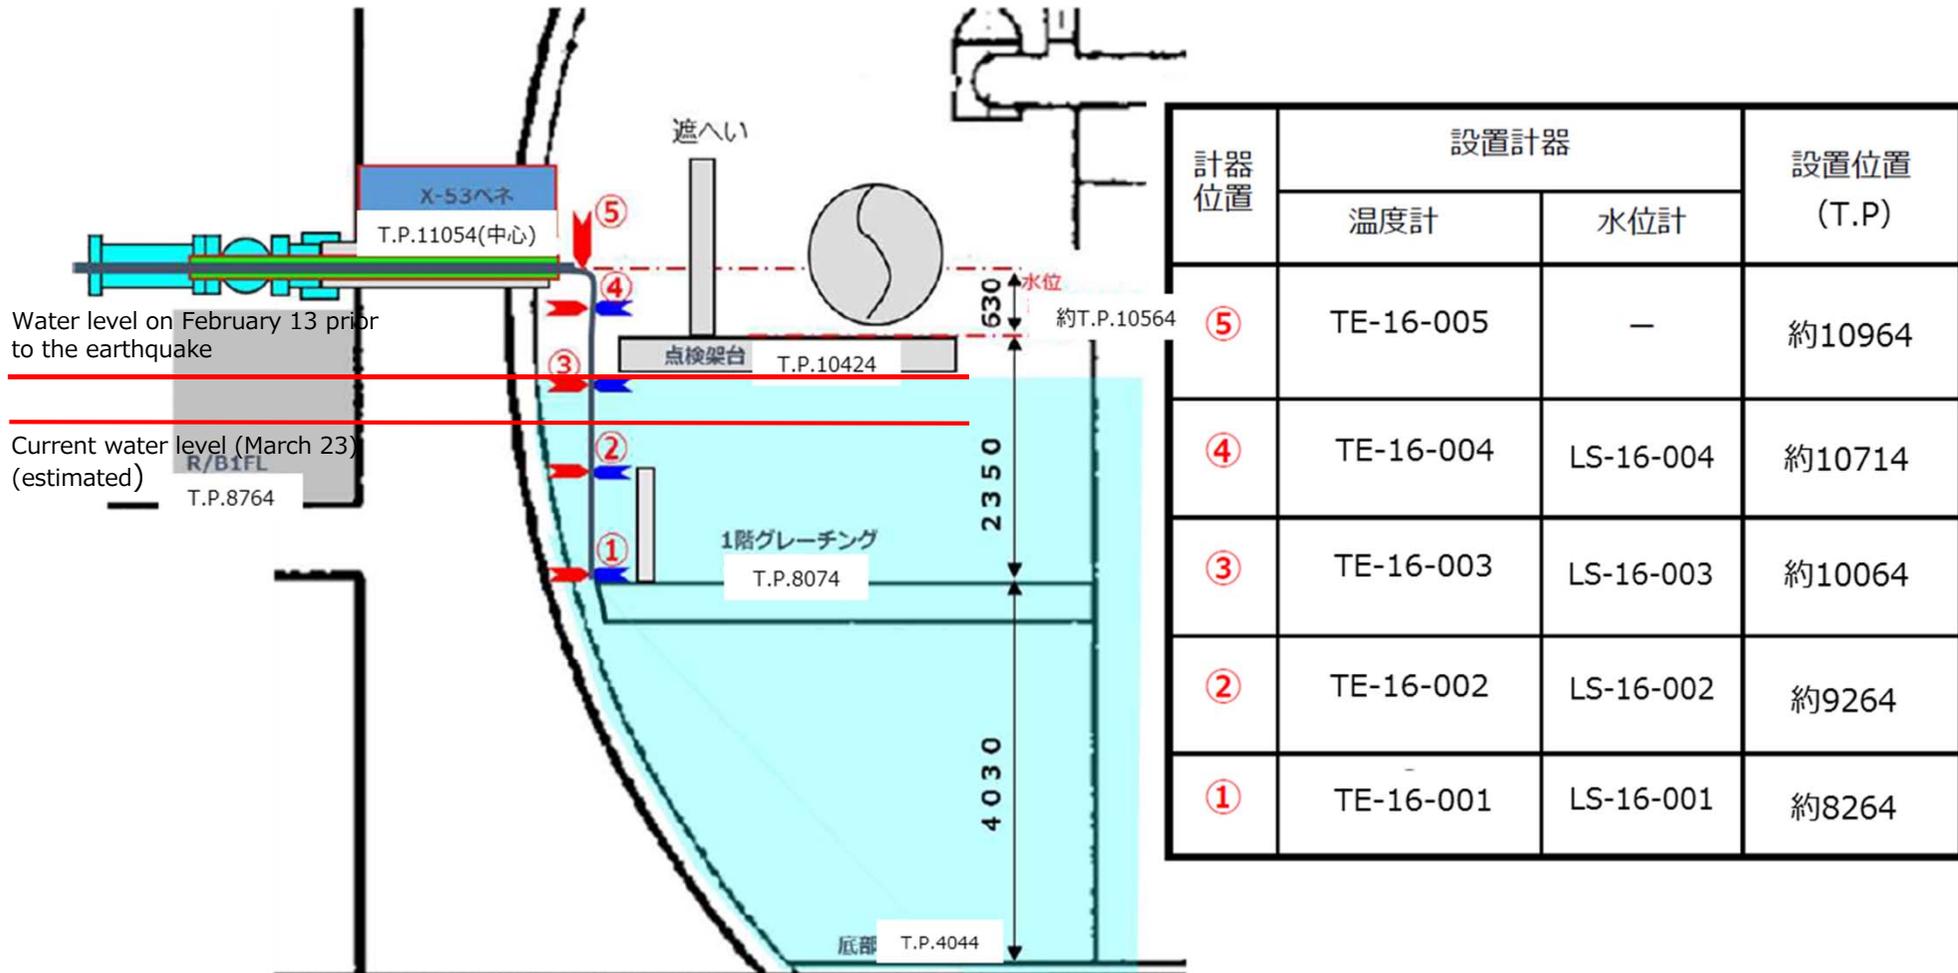
2-2. Trends in parameters related to the Unit 3 PCV water level drop **TEPCO**

- At current time, water levels in the Units 1 and 3 PCVs are dropping slowly, and we have determined that the water level in Unit 3 has almost stabilized. Furthermore, we have confirmed that water levels in both Units 1 and 3 exceed the PCV water levels we experienced during cooling water injection shutdown tests, but we will continue to monitor parameters carefully.

- At Unit 3, cooling water injection volume will be increased when the water level falls below the PCV water level gauge L2 ※ (+ 1.0m³/h) so that PCV water level is kept at a height that can be continually confirmed.

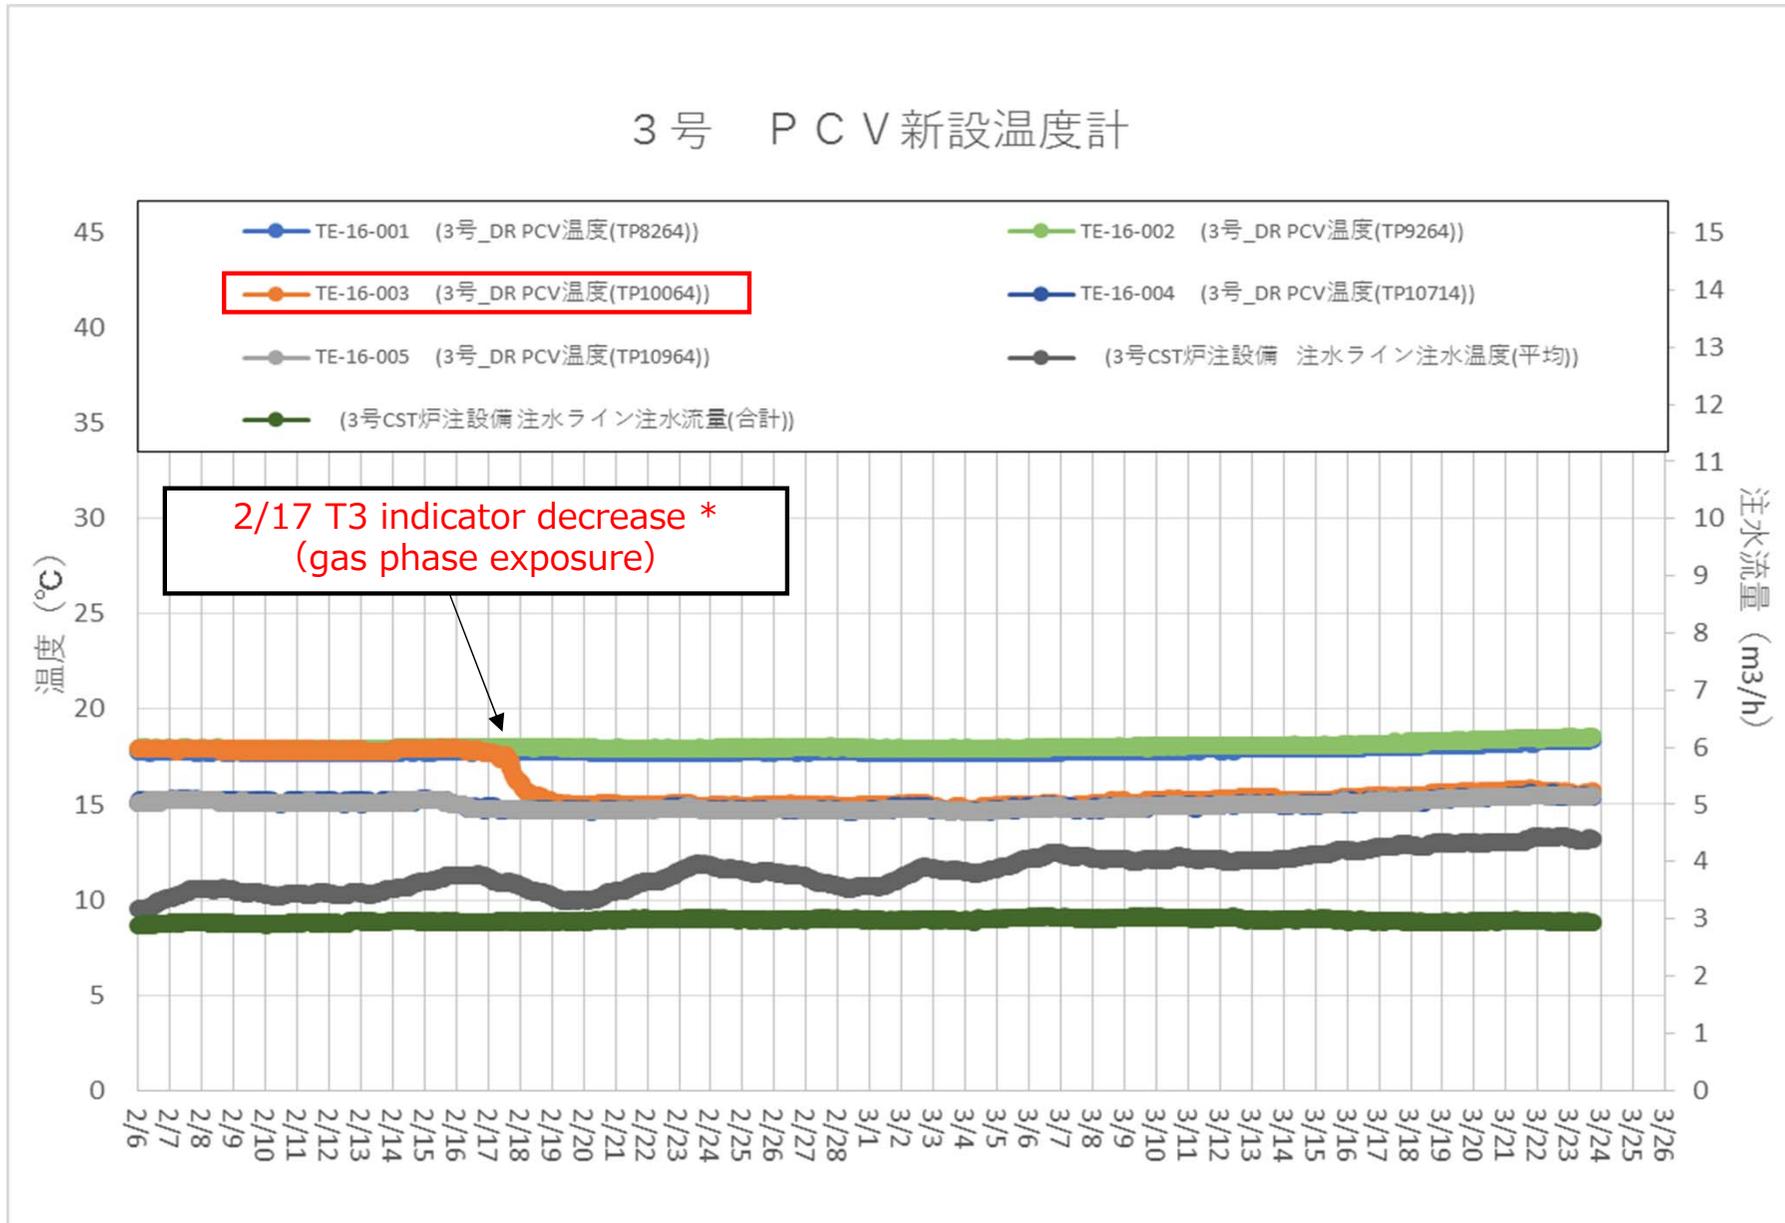
2-2. Trends in parameters related to the Unit 3 PCV water level drop

*From past data we know that temperature gauges inside the PCV read a few degrees Celsius higher amidst gases (exposed) then when submerged in liquids, so we assume that the temperature gauge is exposed.

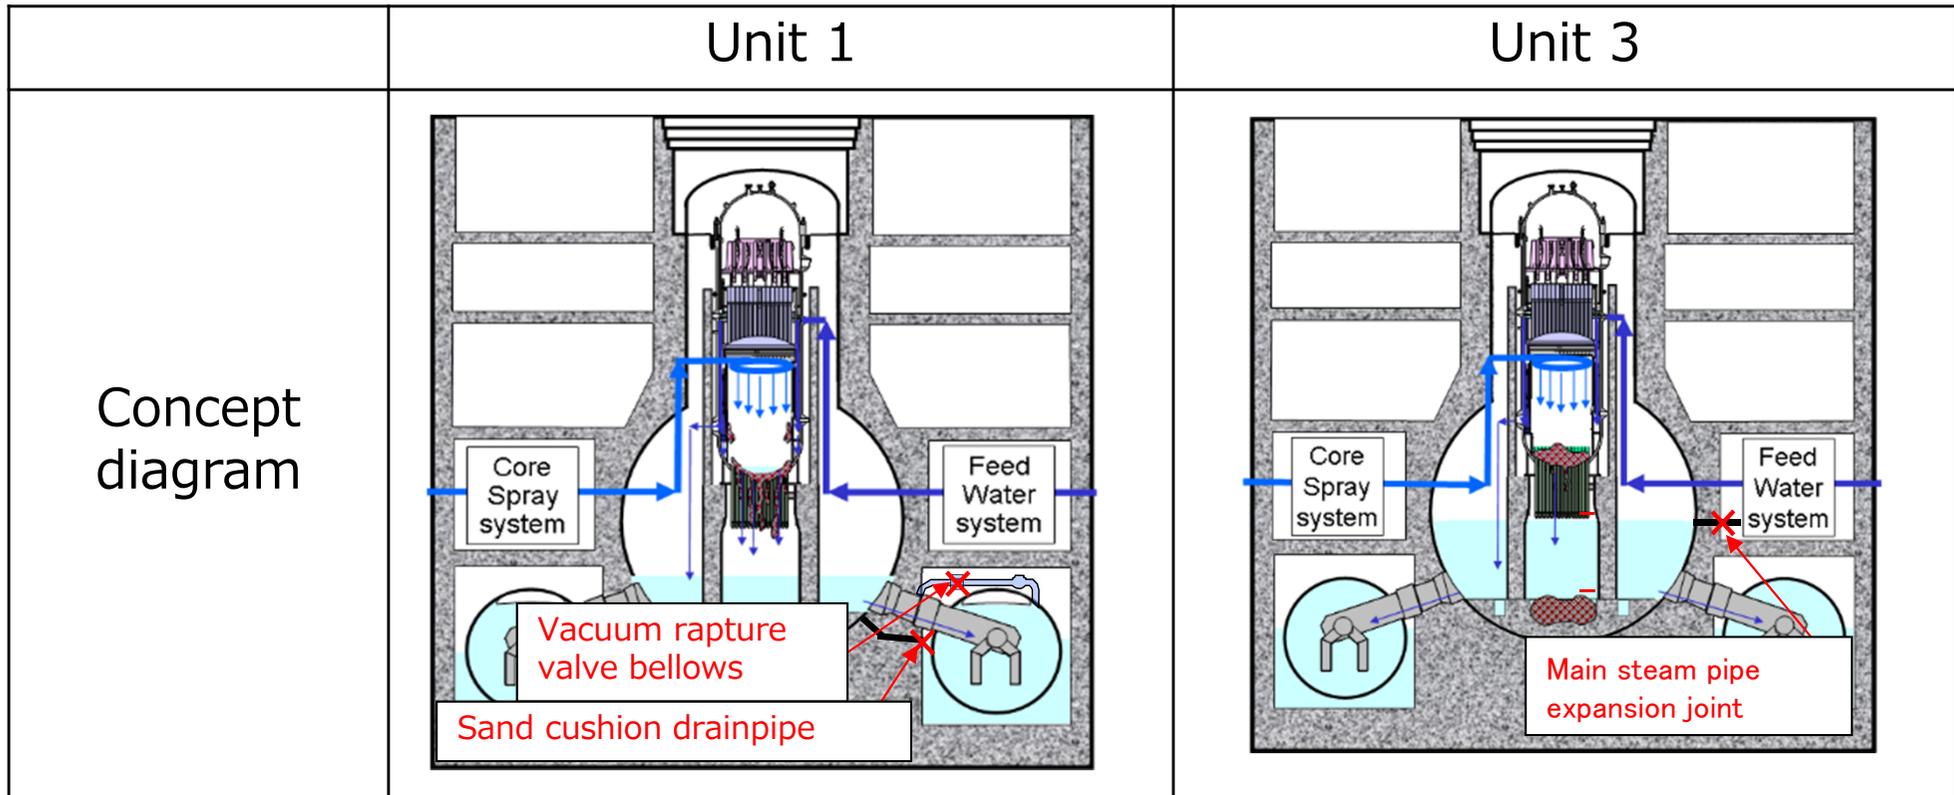
- We have found leaks at the following locations at Units 1 and 3

The Unit 3 PCV water level drop has stabilized around the main steam pipe expansion joints. At Unit 1, water level is slowly dropping around the vacuum rupture valve bellows, and the PCV water level drop continues.

Whereas we cannot deny the possibility that a new leak was caused below the PCV water level, it is more probable that the earthquake caused changes to the status of existing leaks.

- Going forward we aim to obtain more information by monitoring changes in parameters, such as water level, through cooling water injection shut off tests.

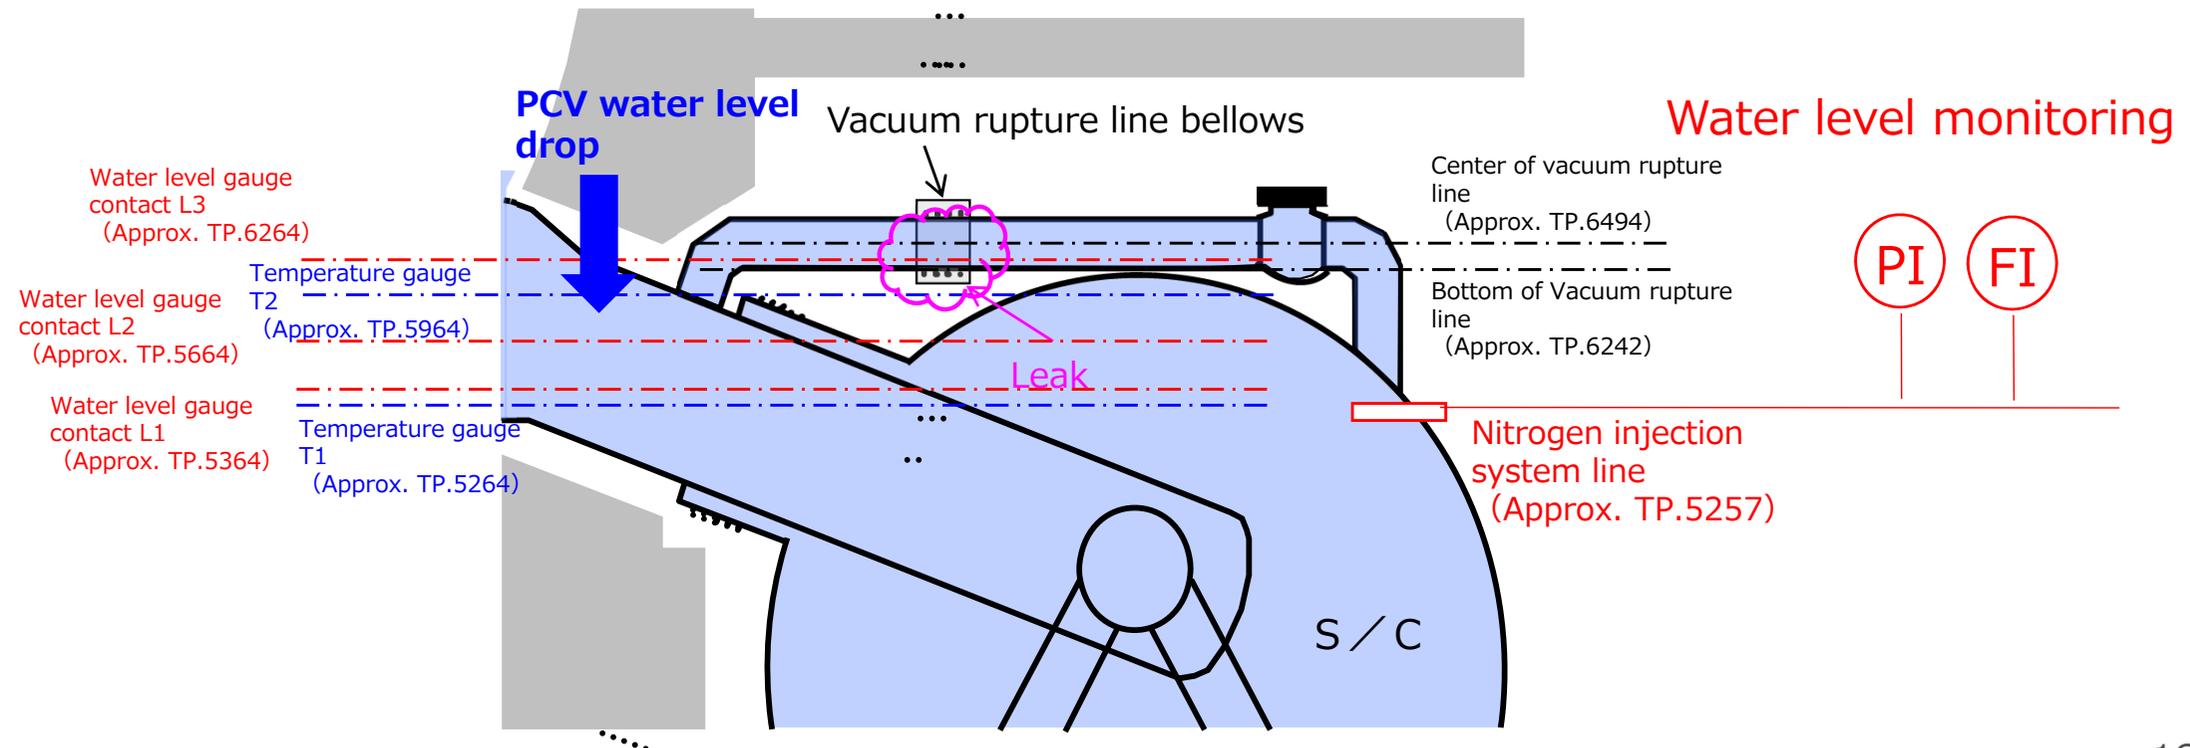
【Reference】 Enhancing Unit 1 water level monitoring instruments

- We are examining the possibility of assessing system pressure to confirm water level trends by additionally installing pressure gauges on the nitrogen injection lines to the S/C. The following action will be needed to achieve this.

- Current flow needs to be reduced in order to improve the accuracy of water level assessment because existing S/C nitrogen injection line outlet pressure results in large system pressure loss.

- Conventional flowmeters/output pressure gauges cannot easily be disassembled, and the measurement ranges need to be changed (low range measurements are required).

- Water level assessment feasibility needs to be confirmed after installation of instruments and changes made to the nitrogen injection flow.
 - Transmission equipment for continually monitoring the water levels also needs to be renovated.

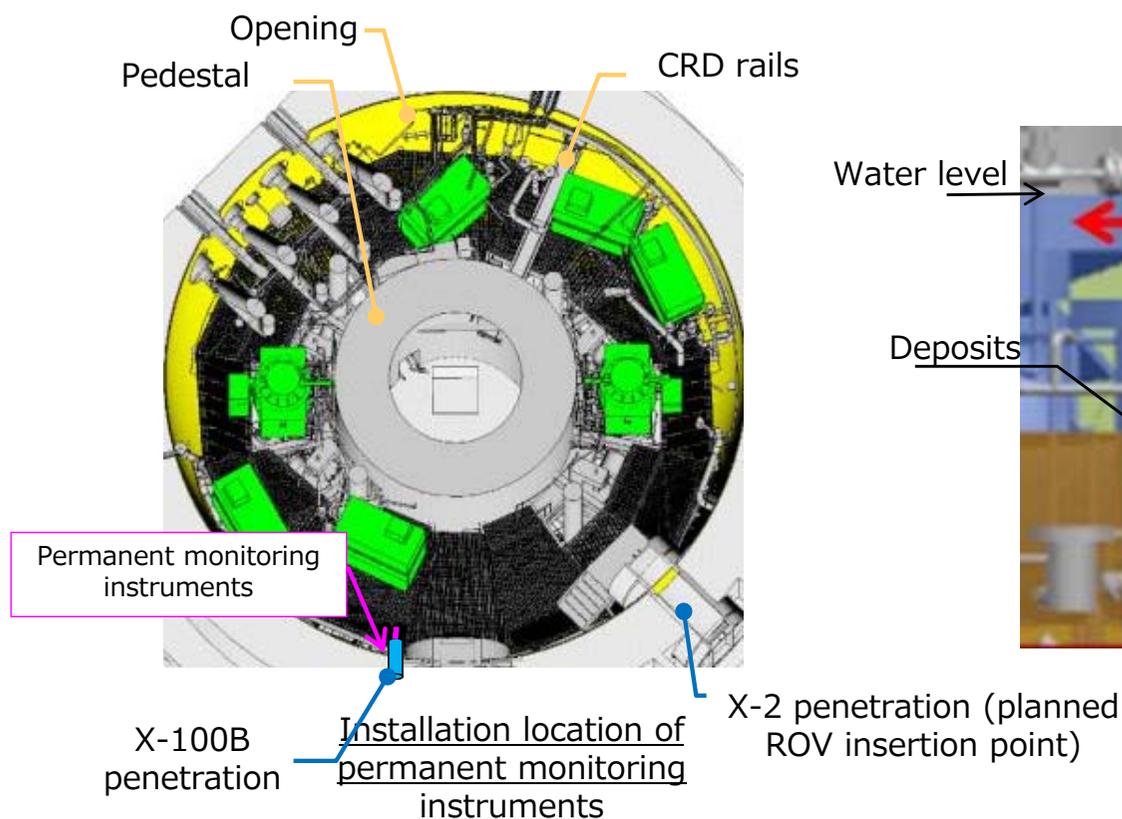
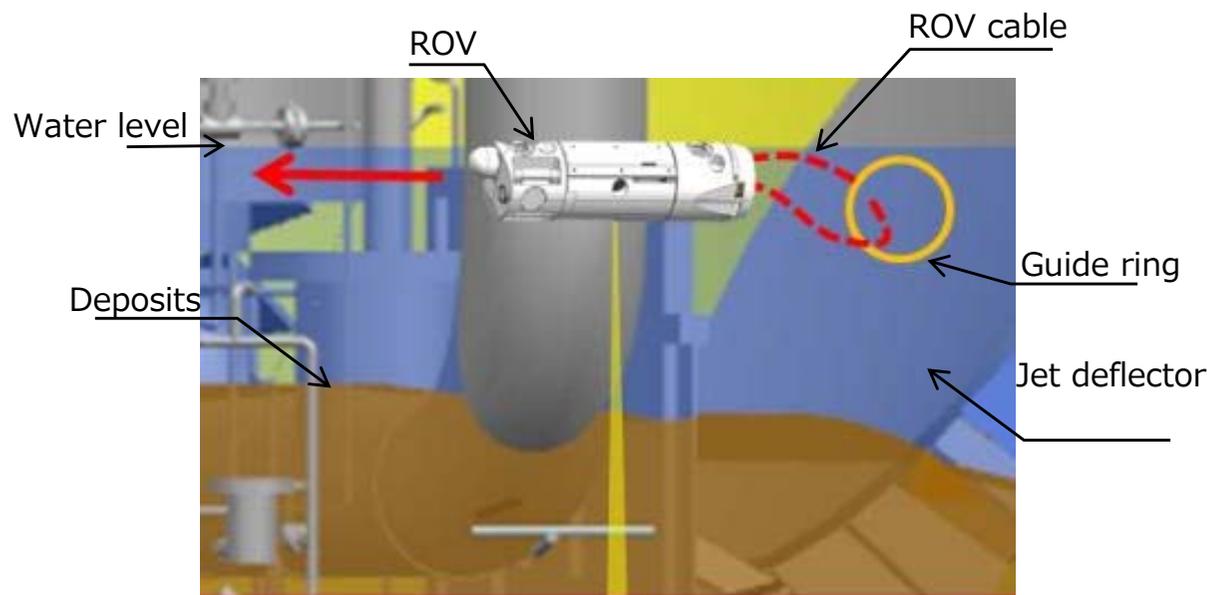
Concept drawing of investigation to measure deposit thickness

- If the guide ring that keeps the ROV cable from getting hung up on obstructions cannot be attached to the jet deflector due to the drop in water level, the risk that obstructions may interfere with the ROV cable will increase.
- If the PCV temperature gauges/water level gauges cannot be removed to avoid obstructions on the investigation route then the scope of the investigation will have to be narrowed.
- The risk of interference by PCV internal structures and deposits will increase if the vertical range of ROV movement is restricted.

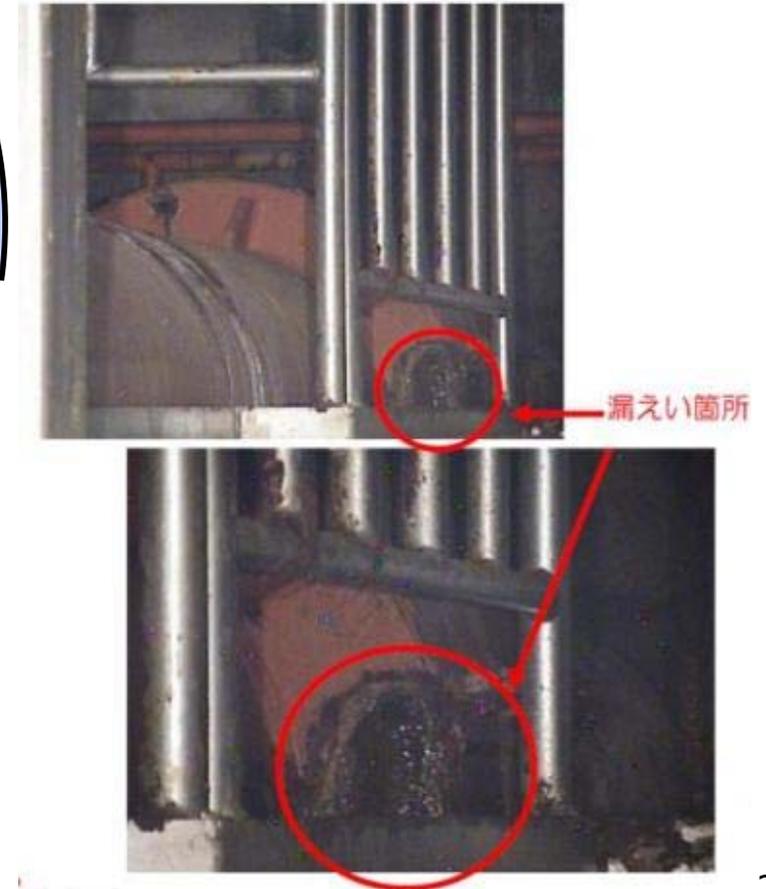
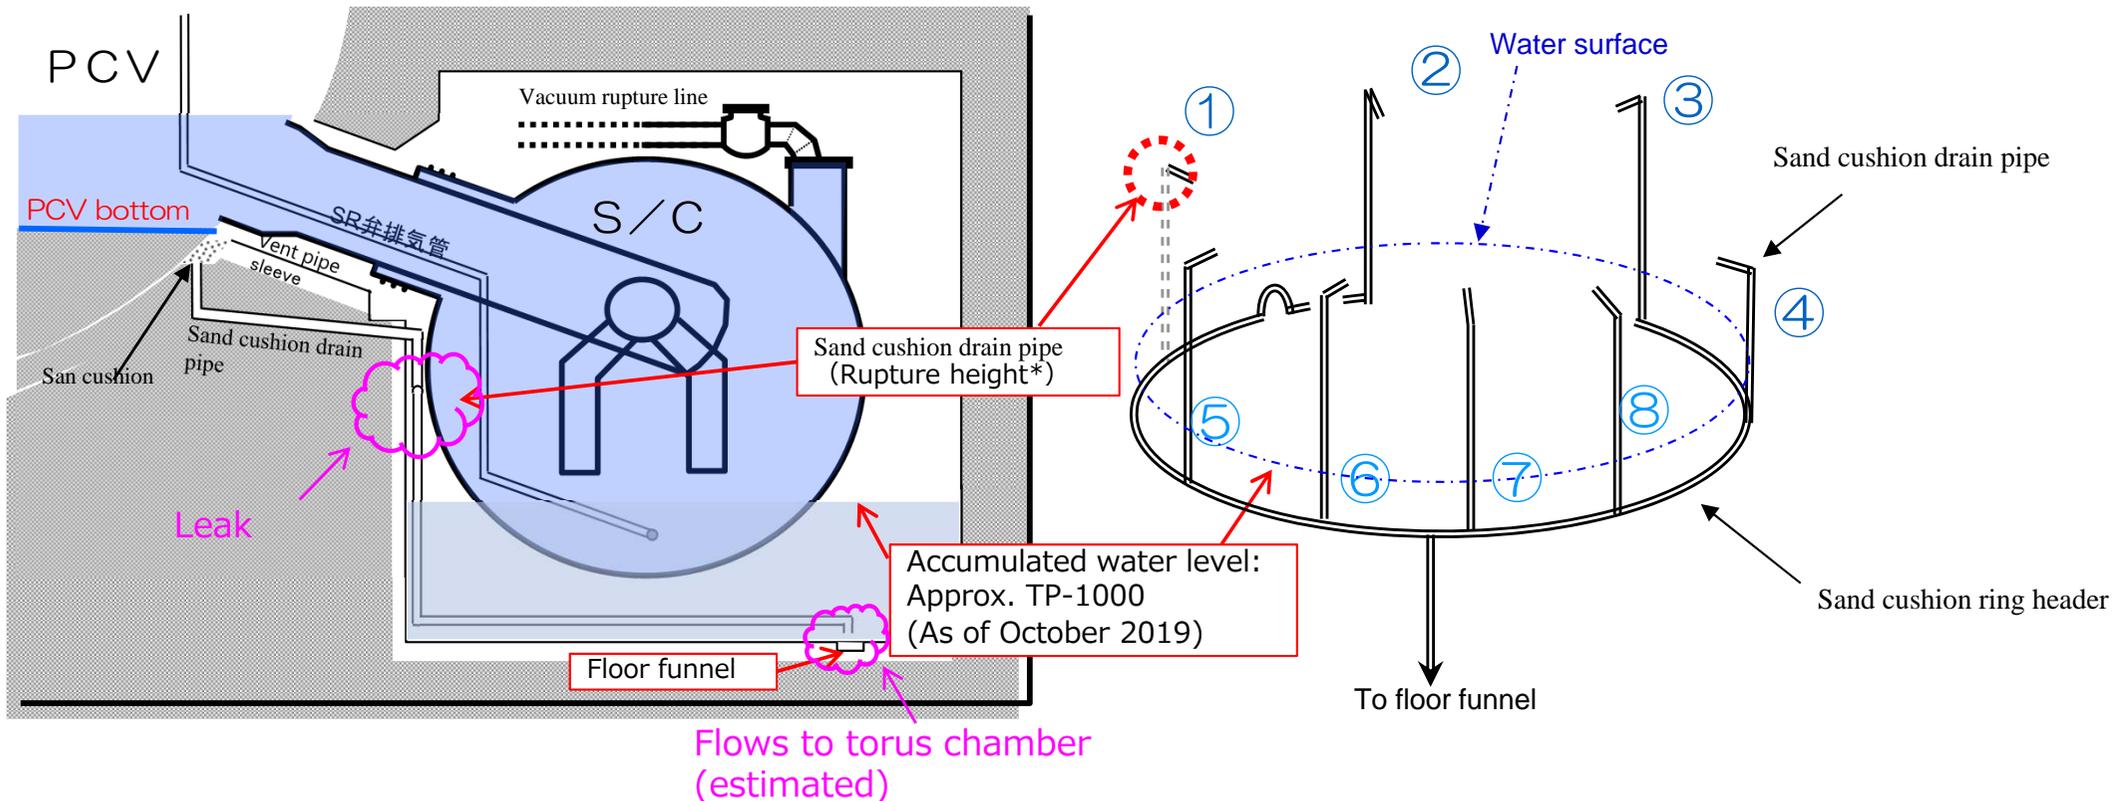
- Prior investigations of Unit 1 have found leaks from the vacuum rupture line bellows and from ruptured sand cushion drain pipes.
- The height of vacuum rupture line bellows installation approximately matches the height of leaks that are assumed to exist based upon D/W pressure behavior during reactor cooling water injection was shut off tests

* There are eight sand cushion drainpipes, and one of them has a rupture that is exposed to the air

- Out of the leaks found from the sand cushion drain pipes, only one is exposed to the air, and the other seven locations of PCV water leaks are submerged (for example, near the floor funnel)

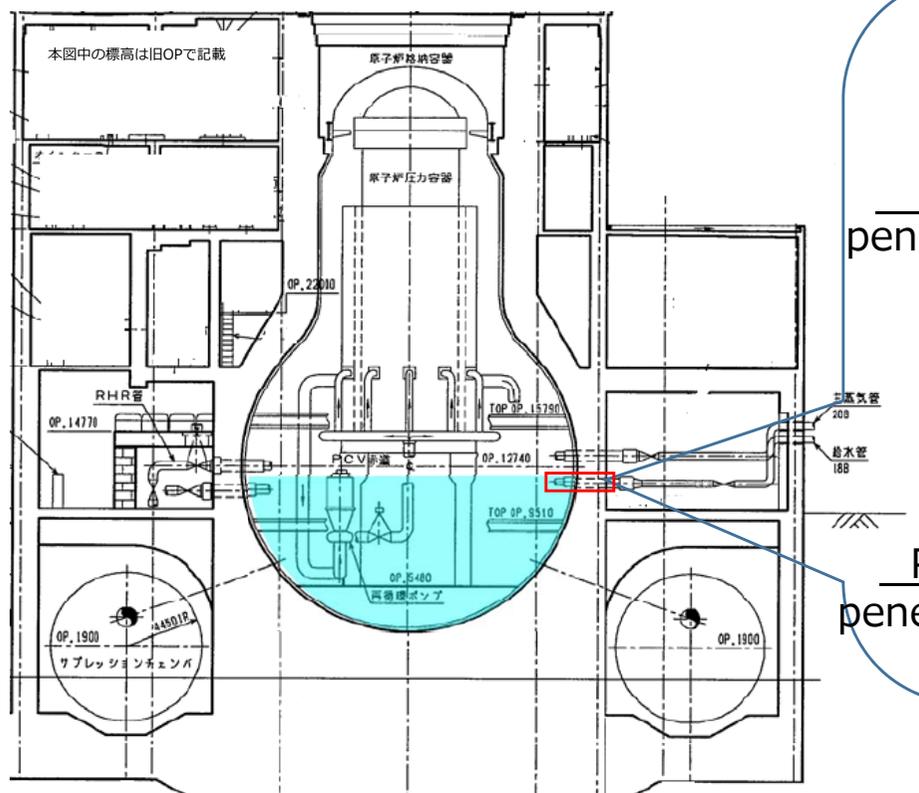
Cross-section of Unit 3 reactor building

- Prior investigations of Unit 3 have found leaks from the main steam pipe expansion joint
