【Overview】

- On March 2, 2021, the simple radiation monitor (plastic scintillation fibers (PSF) monitor) in the unloading wharf drainage channel issued a "High" alarm. When the cause of the "High" alarm was investigated it was found that there was soil (deposit) that contained a gel-like substance with a high dose equivalent rate (Beta + Gamma) of 70 μ m on the surface of the ground in temporary storage area W2, which is upstream from the aforementioned drainage channel. The substance was subsequently collected.

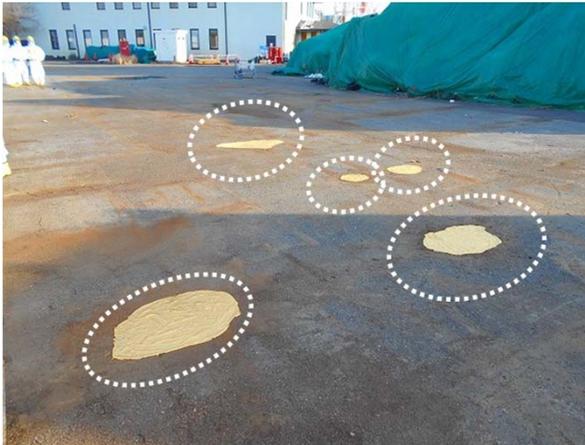
Photo 1. Deposits removed/decontaminating agents applied (March 24)

① The spots in the W2 area where the leak from the container occurred have been decontaminated (completed)

- The deposits were identified and in areas with a high dose equivalent rate of $70\mu\text{m}$ the asphalt was stripped and the spot was repaved
- The repaved areas were also painted in order to prevent the dispersion and leak of radioactive substances

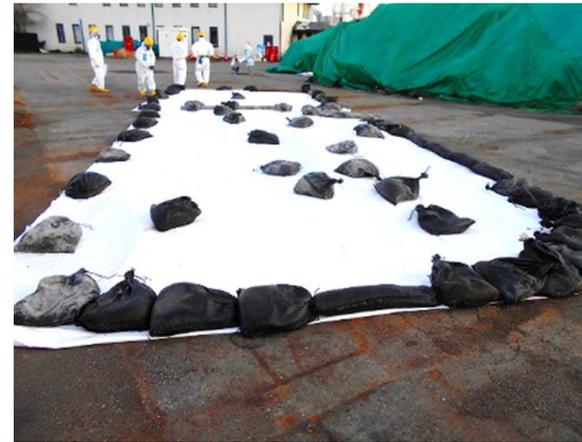
Photo 2. Area covered after deposit removal (March 24)

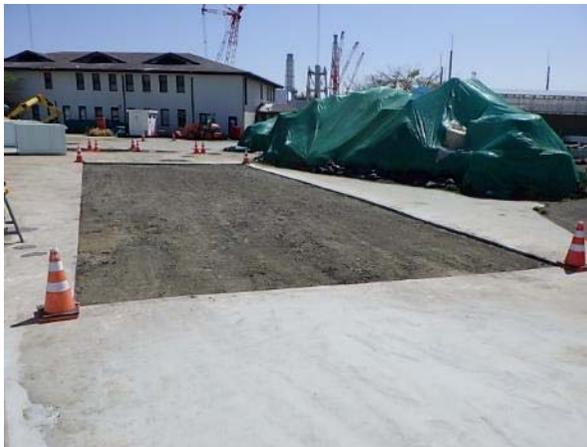
Photo 3. Asphalt stripped (April 15)
(locations of high dose equivalent rate of $70\mu\text{m}$)

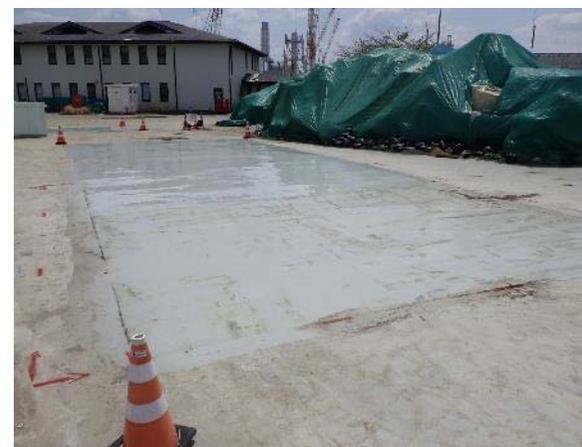
Photo 4. Asphalt repaving (April 15)/painting (April 16, 19th)
(photo taken on April 20)

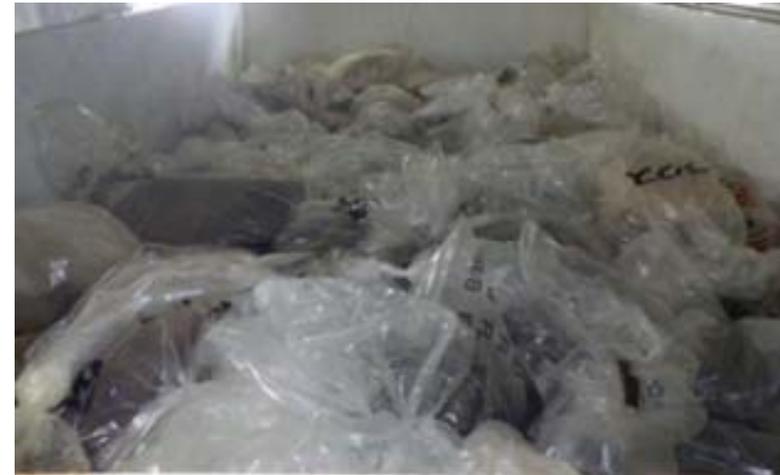
- When the inside of a container showing partial but considerable corrosion (one container) that was transported from the W2 area to the solid waste storage warehouse was inspected, a plastic bag filled with absorbent material that contained water was found, and it could be seen that water had accumulated at the bottom of the container. (Already announced by April 12)

Photo 1. Inside of the container prior to removing the plastic bags

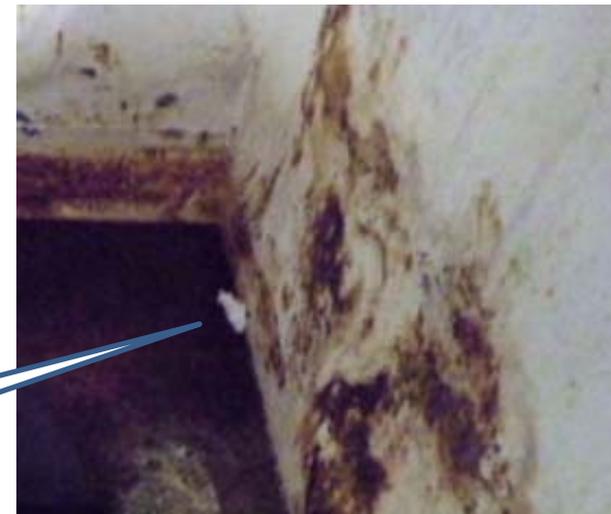
Repair material applied from the outside of the container could be seen inside the container

Photo 2. Inside of the container and repaired area

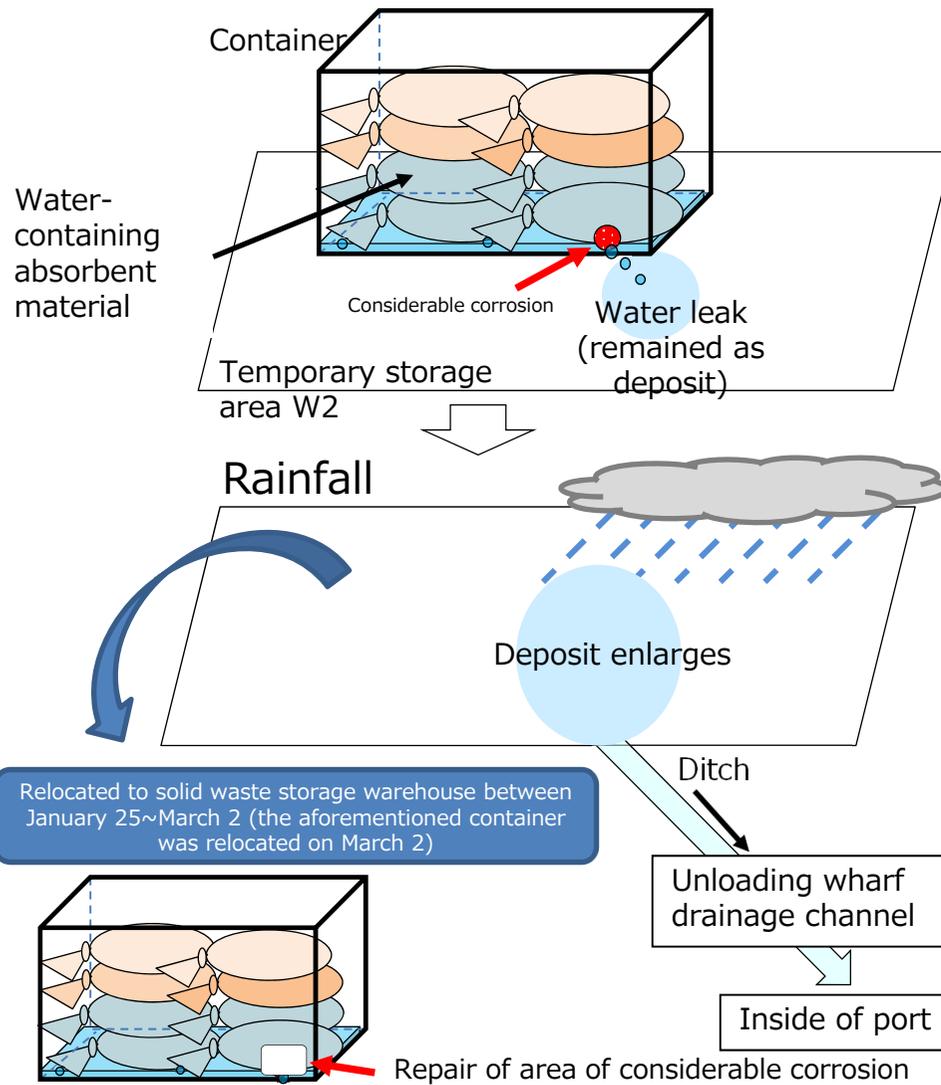
Plastic bags filled with water-containing absorbent material were piled on one another. The pressure from the weight of the bags on top forced the ties on the bags at the bottom to become loose thereby allowing water to leak out into the container.

The bottom of the container corroded as a result of the water that had leaked out into the container

Water containing radioactive substances leaked out of the container from areas at the bottom of the container showing considerable corrosion

When the containers were relocated to the solid waste storage warehouse, the water that had leaked out remained in the area as a deposit

During times of rain, the radioactive substances contained in the deposit were dispersed throughout the area and washed into the ditch

The radioactive substances were washed into the unloading wharf drainage channel via the ditch

"High" radiation alarm indicated by the PSF monitor

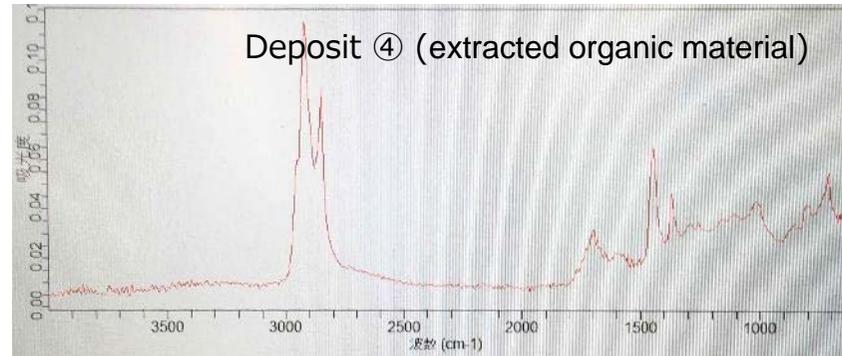
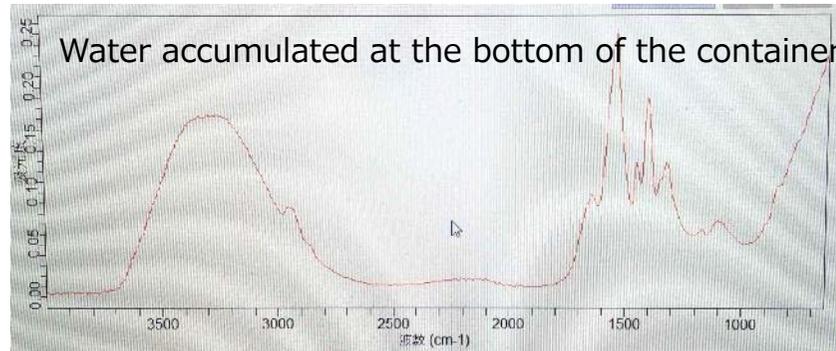
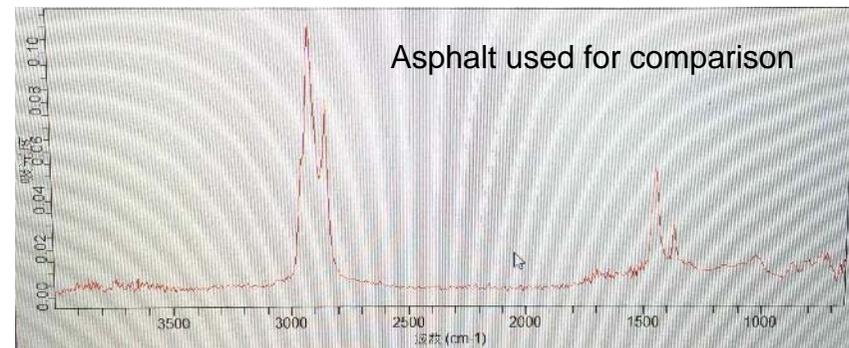
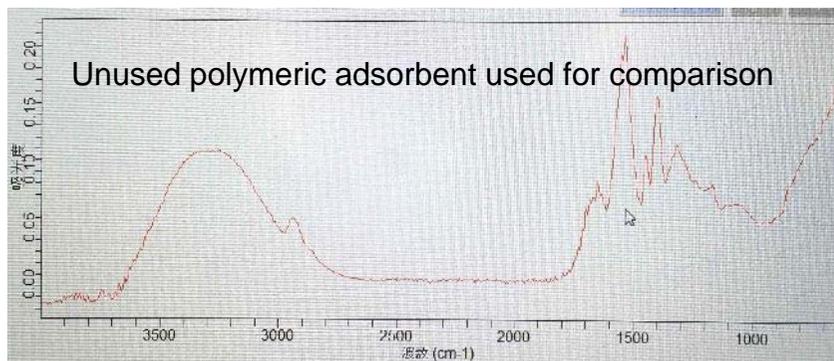
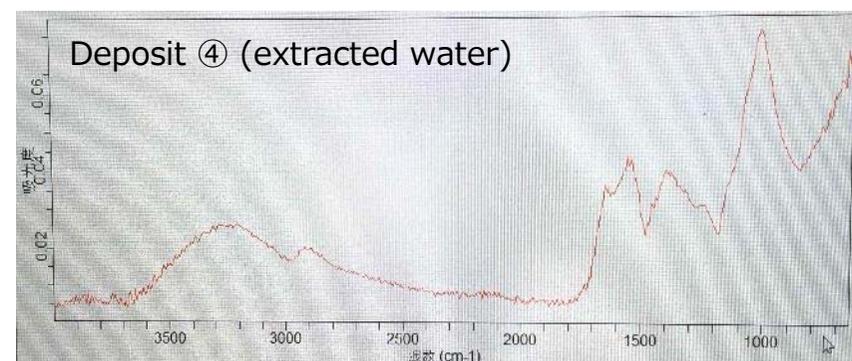
- ✓ Spectral analysis found that the water accumulated at the bottom of the container closely matched the unused polymeric adsorbent used for comparison.
- ✓ Deposit ④ (extracted organic material) closely matched the spectrum of the asphalt used for comparison.
- ✓ Deposit ④ (extracted water) was similar to the spectrum of the water accumulated at the bottom of the container.
- ✓ From the above it was determined that the water accumulated at the bottom of the container is a polymeric adsorbent, and that the deposit contains elements of asphalt, and is a polymeric adsorbent that has absorbed water.
- ✓ The results of radiation measurements, chemical property analysis and molecular composition analysis found that **the deposit was formed by water that had accumulated at the bottom of the container and leak onto the surface of the storage area.**

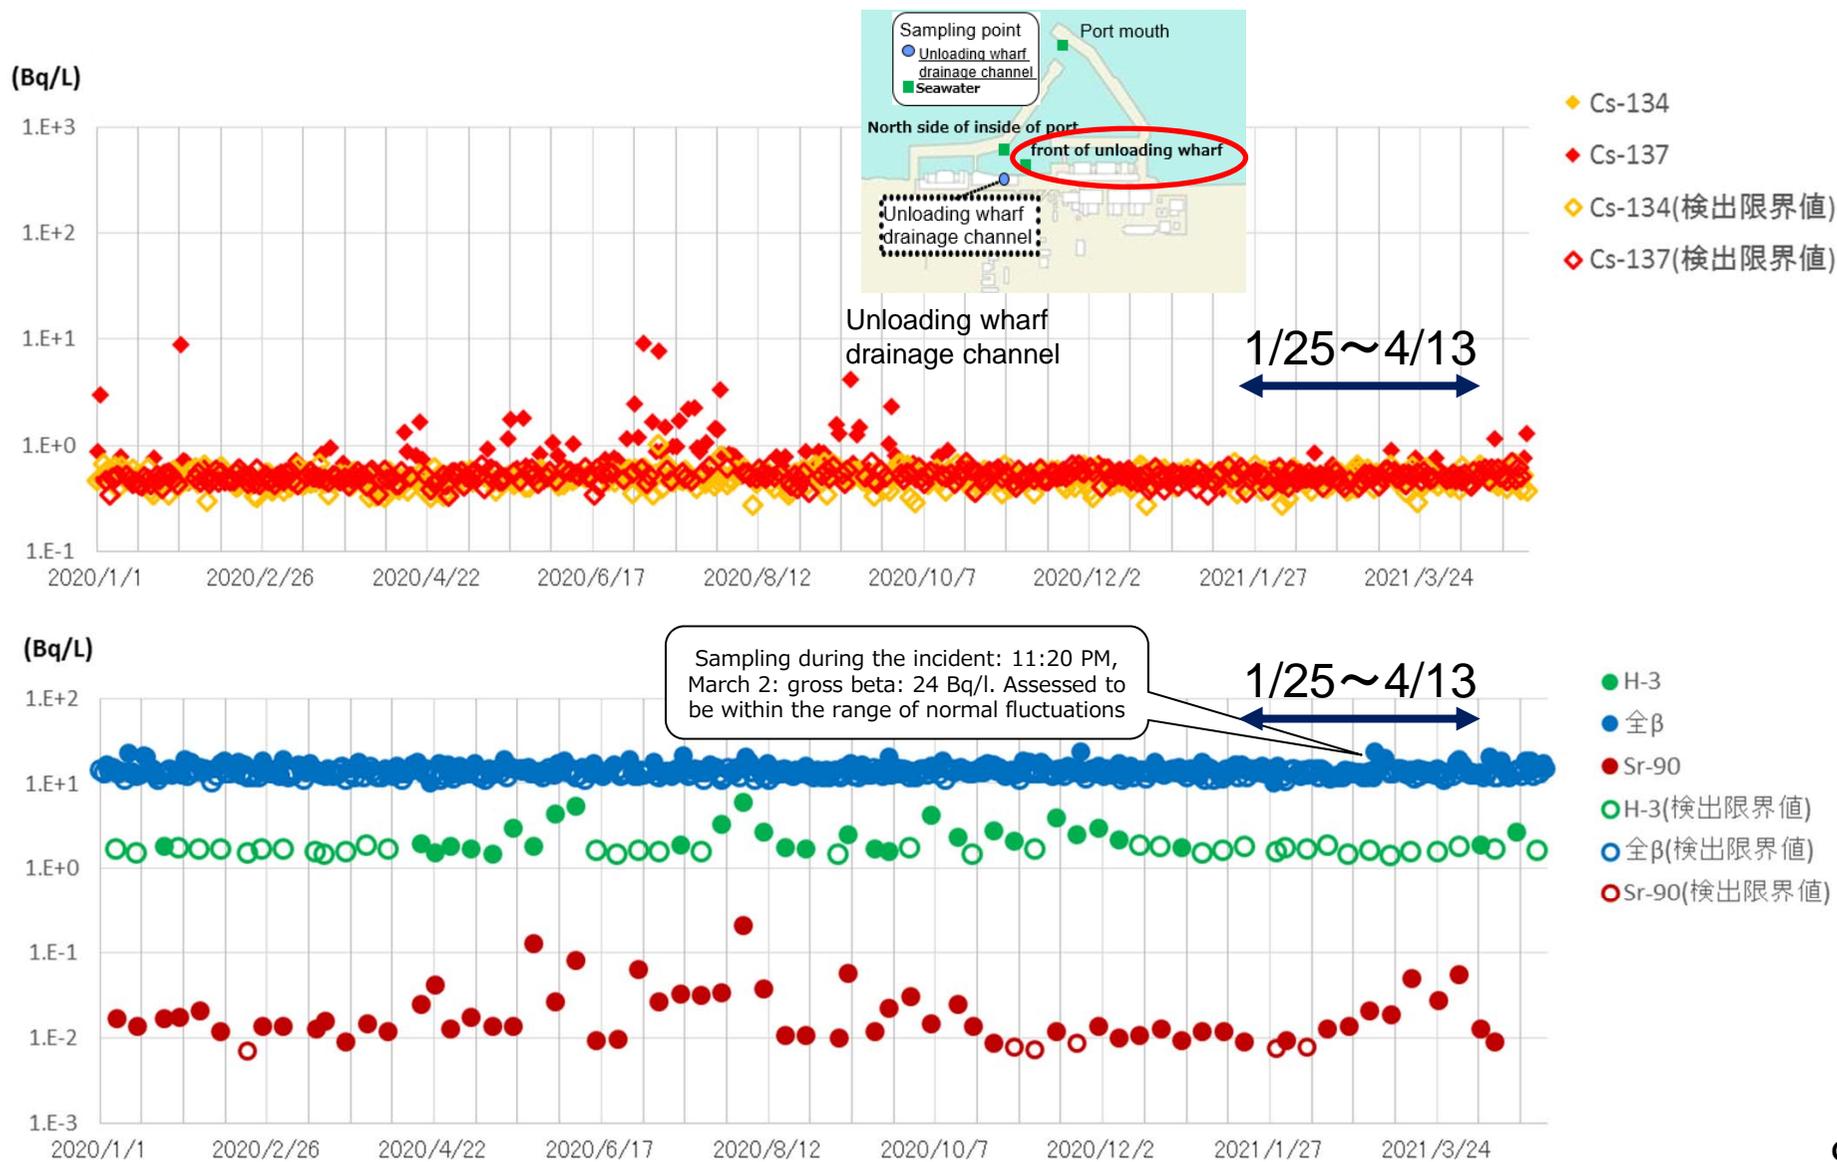
- ✓ **No significant fluctuations have been seen in the concentration of radiation in the seawater at the measuring point in front of the unloading wharf**, which is the closest measurement point to the outlet of the unloading wharf drainage channel

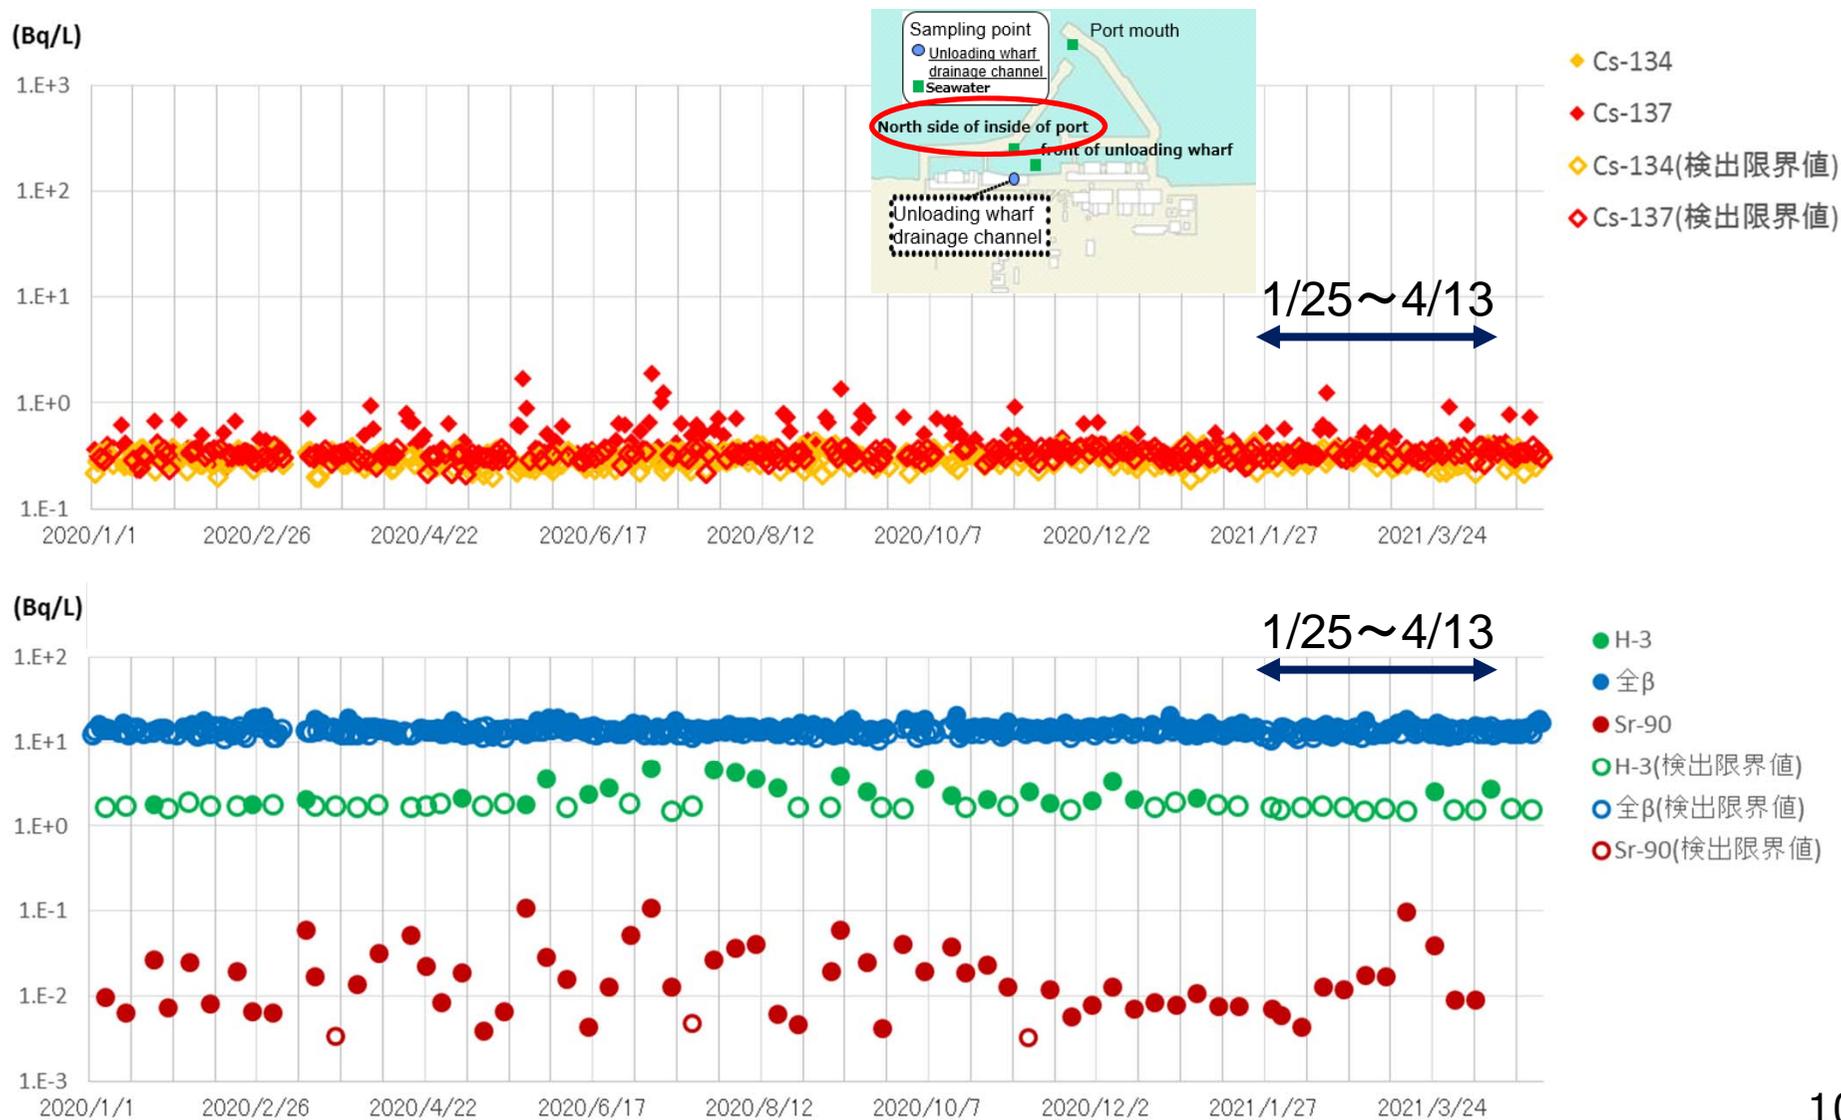
✓ No significant fluctuations in the concentration of radiation in seawater has been found at the measuring point on the north side of the inside of the port

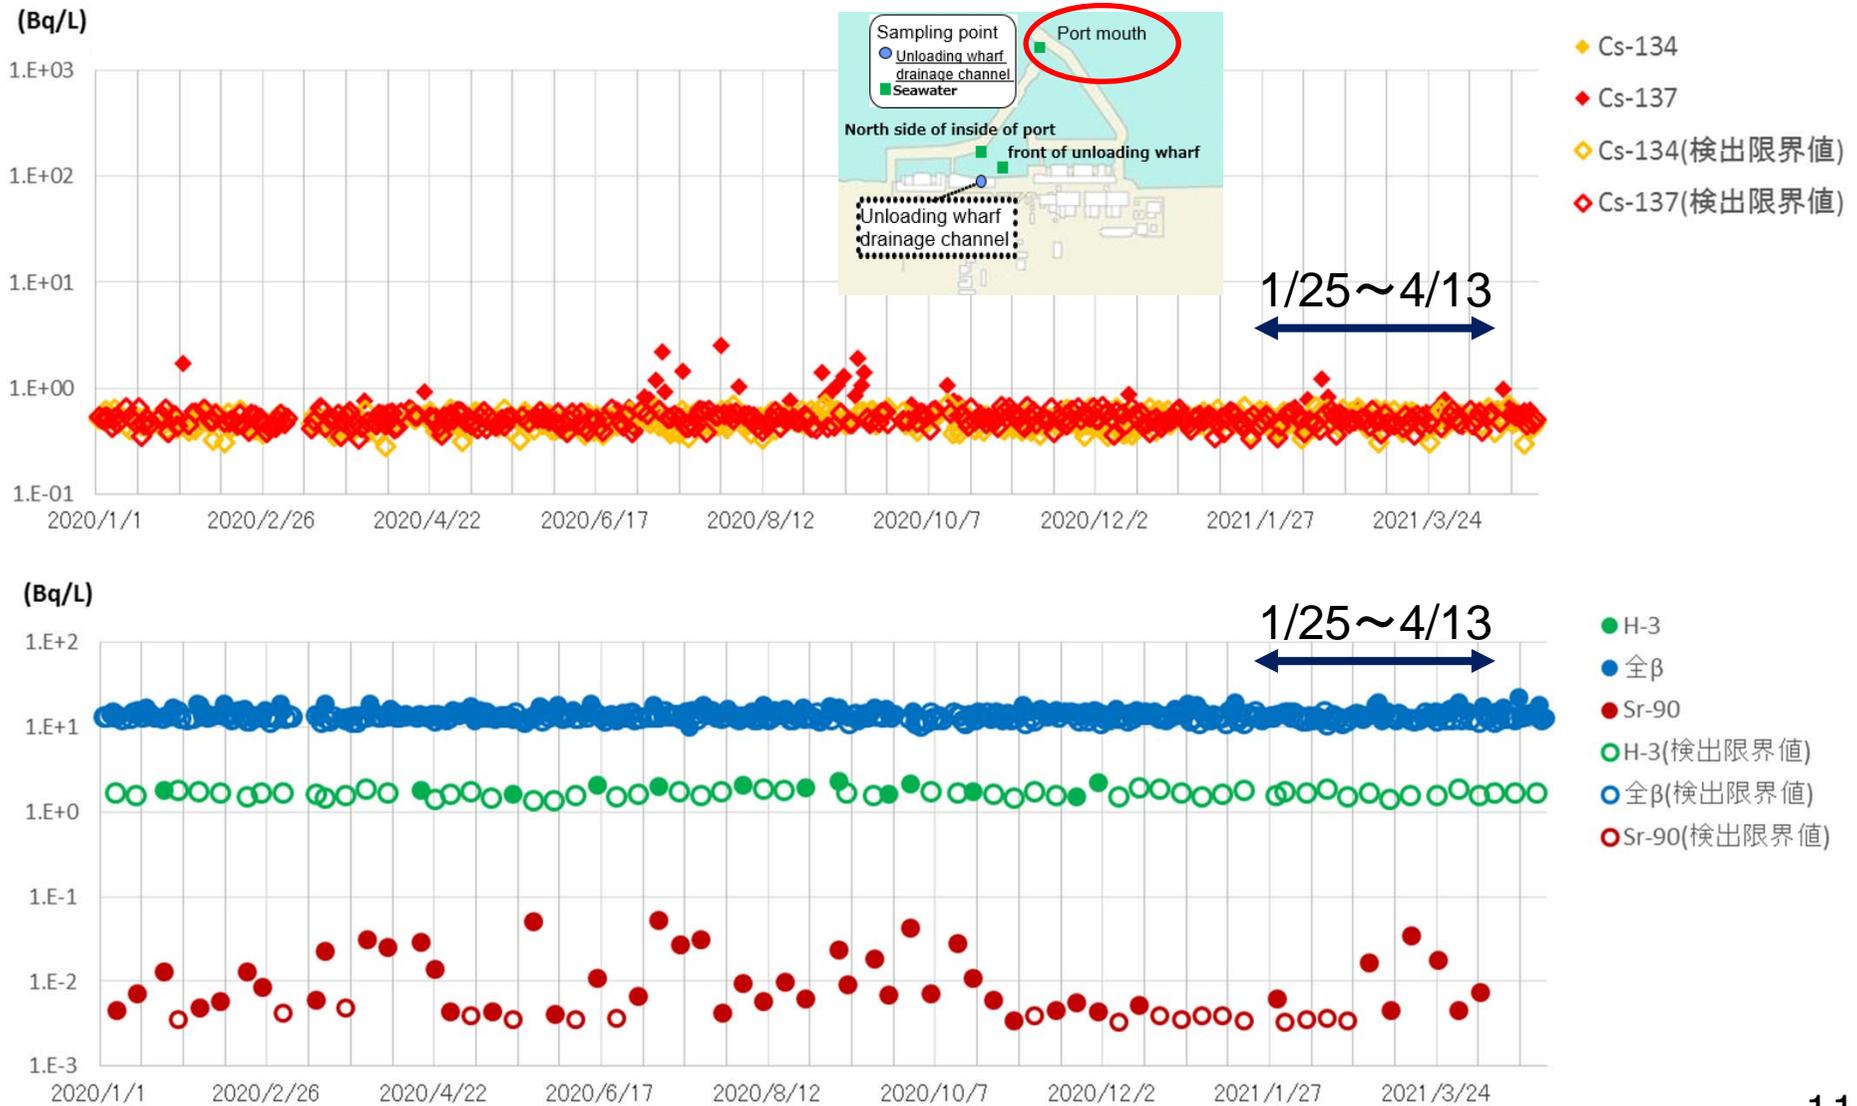
✓ No significant fluctuations in the concentration of radiation in seawater has been found at the measuring point at the port mouth

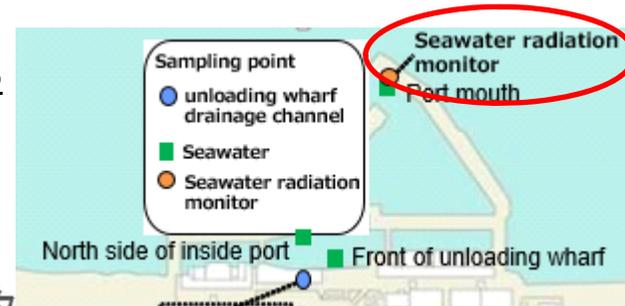
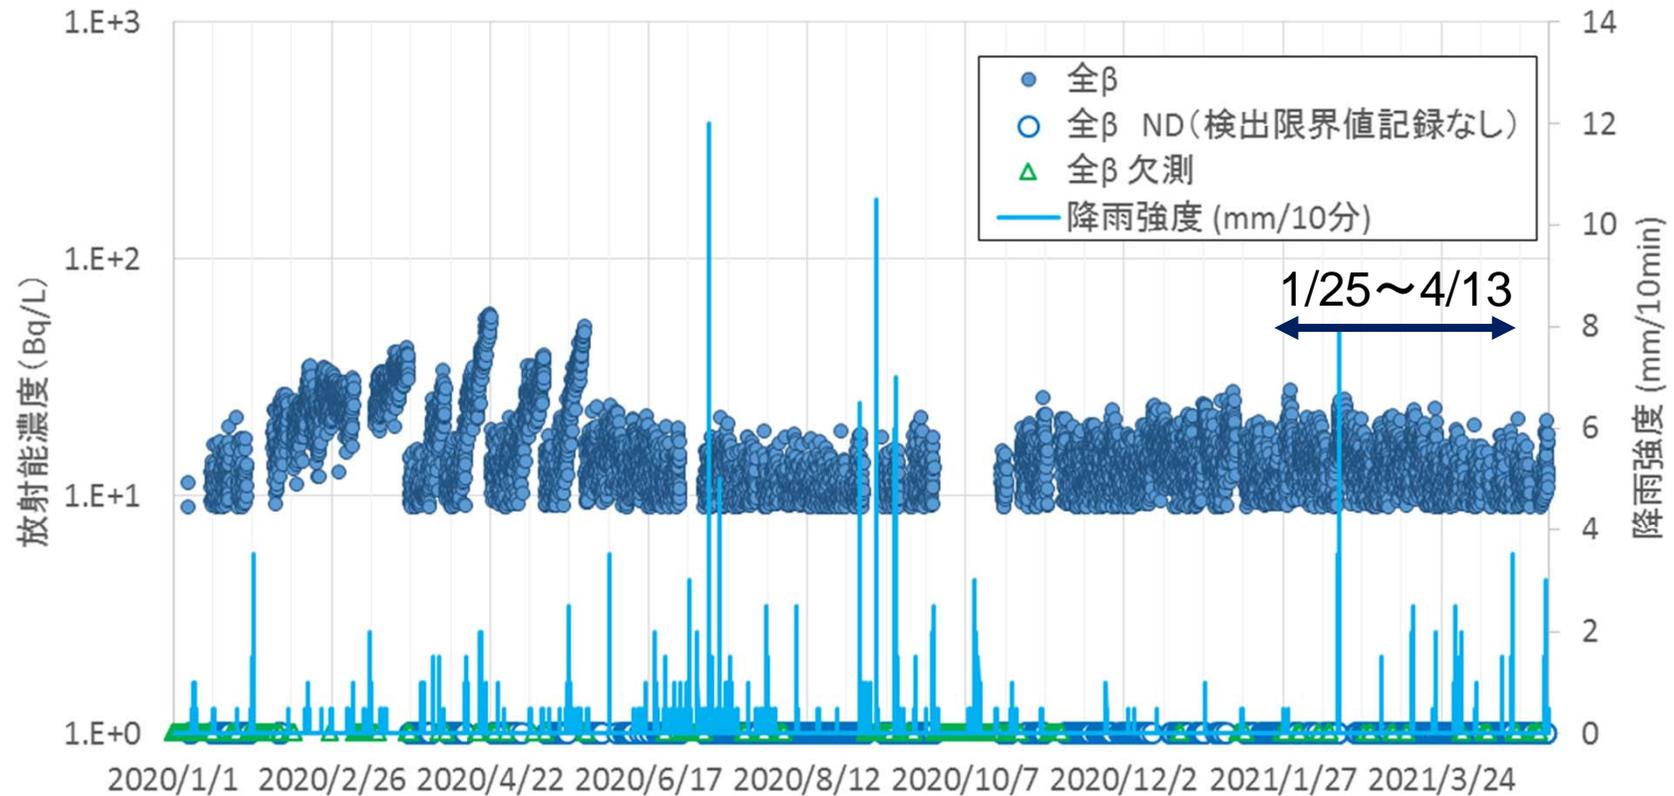
✓ No significant fluctuations have been seen with seawater radiation monitors
