# Multi-nuclide removal equipment (ALPS) and high integrity container (HIC) exhaust filters (Update)

# Inspection of other exhaust filters in light of the damage found to HIC exhaust filters

# ALPS exhaust filter inspections performed in light of damage found to HIC exhaust filters (1)

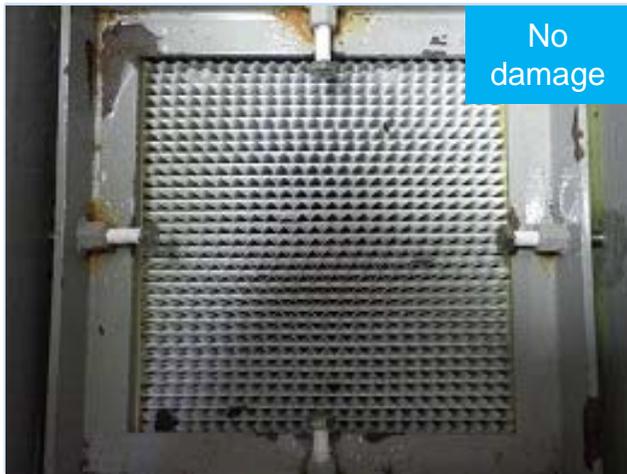
- The inspections found no damage with existing ALPS drainage tank exhaust filters. However, since some damage was found on the same exhaust filters in additionally installed ALPS (Max Approx. 15mm×Approx. 5 mm) the filters were replaced on September 18 as a provisional countermeasure.

Existing ALPS drainage tank exhaust filter

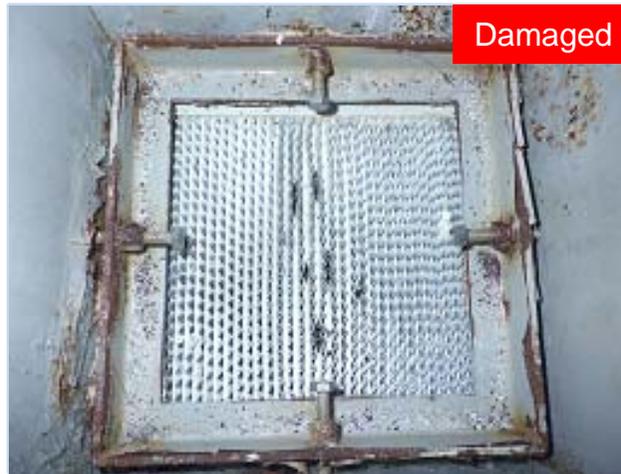
Additionally installed ALPS drainage tank exhaust filter

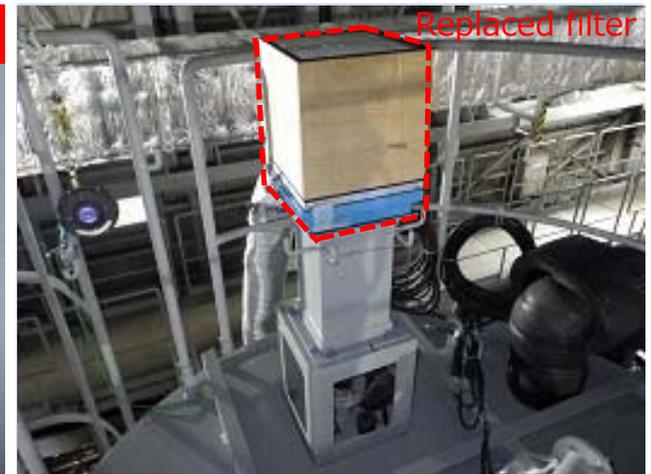
Replacing filters in additionally installed ALPS drainage tanks

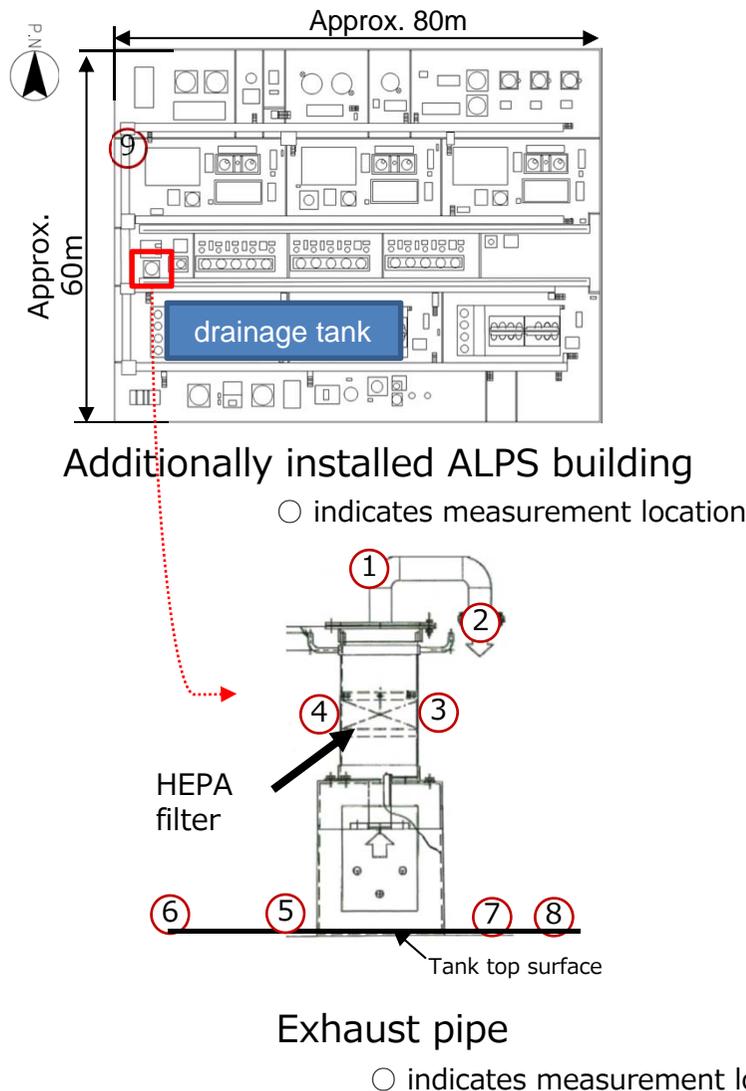
- Surface contamination measurements from the additionally installed ALPS drainage tank exhaust pipe, where exhaust filter damage was found, and the surrounding area do not indicate that contamination spread from the exhaust pipe, which is assumed to be the source of the contamination.

### Surface contamination measurement results (β) Sampling date: Sep. 18, 2021

Sampling point	Measurement [cpm] (Gross value)	Sampling location
①	750	Outer surface of exhaust pipe
②	2,000	Inside surface of exhaust pipe outlet
③	1,700	Side
④	400	Side opposite from exhaust pipe
⑤	1,500	Tank top
⑥	2,400	Tank top
⑦	6,000	Tank top
⑧	2,000	Tank top
⑨	200	Door

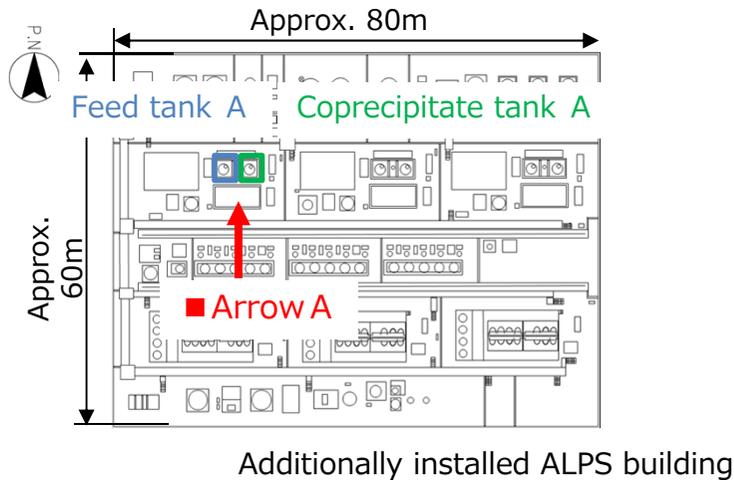
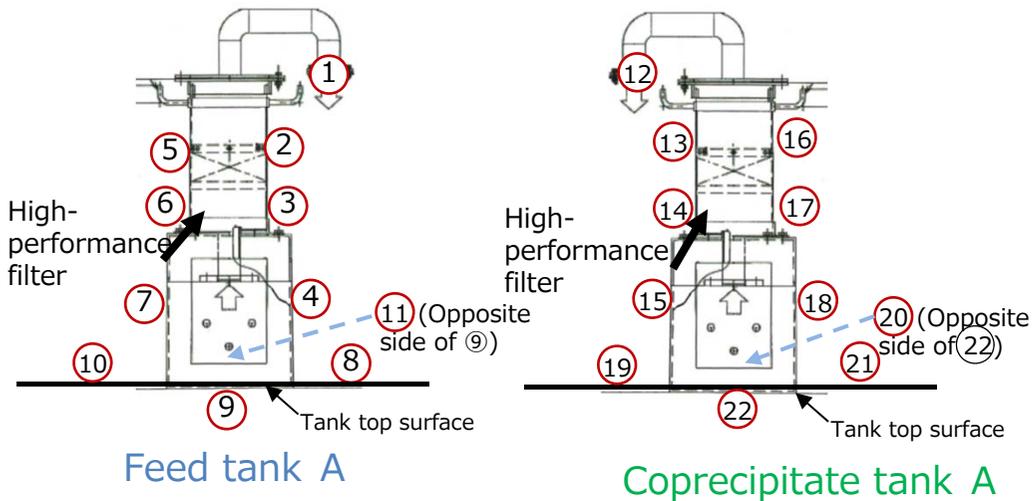
- Surface contamination measurements taken from the exhaust pipes for feed tank A and coprecipitate tank A, where exhaust filter damage was found, and the surrounding area indicate that the source of the contamination is most likely the exhaust pipes.

Arrow A Location of surface contamination measurements from around exhaust pipes

Sampling point	Measurement [cpm] (Gross value)	Sampling location
1	50,000	Inside surface of exhaust pipe outlet
2	3,500	Top of side
3	5,000	Middle of side
4	45,000	Bottom of side
5	900	Top of side opposite from exhaust pipe
6	2,000	Middle of side opposite from exhaust pipe
7	5,000	Bottom of side opposite from exhaust pipe
8	85,000	Tank top
9	6,500	Tank top
10	2,600	Tank top
11	5,000	Tank top

Sampling point	Measurement [cpm] (Gross value)	Sampling location
12	85,000	Inside surface of exhaust pipe outlet
13	18,000	Top of side
14	7,500	Middle of side
15	20,000	Bottom of side
16	10,000	Top of side opposite from exhaust pipe
17	7,000	Middle of side opposite from exhaust pipe
18	3,500	Bottom of side opposite from exhaust pipe
19	70,000	Tank top
20	20,000	Tank top
21	25,000	Tank top
22	9,000	Tank top

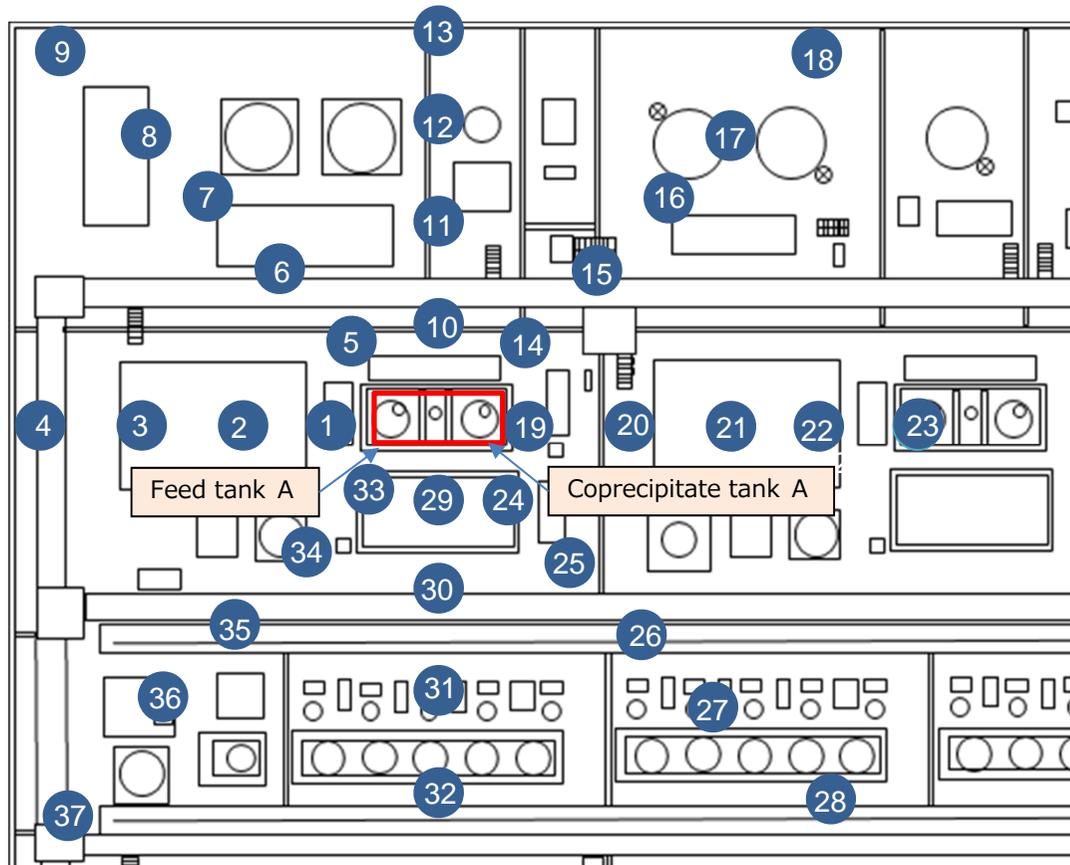
- Surface contamination measurements were taken from around feed tank A and coprecipitate tank A where damage to exhaust filters was found in order to examine the extent of the spread of contamination from the exhaust pipe. Since workers wear the same shoes to move within the area a certain amount of contamination was found on the floor, but only several hundreds CPM of contamination was found in elevated areas suggesting that contamination did not spread past the area around the tank.

Surface contamination measurement results (β)  
 Sampling date: Sep. 20, 2021 Background: 180cpm

Sampling locations	Floor measurement (cpm) Gross value	Elevation measurement (cpm) Gross value	Sampling location (Elevated)
1	700	250	H steel
2	1200	580	Single pipe
3	410	270	Fireproof tarp
4	340	210	H steel
5	600	500	Bottom of walkway
6	700	300	Control panel
7	650	280	Pipe support
8	420	210	Insulation
9	300	210	Wall surface
10	950	390	Bottom of walkway
11	500	200	Control panel
12	1000	270	Outer tank wall
13	1700	250	Wall surface
14	1000	310	Bottom of walkway
15	370	500	Curtain
16	450	200	Control panel
17	700	230	Outer tank wall
18	500	200	Wall surface
19	1600	210	pH meter skid
20	650	200	Tarp
21	700	400	Instrument
22	780	180	Single pipe
23	200	200	Power panel
24	370	250	Power panel
25	800	180	Column
26	350	220	Column
27	310	260	Power panel
28	600	270	Column
29	610	330	Wall surface
30	260	270	Column
31	450	200	Control panel
32	600	200	Column
33	1500	230	Outer tank wall
34	700	540	Control panel
35	210	230	Column
36	600	300	Power panel

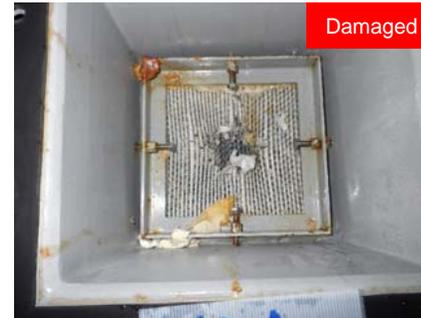
※ 4 : Carbonate soda storage tank 1 : Approx. 200mm×Approx. 10mm、Coprecipitate tank A: Approx. 100mm×Approx. 50mm、  
Feed tank A: Approx. 200mm×Approx. 40mm

Additionally installed ALPS System A Coprecipitate tank

- Since this tank is filled with chemicals, it is possible that chemical deposits formed on the exhaust filters over years of use thereby clogging the filters.
- Air blows were implemented during internal cleaning of the tank in FY2016, and it is possible that the pressure from the air blows damaged the exhaust filter.

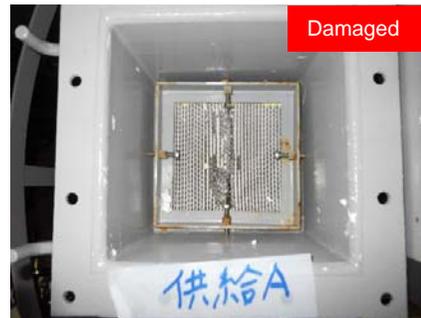
Additionally installed ALPS System A Feed tank

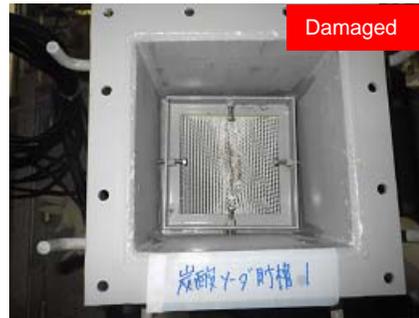
Additionally installed ALPS Carbonate soda storage tank 1

- Since this tank is filled with relatively concentrated chemicals, it is possible that chemical deposits formed on the exhaust filters over years of use thereby clogging the filters. And, although air blows were not implemented, it is possible that the damage was caused by the flow of air caused in conjunction with fluctuating tank water levels.

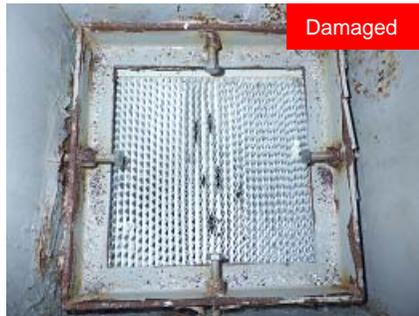
Additionally installed ALPS drainage tank  
(Reposted)

- The adsorption tower exhaust pipe and drainage tank are connected, and it is assumed that the pressure from the air blow, which contains mist used during the reverse washing of adsorption towers, damaged the drainage tank exhaust filter.

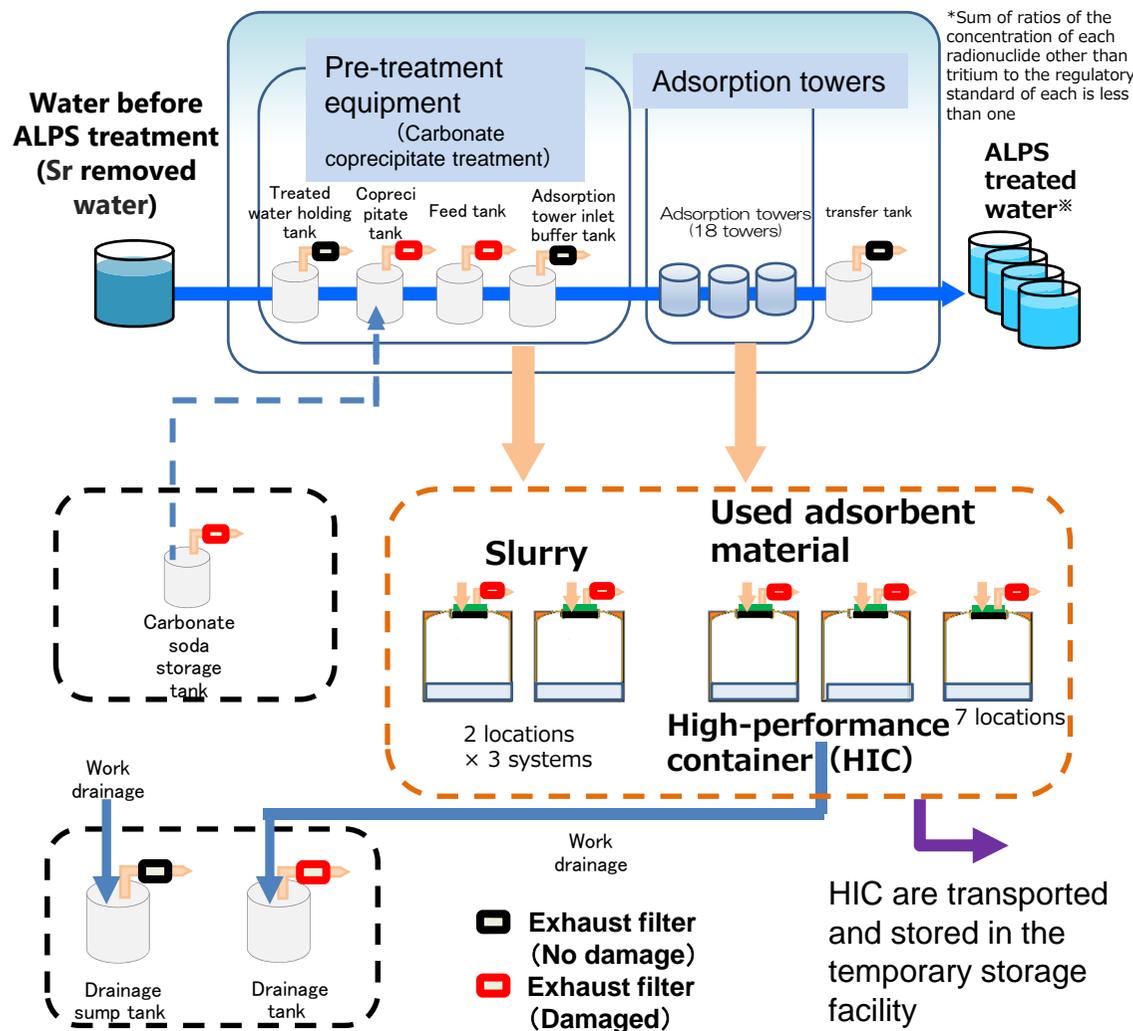
No	Equipment	Exhaust filter visual inspection	Smear results* (Near exhaust filter outlet)
1	Treated water receiving tank1	No abnormalities	Corresponds to BG
2	Treated water receiving tank2	No abnormalities	Corresponds to BG
3	Coprecipitate tank A	Damaged	9500cpm
4	Coprecipitate tank B	No abnormalities	Corresponds to BG
5	Coprecipitate tank C	No abnormalities	Corresponds to BG
6	Feed tank A	Damaged	14000cpm
7	Feed tank B	No abnormalities	500cpm
8	Feed tank C	No abnormalities	Corresponds to BG
9	Adsorption tower inlet buffer tank A	No abnormalities	Corresponds to BG
10	Adsorption tower inlet buffer tank B	No abnormalities	800cpm
11	Adsorption tower inlet buffer tank C	No abnormalities	Corresponds to BG
12	Transfer tank 1	No abnormalities	600cpm
13	Transfer tank 2	No abnormalities	Corresponds to BG
14	Carbonate soda storage tank 1	Damaged	Corresponds to BG
15	Carbonate soda storage tank 2	No abnormalities	Corresponds to BG

16	Drainage tank	Damaged	1700cpm
17	Drainage sump tank 1	No abnormalities	700cpm
18	Drainage sump tank 2	No abnormalities	700cpm

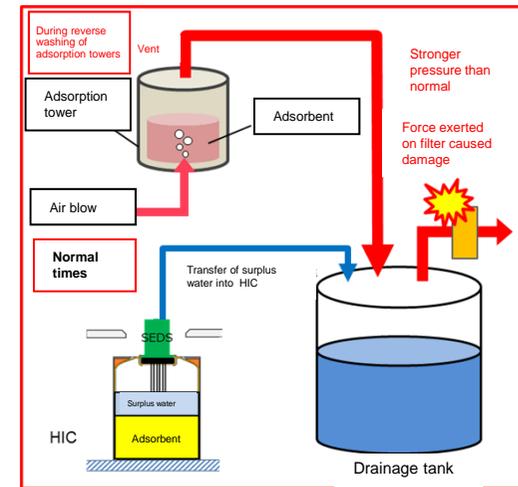
Cause of damage to drainage tank (hypothesized)

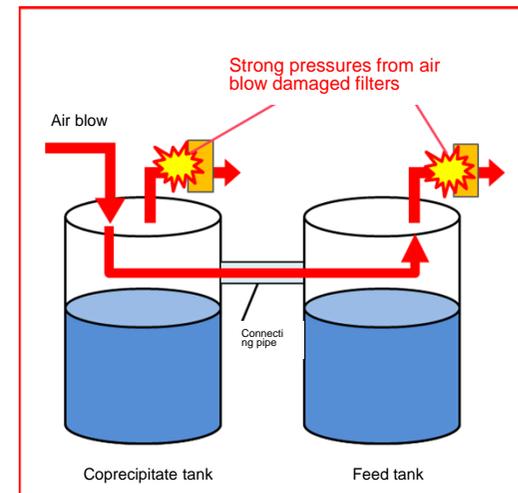
Cause of damage to coprecipitate/feed tanks (hypothesized)

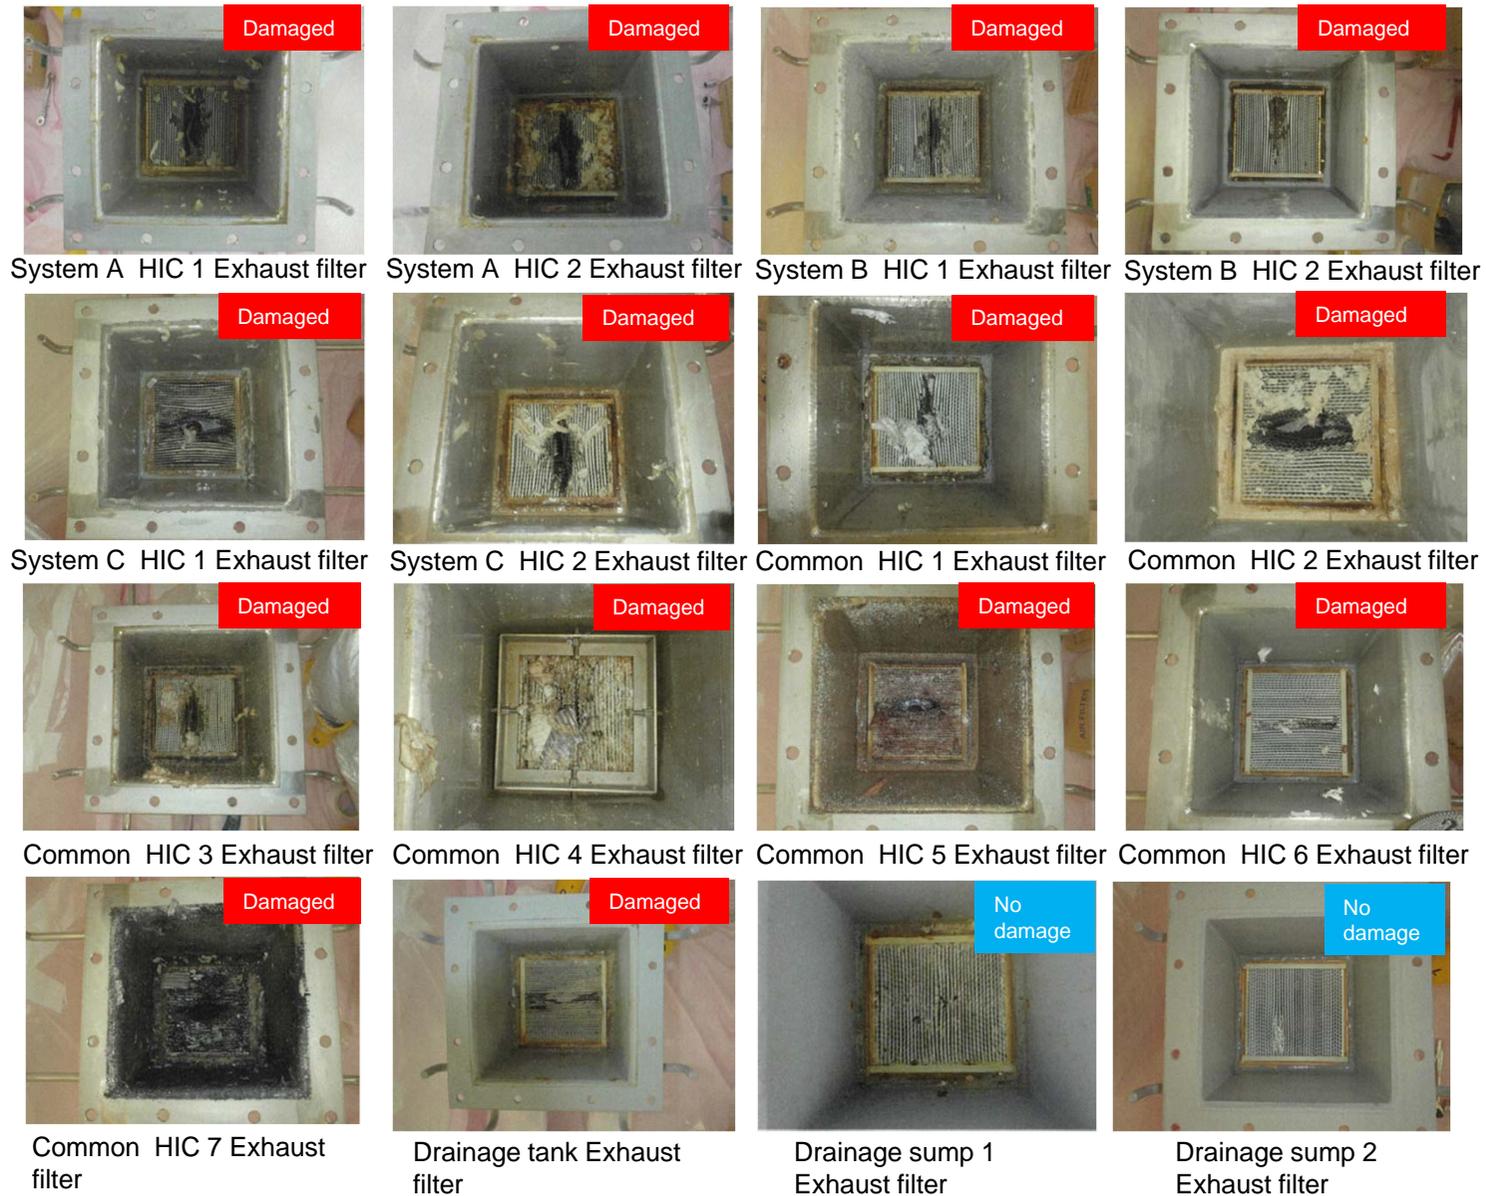
- Damage was found in a total of 25 locations (Existing ALPS: 12 locations; Additionally installed ALPS: 13 locations) when the aforementioned exhaust filters were replaced due to condensation at exhaust outlets (July through October 2019), and at the time no steps were taken to ascertain the cause of the damage.

# (Reference) Conditions of filters during additionally installed ALPS exhaust filter inspection performed from July through October 2019

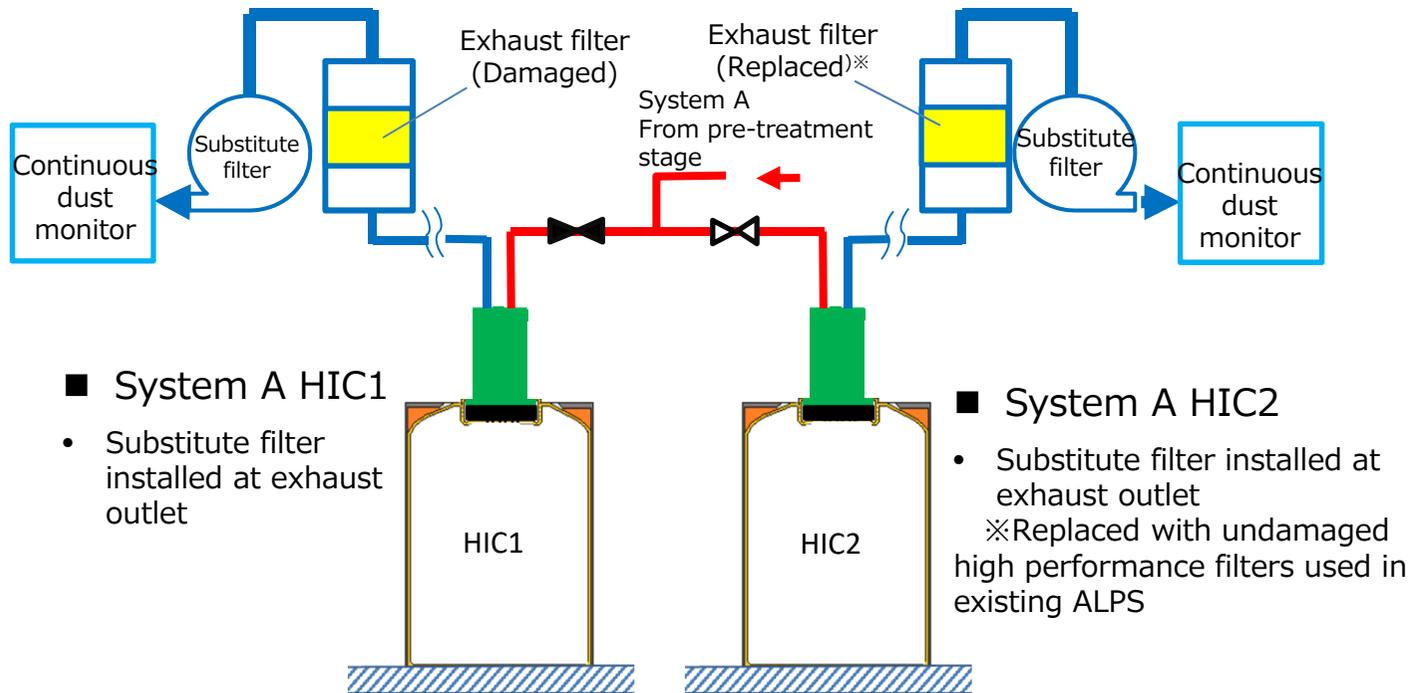
Temporary countermeasures implemented at additionally installed ALPS System A

- Substitute filters were installed downstream of the HIC exhaust filters to mitigate the impact of mist and blown air
  - A continuous dust monitor was installed to be able to immediately detect damage to the substitute filters

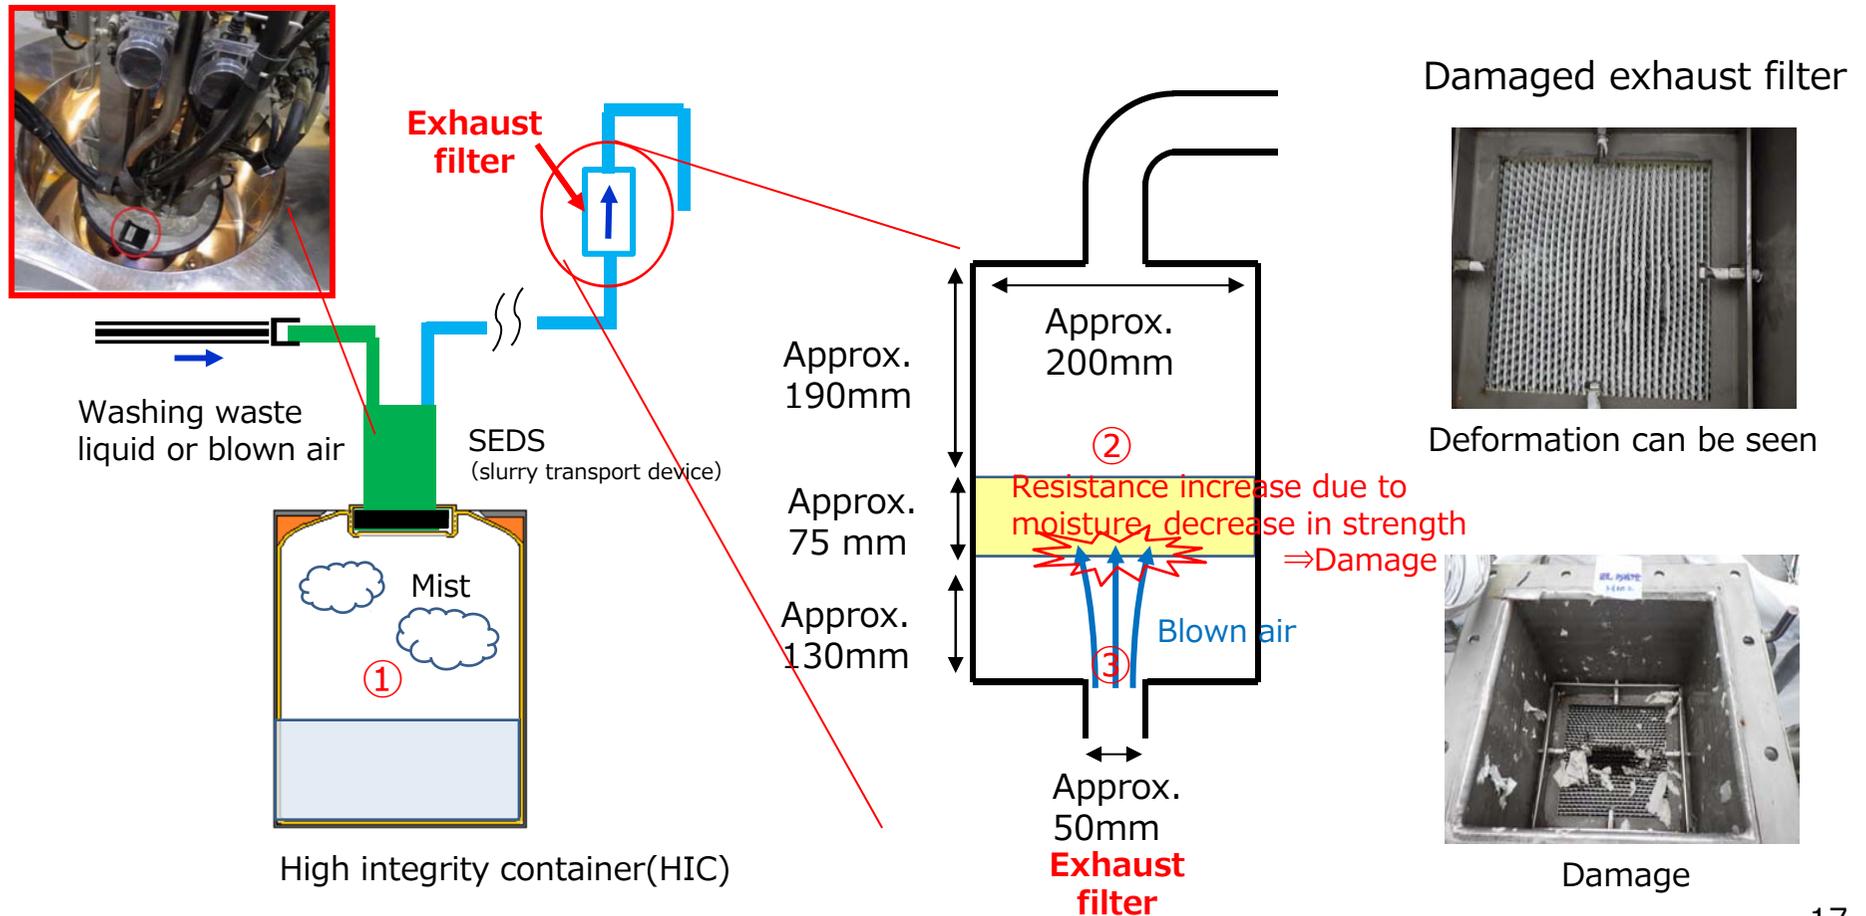
- The following is the hypothesized cause of exhaust filter damage
  - ① Mist was generated inside the HIC by washing waste liquid during the pre-treatment phase of ALPS operation or when air was blown into the system to expel adsorbents.
  - ② The exhaust filters were moistened by the mist that reached them due to the blown air thereby increasing air resistance. It is hypothesized that filter strength had also deteriorated.
  - ③ The blown air concentrated at the center of the exhaust filters caused damage.
