# Location of the detailed visual inspection of the perimeter of the pedestal and inspection schedule

Conditions near PLR Pump (B) and jet deflector (H) (from March 14 investigation①)

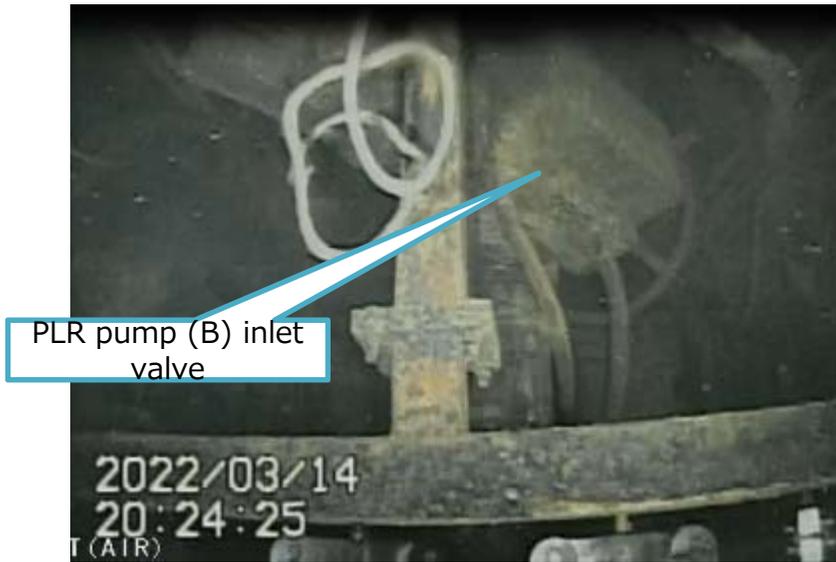
Photo 1. Conditions near the PLR pump (B) inlet valve

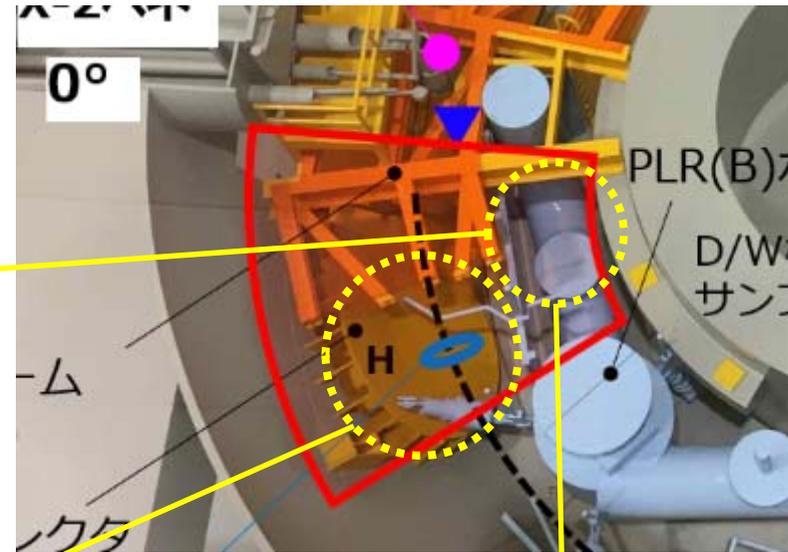
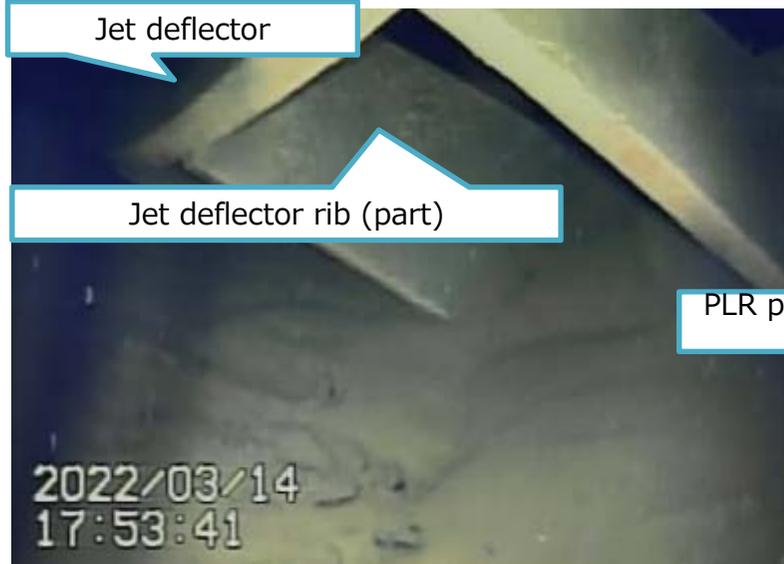
Photo 2. Conditions at bottom of jet deflector (H)

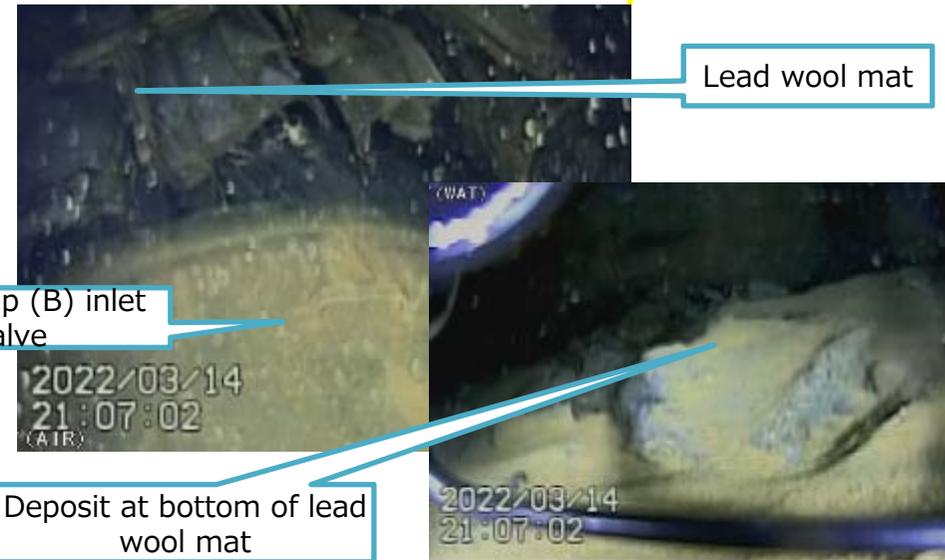
- ② Clump-like deposits were found at the bottom of the lead wool mats ※<sup>5</sup> near the PLR (B) inlet valve and also near jet deflector (F) (refer to photo 3 on slide 5, and photo 2 on slide number 10).

Photo 3. Conditions near PLR pump (B) inlet valve

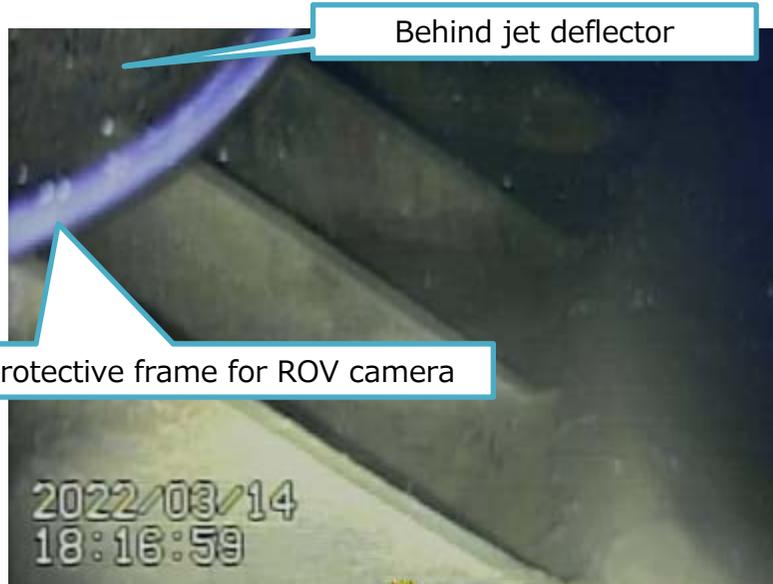
- ③ Deposits were found behind jet deflectors H, G, and F (suppression chamber side) (refer to slides 6, 8, and the 9).
    - ④ A continuous stream of bubbles was seen coming from the vent pipe connected to the suppression chamber behind jet deflector F (suppression chamber side) (Refer to photo 2 on slide 9).

Photo 1. Conditions behind jet deflector (H) ①

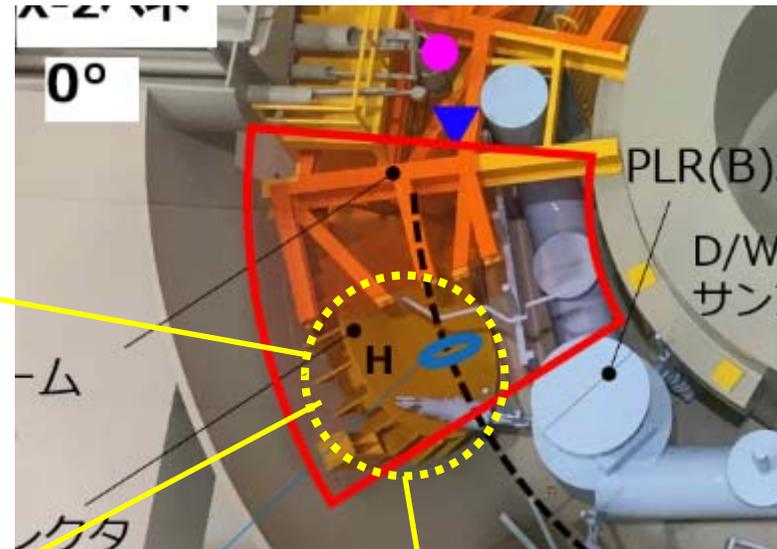
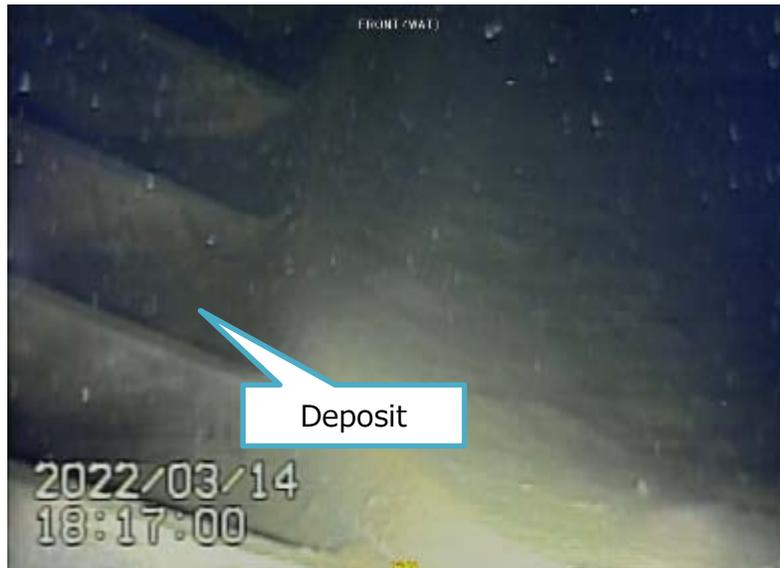
Photo 2. Conditions behind jet deflector (H) ②

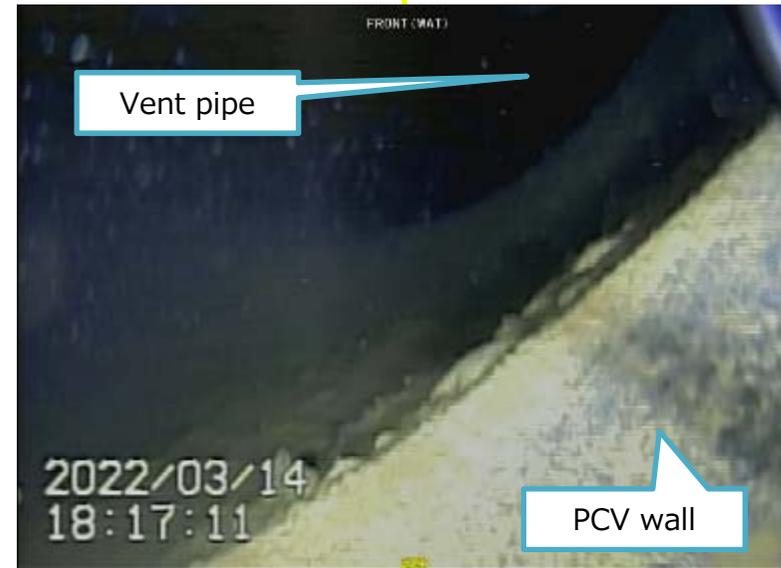
Photo 3. Conditions behind jet deflector (H) ③ 6

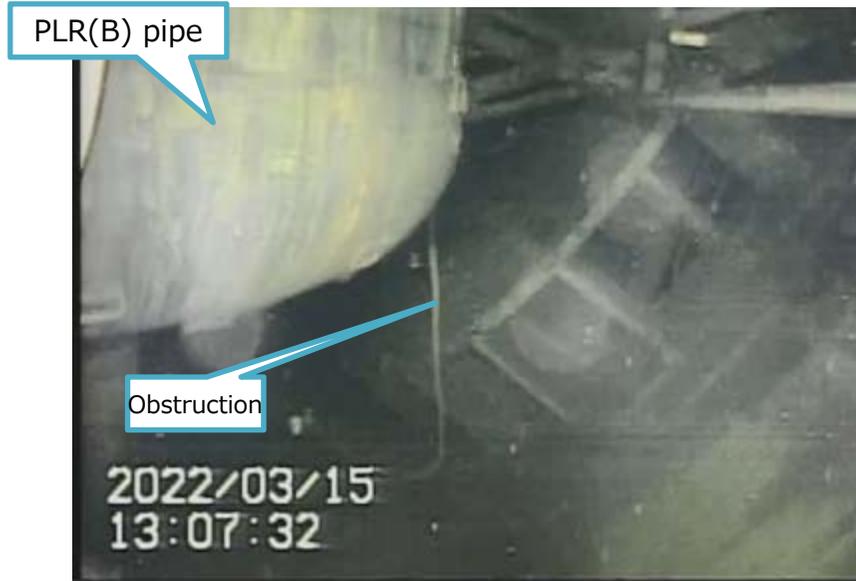
- ⑤ Obstructions were found near jet deflector G (refer to slides 7 and 8)
  - This information shall be analyzed going forward and additional investigations of these areas may be performed as necessary using ROV's B, C, D, and E during investigations planned for the future.

Photo 1. Looking down on jet deflector (G)

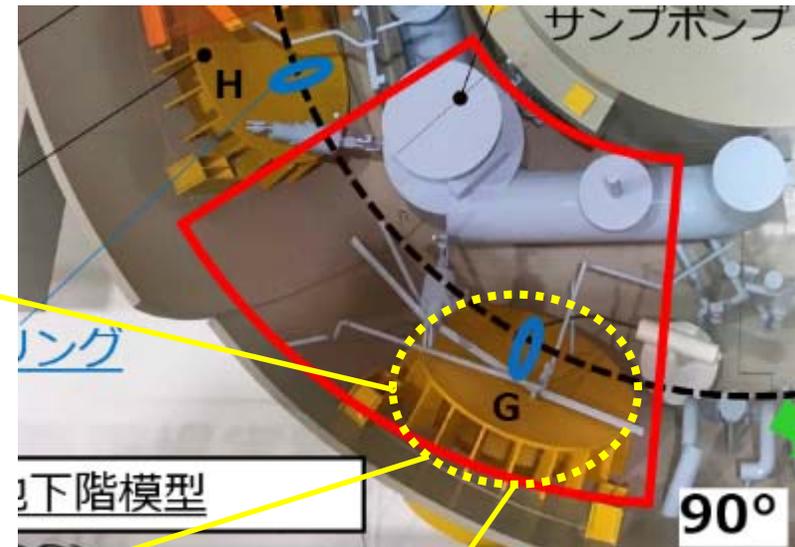
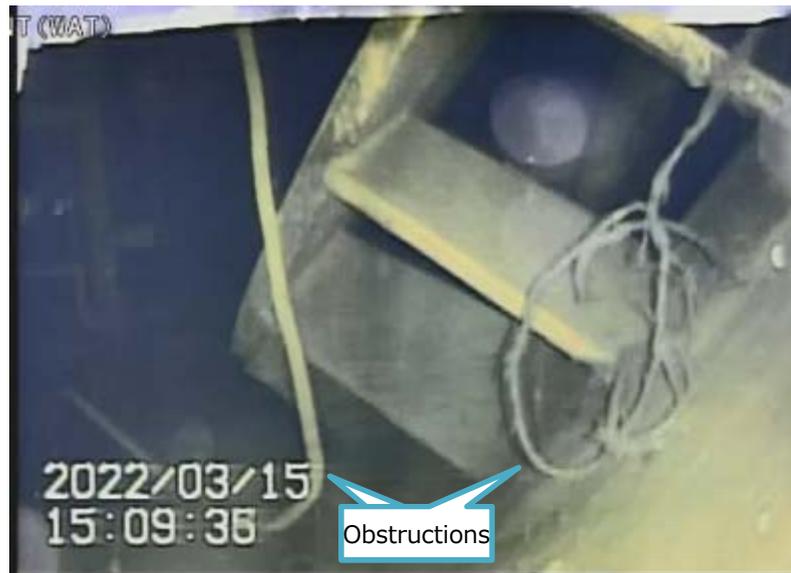
Photo 2. Conditions near jet deflector (G)

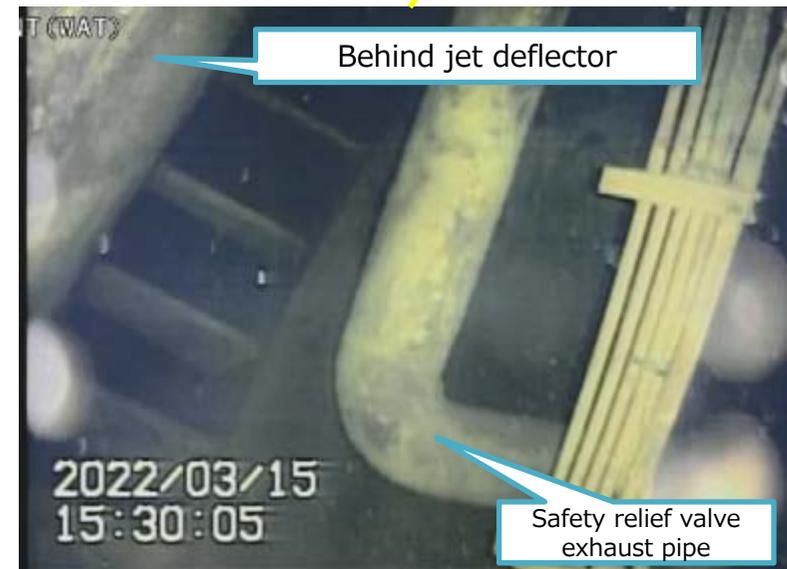
Photo 3. Conditions behind jet deflector (G) 7

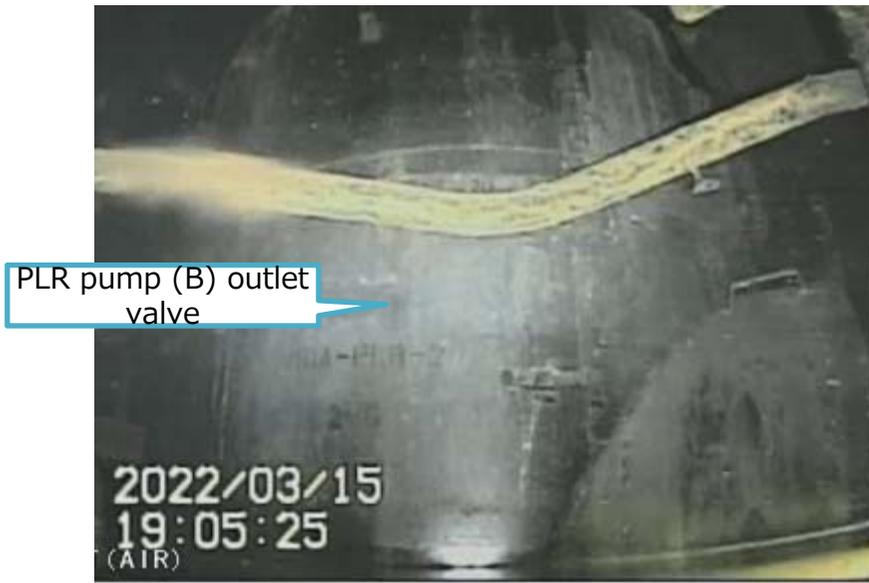
Photo 1. Conditions near PLR pump (B) outlet valve

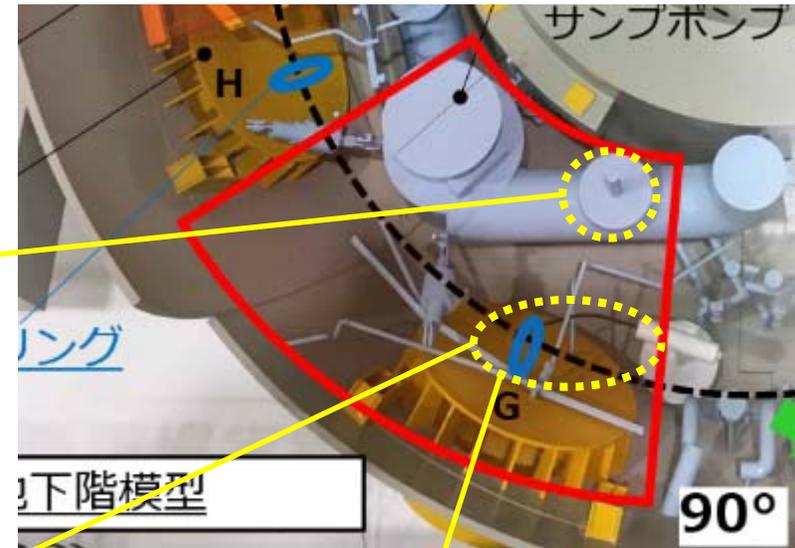
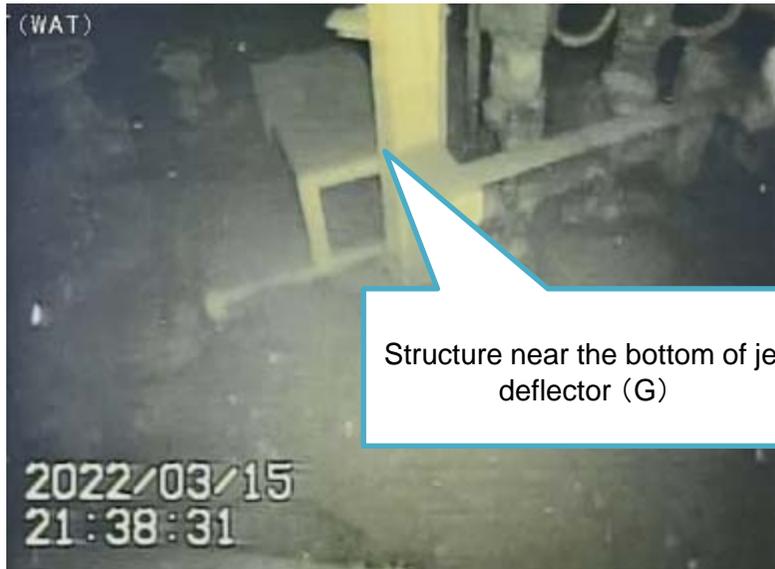
Photo 2. Conditions near the bottom of jet deflector (G)①

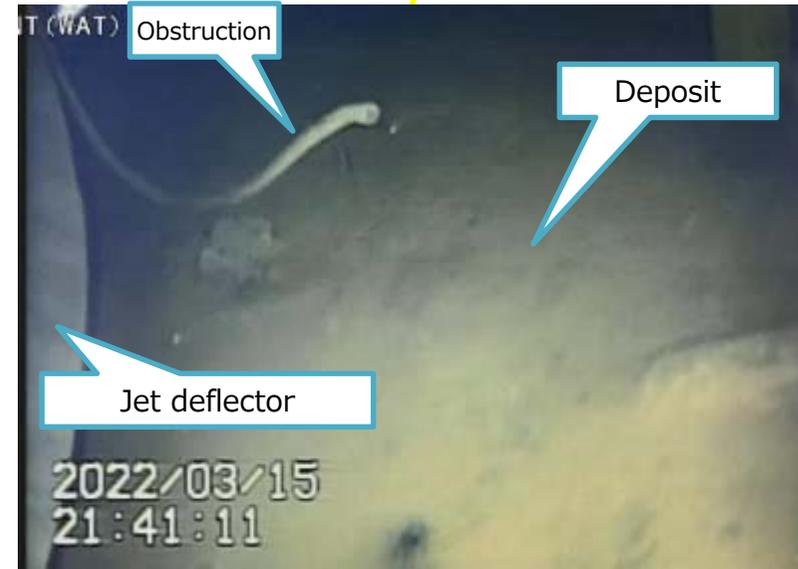
Photo 3. Conditions near the bottom of jet deflector (G) ② 8

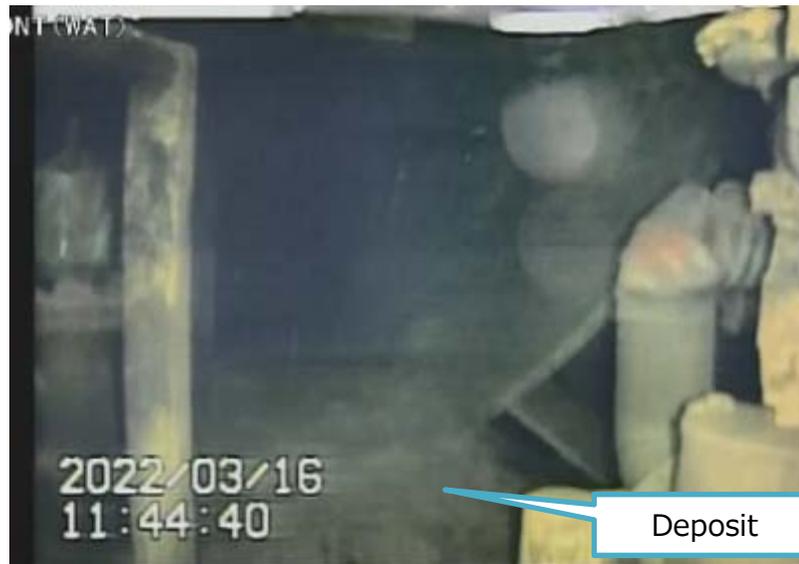
Photo 1. Looking down on jet deflector (F)

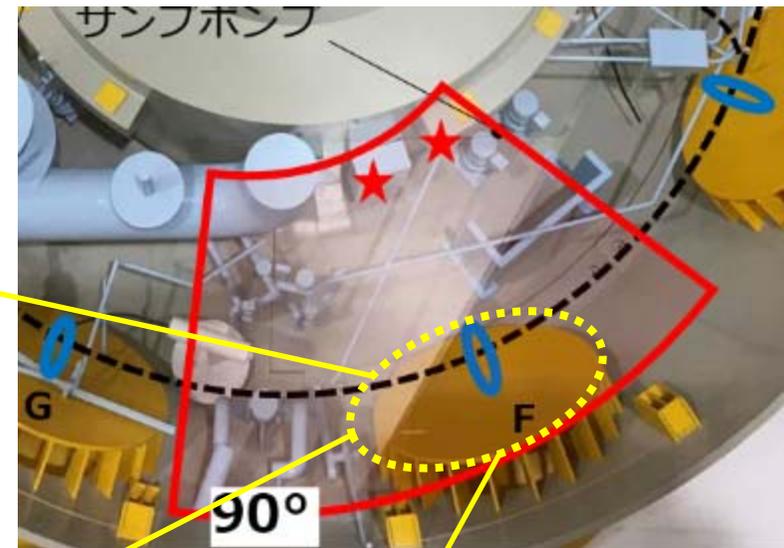
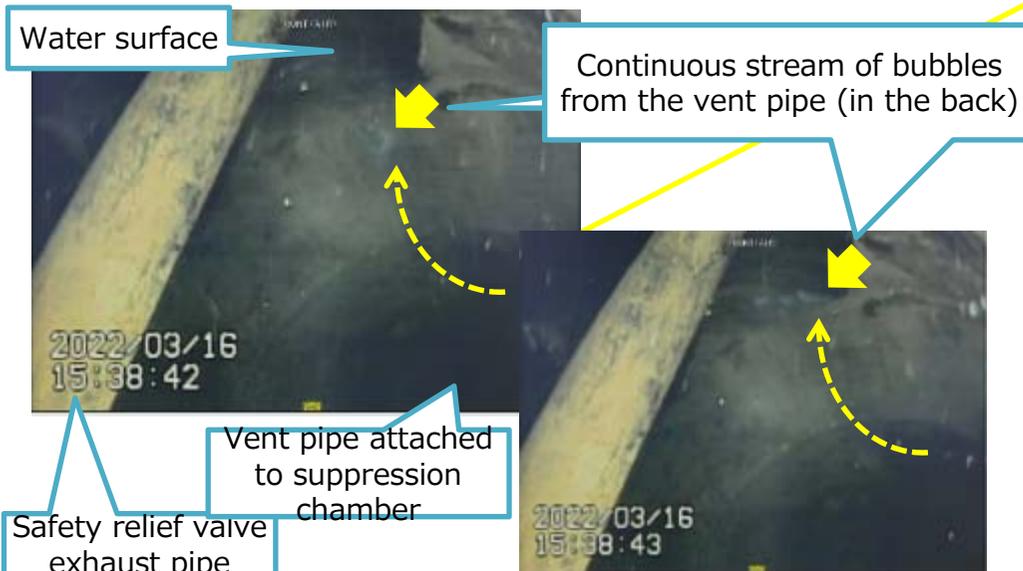
Photo 2. Conditions behind jet deflector (F) ①

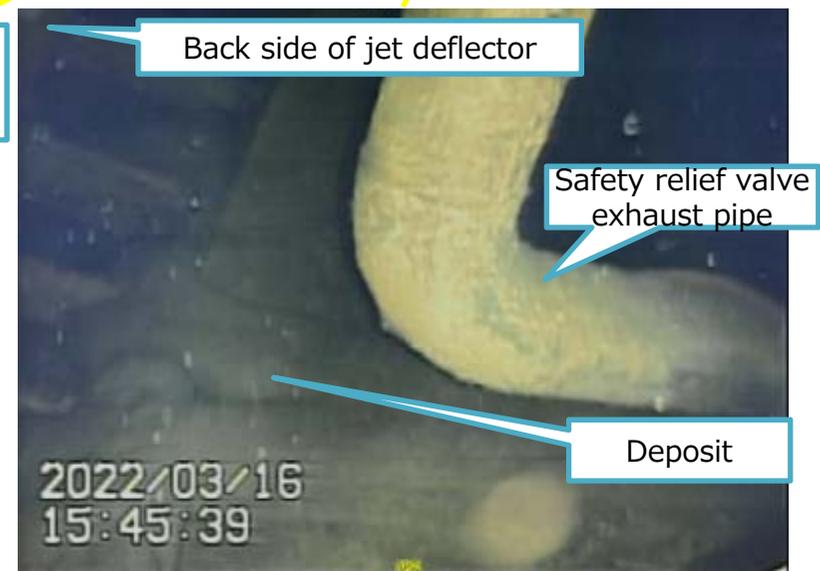
Photo 3. Conditions behind jet deflector (F) ② 9

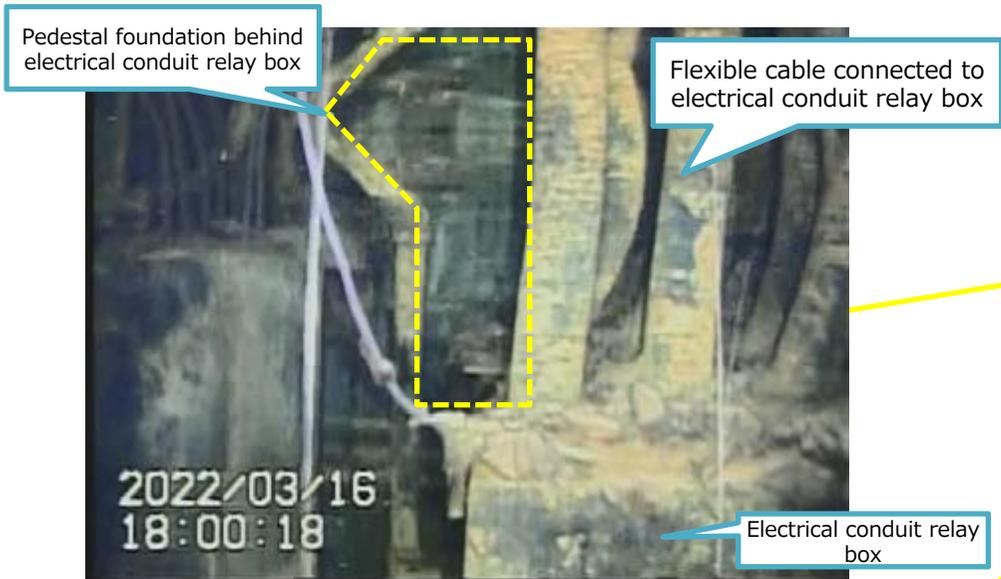
- ① Existing structures, such as the primary loop recirculation system (hereinafter referred to as, "PLR") (B) pipes/pump and jet deflectors ※<sup>4</sup>, and pedestal foundation, showed no visual signs of extensive damage (refer to slides 5-10).

Photo 1. Conditions near pedestal foundation①

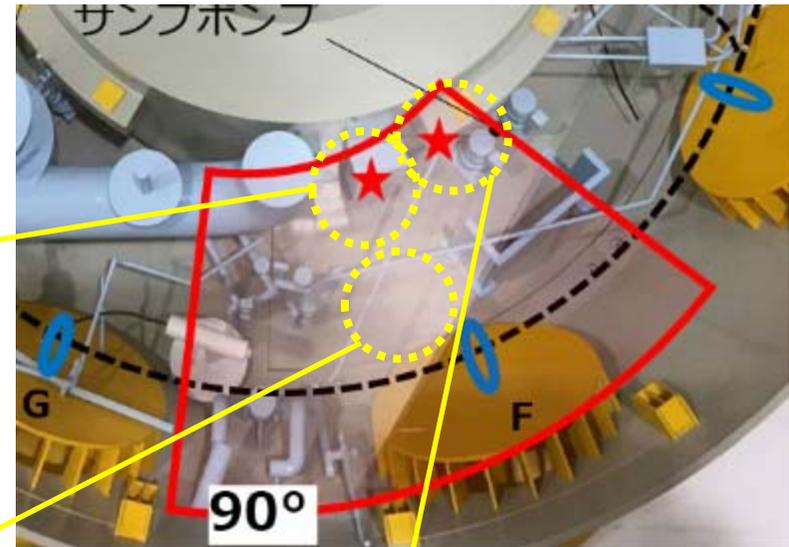
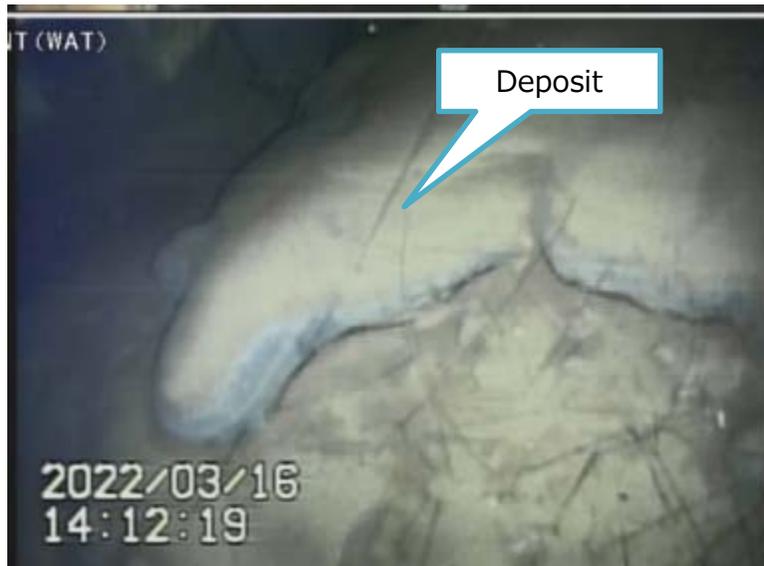
Photo 2. Conditions near jet deflector (F)

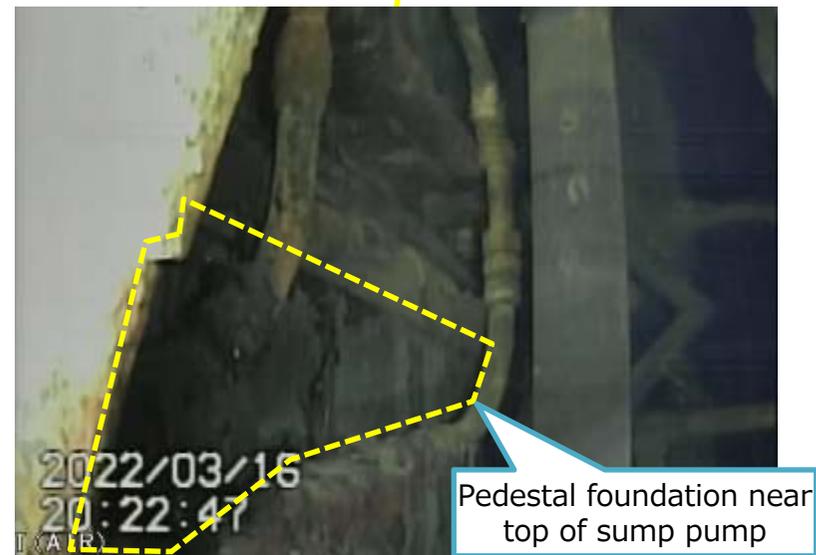
Photo 3. Conditions near pedestal foundation② 10

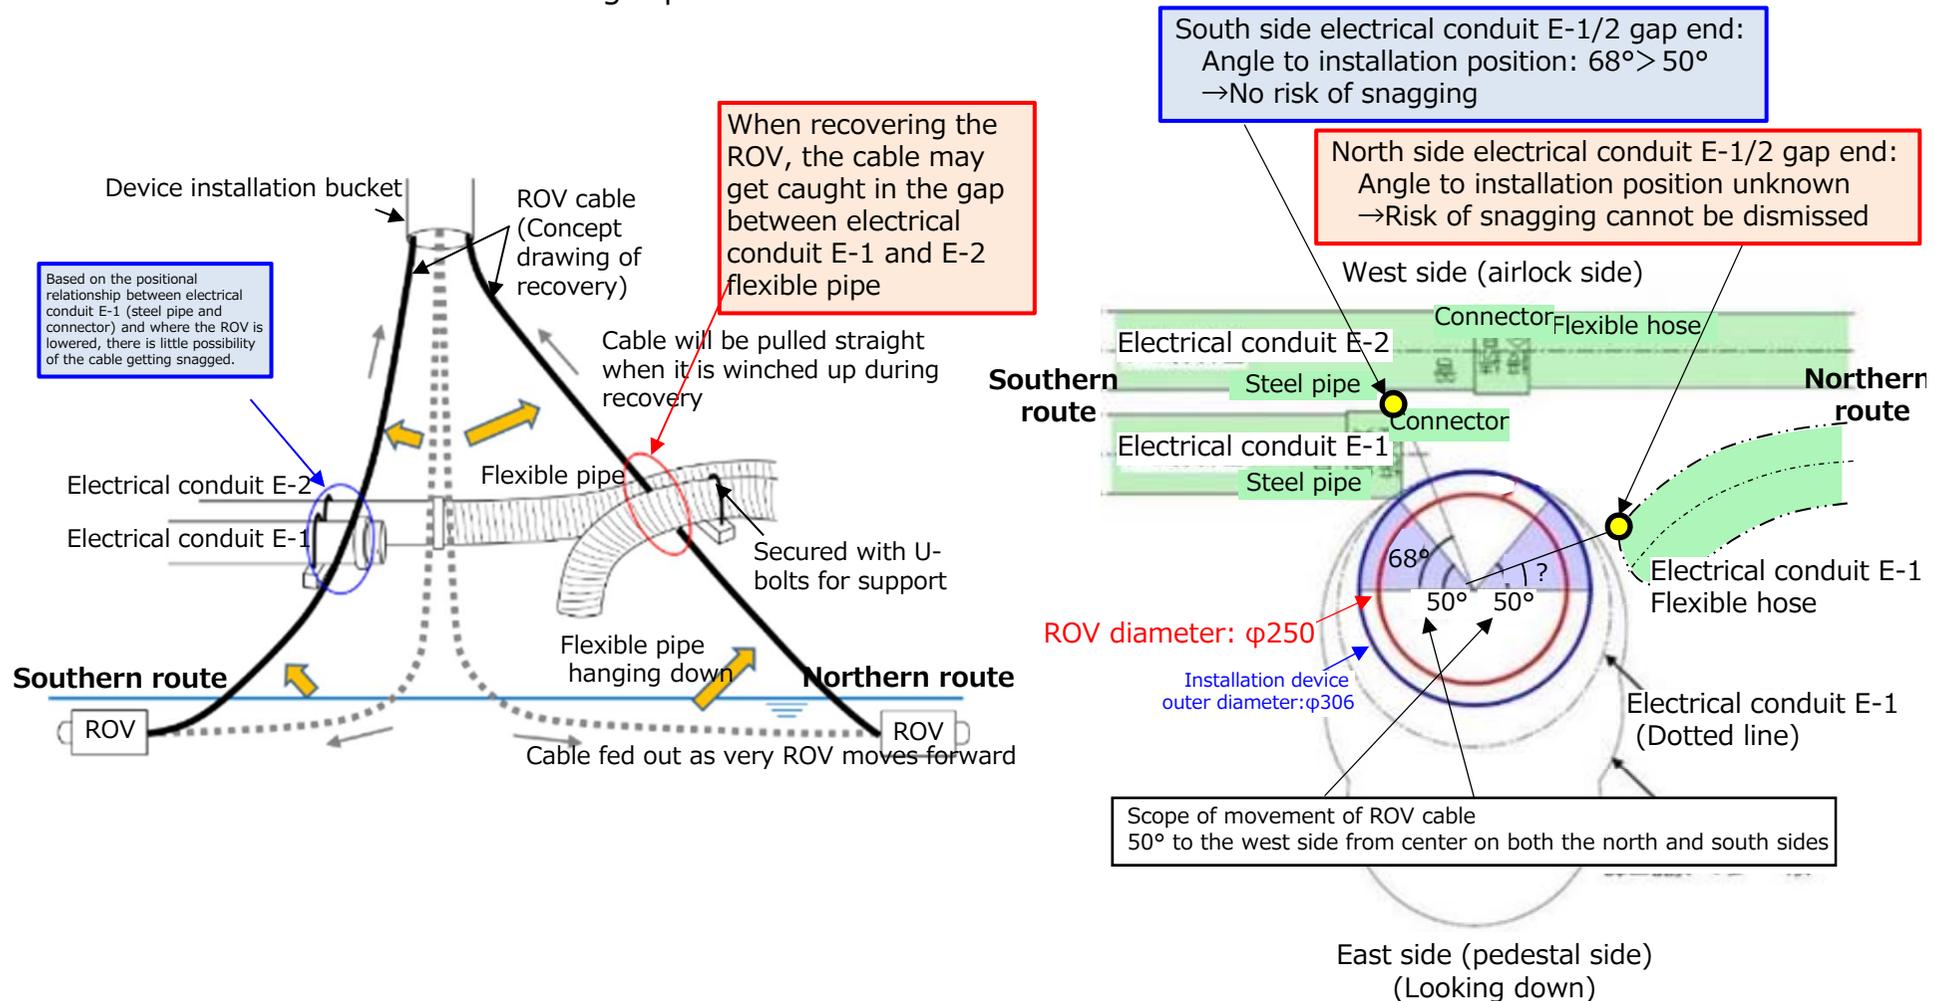
## 【Reference】 Foreseen risks and countermeasures (2/5)

- During preparations to insert PCV internal investigation equipment, an electrical conduit that is obstructing the path was seen, and there is the risk that the submersible ROV cable will get snagged when investigating the northern route.
- If the ROV cable gets snagged, it will be impossible to recover the ROV and insert other ROV's, so investigation of the northern route is no longer possible.
