Implementation Status of the Fukushima Daiichi Nuclear Power Station  
Unit 1 Primary Containment Vessel Internal Investigation (ROV-A2)  
(work conducted on May 17 and 18)

< Reference Material >  
May 19, 2022  
Tokyo Electric Power Company Holdings, Inc.  
Fukushima Daiichi D&D Engineering Company

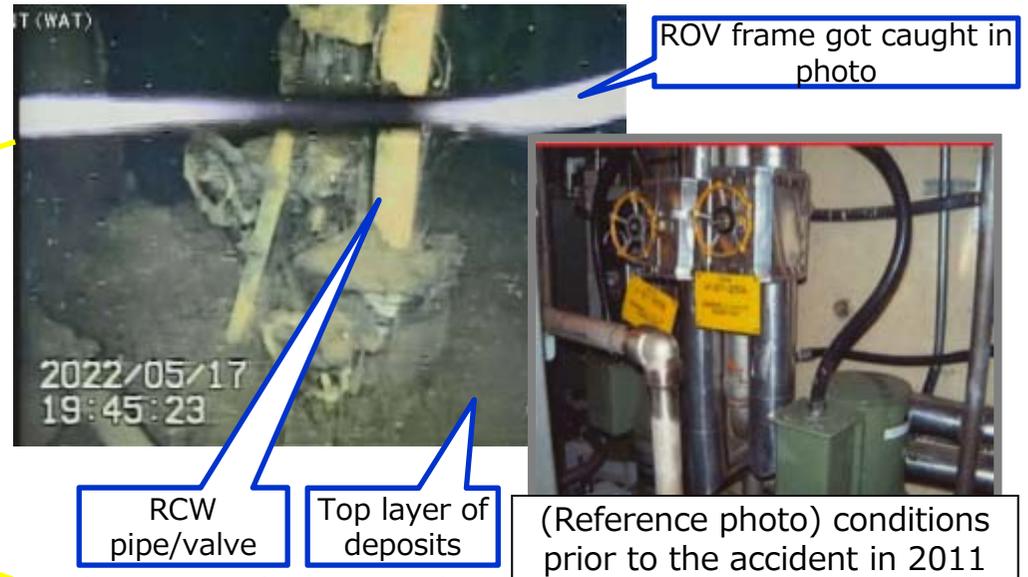
Photo 1. Conditions near the equipment drain sump pump

- ① No large damage to the pipes/valves of the reactor auxiliary cooling water system (hereinafter referred to as, "RCW") or the pipes (A) for the primary loop recirculation system (hereinafter referred to as, "PLR") was visible (Refer to photo 1 on slide 5, and photo 1 on slide 9).

- ② Deposits were found near the equipment drain sump pump (Refer to photo 1 on slide 5).
    - ③ Deposits form a top and bottom layer near the equipment drain sump pump shielding, and the inside is hollow (Refer to photos 2 and 3 on slide 5).

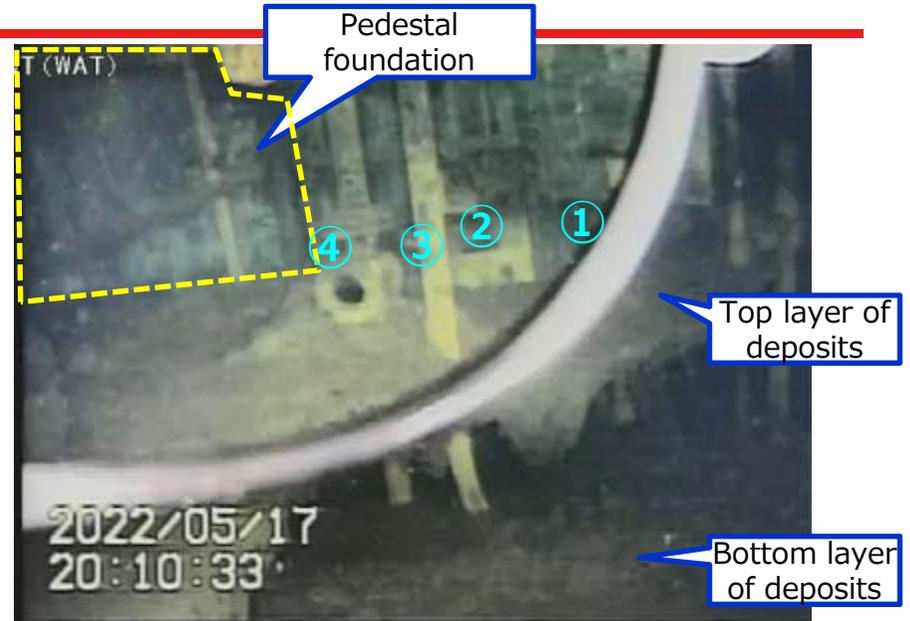
Photo 1. Conditions at top of pedestal foundation

- ④ No large damage was seen from the top of the deposits to the top of the pedestal foundation. Objects that are thought to be rebar were also found below the top layer of the deposits (Refer to photos 1 and 2 on slide 6, and photo 2 on slide 9).

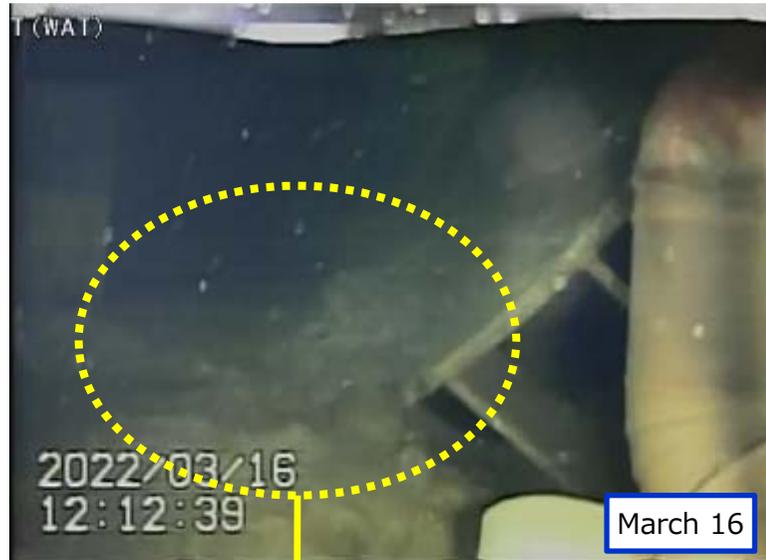
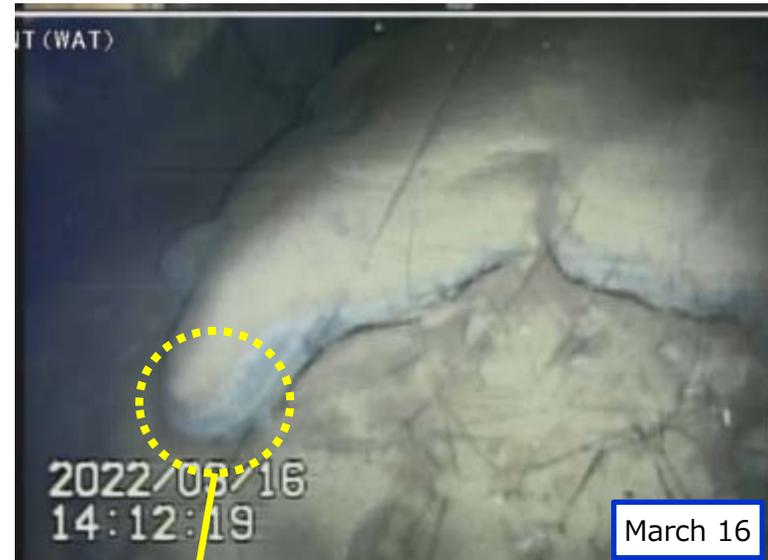
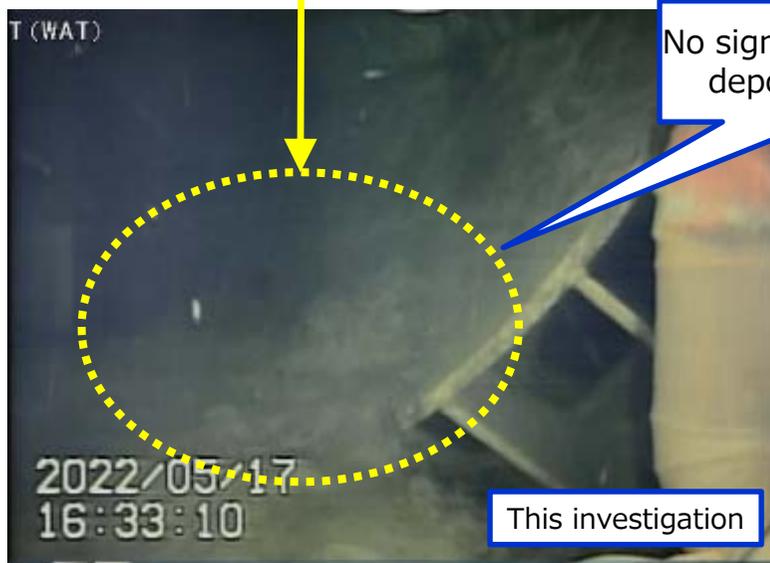
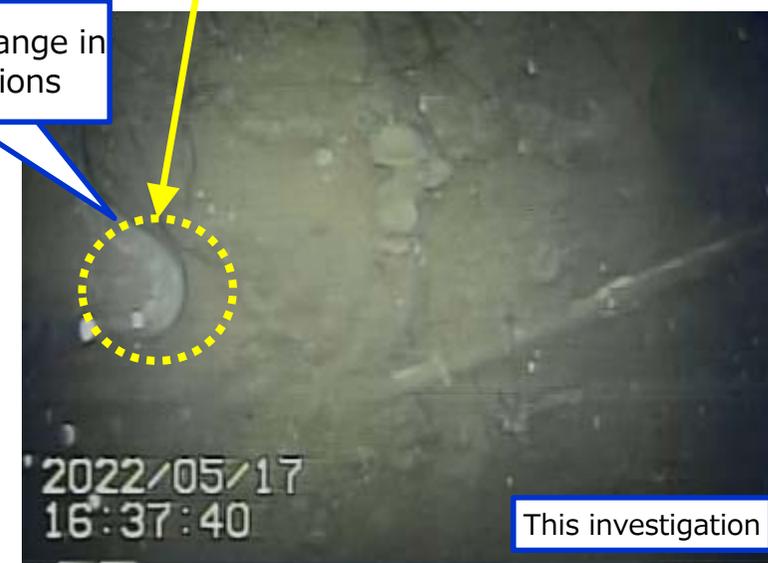
- ⑤ No significant changes have been seen in the condition of deposits near jet deflector<sup>※4</sup> (F) compared to prior to the earthquake on March 16 (Refer to slide 7).

No significant change in deposit conditions

Photo 1. Looking down on jet deflector (F)

Photo 2. Conditions around jet deflector (F)

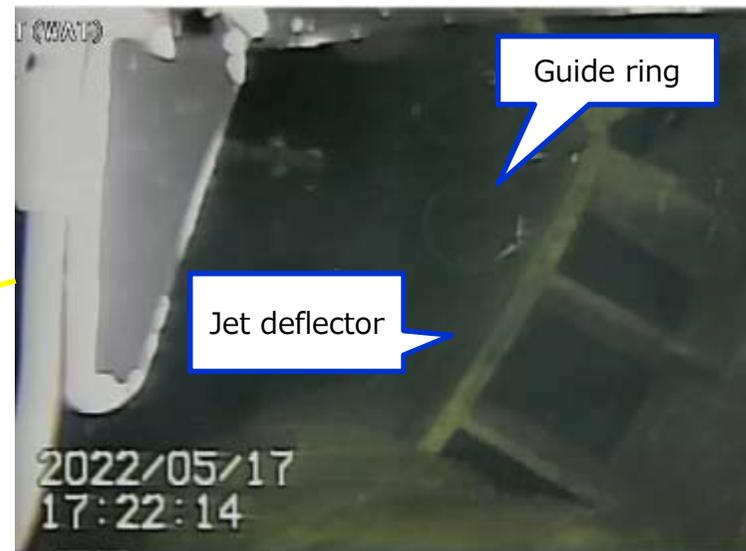
Photo 1. Looking down on jet deflector (E)

- ⑥ Clumped deposits were found on the bottom surface and at the back (pressure suppression chamber side) of jet deflector (E) (Refer to slide 8).

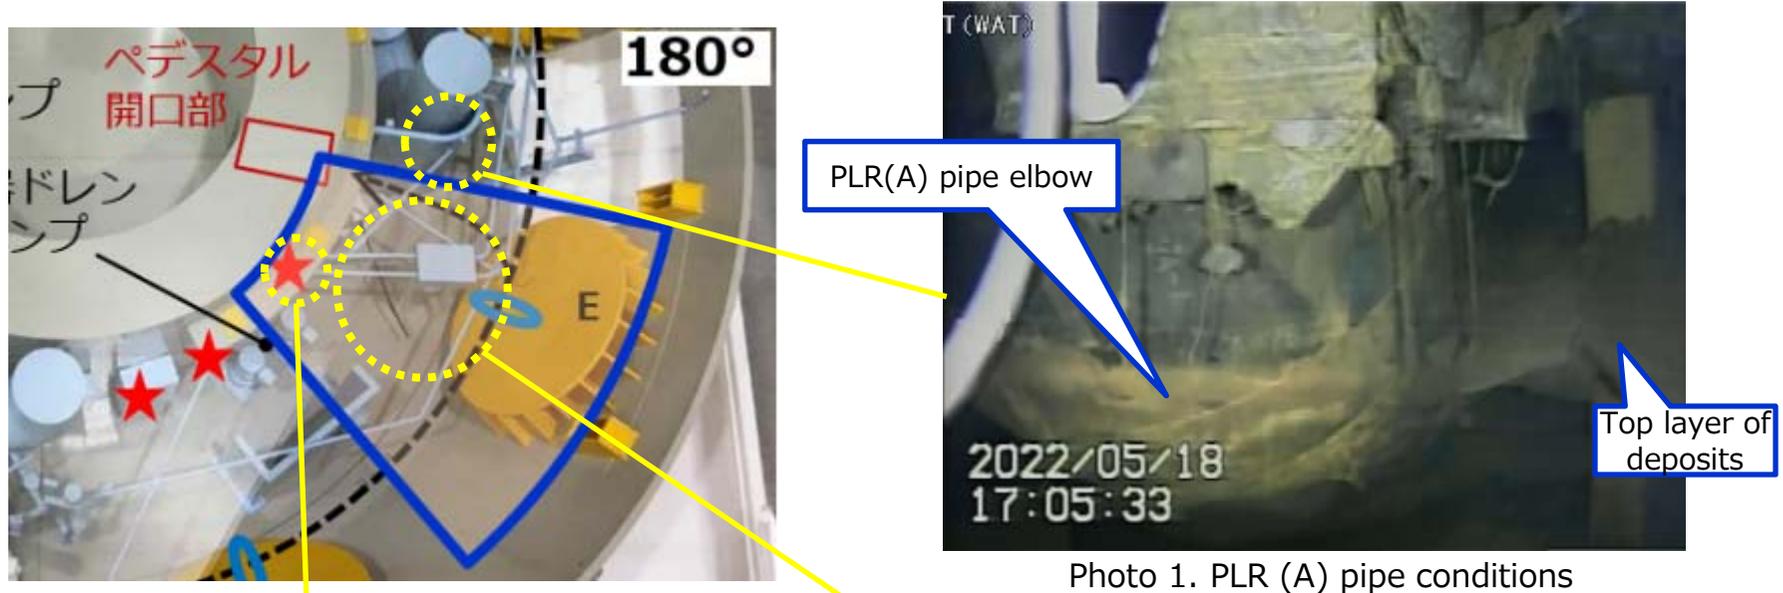
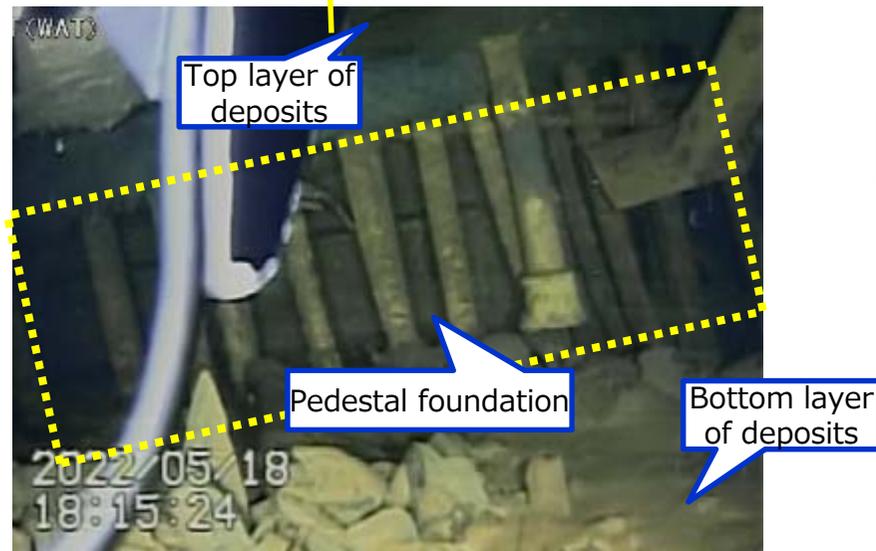
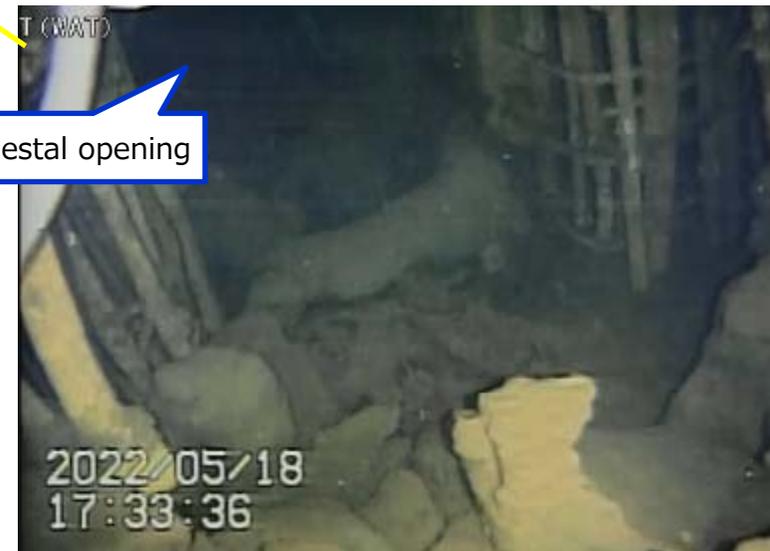
# Conditions around the PLR (A) pipe and pedestal (from May 18 investigation②)

- 
- Today (May 19), we continued to use submersible ROV-A2 to investigate the condition of existing structures and the status of deposit dispersion around the pedestal near jet deflector (D) and the pedestal opening (photo 3, slide 9).
