< R e f e r e n c e d o c u m e n t > J a n u a r y 1 8 , 2 0 2 4 Tokyo Electric Power Company Holdings, Inc. Fukushima Daiichi Decontamination & Decommissioning Engineering Company

Fukushima Daiichi Nuclear Power Station Unit 2 Primary Containment Vessel Internal Investigation/Trial Retrieval Preparations Status of progress with deposit removal

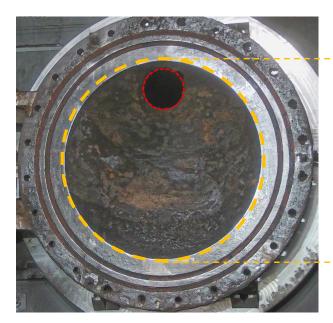
External view of X-6 penetration before pushing

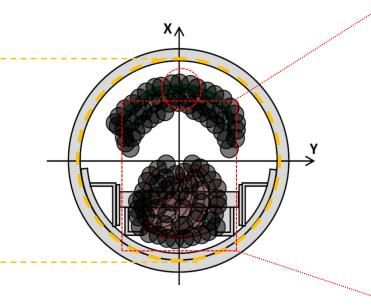
Planned scope of deposit collapse

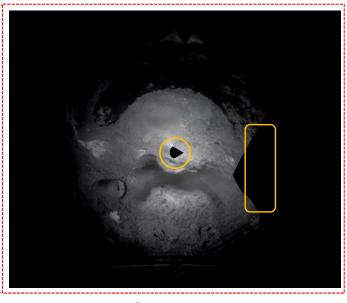
Status of deposit collapse
**Composite image with integrated pictures

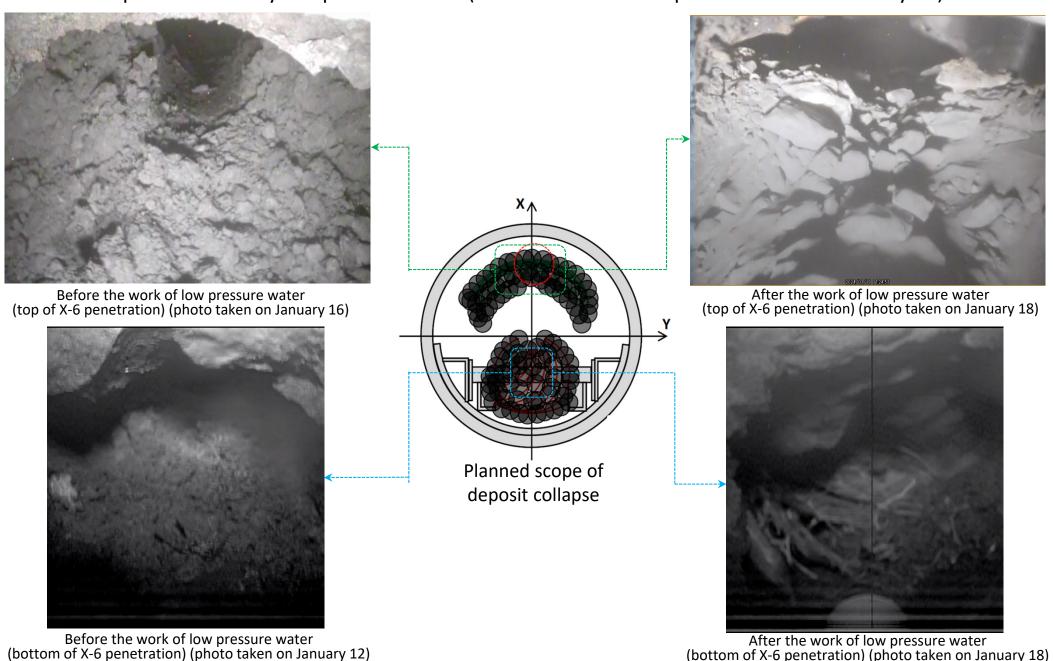
■ Status of deposit removal by low pressure water (before the start of deposit removal on January 18)
