Fukushima Daiichi Nuclear Power Station Drone investigation of the inside of the Unit 1 and Unit 3 reactor buildings

November 27, 2025

Tokyo Electric Power Company Holdings, Inc.

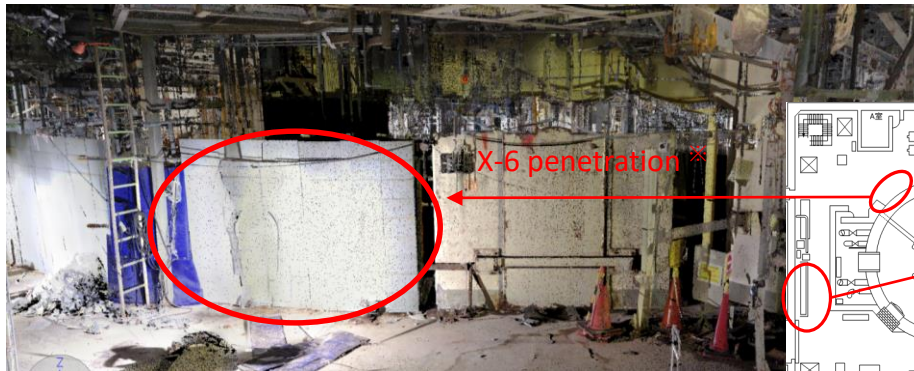
Jet pump instrument rack
(northwest area, 1st floor, reactor building)

- The jet pump instrument rack closest to the X-6 penetration in the northwest area contributes greatly to these high doses, and we are deliberating flushing the pipes or removing them in order to reduce doses, but since the pipes are connected to the PCV, removing them would require deliberation of how to build and seal a PCV boundary.

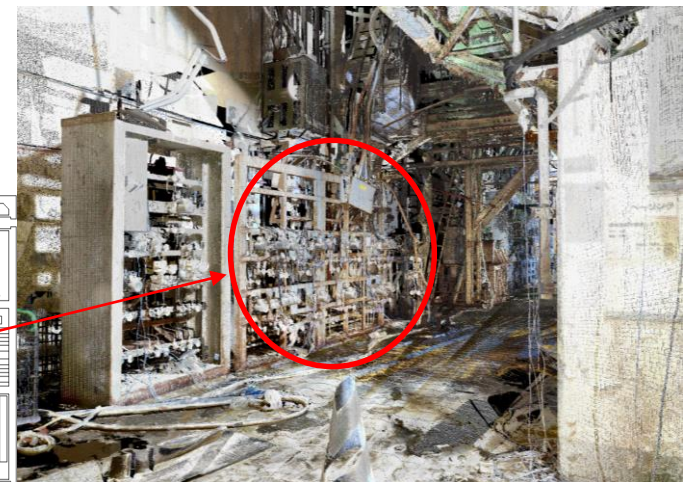
High pressure coolant injection system instrument rack
(west area, 1st floor, reactor building)

- Furthermore, the west area, which is the access route to the northwest area, is littered with instrument racks that may obstruct the carrying in of equipment, so likewise, deliberating a boundary that considers the PCV is necessary if they are to be removed.

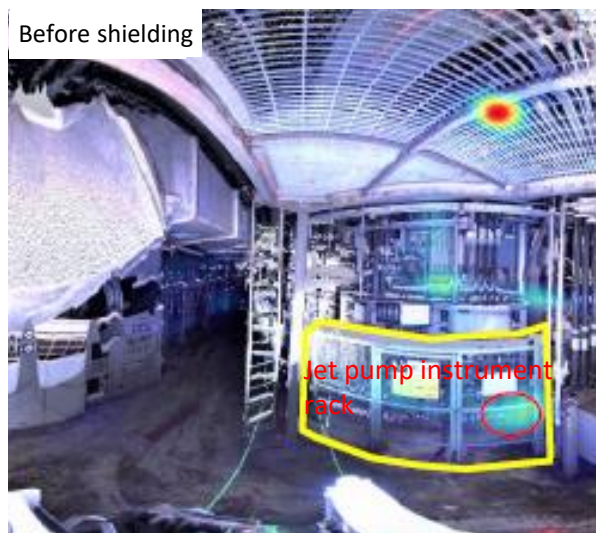
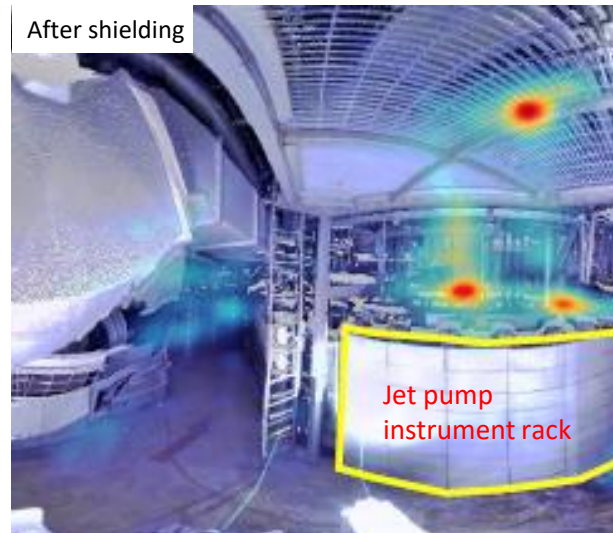
Reference. Results of the investigation around the X-6 penetration

- The HCU (north side) is greatly affected by doses from the jet pump instrument rack, and it is not clear whether there are any other radiation sources.
- The HCU and jet pump instrument rack, which are the main radiation sources, have been shielded, and the air dose rate around the X-6 penetration is between 3~5mSv/h, thereby prohibiting workers from remaining in the area for a long period of time.

- Dose reduction measures for the jet pump instrument rack closest to the X-6 penetration are being deliberated.
- Due to the difficulty of work implementation, it is expected that much time will be needed to reduce doses in the HCU.

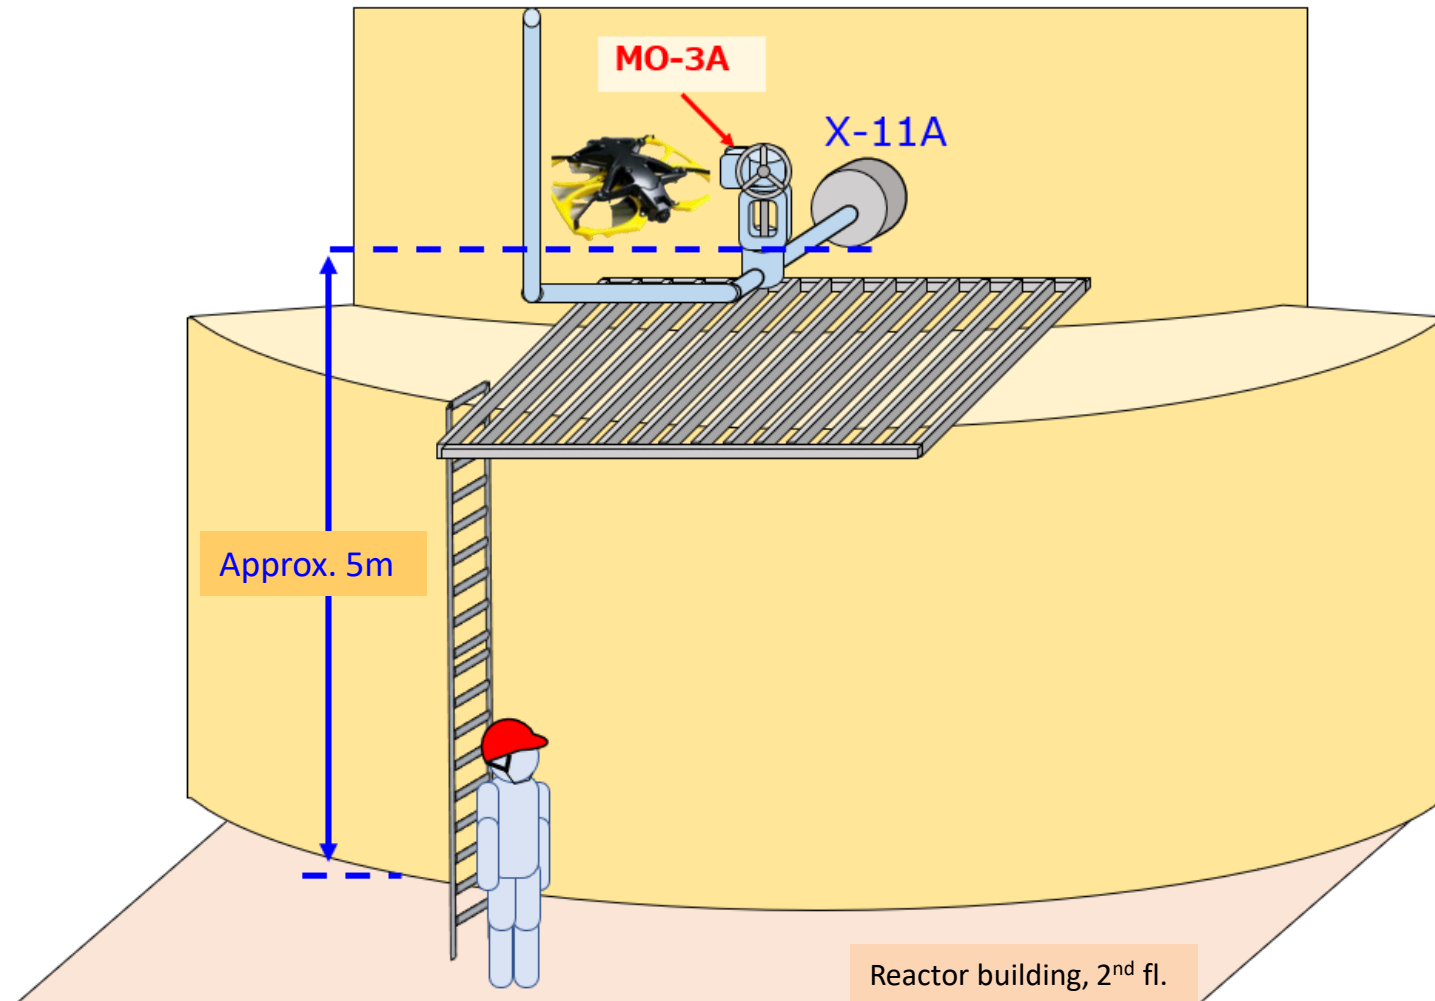
Ex.) Unit 1, 2nd floor, X-11

- The penetration is approx. 5m from the floor, and neither the penetration, nor master valves in the vicinity, cannot be directly viewed, so drones will be used to investigate it.
- The same is true for the other investigation targets at Units 1 and 3.

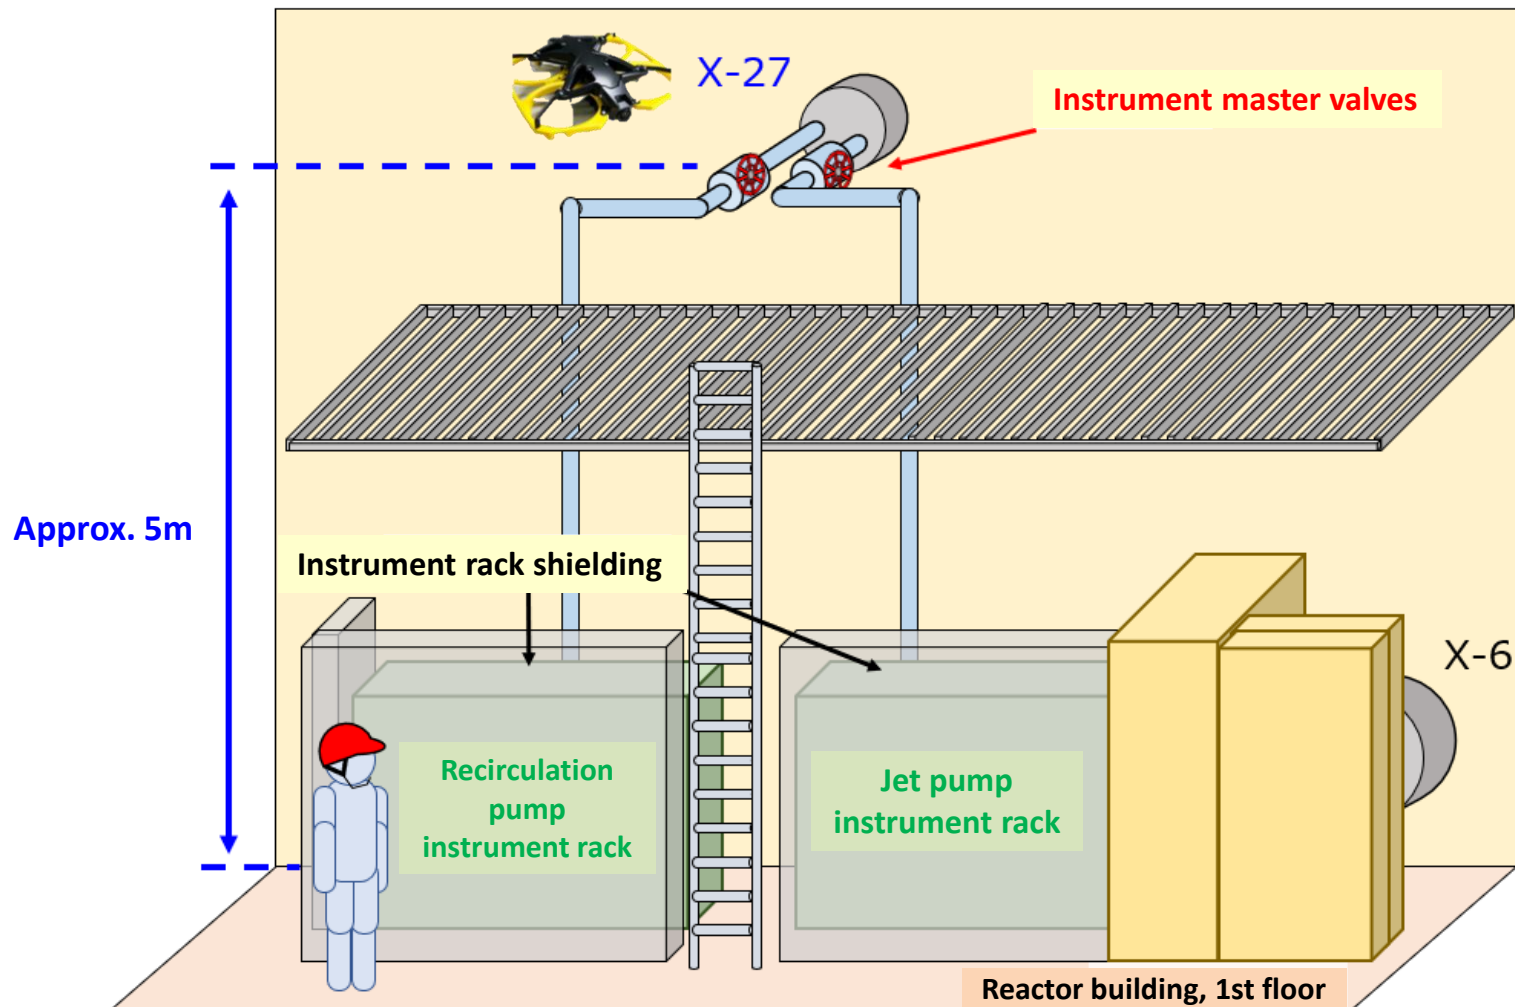
Ex.) Unit 3, 1st floor, X-27

- The penetration is approx. +5m from the floor, and neither the penetration, nor master valves in the vicinity, cannot be directly viewed, so drones will be used to investigate it
- The same is true for the other investigation targets at Units 1 and 3
