Fukushima Daiichi Nuclear Power Station Unit 1

Results of Drone investigation of the inside the reactor buildings

January 29, 2026

Tokyo Electric Power Company Holdings, Inc.

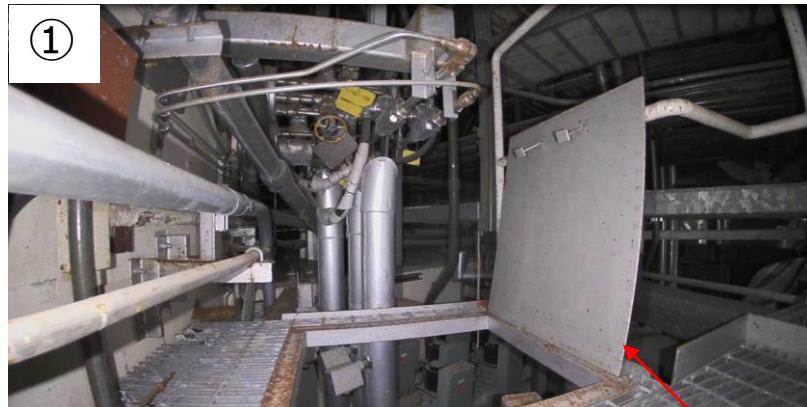
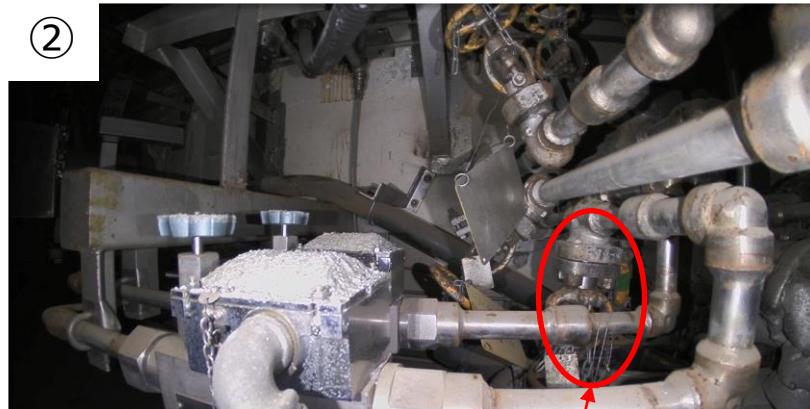
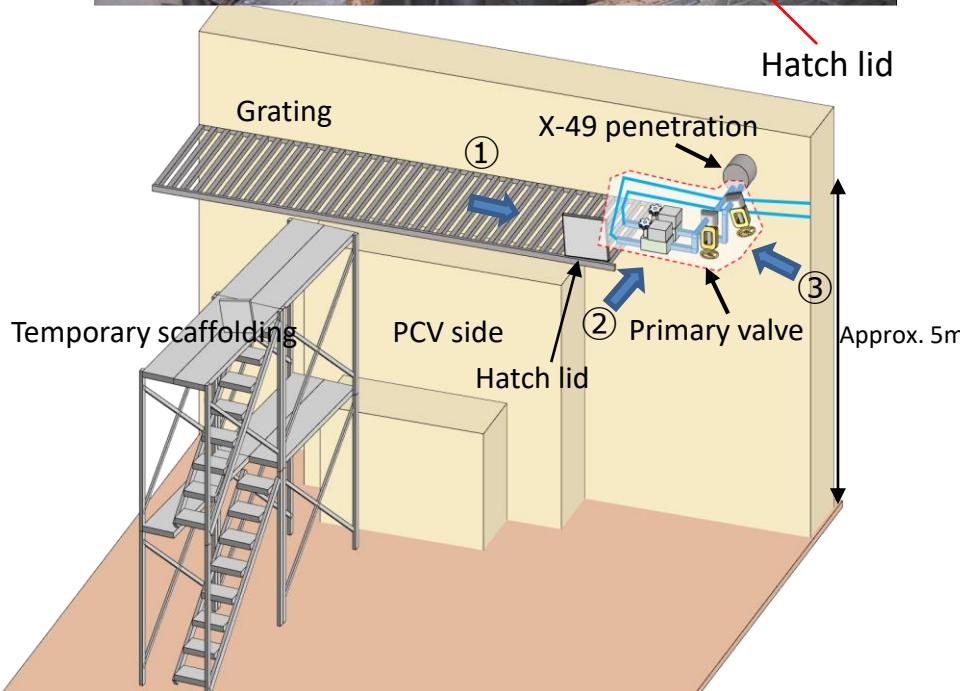
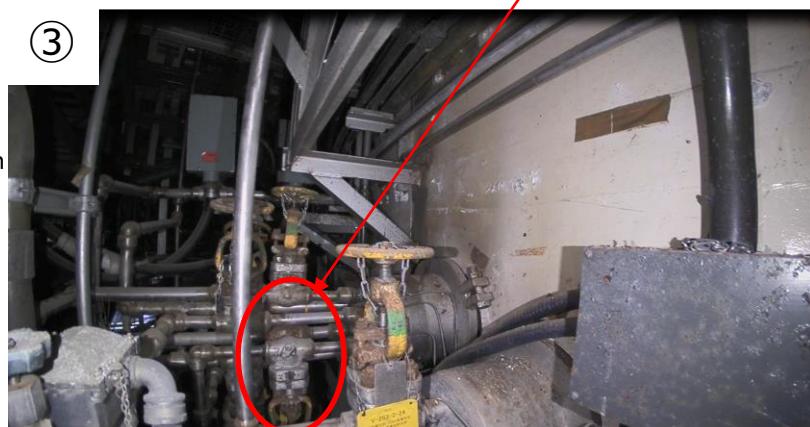
- No remarkable damage, deformation, or excessive corrosion was found on the IC system instrument line primary valve, etc.
- It was also confirmed that there are no remarkable obstructions in the vicinity or along the access route to the aforementioned valve.

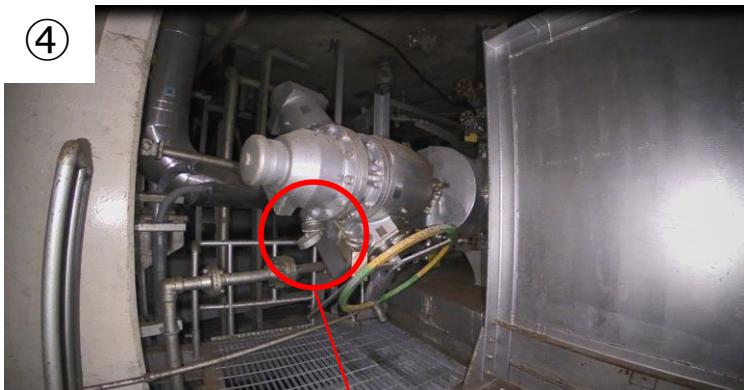
④

- No remarkable damage, deformation or excessive corrosion was found on IC system MO valve (3A),etc.
- It was also confirmed that there are no remarkable obstructions in the vicinity or along the access route to the aforementioned valve.

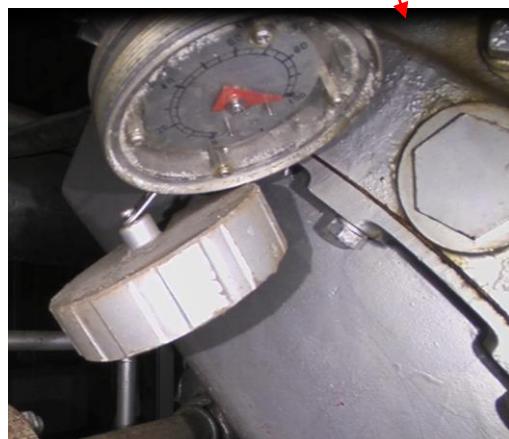
Target of this investigation: MO valve (3A)

3A valve opening angle gauge
(indicates full open)

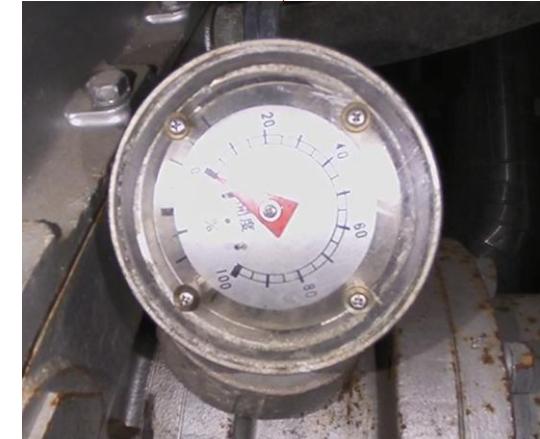
3B valve opening angle gauge
(indicates full open)
