# ALPS Treated Water Discharge Status Update

February 26, 2026

Tokyo Electric Power Company Holdings, Inc.

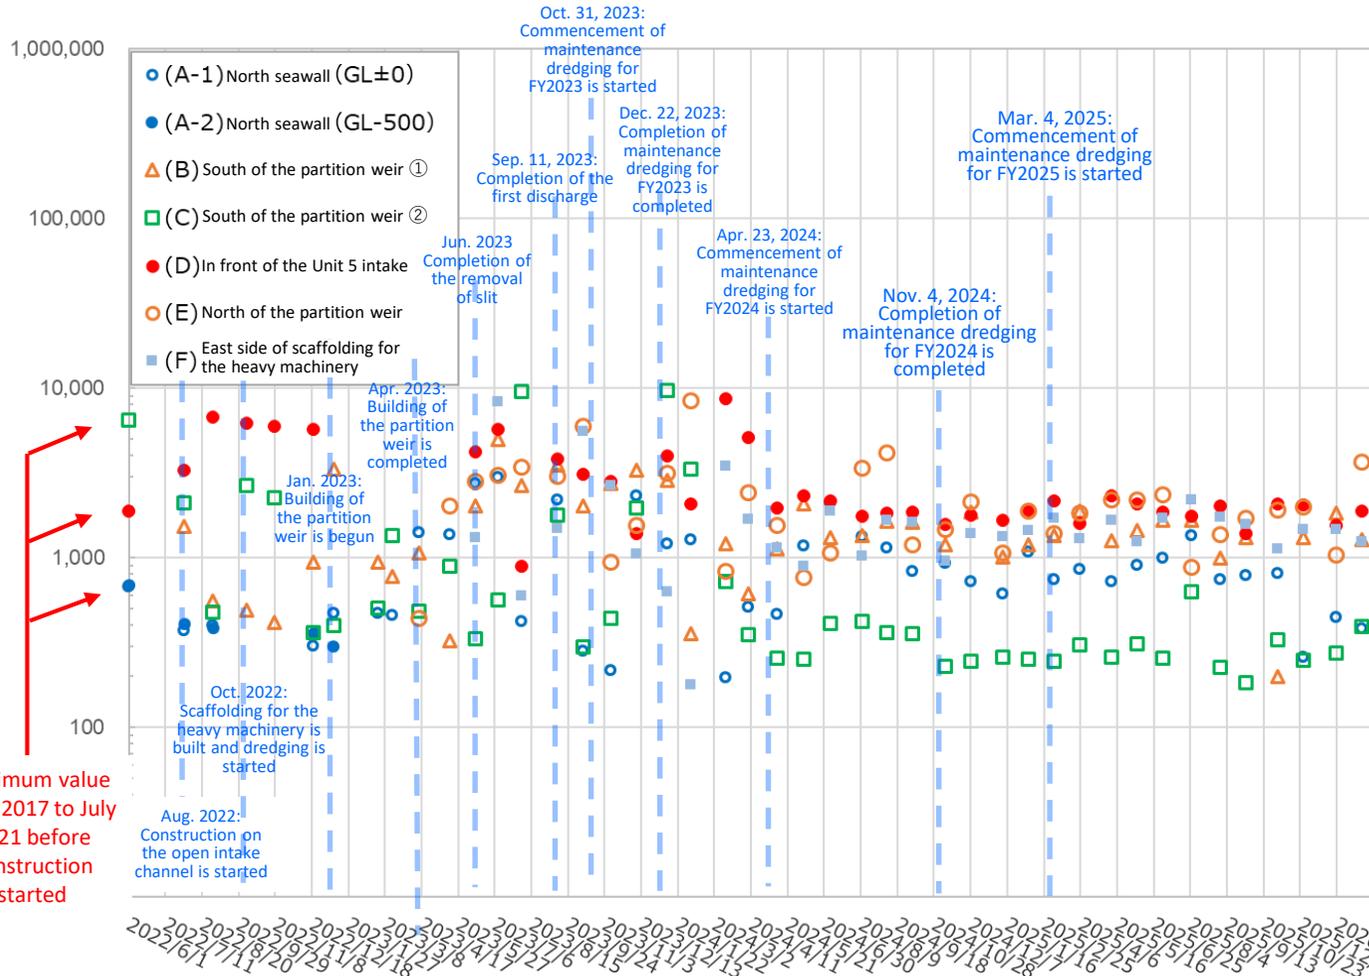
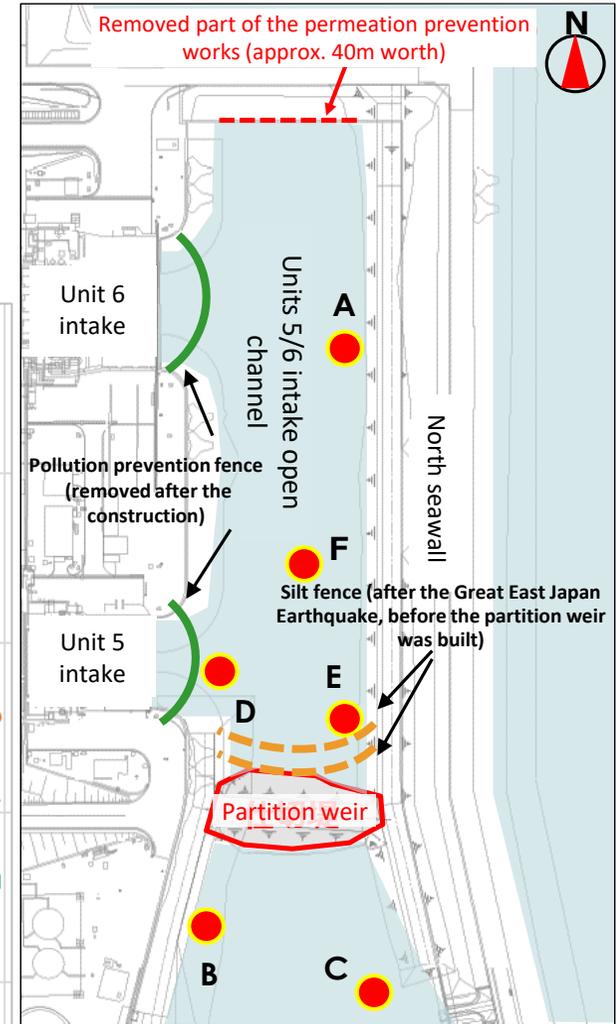
- Monitoring results for seabed soil in front of Unit 5 intake did not show significant fluctuations from the beginning of construction at the intake open channel until December 2022. While they showed higher readings after January 2023, we have confirmed that these readings decreased after the completion of silt removal.
- We will continue to monitor the seabed soil.

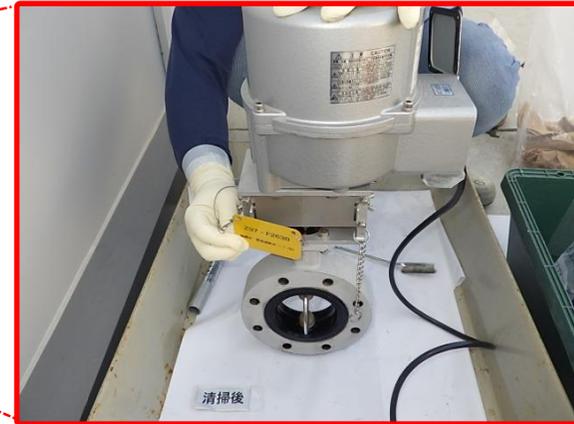
Emergency isolation valve-1 System A  
(after cleaning)

- A disassembly inspection of emergency isolation valve-1 Systems A and B was implemented and no abnormalities such as corrosion were found. Pictures of the disassembly inspection are shown below.

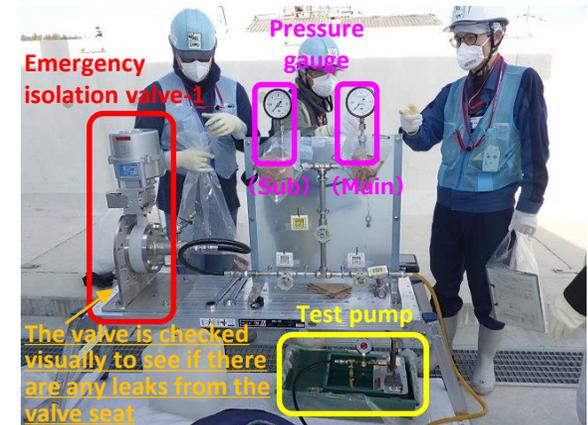
Valve seat leak tests\*

\* With the valve completely closed test pressure was maintained at 1.1MPa (product pressure rating) for more than one minute to see if there were any leaks from the valve seat

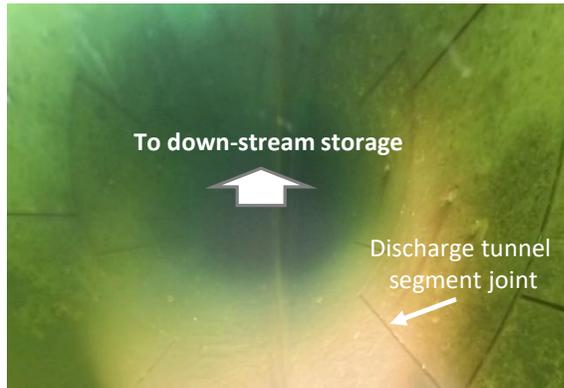
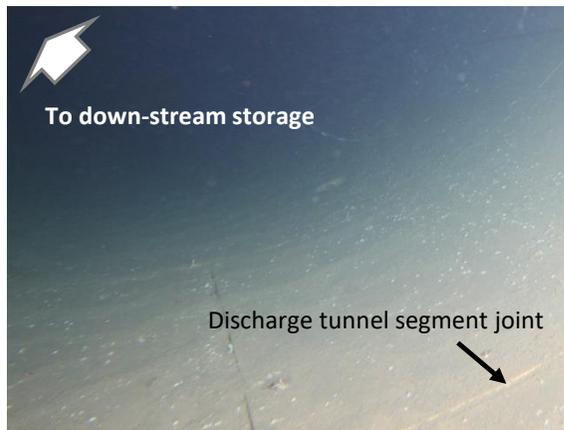
## ① Discharge tunnel conditions (Around 350m from the discharge outlet)

- An inspection of the inside of the discharge tunnel was conducted and it was confirmed that there were no abnormalities.
- A submersible ROV was used to inspect the entire inside of the discharged tunnel (approx. 1,000m), and it was confirmed that the concrete is intact and that sediment and marine organisms' adhesion is minimal and is not affecting water flow.

- No large changes were seen compared to last year
- Sediment is only a few centimeters thick
- Minimum marine organisms' adhesion

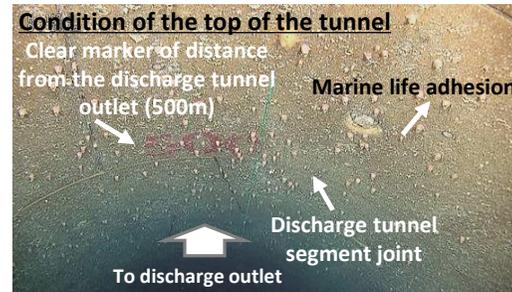
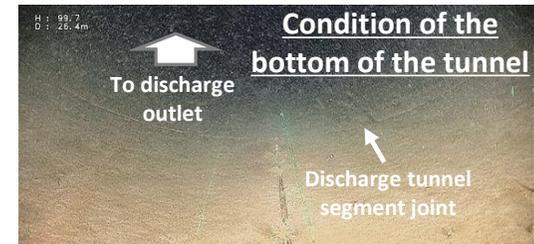
## ② Discharge tunnel conditions (sections not inspected last fiscal year\*) (Approx. 500m from down-stream storage)

- As with other sections no abnormalities were found
- Sediment is only a few centimeters thick
- Minimum marine organisms' adhesion

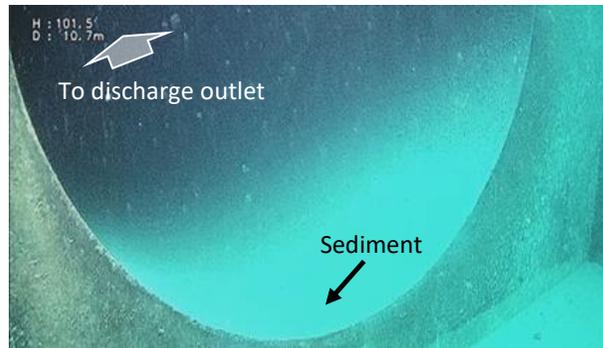
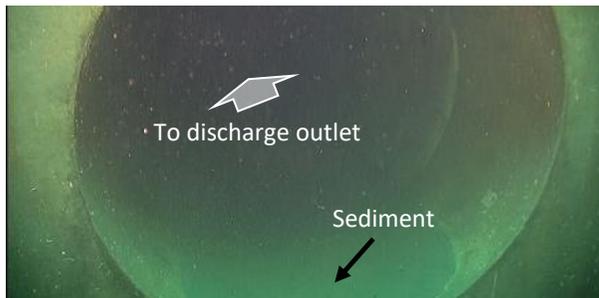
### ③ Discharge vertical shaft (down-stream storage) conditions (Discharge tunnel inlet)

- No large changes were seen compared to last year
- Sediment is only a few centimeters thick at the bottom

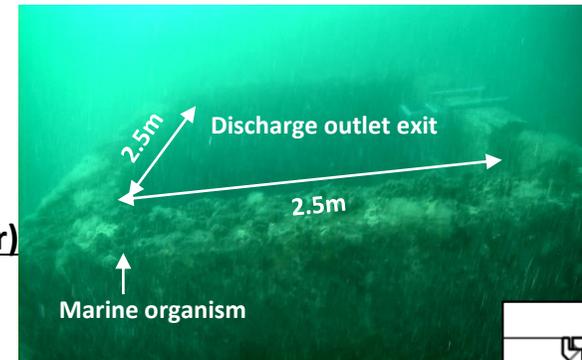
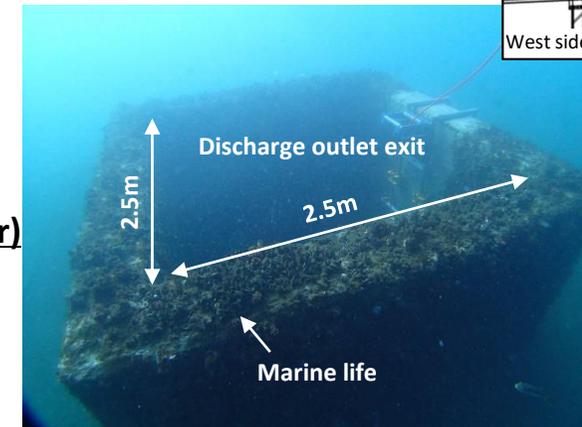
### ④ Discharge outlet conditions (Discharge outlet exit)

- No large changes were seen compared to last year
- Sediment is only a few centimeters thick

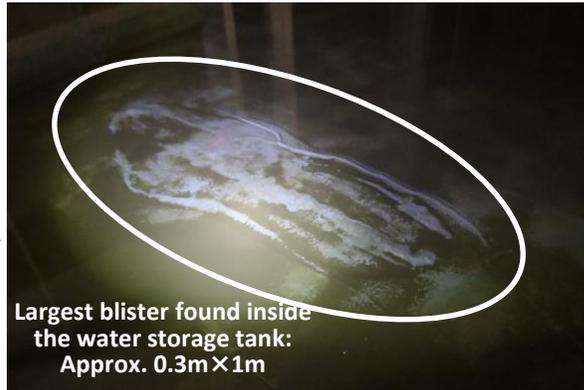
**Prior to repairing blisters inside the water storage tank (at the bottom)**

- The sealant on the inside of the upper-stream storage was repaired and the tank filled with water to confirm water tightness<sup>※</sup>
  - Sealant blistering was repaired by cutting out the blister, draining it, drying it, and then reapplying sealant
