Fukushima Daiichi Nuclear Power Station Unit 3 PCV Internal Investigation (non-submerged area) using Micro-drones

February 26, 2026

Tokyo Electric Power Company Holdings, Inc.

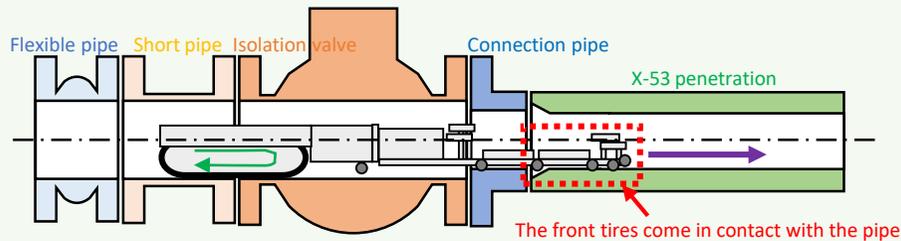
① : Front of the device moves into the X-53 penetration

When the connection pipe and X-53 penetration are aligned correctly

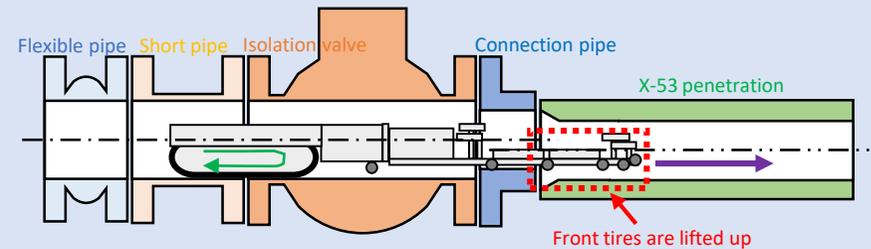
① : Front of the device moves into the X-53 penetration

- However, when there is misalignment between the connection pipe and the X-53 penetration as in the actual insertion pipe, **the front of the insertion device becomes cantilevered** when it reaches the X-53 penetration. As a result, **the load concentrates on the middle tires, preventing the device from overcoming the step and causing it to become caught.** This is considered to have been the cause of the event.

When the connection pipe and X53 penetration are misaligned

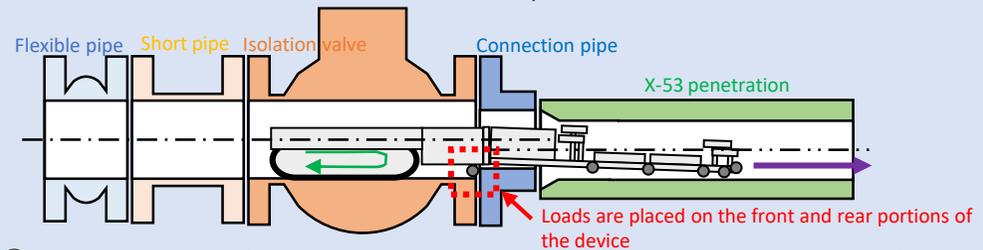
② : Middle tires hit the aforementioned step

- The results of the insertion device running tests showed that when the connection pipe and the X-53 penetration are misaligned, **the middle tires of the device get caught on the step between the isolation valve and the connection pipe.**

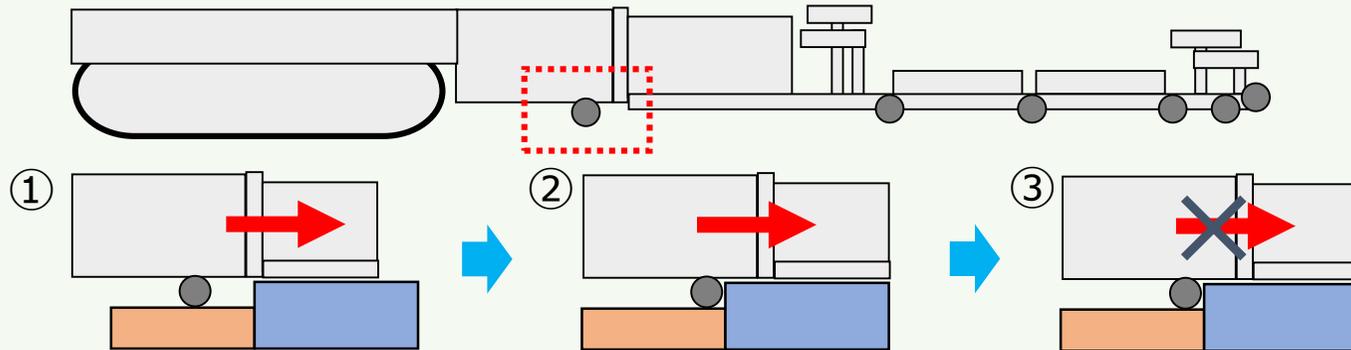
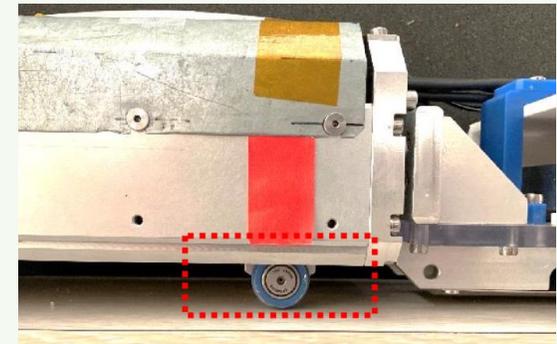
Tires in the mid-section of the device before improvement (Photograph of the model)

[Prior to improvement] Only two middle tires (one on each side)

Since the step must be overcome by a single tire, the device is more susceptible to the effects of snagging.

- The middle tires have been redesigned so as to mitigate the chance of getting caught on the step between the isolation valve and the connection pipe.

- Five tires have been arranged in an arch to enable steps to be smoothly overcome and mitigate any impact that this step will have when the device is passing over it.

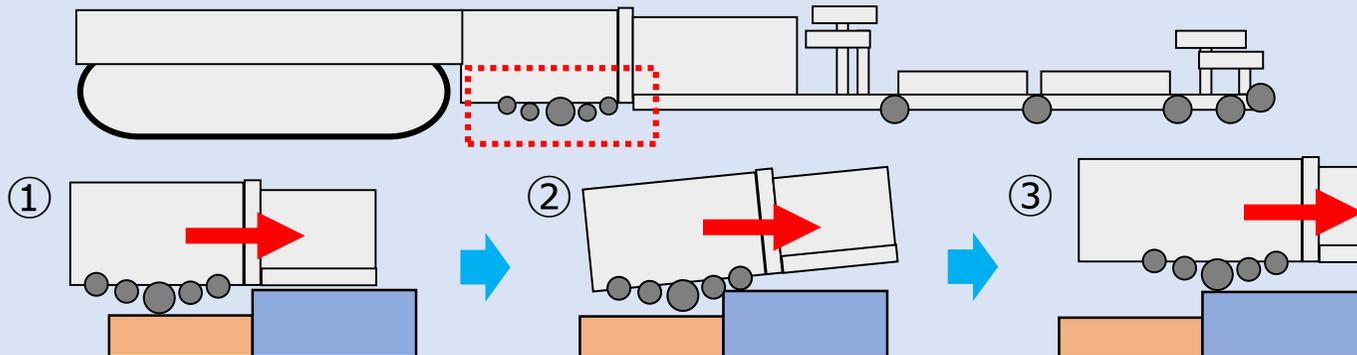
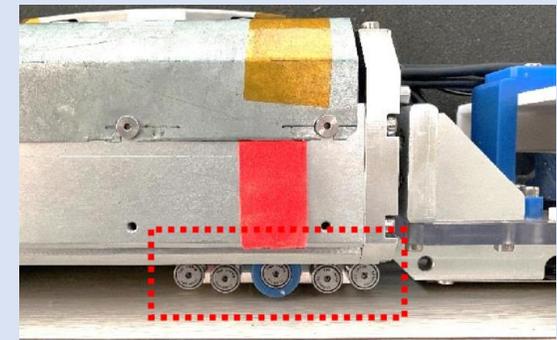
Tires in the mid-section of the device after improvement (Photograph of the model)

[After improvement] There are now 10 middle tires (five on each side)

By having multiple tires overcome the step in stages, the effects of snagging are mitigated.

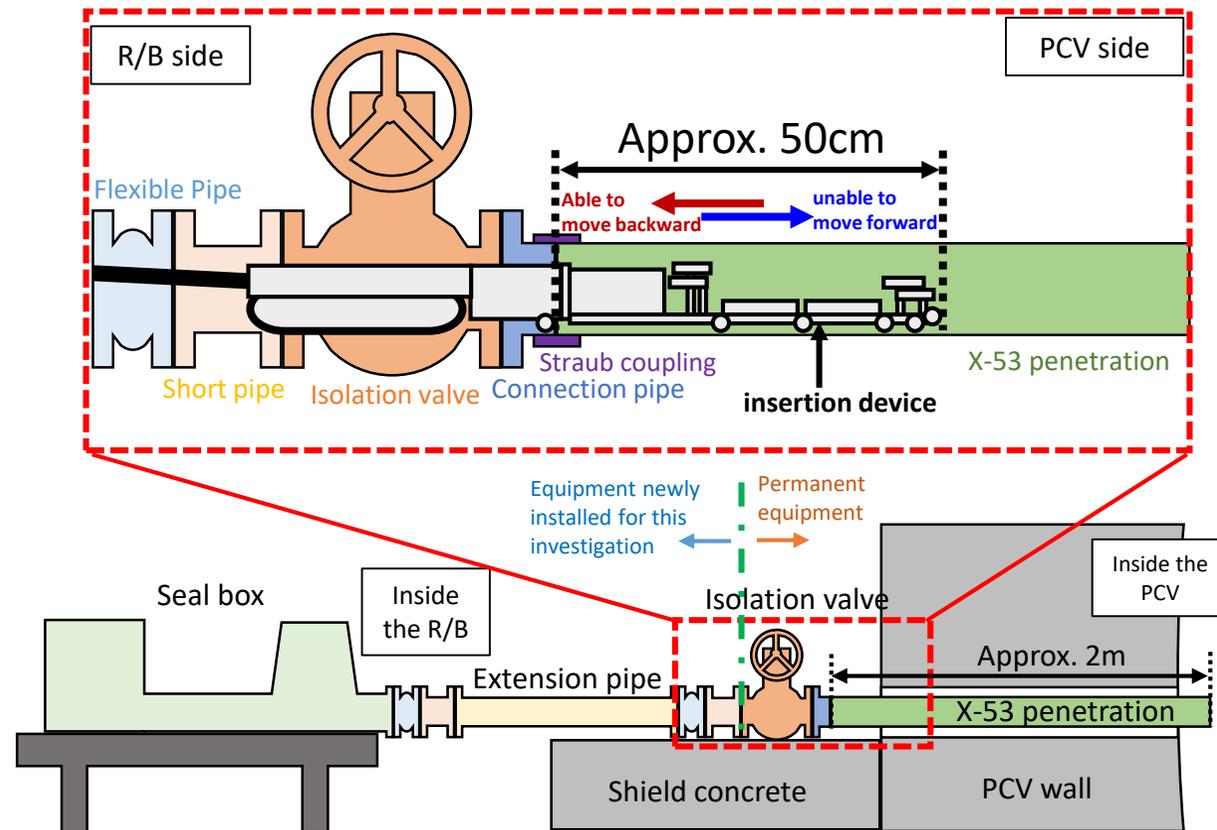
Diagram showing the unable to move the insertion device forward

- When conducting function tests of the investigation device it suddenly became impossible to move the insertion device forward inside the X-53 penetration.
- Several attempts were made at insertion, but the device was unable to move forward past a certain point (approximately 50cm into the X-53 penetration).
- The device could be moved backwards, so normal procedures for withdrawal were conducted and the insertion device was returned to the seal box (Since the device was withdrawn to the seal box, the isolation valve, which is the PCV boundary, did not have to be opened or closed).

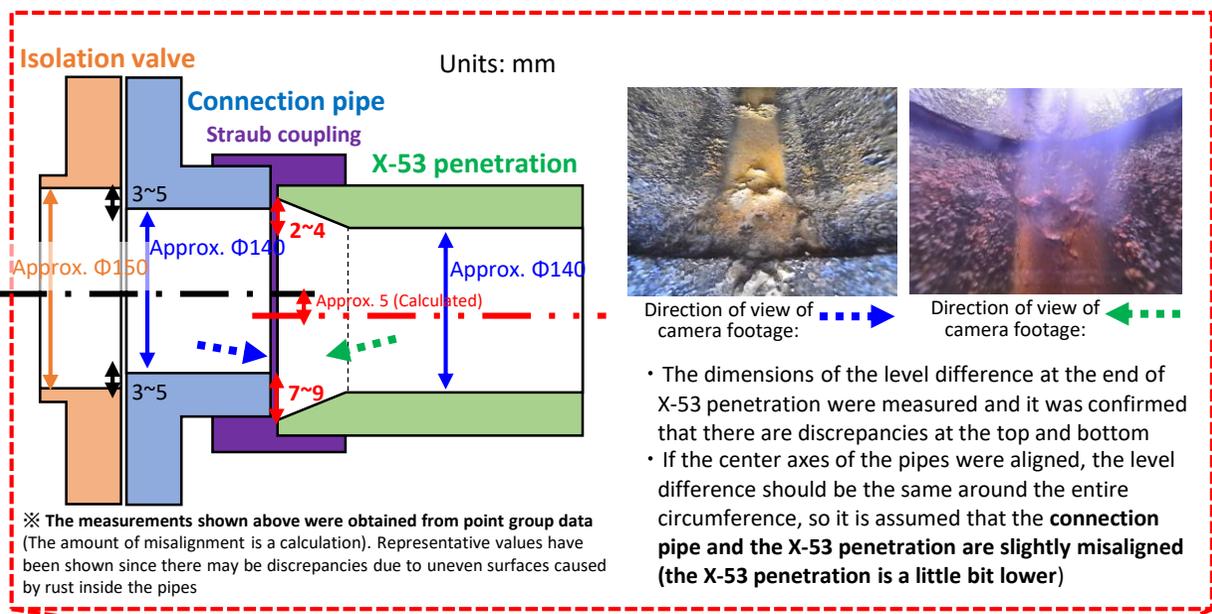
- Analysis of obtained footage (footage from point grouping) shows that the center axes of the **connection pipe and X-53 penetration are slightly misaligned.** ※1
- From these results we assume that the reasons why the insertion device cannot move passed this point is because the **cross-sectional area of the pathway becomes smaller and the crawler loses grip.** ※2
- Going forward, the obtained data will be further analyzed in detail and countermeasures deliberated.

- The dimensions of the level difference at the end of X-53 penetration were measured and it was confirmed that there are discrepancies at the top and bottom
- If the center axes of the pipes were aligned, the level difference should be the same around the entire circumference, so it is assumed that the **connection pipe and the X-53 penetration are slightly misaligned (the X-53 penetration is a little bit lower)**

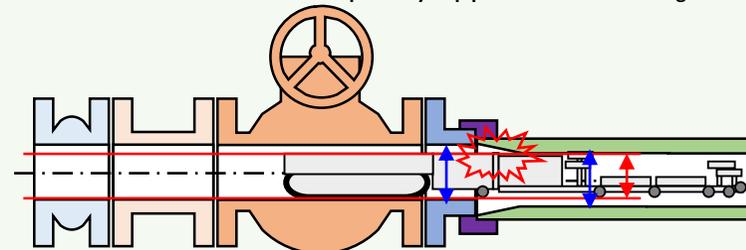
Reduction in cross-sectional area of pathway as pipe core becomes misaligned

- Reduction in cross-sectional area in longitudinal direction as pipe center axes becomes misaligned (red arrow)
- If the system is designed based on the minimum pipe diameter (blue arrow) then the device will not be able to pass the point where the cross-sectional area becomes narrower

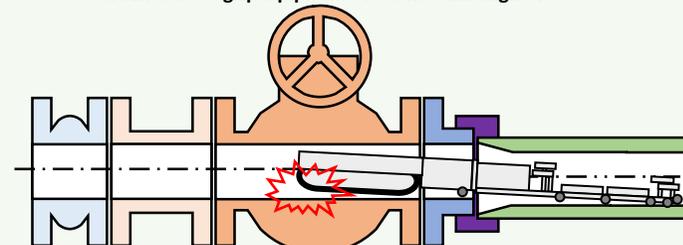
Crawler loses grip a pipe core becomes misaligned

- The entire X-53 penetration is lower, relatively, due to the misalignment
- After the front of the device passes through the X-53 penetration, it tilts downward forcing the crawler to lift and lose grip thereby making it unable to move forward any further
