# Fukushima Daiichi Nuclear Power Station Unit 3 PCV Internal Investigation (non-submerged area) using Micro-drones

August 27, 2026

Tokyo Electric Power Company Holdings, Inc.

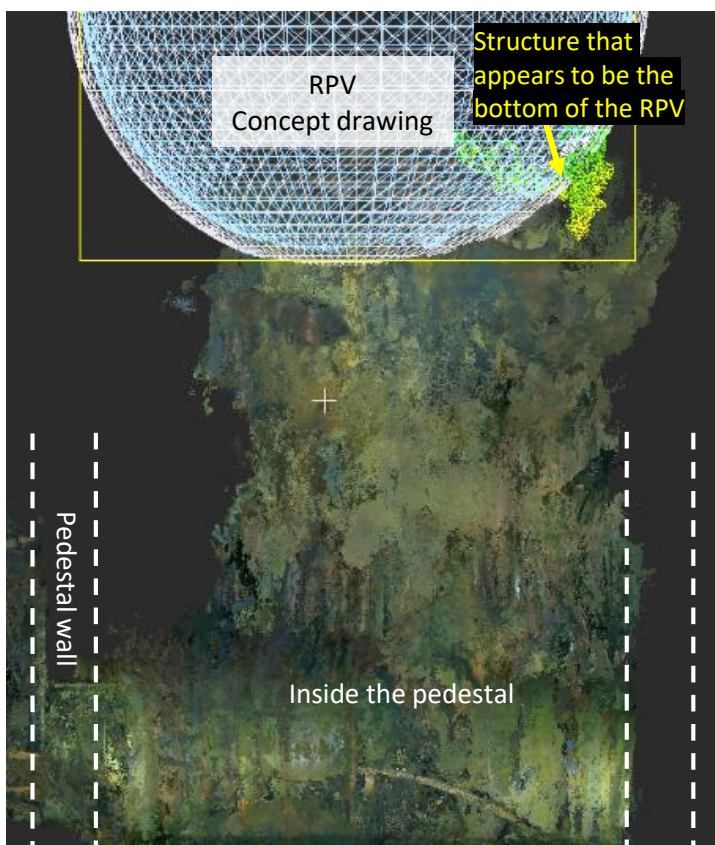
- After using the generated point cloud data to assess the dimensions of the objects seen in the footage, we have confirmed that **the structure that appears to be the bottom of the RPV is consistent both in location and thickness with the dimensions of the bottom of the RPV as shown in schematics, and it is highly likely that they are the same structures.**
- **The space at the bottom of the RPV is oval in shape and we estimate that its maximum diameter is approximately 3m.**
- Since the maximum flight height of the drone was approximately 9.4 meters from the bottom of the pedestal, we estimate that the drone temporarily flew inside the RPV.

Positional comparison of structure that appears to be the bottom of the RPV (green)

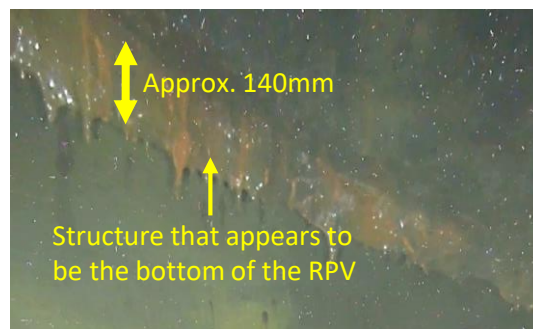
Thickness of the structure that appears to be the bottom of the RPV

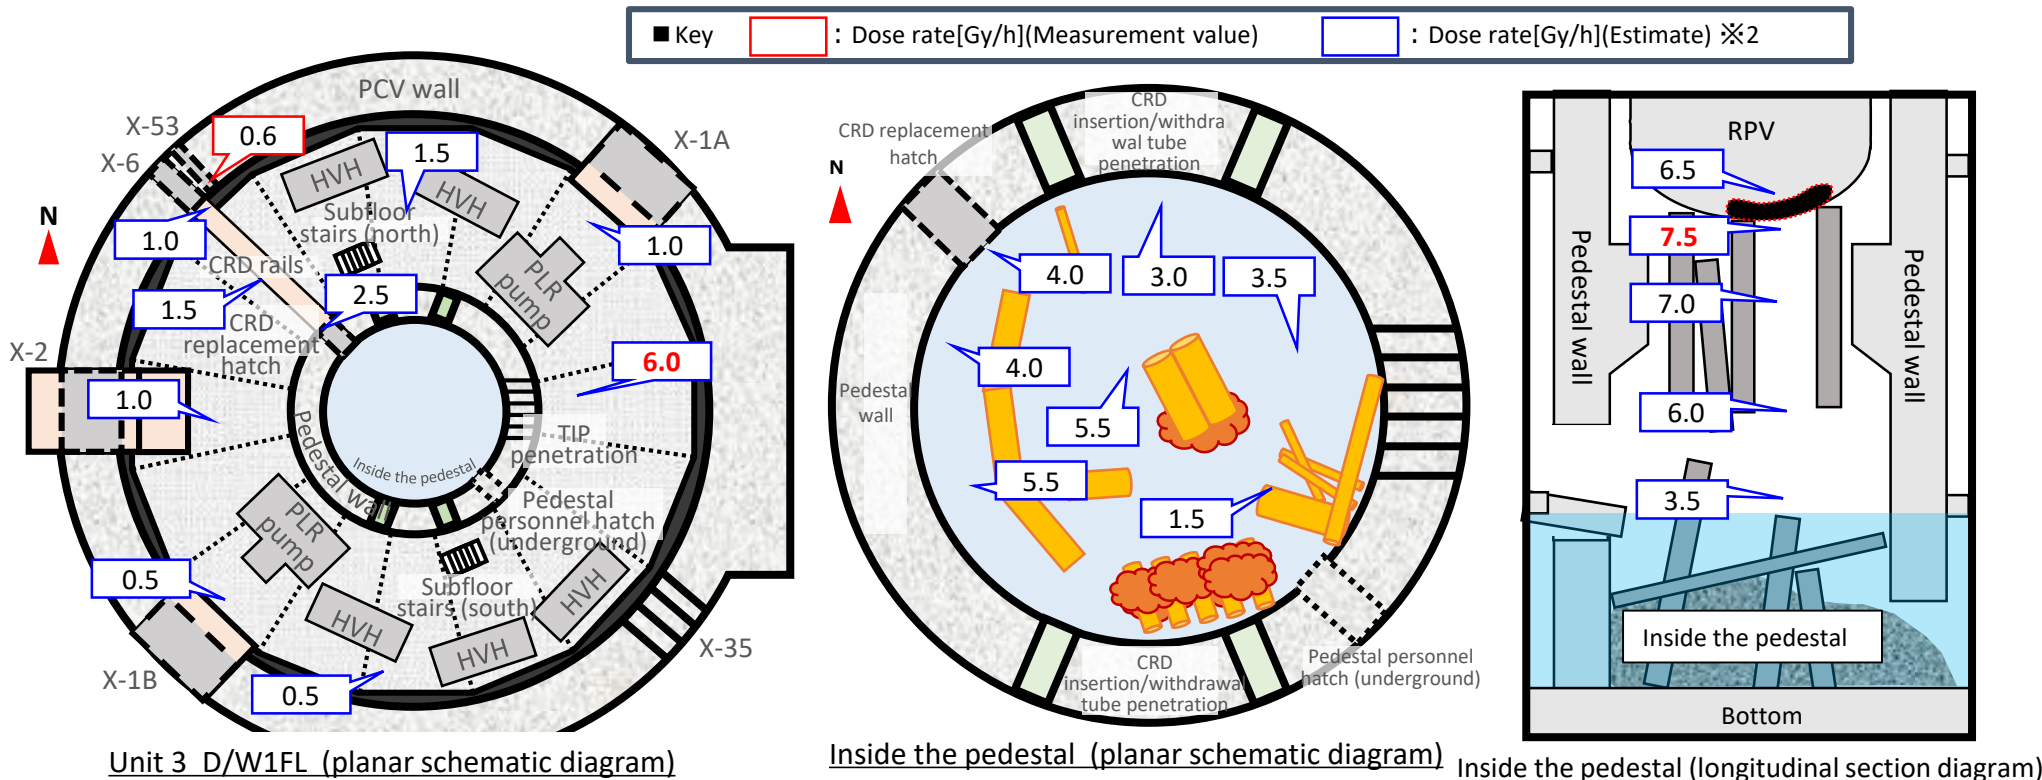
- Dose rates outside the pedestal were estimated to be between approximately 0.5-6.0Gy/h, and highest on the east side.** The reason why dose rates are high on the east side is being deliberated. (The dose rates may be affected by MS system piping or the migration of radioactive substances caused by the flow of water from inside the PCV)

- Dose rate estimates for the inside of the pedestal were between approximately 1.5-7.5Gy/h, and the highest dose rates were found around the bottom of the RPV.** Since dose rates increase as we approach deposits or adhesions, it is estimated that these are significant radiation sources.

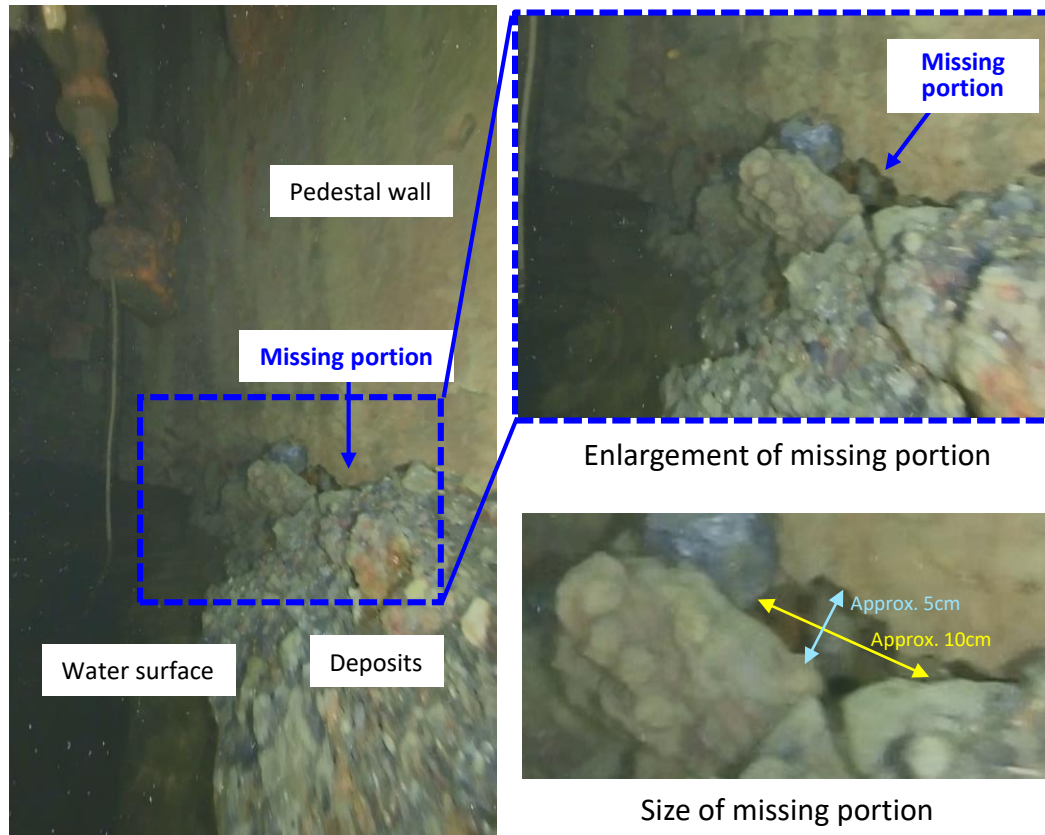
- During examination of the point cloud data we found that a portion of the pedestal wall is missing.
- The missing portion is approximately 10cm x 5cm in size, and the estimated location is approximately three meters from the floor on the south-southeast side of the inside of the pedestal (estimate).
- The footage was reviewed again to look for other missing portions of the wall, but none could be found within the scope of the footage taken.
- Since only a portion of the wall is missing, we believe that the impact on pedestal integrity is minimal, but this location will be the target of future investigations in order to expand our knowledge.

Missing portion of pedestal wall

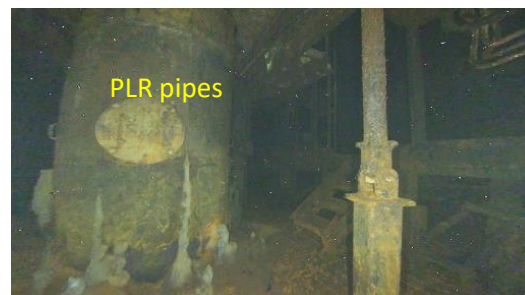
①: Outside the pedestal (Northwest area)

- **Equipment/ obstructions:** No large scale damage or obstructions were seen (rust and fallen insulation was found)
- **Flight route:** With the exception of the southeast area where a signal strength was poor, flights were flown in the clockwise and counterclockwise directions on the first floor of D/W

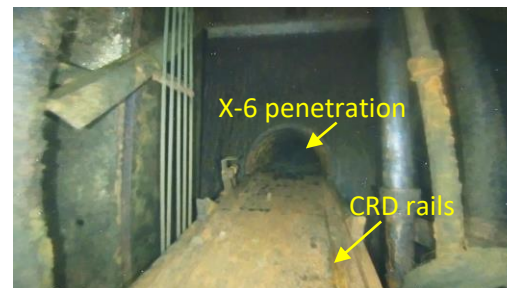
① : External view of the X-6 penetration

- **X-6 penetration:** No obstructions were seen around the penetration. There are cables around the inside of the entire penetration, but no deposits like those found at Unit 2 were seen in the scope of the footage.
- **CRD rails:** No significant damage or obstructions were found but an uneven surface was seen
- **CRD replacement hatch:** No obstructions were found in the vicinity of the hatch

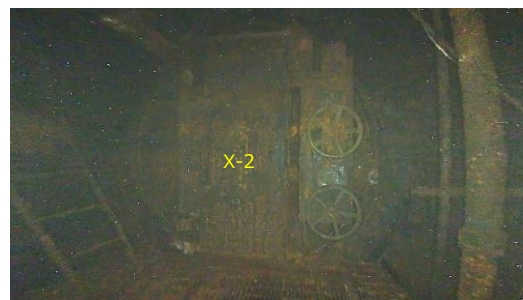
① : X-2 penetration

- **X-2 penetration, X-1B penetration: No damage, deformation of the penetration or obstructions were found**
- **CRD insertion/withdrawal tube (south): No damage or deformation of the southwest side pipes were seen.** Signal strength on the southeast side is poor and flights could not be flown so this area was not investigated
- **Subfloor stairs (south): No damage or deformation of the stairs or obstructions was seen**
- **X-35 penetration:** Signal strength in the southeast area outside the pedestal was poor thereby preventing any flights from being flown.

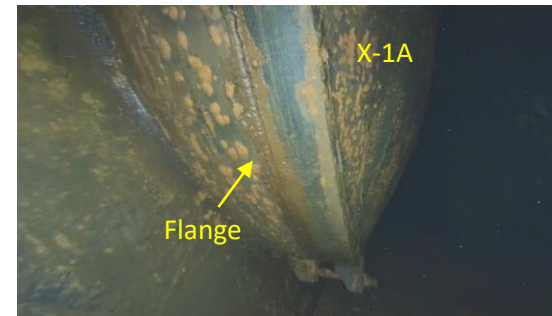
① : X-1A penetration (Flange)

- **X-1A penetration: No damage, deformation of the penetration or obstructions were found**
- **CRD insertion/withdrawal tube (north): No damage or deformation of the pipes on the northwest or northeast sides**
- **Subfloor stairs (north): No damage or deformation of the stairs or obstructions was seen**

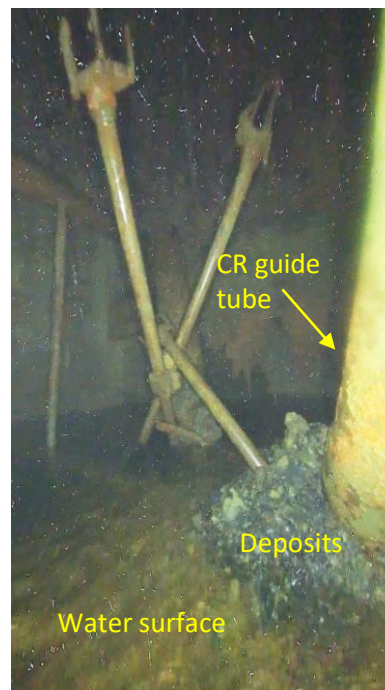
- **Deposits:** Deposits were found at the bottom of the CRD guide tubes in the center. It is assumed that some exist underwater.
- **Fallen structures:** CRD guide tube, which are RPV internal structures, were found
- **CRD replacement machine ancillary equipment:** The platform was found to be tilted. The footage is currently being reviewed to look for other pieces of equipment
- **PCV water levels:** By comparing the height of the water surface with the height of structures we confirmed that water level is approximately the same as the water level in the PCV calculated from the S/C pressure gauge. (The water level outside the pedestal is also approximately the same)

① : Deposits

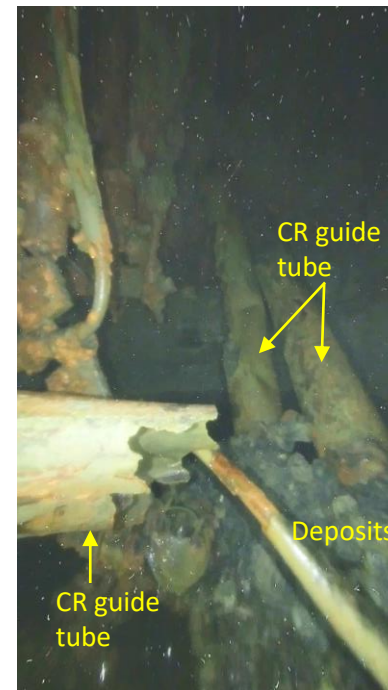
② : Fallen structures

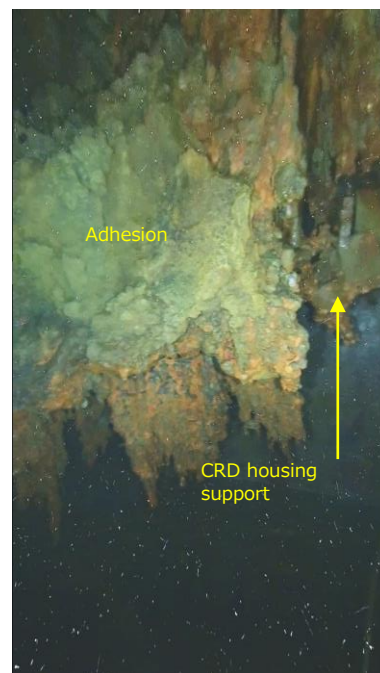
- **Adhesions:** Clump-like adhesions were seen on the south side of the CRD housing group
- **Pedestal wall surface:** No remarkable damage was seen within the scope of the footage
- **TIP penetration:** Damaged TIP guide tubes were found
- **Fallen structures:** Part of the CRD housing group, which is a structure at the bottom of the RPV, was found to be tilted, and slightly lower than its original position.

① : Adhesion

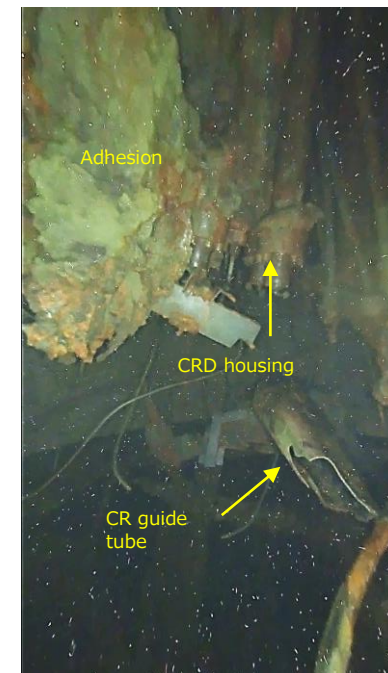
③ : Fallen upper structures (CRD housing group)

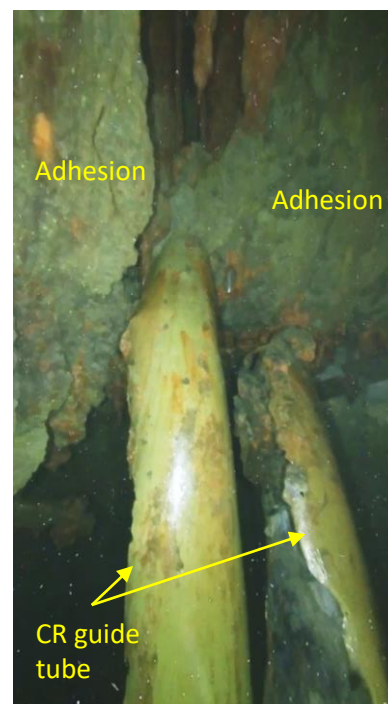
① : Bottom of arrow

- **Adhesions:** Clump-like adhesions were seen on the CRD housing group near the center and southeast side
- **CRD housing group:** Although the CRD housing group is tilted and deformed, most of it remains in its original position. **There is a space towards the top from the center to the southeast**
- **CRD insertion/withdrawal tube:** Only the southeast portion could be photographed and **damage to the pipes was seen**

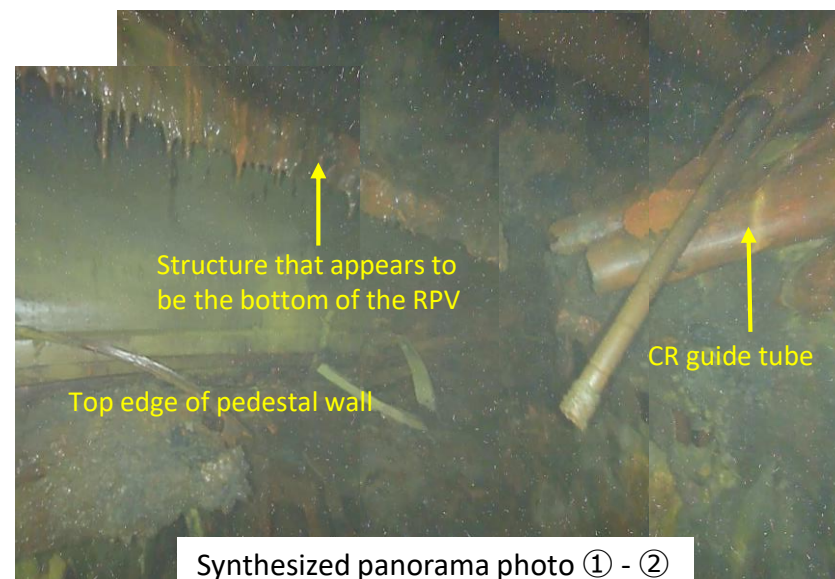
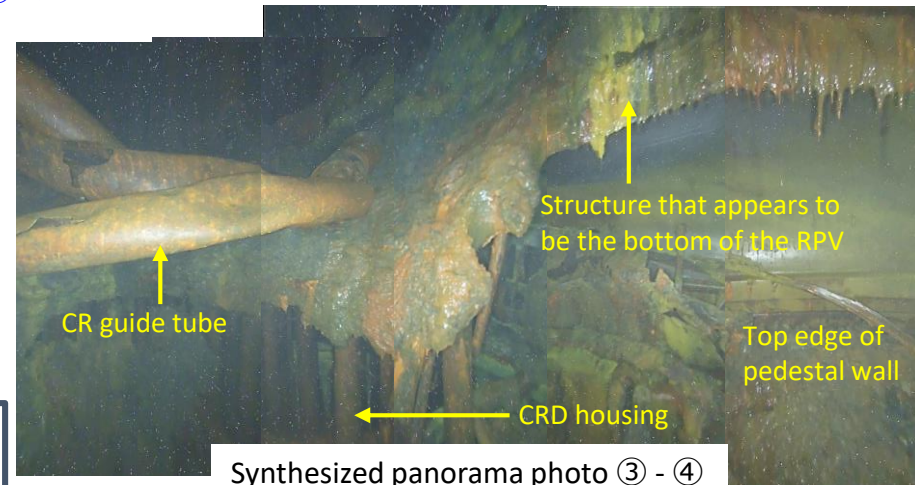
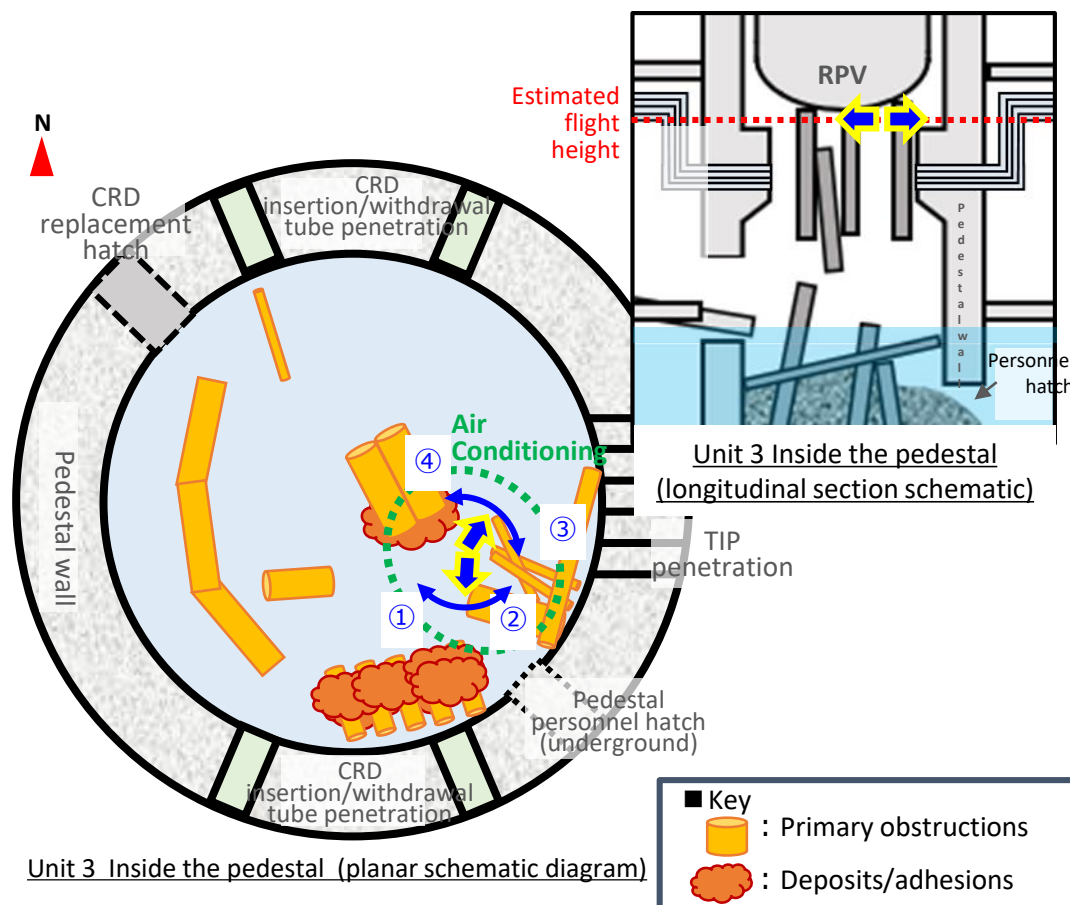
- The drone was flown from the space identified during the investigation of the top until the height possible with the available signal strength and footage of the area near the bottom of the RPV was acquired
- A structure that appears to be the bottom of the RPV and CRD guide tubes lying about where seen
- It is also assumed that there is a space at the top
