**<Status Report>**  
**Status of General Inspections Implemented  
after Discovering Partial Incompletion of Safety  
Measure Renovations at Kashiwazaki-Kariwa  
Nuclear Power Station Unit 7**

September 22, 2021  
Tokyo Electric Power Company Holdings, Inc.

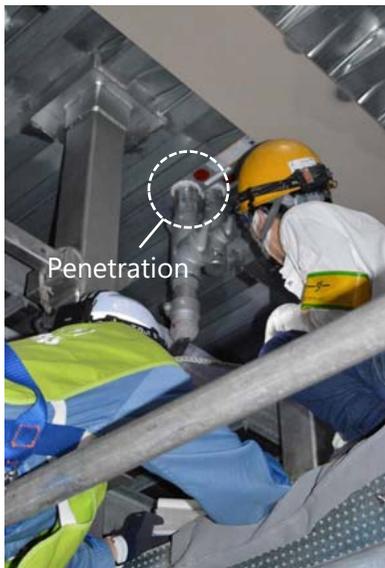
Penetrations in high areas are checked by assembling scaffolding

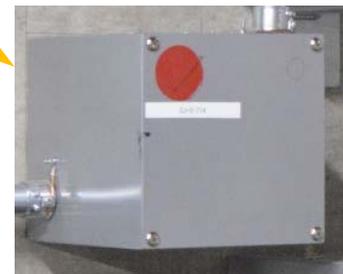
Marked metal box

- ✗ Penetrations requiring fire protection measures are given a **red circle**
- ✗ Penetrations requiring flood protection measures are given a **blue circle**
- ✗ Penetrations requiring neither measures are given a **black circle**

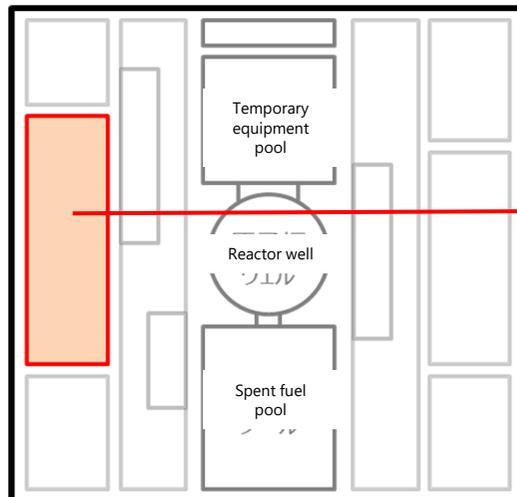
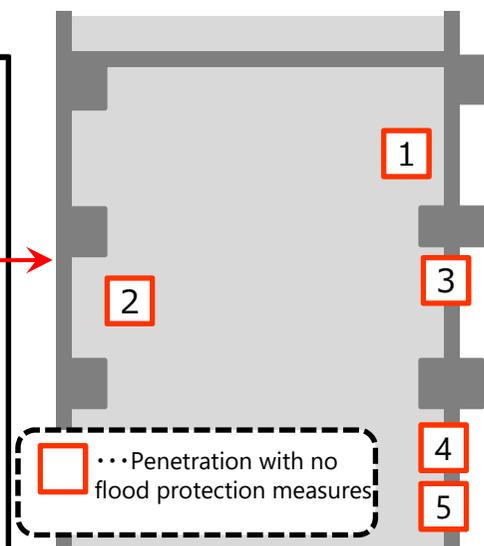
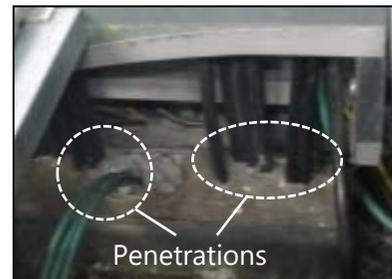
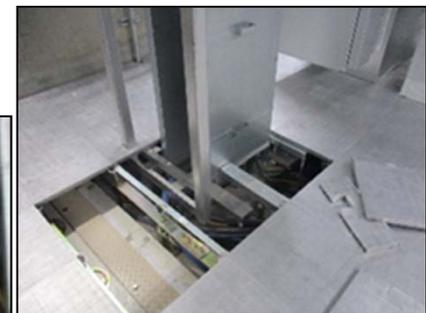
Unit 7 Reactor Building 3MF (plan view)

Renovation details	Occurred location	Common process-related problems
Flood protection measures <b>(Similar to type ③ on Slide 7)</b>	Wall and floor penetrations at 3MF of Unit 7 Reactor Building (5 locations)	Schematics of flood protection zones should have been compared between design management departments and work management departments of TEPCO

**All locations are under the floor and are difficult to be directly viewed**

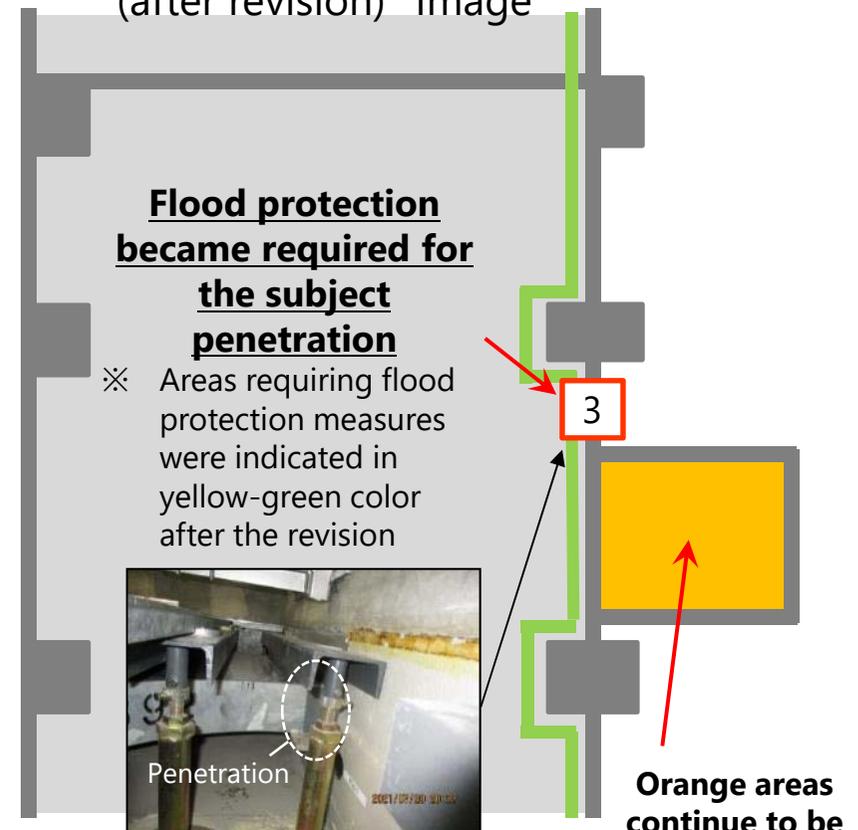
Flood protection demarcation map (after revision) \*Image

- The design management departments presented the materials on the revision of the flood protection demarcation map to the work management departments but they did not explain it in detail.
- The work management departments did not check the details of the revision with the design management departments, and incorrectly determined the penetration as not subject to flood protection measures.

Wall penetration (under the floor)

Orange areas continue to be subject to floor protection

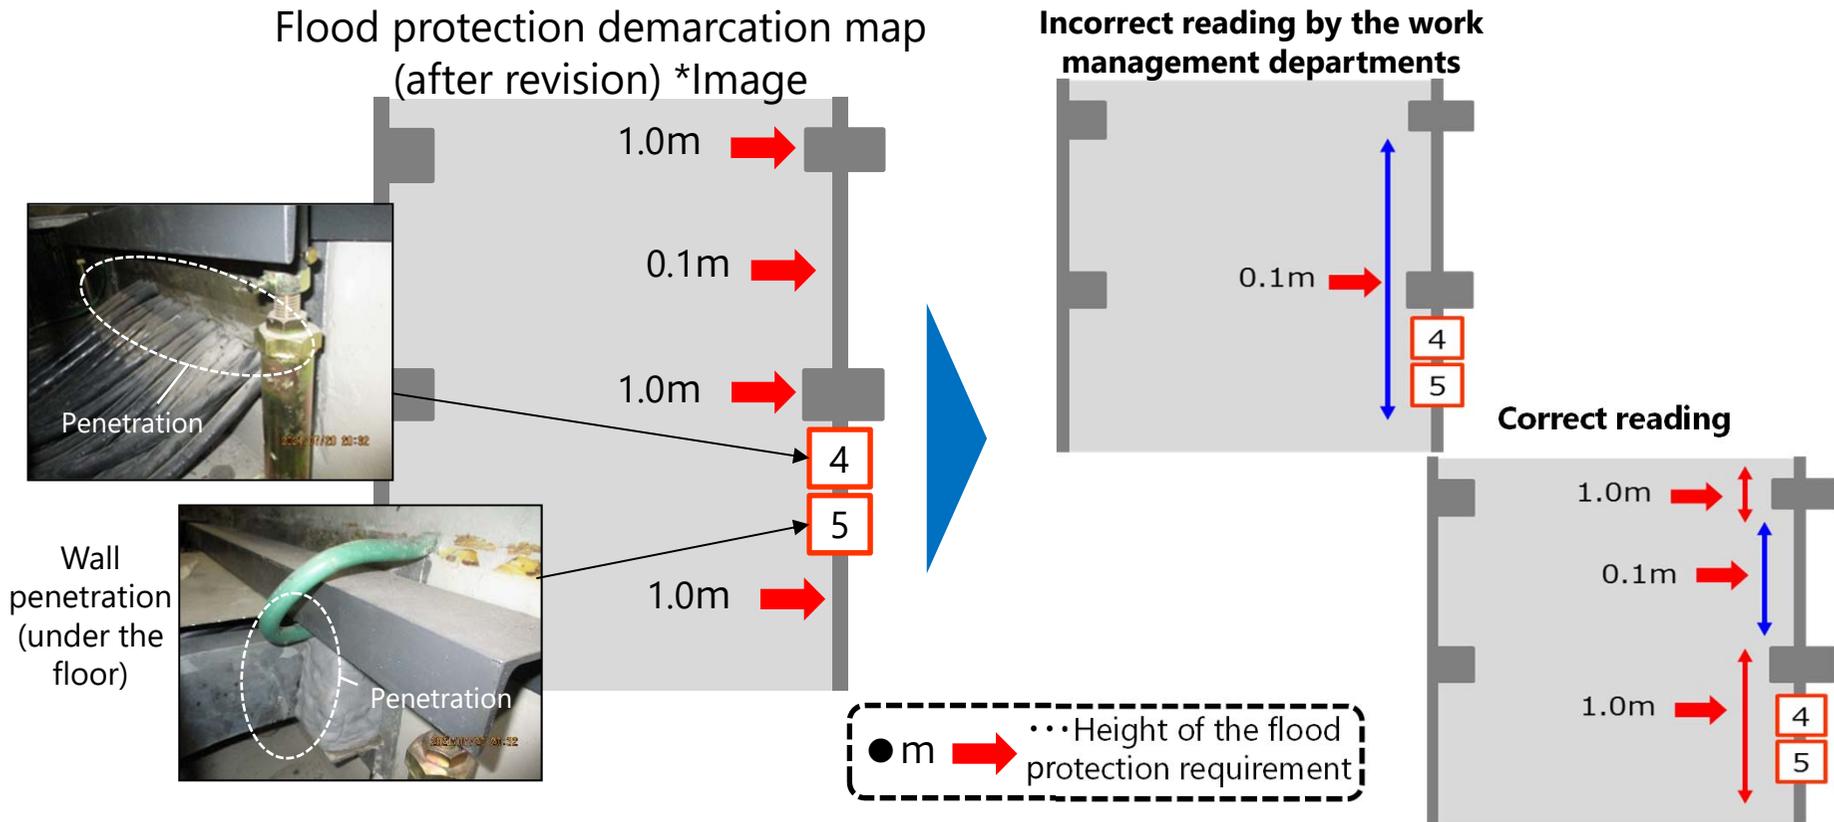
- The design management departments held a briefing on the revision of the flood protection demarcation map, but they did not thoroughly check whether the work management departments correctly understood the revision
- The work management departments did not check the details of the revision, and thus, incorrectly determined the subject penetrations as not subject to flood protection measures

- ✓ When the design management departments revised the flood protection demarcation map, they set the flood protection requirement of the wall that included penetrations 4 5 as "able to withstand flooding of 1.0m" (=requiring flood protection measures)
- ✓ The work management departments incorrectly read the waterproofing requirement of the subject wall as "0.1m" (=not requiring flood protection measures), which caused the renovation to be overlooked

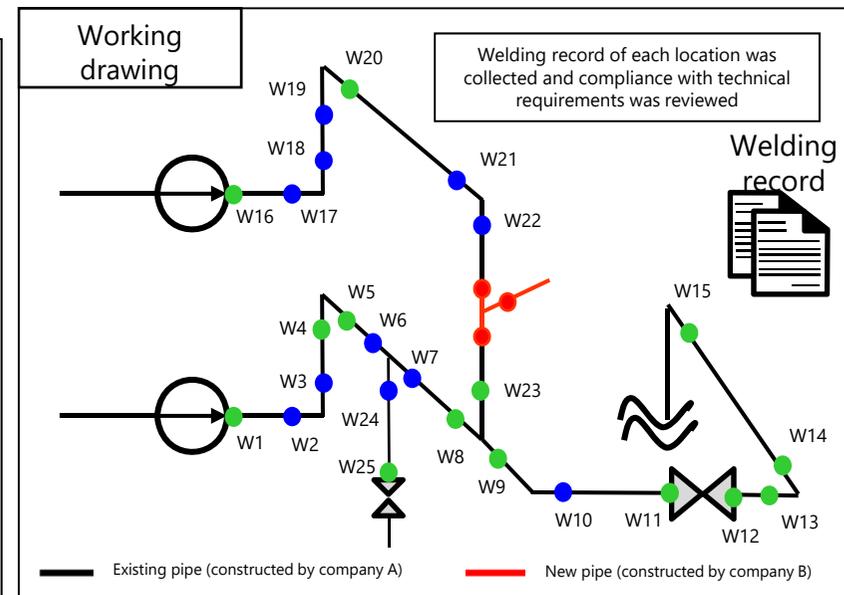
- ✓ TEPCO did not detect it as a problem that the inspection records submitted by contractors did not comply with the requirements (mechanical tests not performed / different nondestructive inspection)
- ✓ Misrecognized as not subject to the technical requirement compliance review since the record forms received from contractors were the same as those used for the welding contractor inspection
- ✓ Misrecognized as welds subject to the technical requirement compliance review and not subject to said review both existed on a single component (section)
- ✓ Identification was overlooked as multiple members divided up the work
- ✓ Both TEPCO and contractors determined that additional assessment was unnecessary, but assessment documents should have been created based on confirmation by expert welding organizations

※ ● ● ● in the welding drawing are welded areas. ● has undergone welding contractor inspection, ● has undergone technical requirement compliance review, ● requires welding contractor inspection based on the technical requirement compliance review

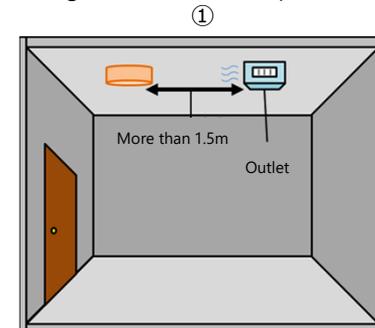
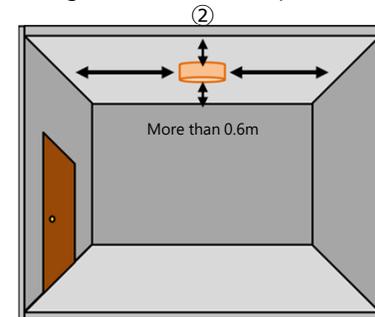
Image of installation requirement

- ① Install the detector more than 1.5m from the air outlet of the ventilation port. However, if the outlet is located more than 1m from the ceiling on a wall, the detector may be installed within 1.5m from the outlet.
- ② Install the smoke detector more than 0.6m from the wall or beam.
