Impact of the Niigata Chuetsu-oki Earthquake on the Tokyo Electric Power Company (TEPCO) Kashiwazaki-Kariwa Nuclear Power Station and Countermeasures

September 2007

The Tokyo Electric Power Company, Inc.

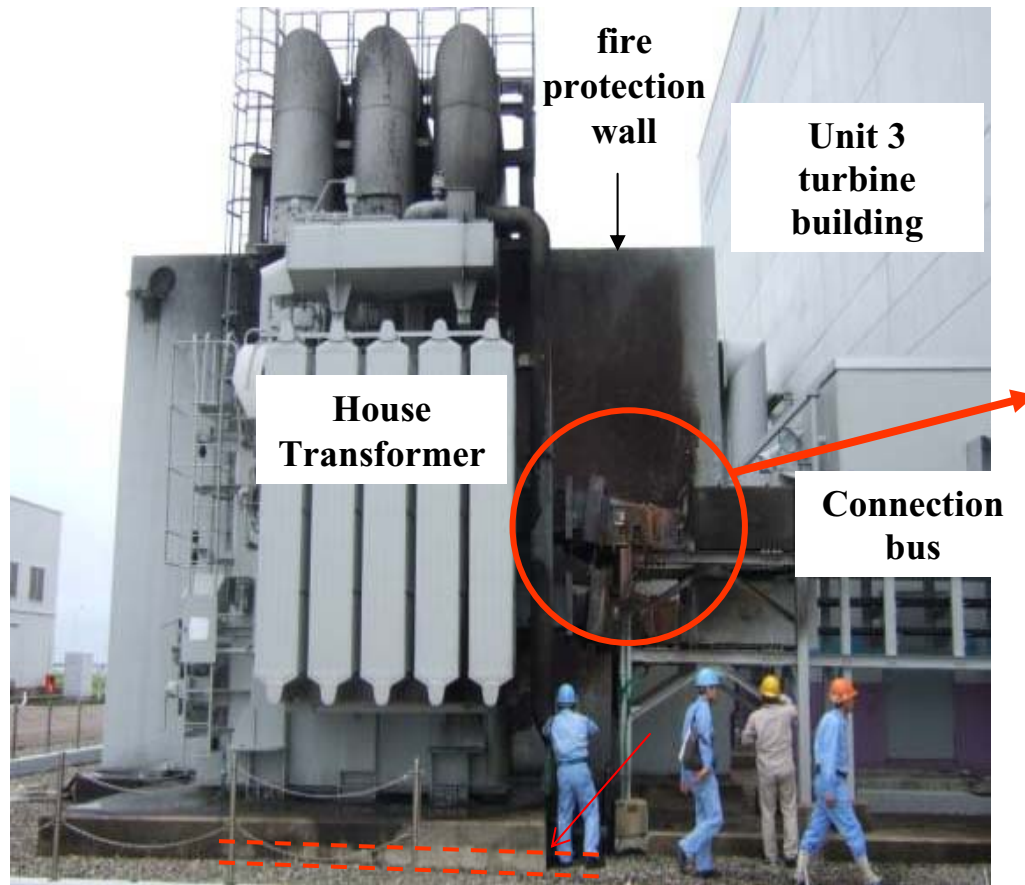
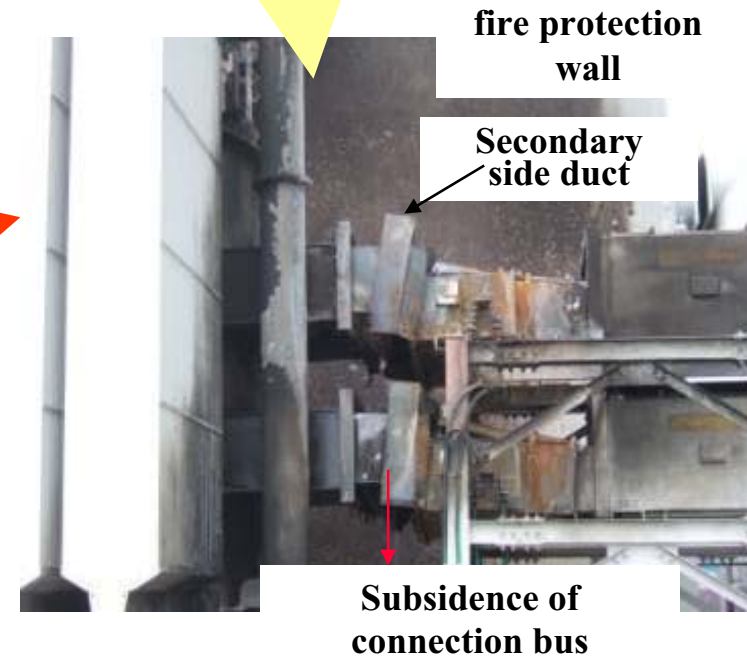
[Unit 3 House Transformer Fire]

- The fire protection wall prevented the fire from spreading to other areas.
- Soil deformation is presumed to have caused a short circuit. An in-depth investigation is in progress.

Subsidence of the connection bus of the secondary side of the transformer relative to the transformer itself.

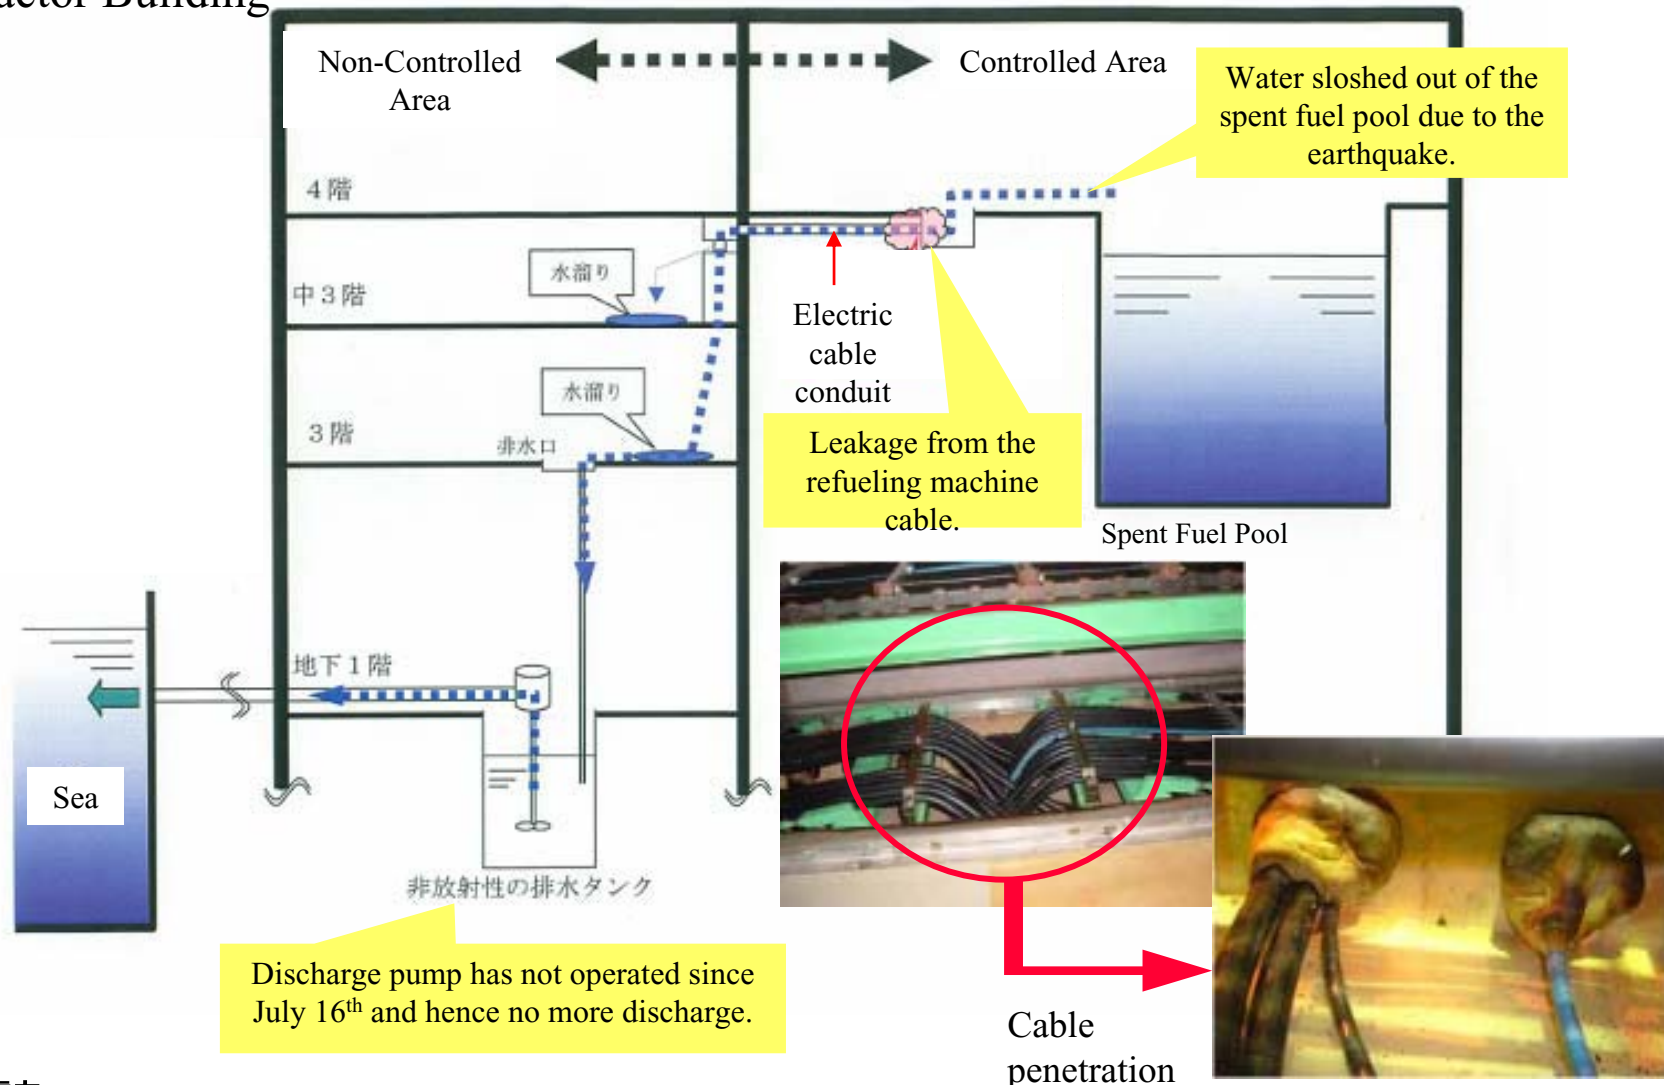
Unit 6 Reactor Building

- It is presumed that water sloshed onto the floor from the spent fuel pool and flowed along the electric cable conduit to the non-controlled area.

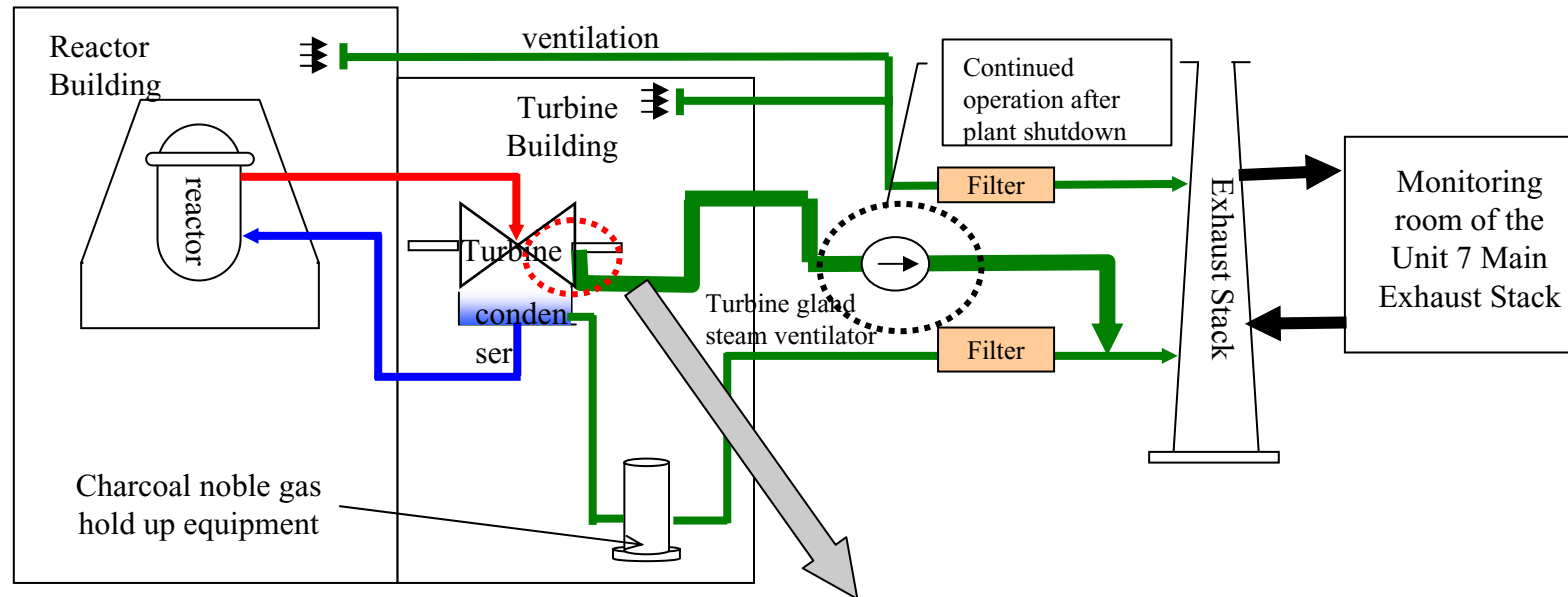
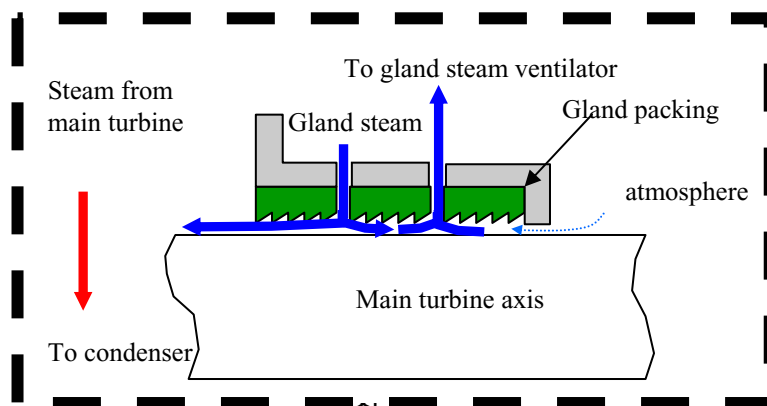
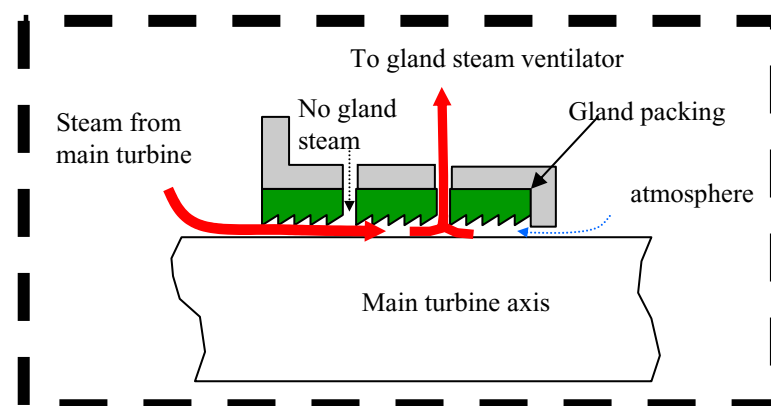
[Radioactive Materials Detected from the Unit 7 Main Stack Monitor]

- It is presumed that radioactive materials were sucked out from the condenser and subsequently released from the main stack due to the delay in shutting down the gland steam ventilator after automatic shutdown of the reactor.
- No radioactive material has been detected in measurements after July 19.

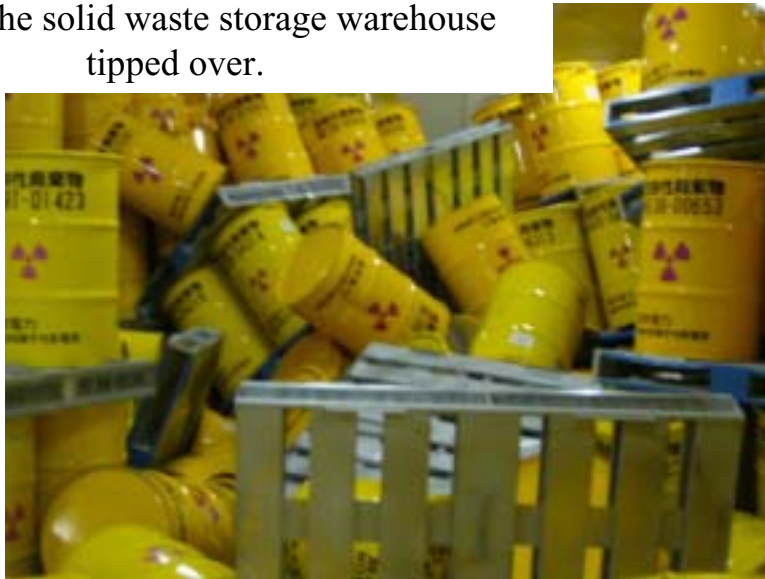
Several hundred drums containing low-level waste in the solid waste storage warehouse tipped over.

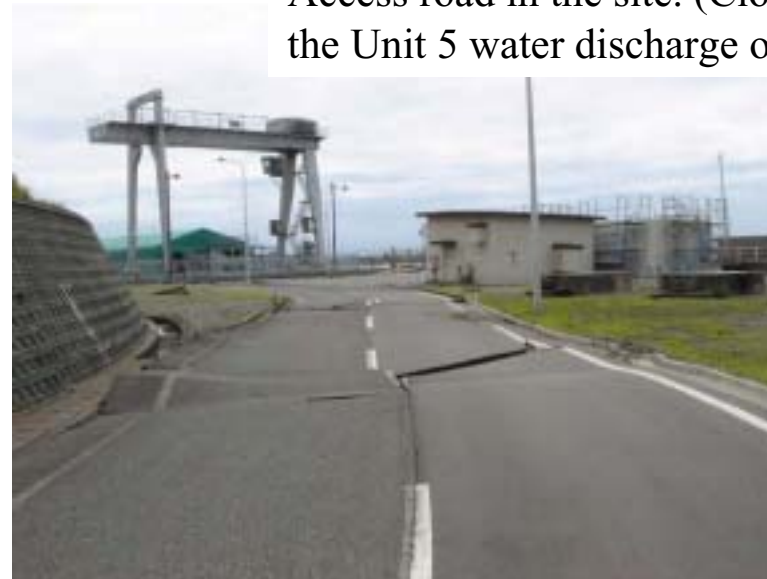
Access road in the site. (Close to the Unit 5 water discharge outlet.)

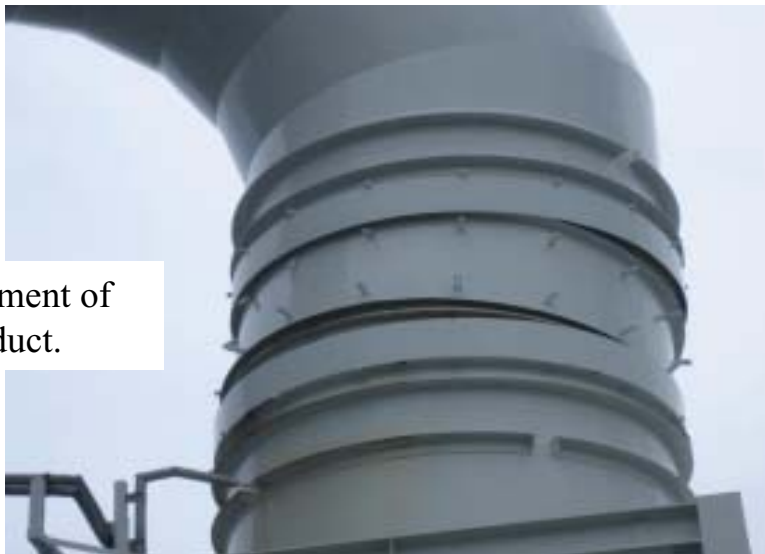
Displacement of exhaust duct.

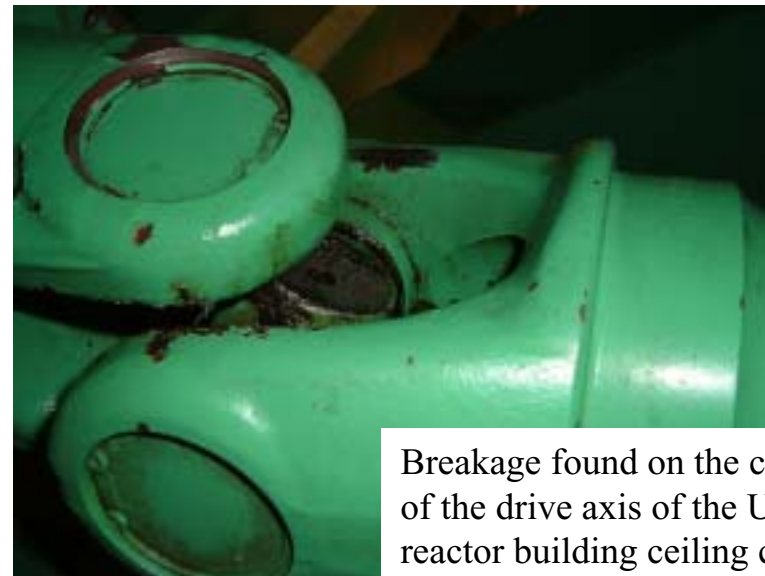
Breakage found on the coupling of the drive axis of the Unit 6 reactor building ceiling crane.
