# Results of the Fourth Soundness Inspection of Unit 4 Reactor Building at Fukushima Daiichi Nuclear Power Station

February 13, 2013

Tokyo Electric Power Company

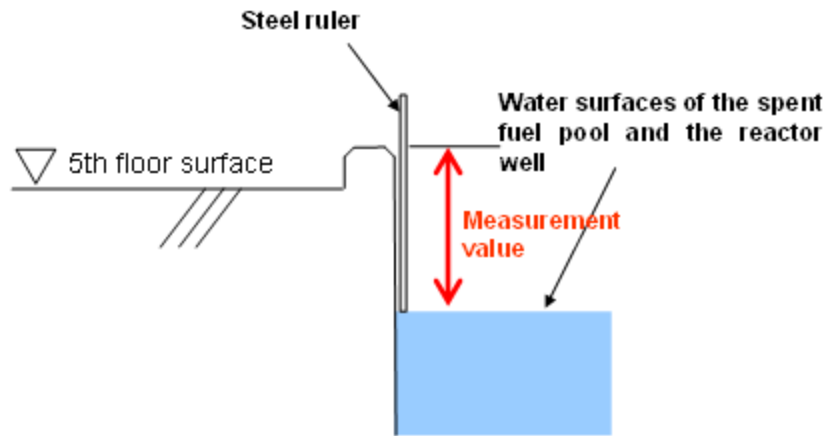
Considering that the water level measurement values on the four corners were about the same, it has been concluded that the 5th floor surface and the water levels of the spent fuel pool and the reactor well are parallel and the building is not tilted similarly to the past results.

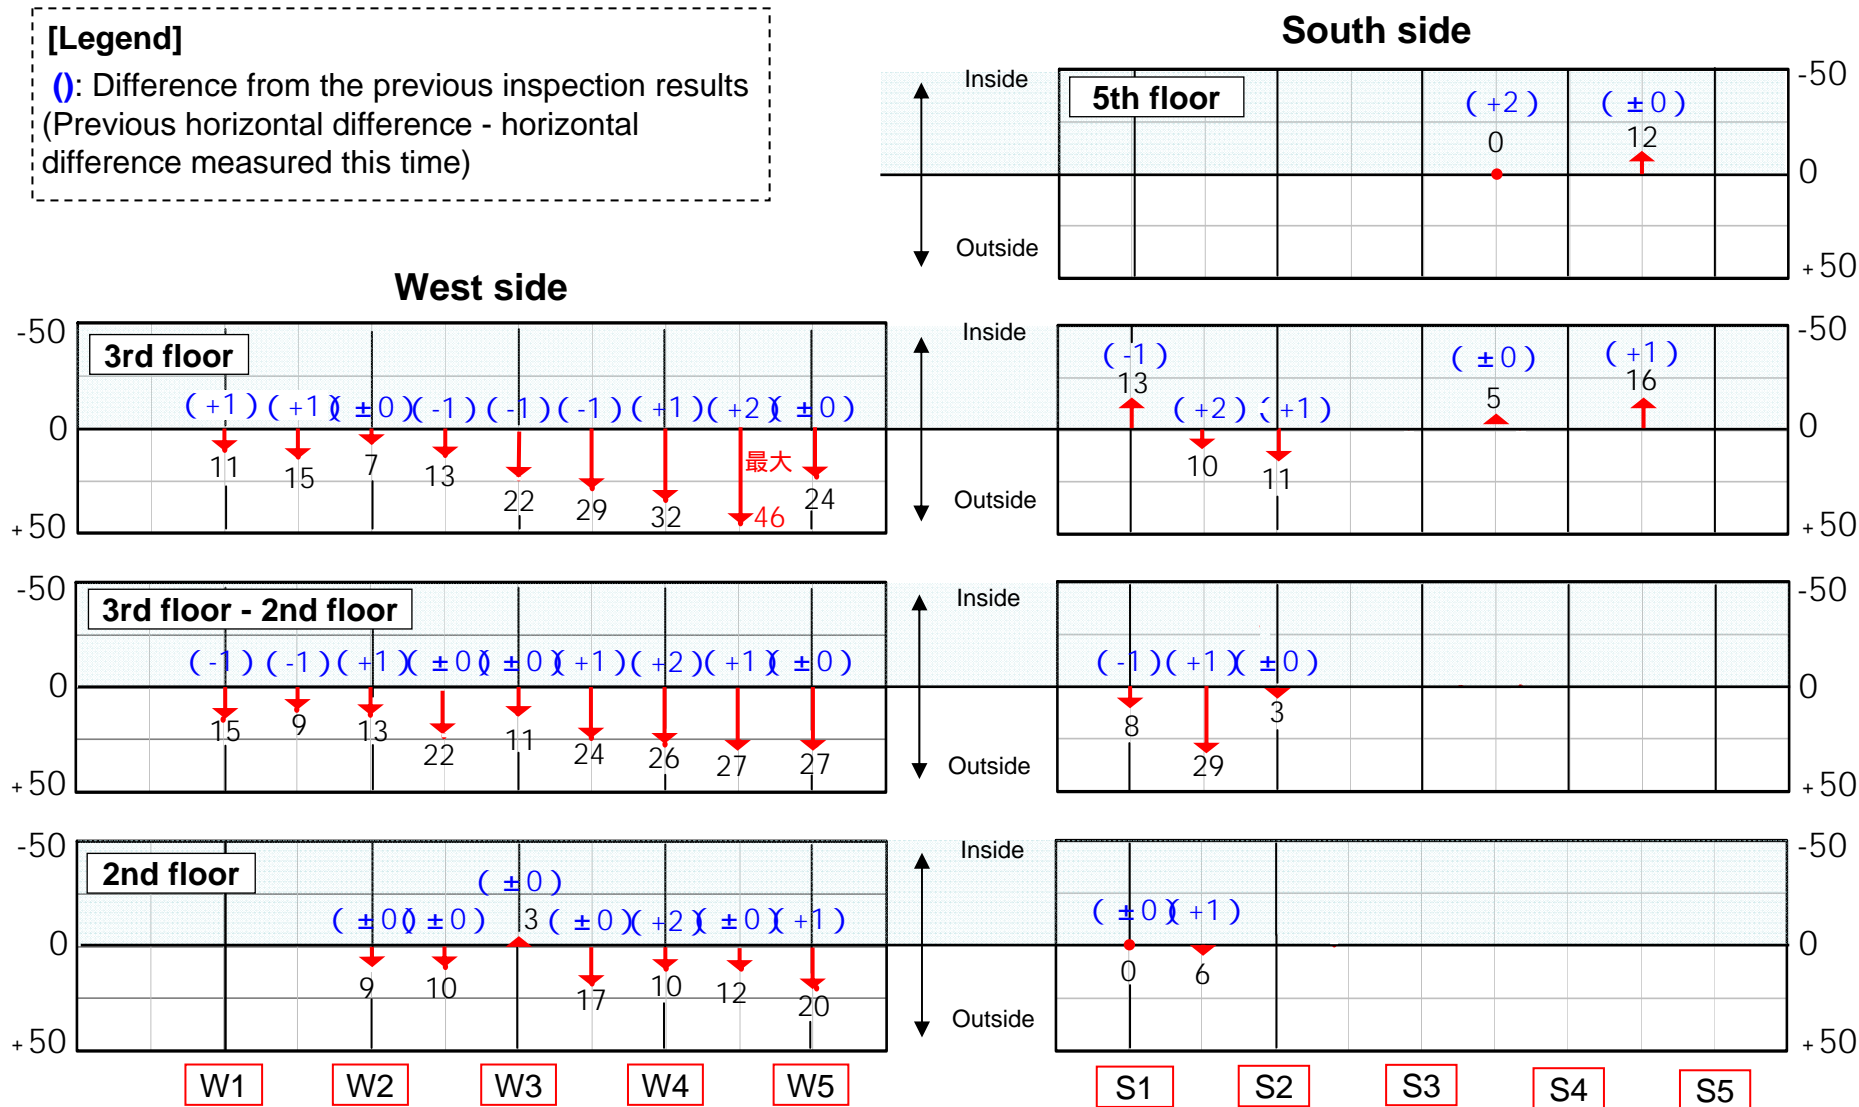
### Horizontal difference\*1 calculation results (Unit: mm)

Based on the changes in the horizontal difference over time (from the first to the fourth inspection), no tendency of building tilt was confirmed.

- The horizontal differences measured this time were about the same as those in the first inspection (May 2012), the detailed inspection of outer walls (June 2012) and the second and the third inspections (August and November 2012), and the deformation characteristics on the measurement points were also similar.

- The small difference from the previous measurement results may be due to factors such as error of the optical equipment (Measurement error of  $\pm 2\text{mm}$  may cause approx. 4mm (Max.) error in horizontal difference) and thermal expansion of concrete (thermal expansion coefficient: Approx.  $7-13 \times 10^{-6}/$  ) which may cause approx. 3-7mm error because of the difference of average monthly temperatures between November and January/February.

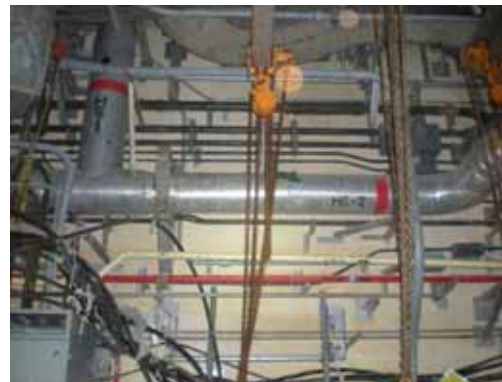
① West wall

Since no crack of a width of 1mm or more or with possible rebar corrosion was found as a result of visual inspection (similarly to the past results), it has been concluded that there is no hazardous deterioration of structural durability.

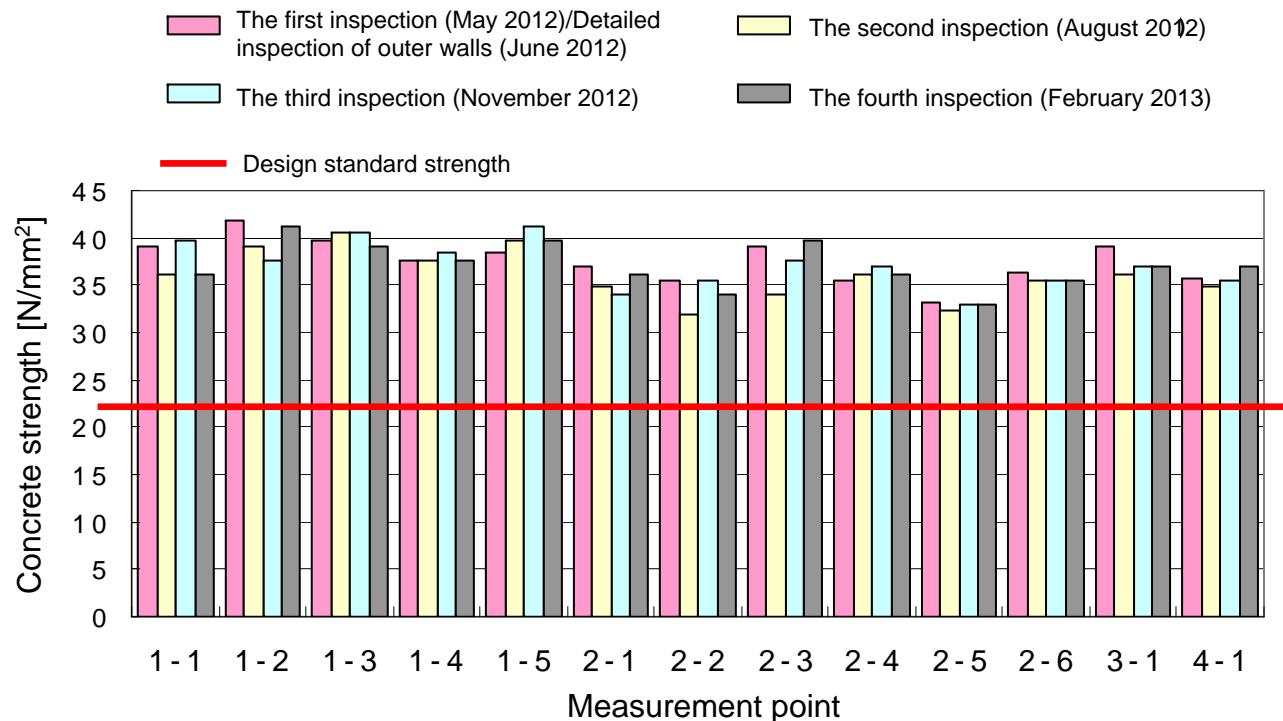
### Concrete strength evaluation results

As a result of measurement, the concrete strengths on all the measurement points were above the design standard (22.1N/mm<sup>2</sup>) similarly to the past results. The concrete strength is considered to be about the same as the past results taking into considerations the error of Schmidt Hammer\*<sup>1</sup> and that the measurement points were set at slightly different locations from the previous ones.

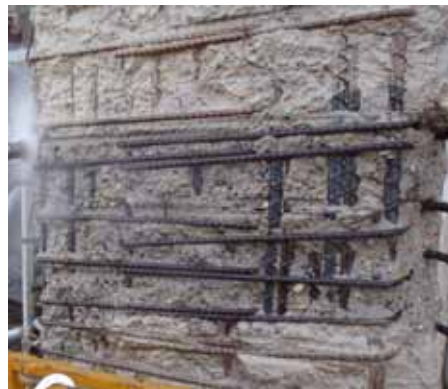
Photo 1: Before trial implementation

Since the concrete surface of the posts and beams in Unit 4 Reactor Building came off and rebar is partially visible due to the hydrogen explosion, corrosion prevention measure (spraying mortar onto the exposed parts) will be implemented for the purpose of ensuring the durability of the members starting from around March 2013.

Trial implementation was done at the site to confirm if mortar spraying can be applied.
