# Camera Images Acquired at Unit 1 Torus Room Investigation at Fukushima Daiichi Nuclear Power Station (Day 1)

[Results of investigation using a camera]

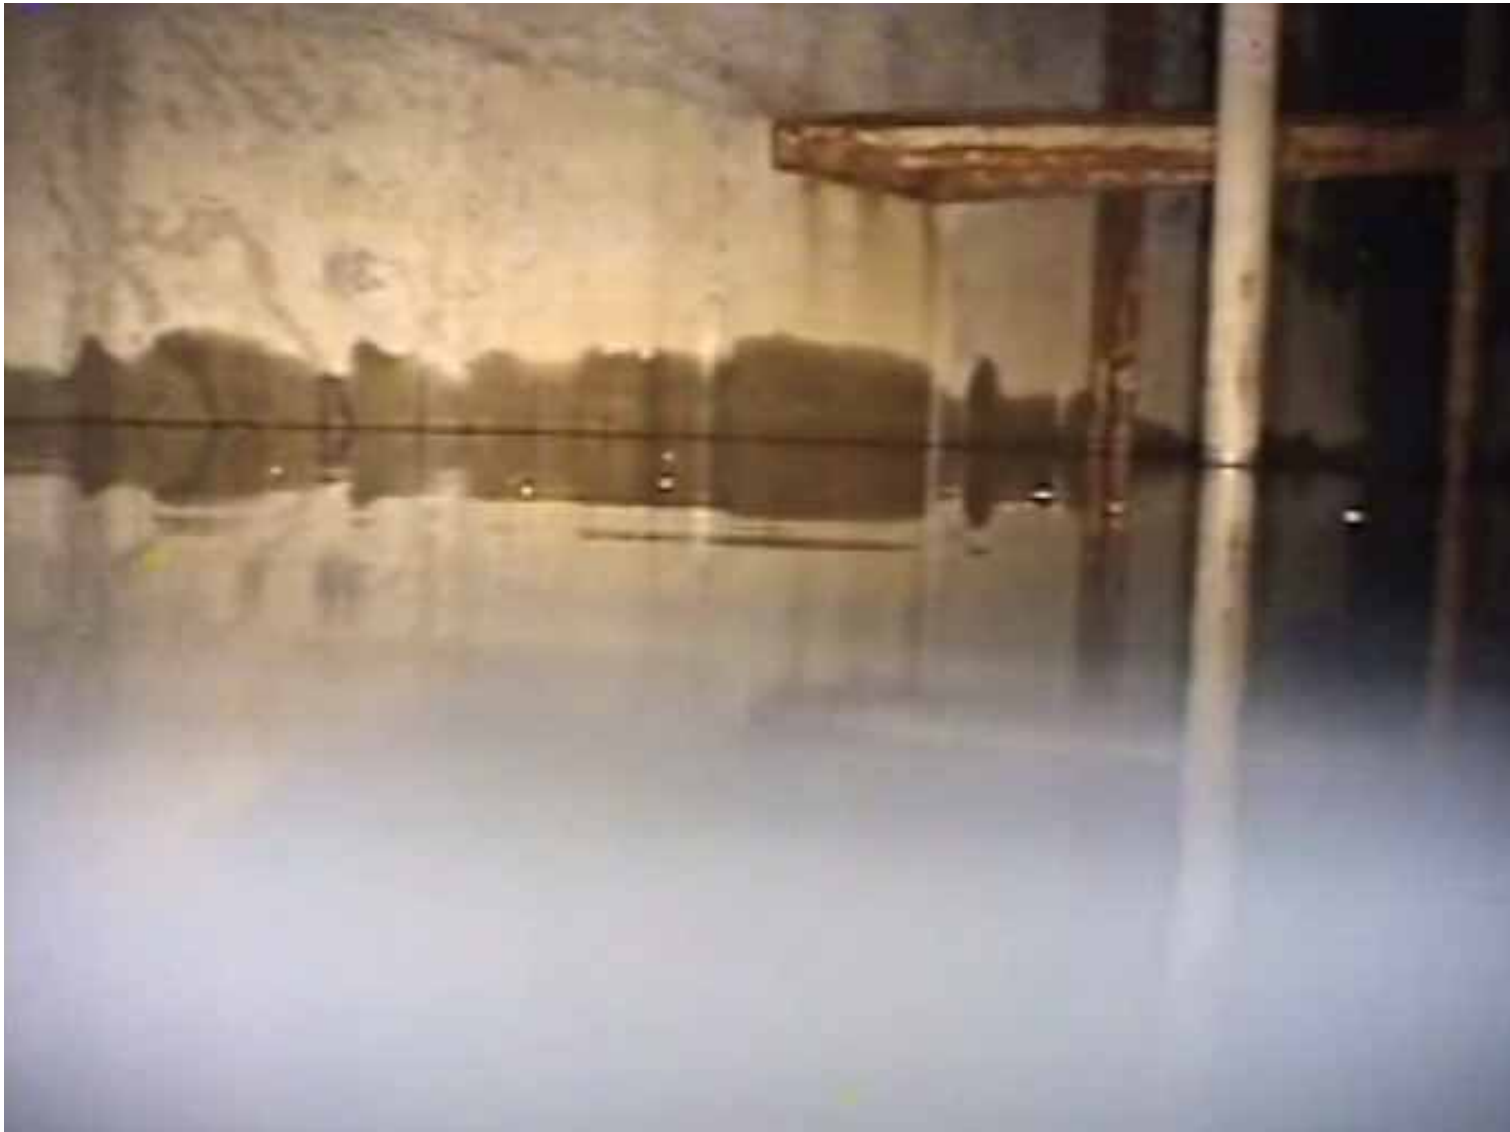
**[Photo 3] Accumulated water surface (Camera position: Approx. OP.3700)**

Approx. OP.3700 (Depth: Approx. 4.9m)

Approx. 60cm

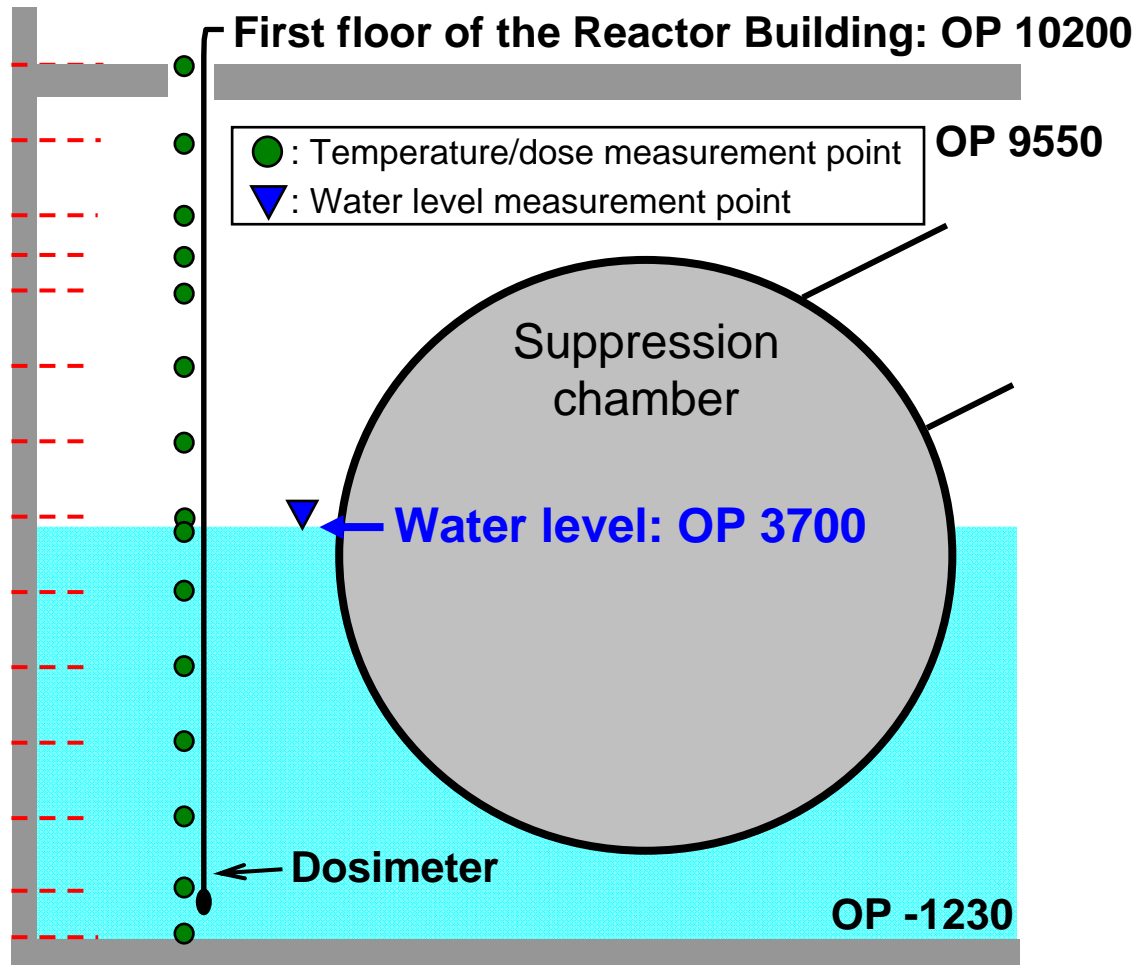
# < Reference > Temperature/dose measurement results

Location	Temp. [ °C ]	Dose [ mSv/h ]
OP.10200	4.8	1.5
OP.9200	16.3	180
OP.8200	17.4	220
OP.7700	17.3	230
OP.7200	16.9	250
OP.6200	17.1	420
OP.5200	17.4	780
OP.4200	17.7	920
Water level: Approx. OP.3700	19.8	800
OP.3200	22.7	110
OP.2200	22.9	93
OP.1200	22.9	83
OP. 200	22.9	82
OP. -800	22.8	90
OP.-1230	22.8	95
