Results of Investigation of the Lower Part of Unit 2 Vent Pipe at Fukushima Daiichi Nuclear Power Station

March 13, 2013

Tokyo Electric Power Company

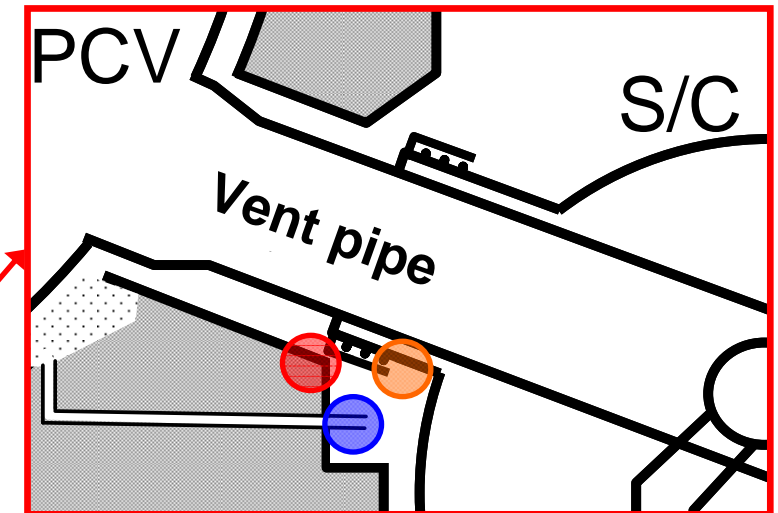
Lower part of the vent pipe (Enlarged)

Lower part of the vent pipe bellows cover: No water leakage found

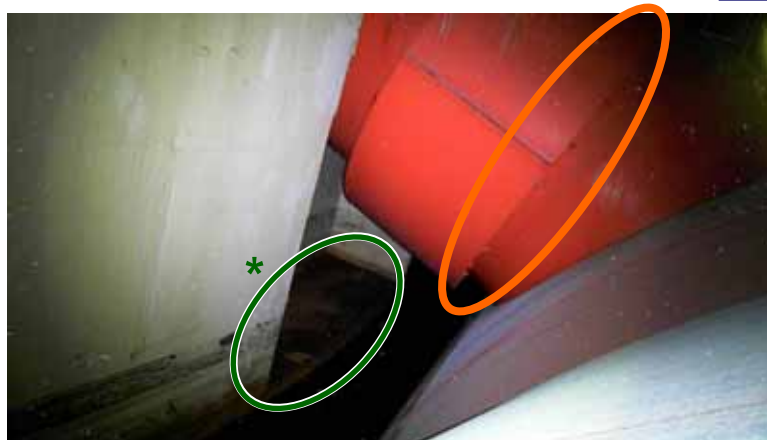
Edge of the vent pipe sleeve
Edge of the sand cushion drain pipe

No water leakage (water flowing) was found on the concrete stage (*) on the lower part though the condition was not directly checked.

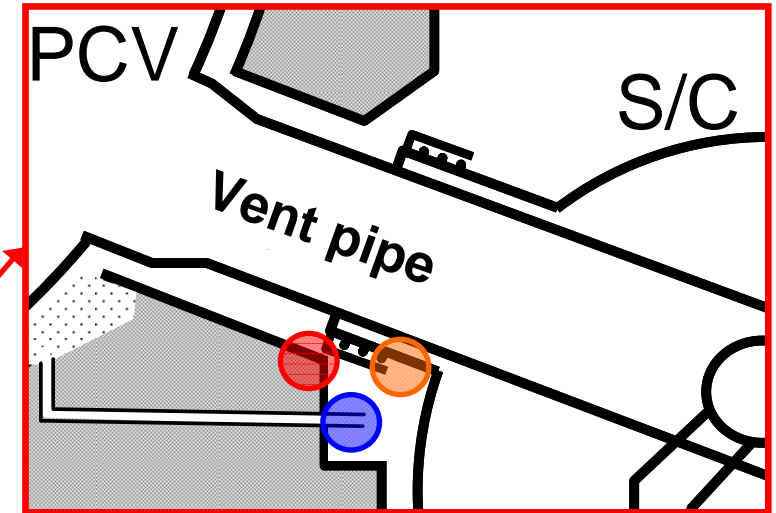
Lower part of the vent pipe (Enlarged)

Lower part of the vent pipe
bellows cover: No water leakage
found

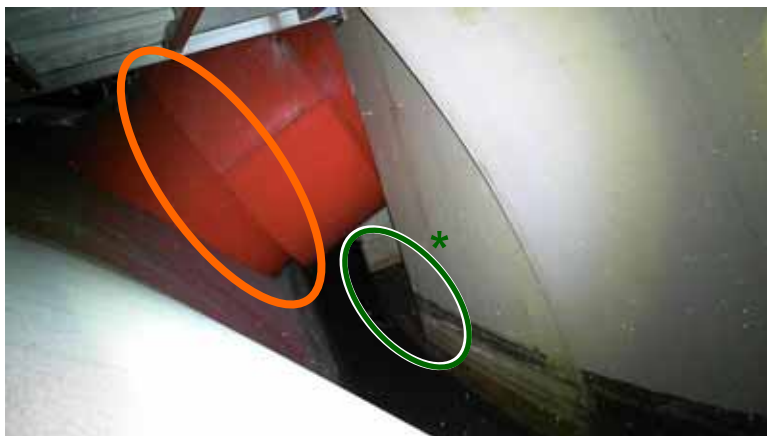
Edge of the vent pipe sleeve
Edge of the sand cushion
drain pipe

No water leakage (water flowing) was found on the concrete stage (*) on the lower part though the condition was not directly checked.
