Results of Investigation of the Lower Part of Unit 2 Vent Pipe at Fukushima Daiichi Nuclear Power Station

March 15, 2013

Tokyo Electric Power Company

Investigation Locations and Current Conditions (North-northwest Vent Pipe)

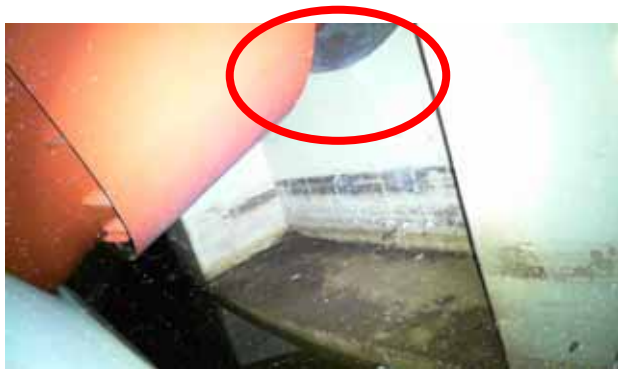
Edge of the vent pipe sleeve

1. No water leakage was found at the edge of the vent pipe sleeve.
2. No water leakage was found at the edge of the sand cushion drain pipe.
3. No water leakage was found at the lower part of the vent pipe bellows cover.
