Work Performed Today (April 12) in Response to the Leakage from the Underground Reservoirs

April 12, 2013

Tokyo Electric Power Company

Cause Investigation of the Leakage

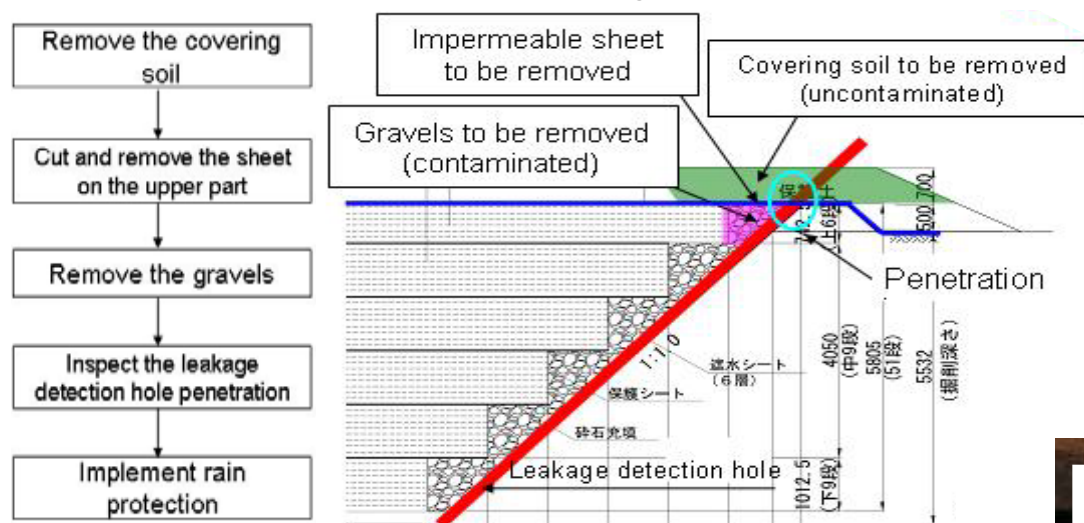
- Visually inspect the conditions of the impermeable sheet and the leakage detection hole in the leakage detection hole penetration in the northeast side of the underground reservoir No. 2 where the leakage is suspected.

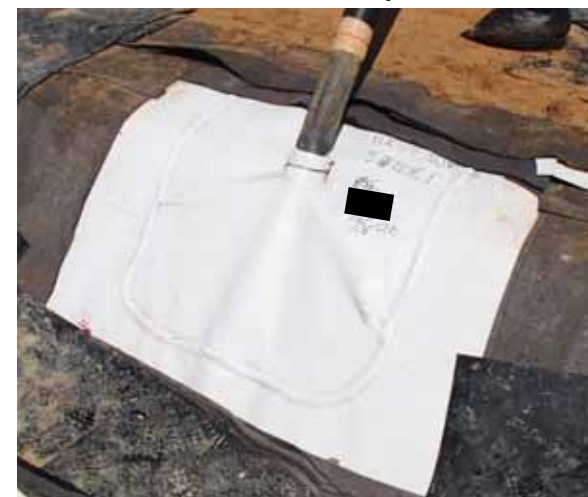
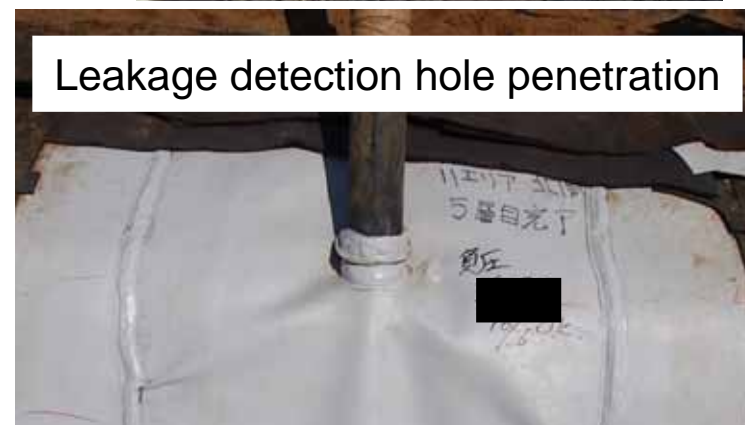
- Investigation of the leakage detection hole penetration

No problem was found as a result of the investigation.

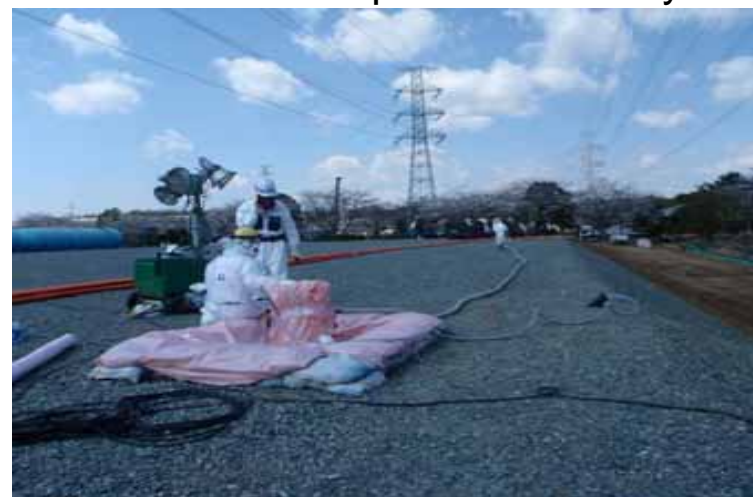
Work to prevent the expansion of contaminated water performed in the northeast side of the leakage detection hole of the underground reservoir No.1
