Leakage from the Pipe Flange of the Underground Reservoir No.3: Cause and Countermeasure

April 12, 2013

Tokyo Electric Power Company

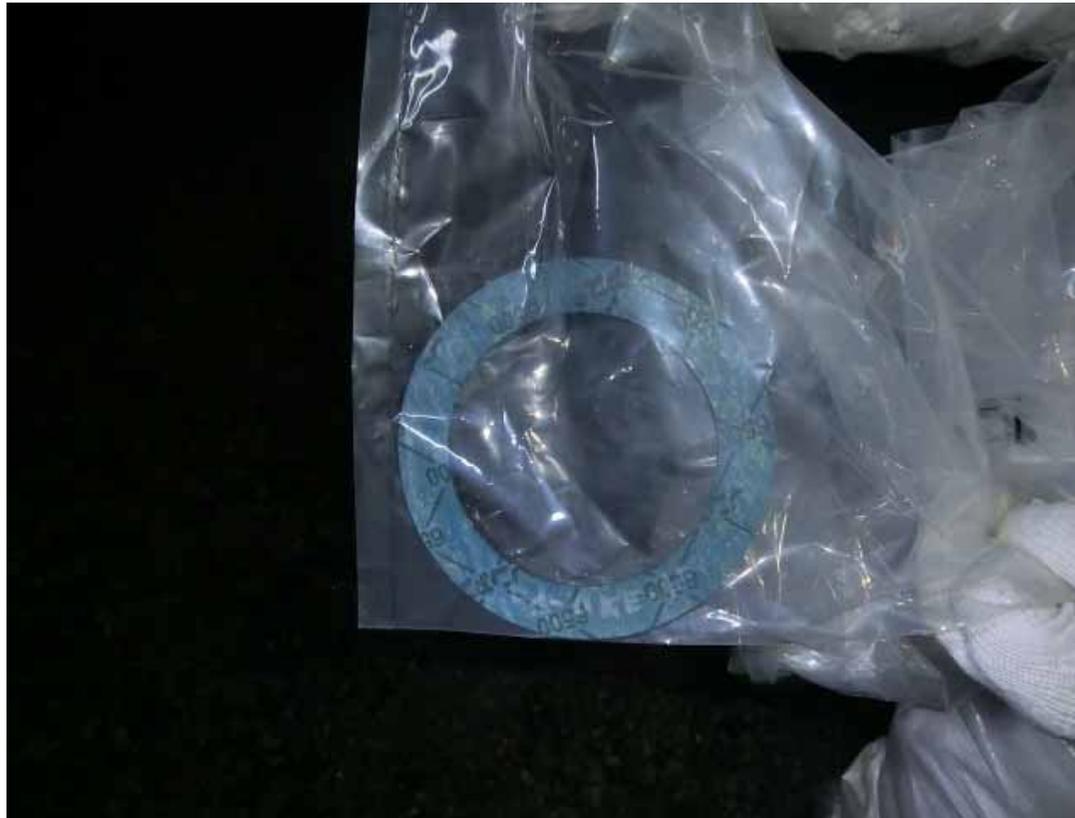
Disassembly of the Flange

- Cause investigation: As a result of disassembling the flange,
 1. No abnormality such as a crack, scratch, deformation, etc. was found with the gasket and the flange.

- Conditions of the gasket and the flange
 - No defect such as a crack, scratch, deformation, etc. was found.
 - The gasket has been replaced with a new one.

- Countermeasure: After the packing of the flange was replaced at 7:50 PM on April 11 and checking the tightening condition, the flange has been recovered. The contaminated gravels have been removed.

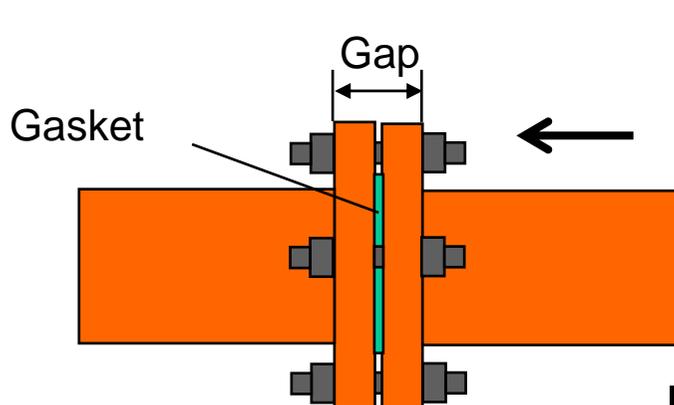
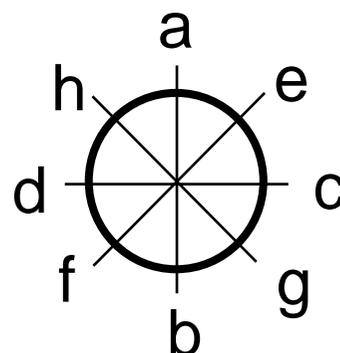
Gap Measurement Performed on the Flange

2. As a result of measuring the gap between flange surfaces, **the amount of gap was found to be inhomogeneous and the crushing amount was found to have been increased.**

- Assumed cause: Decrease in flange surface pressure induced by the change in the tightening condition of the flange due to the air temperature change overtime.

- The gap on the upper part of the flange was found to be larger than other portions.
- The bolts installed on the upper part of the flange were found to be loose.

- The crushing amount at the time of the installation was within the range of 0.13-0.2 (control value).
- The crushing amount measured after the leakage was larger than that at the time of installation.
- Due to the weather conditions (dry winter season) and the temperature change, etc. since the installation on December 25, it is assumed that the tightening condition of the flange was changed (increased crushing amount, loose bolts).

- As for the flanges for which water passing test or air tightness/leakage test has not been done, **gap measurement** and **torque confirmation** will be performed.
- Monitoring for leakage will be performed with the flanges **protected** (with vinyl, etc.) and a **supervisor** and **report method (PHS)** in place during water transfer to allow for prompt suspension of transfer in the case that an abnormality is found.
- When passing water through the pipe, repeat **inching (for about 30 seconds)** a few times before starting regular operation taking into consideration the risk of leakage. **Patrol** will be performed about 30 minutes after the start of operation in order to check for leakage (leakage check).
