Committee for monitoring and  
evaluating the specified  
nuclear facilities (provisional  
translation) (9th meeting)  
Reference 1-1

# Background of underground reservoir plan, current actions (cause analysis etc.), and future direction

April 19, 2013

Tokyo Electric Power Company

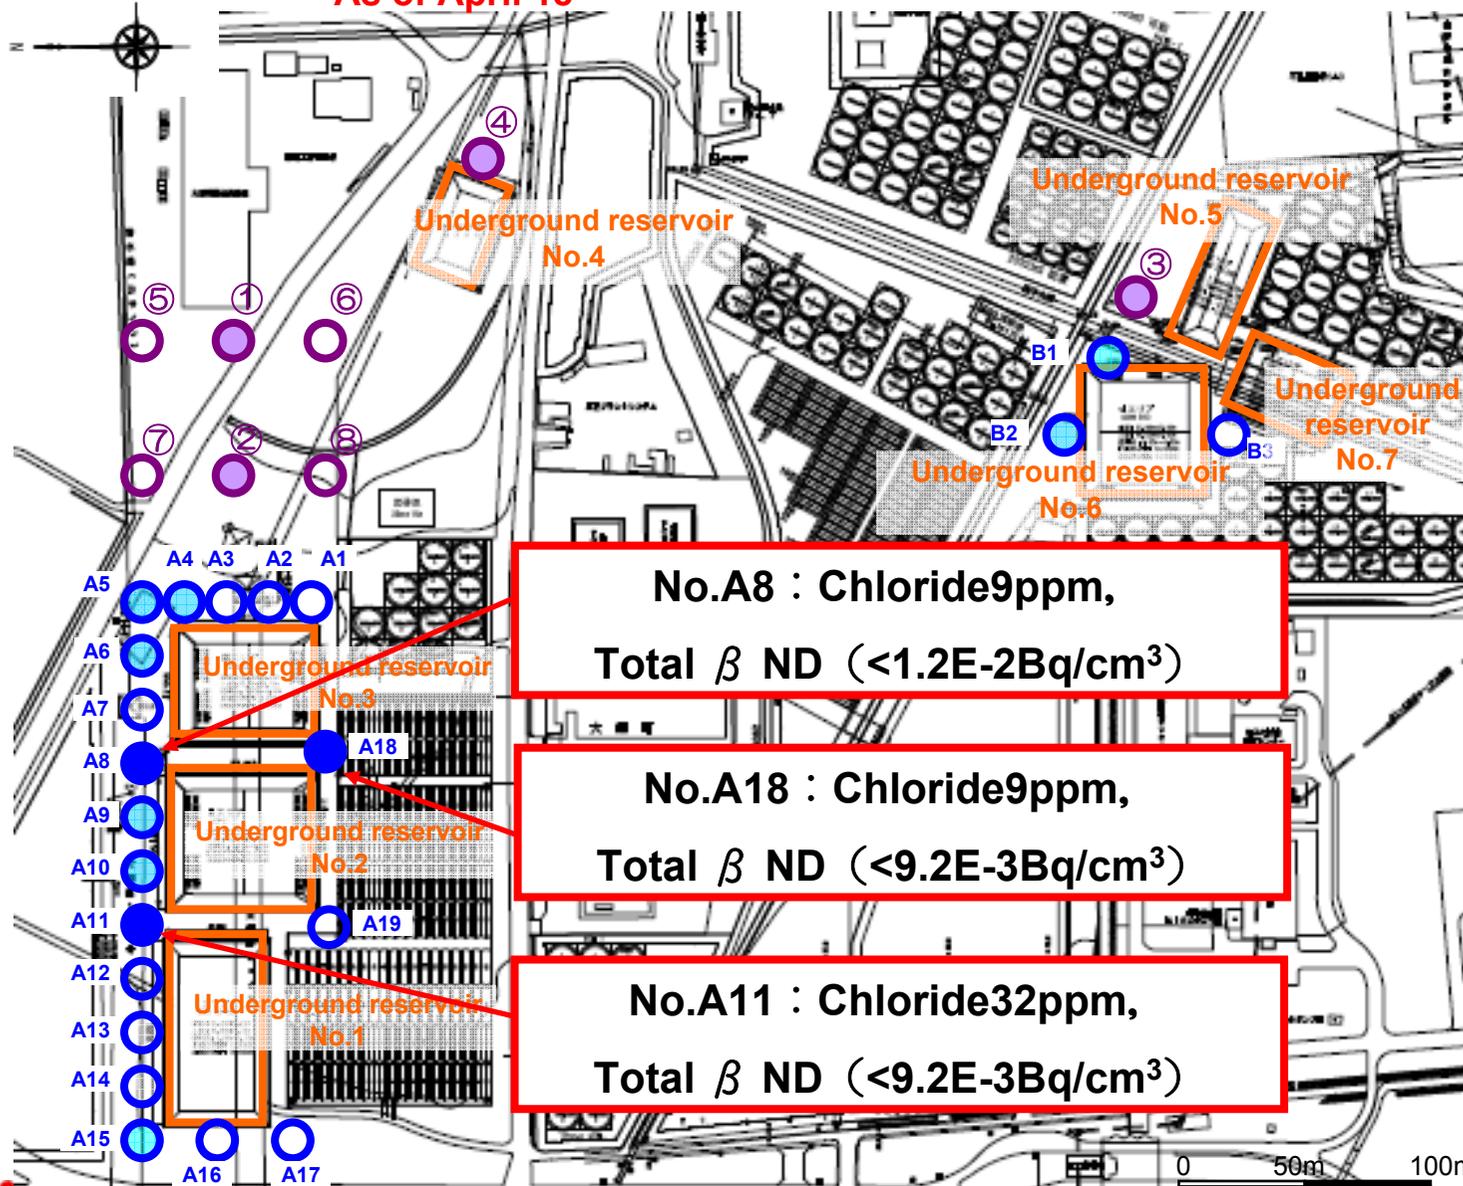
**No.A8 : Chloride 9ppm,  
Total β ND (<1.2E-2Bq/cm<sup>3</sup>)**

**No.A18 : Chloride 9ppm,  
Total β ND (<9.2E-3Bq/cm<sup>3</sup>)**

**No.A11 : Chloride 32ppm,  
Total β ND (<9.2E-3Bq/cm<sup>3</sup>)**

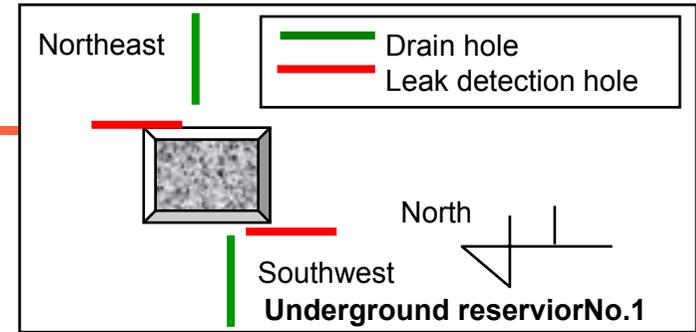
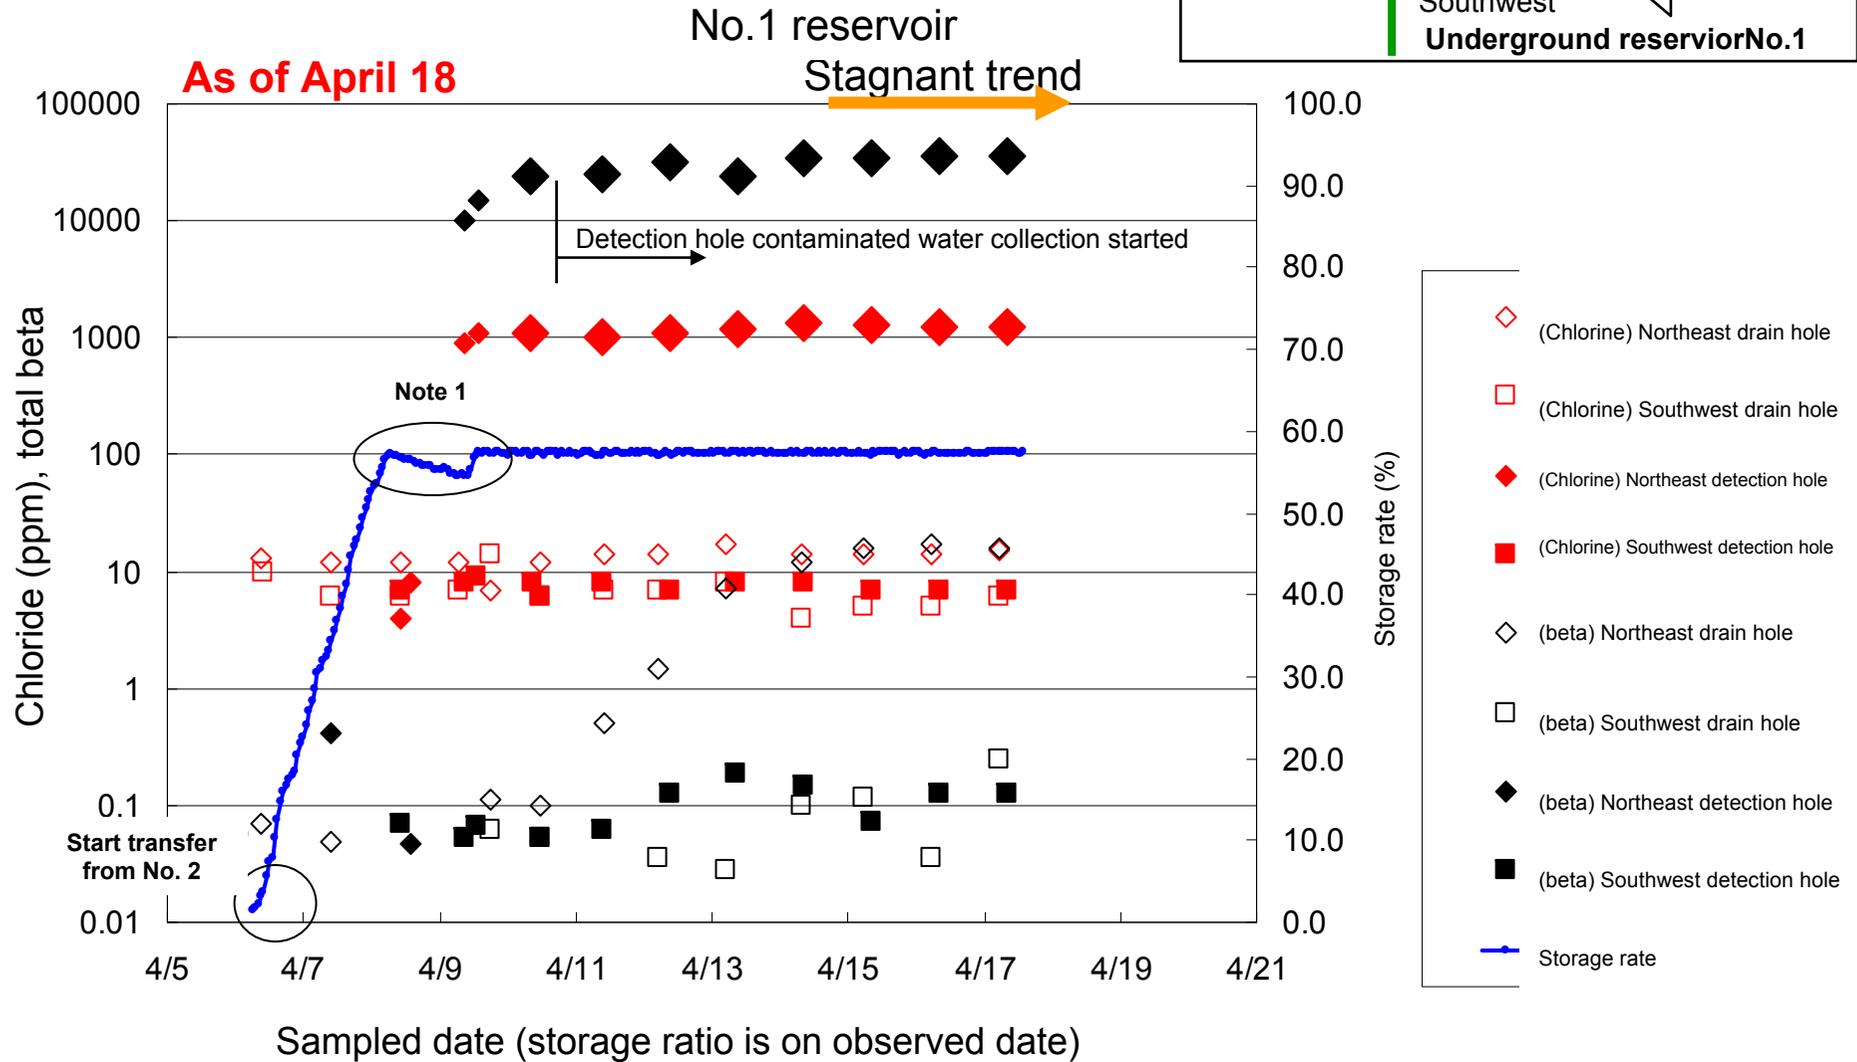
# [Reference 1-1] No1 monitoring data

Note1: After shutdown of transfer pump from underground reservoir No2 to No1, some water returned to No2 due to siphon effect is water level decreased, Resumed transfer on 4/9.

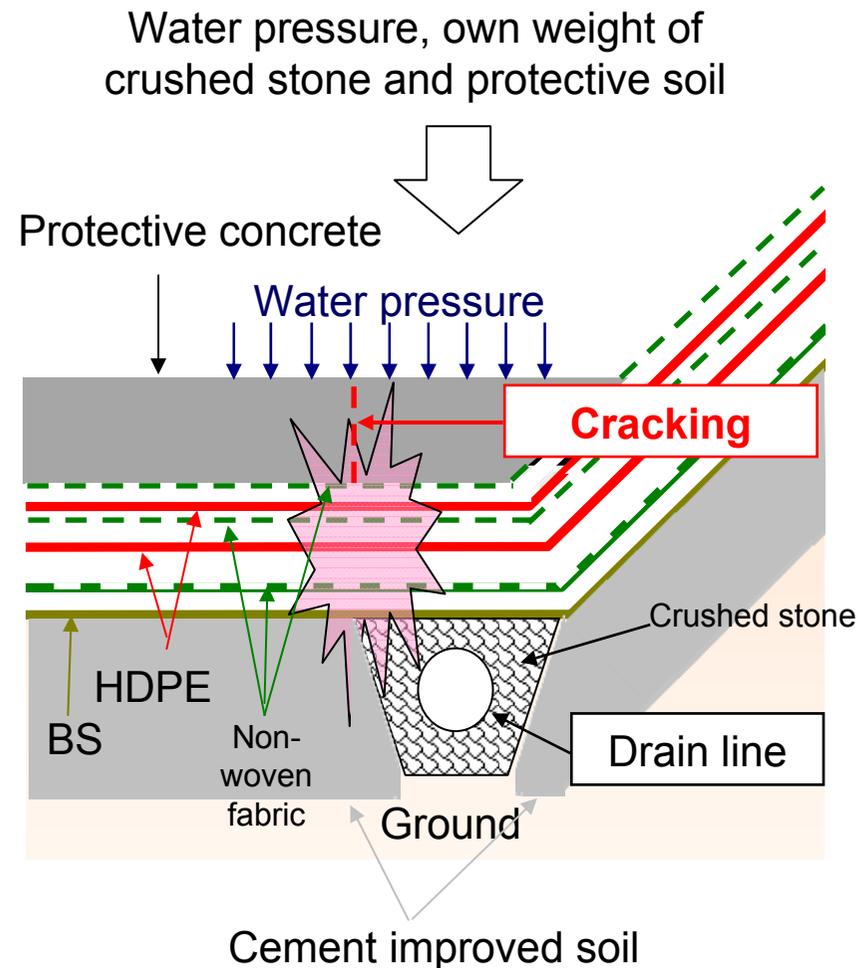
## [Reference 2-1]

### Damage to bottom slam/ drain pipe underground area (assumed causes)

- Bottom slab drain pipe was installed by excavating the ground and laying cement-modified soil on the bottom and laying the drain pipe by excavating into the modified soil in a concave shape. Top, bottom, sides gaps around it were filled with crushed stones. It was covered with a mat and impermeable sheet was installed.
- It has been identified that there may be **cracking and damage** to the protective concrete directly above the filled crushed stone due to lack of compacting it and effects of consolidation settlement and water pressure. This may have caused **local shear stress in the impermeable sheet and led to damage.**

Conceptual drawing of installation of drain line at bottom/ damage

b. Sloped areas			• General areas	○	○	○	• During design: Cover mat was installed on crushed stones to protect the impermeable sheet to enhance reliability • During work: In order to prevent damage to the sheet due to cracking of the bottom slab concrete due to water pressure, non-woven fabric was installed and water filling test was conducted which verified that there were no problems • However, because there is concern of sheet damage due to stress concentration and creep for said location, specific damage mechanisms will be considered [Reference 2-1]

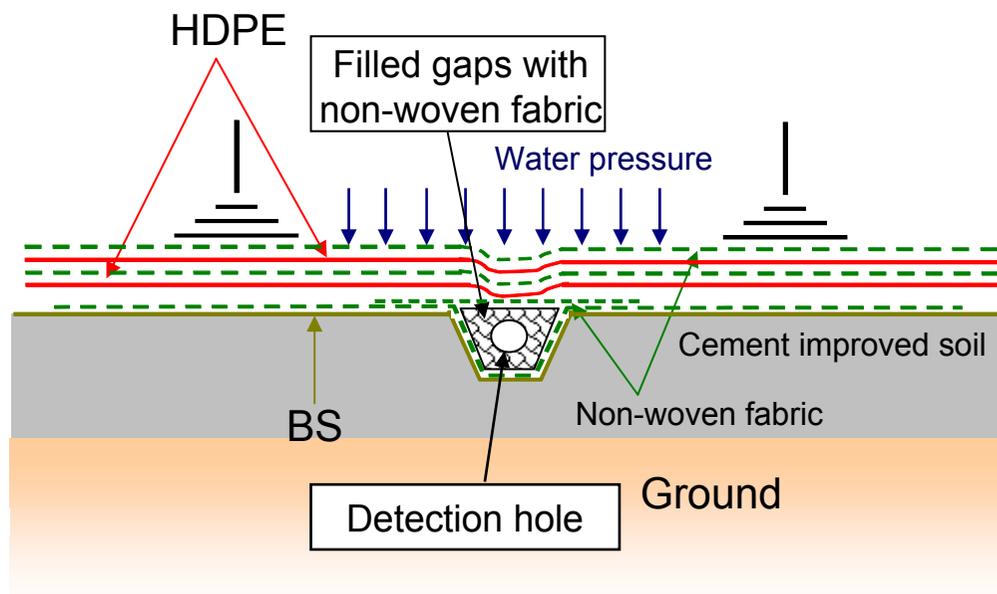
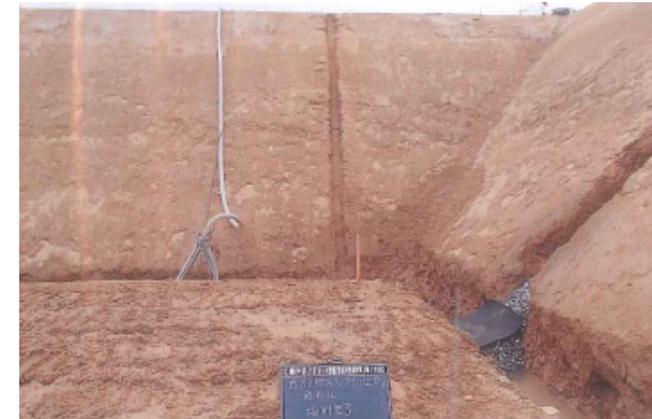
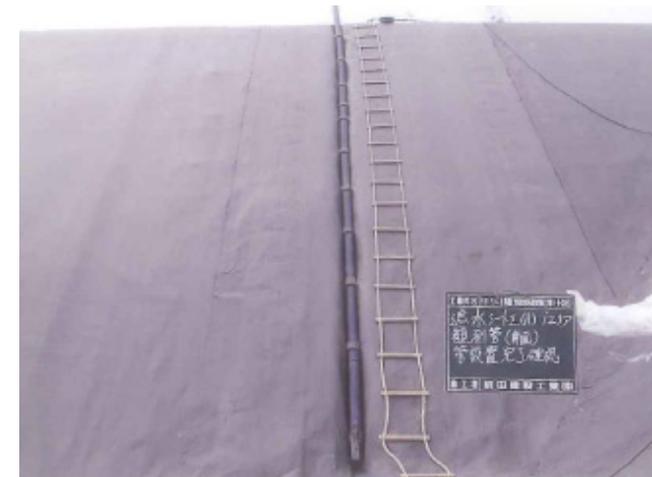
## [Reference 2-2] Sloped area/ leak detection pipe Damage to installed area (assumed causes)

- Leak detection hole is installed by attaching cement improved soil on excavated slope of the ground, and the improved soil was excavated in a concave shape. The space on top and sides were filled with non-woven fabric, non-woven fabric and impermeable sheet was installed on top.
- Due to deficiency in filling the gap with non-woven fabric, there were bumps on the sheet bottom surface, causing deformation of the sheet due to water pressure. **This causing localized stress concentration, causing concern for damage.**

Conceptual drawing of installation of detection hole/ deformation and damage, photo of installation

• Leak detection pipe installed area	○	○	○	• During design: Enhanced reliability by installing non-woven fabric on upper area of detection hole • During work: To prevent gradual deformation and damage of the sheet after operation due to gaps remaining between the leak detection pipe installation area and sheet, the space is filled with non-woven fabric and water-filling test was conducted which verified that there were no problems • However, because there is concern of sheet damage due to stress concentration and creep for said location, specific damage mechanisms will be considered [Reference 2-2]
② Adhesion area		a. Self-adhesion areas	• General areas	○	○	○	• During work: Pressurized test of adhesion area was conducted for all lines and field strength test was conducted, as well as water-filling test which verified that there were no problems

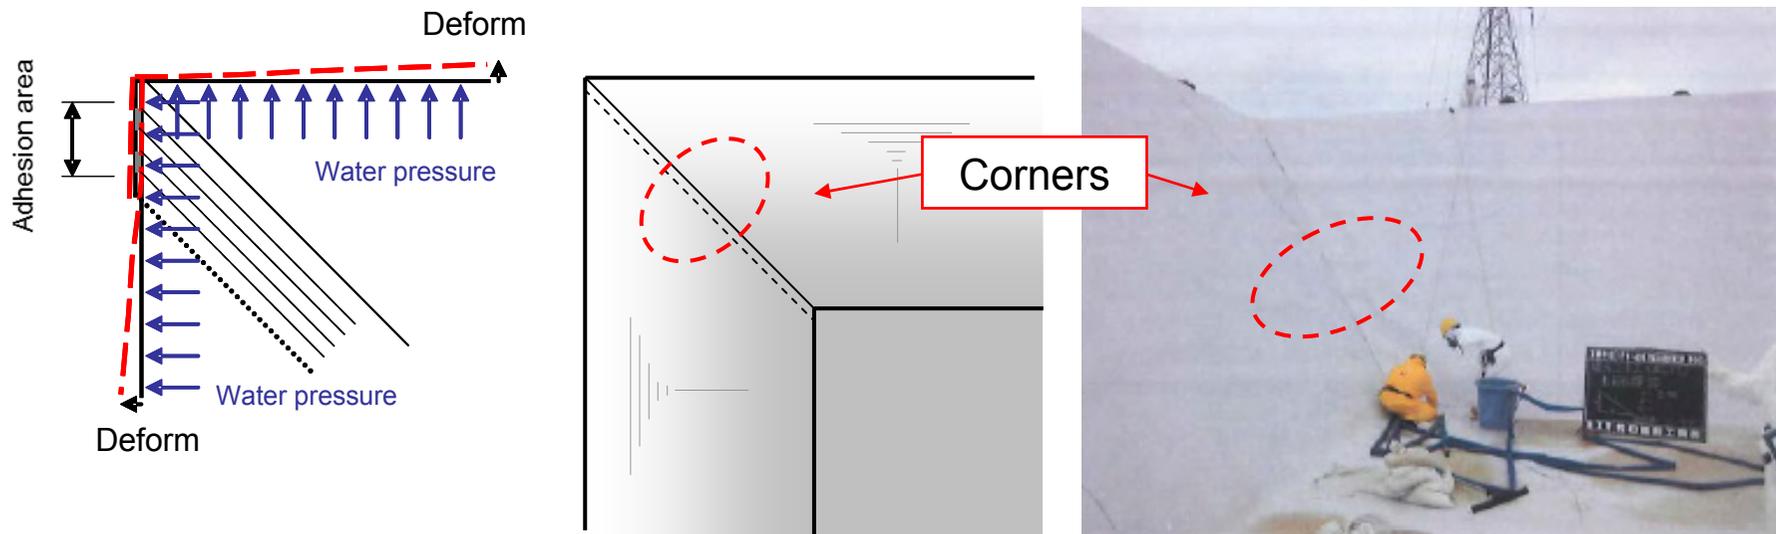
## [Reference 2-3]

### Damage to sloped corner/ self adhesion area (assumed causes)

- In the sloped corners, due to problems with work, impermeable sheets were joined together with self-adhesion.
- Gaps are easily formed between the impermeable sheet and ground in sloped corners.
- Due to water pressure from stored water, stress concentrated in corners, causing large deformation, and **may have caused damage**.

Conceptual image of deformation of sloped corner adhesion area,  
photo of work conditions

• Corners	○	○	○	• During design: Due to stress concentration of automatic adhesion area of sloped corners, in order to prevent gradual deformation of damage of the adhesion area, materials with enough stretch were adopted • During work: Conducted pressurized test of adhesion area for all lines and water-filling tests which verified that there were no problems • However, because there is concern of sheet damage due to stress concentration and creep for said location, specific damage mechanisms will be considered [Reference 2-3]

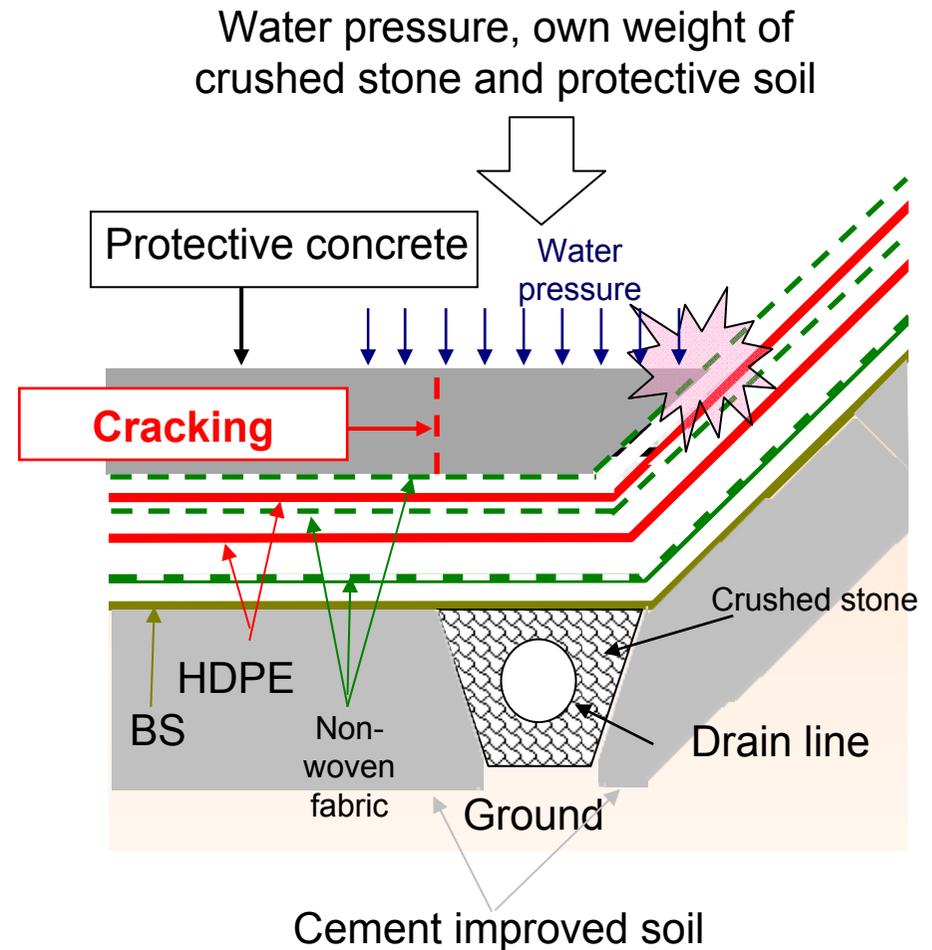
## [Reference 2-4] Damage to bottom slab protective concrete contact area (assumed causes)

- There **may be cracking/ damaging** of bottom slab protective concrete caused by deficiency in compacting the drain pipe filled crushed stone, and effects of consolidation settlement and water pressure.
- With this, the edge (sharp corner) of protective concrete contacted impermeable sheet **may have damaged the impermeable sheet.**

Conceptual drawing of installation of protective concrete/ damage

• Patch ~Sheet	○	○	○	• During work: To prevent gradual deformation and damage of adhesion area because defects easily occurs due to difficulty of manual adhesion, negative pressure test of adhesion areas were conducted for all lines and water filling test conducted which verified that there were no problems (note that it was confirmed that there was no abnormality based on the results of excavation study of No.2 underground reservoir)
④ Protective concrete contact area		a. Sloped area	• Cracking of protective concrete due to water pressure, edge contacted with sheet and caused sheet damage	○	○	○	• During design: To prevent cracking of bottom slab occurring due to water pressure and the edge coming into contact with the sheet causing damage to the sheet of the sloped area, non-woven fabric was installed on the upper surface of the impermeable sheet to protect it. • During work: Verified that there were no problems with water filling test • However, because there is concern of sheet damage due to stress concentration and creep for said location, specific damage mechanisms will be considered [Reference 2-4]
