# Small Animals (Mice) Found in the Low Voltage Transformer Box for Unit 2 Spent Fuel Pool Alternative Cooling System at Fukushima Daiichi Nuclear Power Station

< Reference >  
April 22, 2013  
Tokyo Electric Power Company

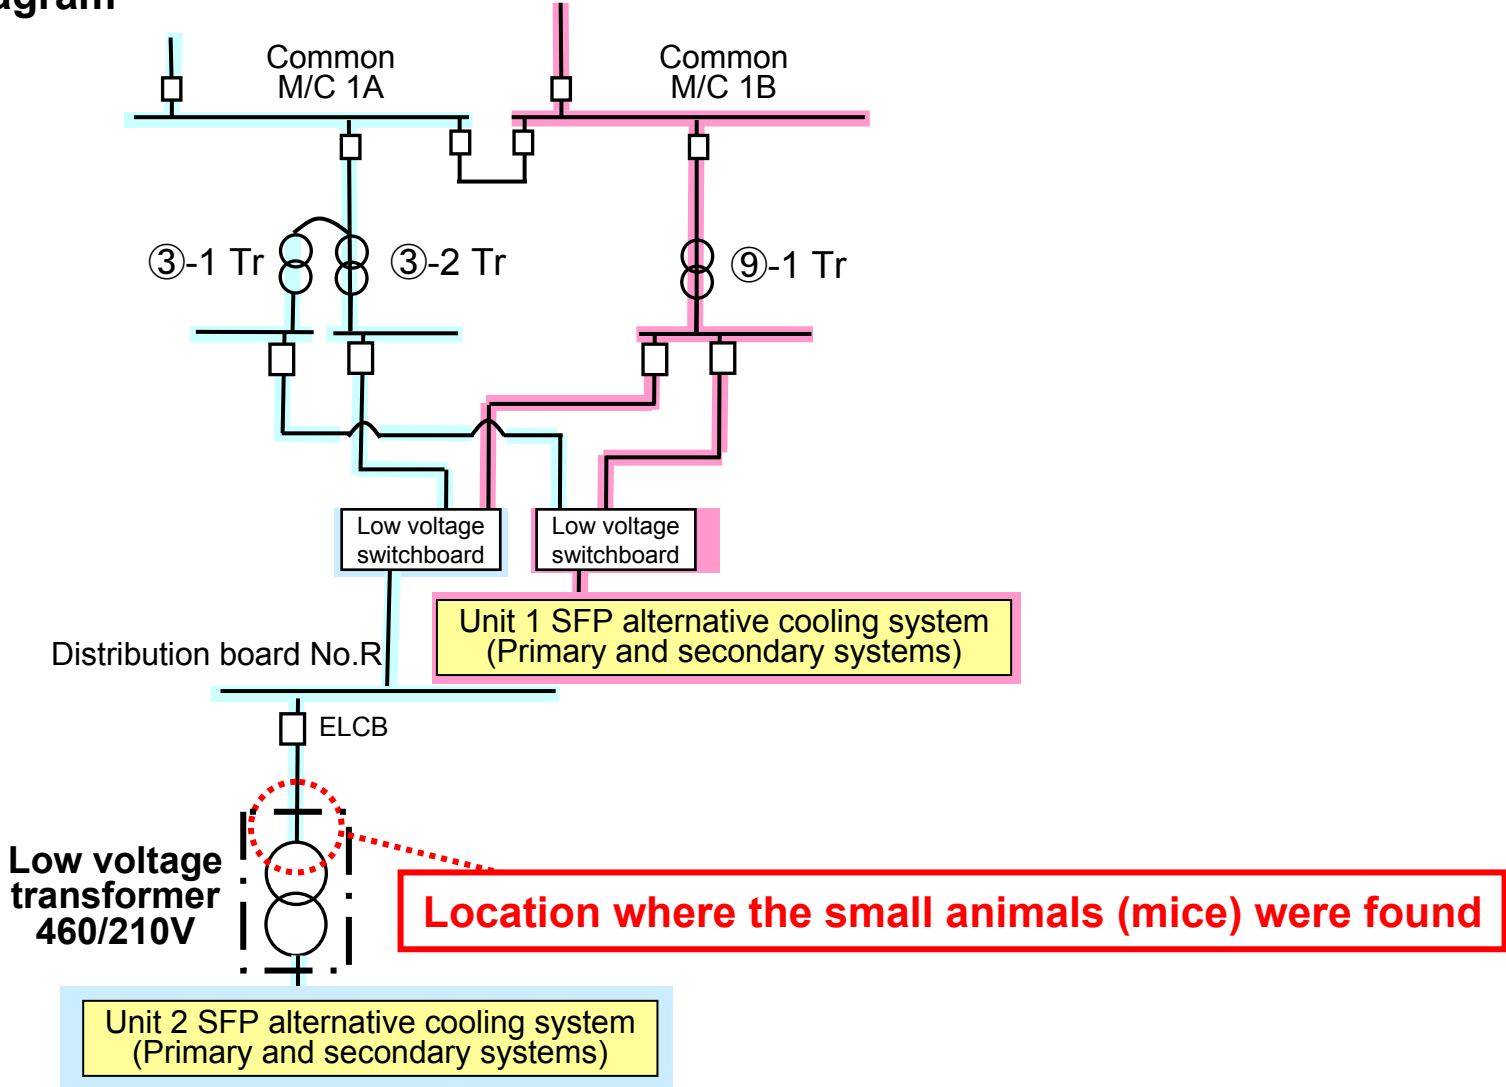
## (4) Single-line diagram

# Location Where the Dead Small Animals Were Found

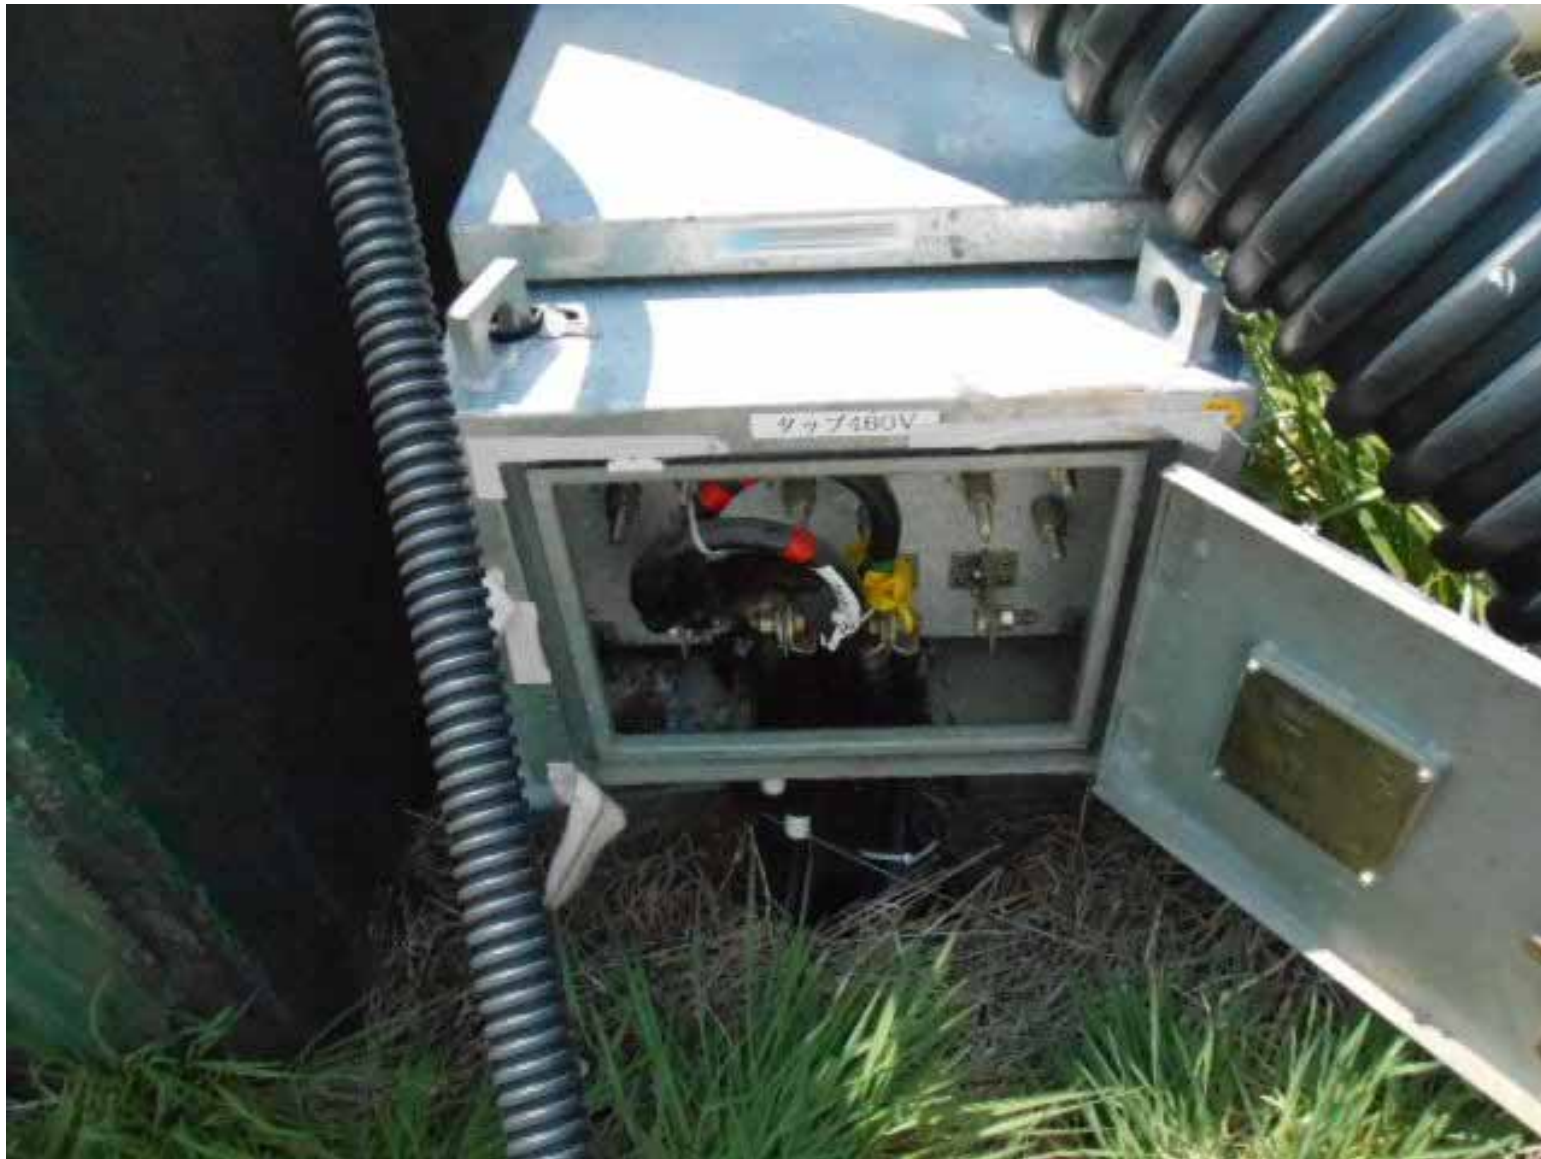
## Photo Taken at the Site (1)

Small animals were found dead near the terminal on the primary side upon opening the door of the low voltage transformer box.

After isolation was confirmed, removal of the small animals, insulation resistance measurement and protection cover installation over the transformer box opening were performed.

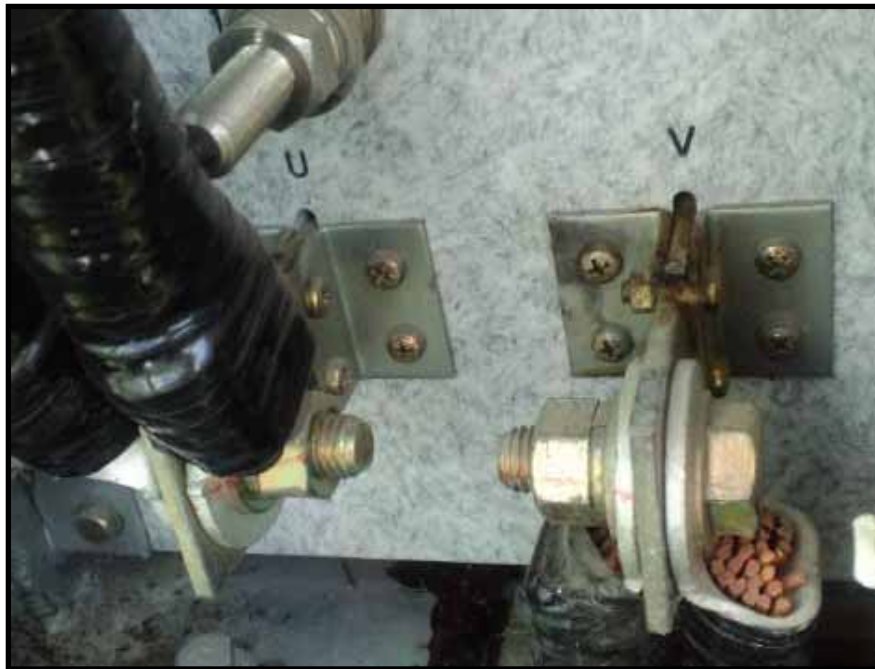
After the small animals were removed, appearance inspection was performed on the transformer. No damage (burn) was found on the terminal and no abnormality was found with the appearance of other areas. As a result of insulation resistance measurement, no problem was found in the primary side of the transformer, the interphase on the secondary side and the voltage to ground.

After cleaning

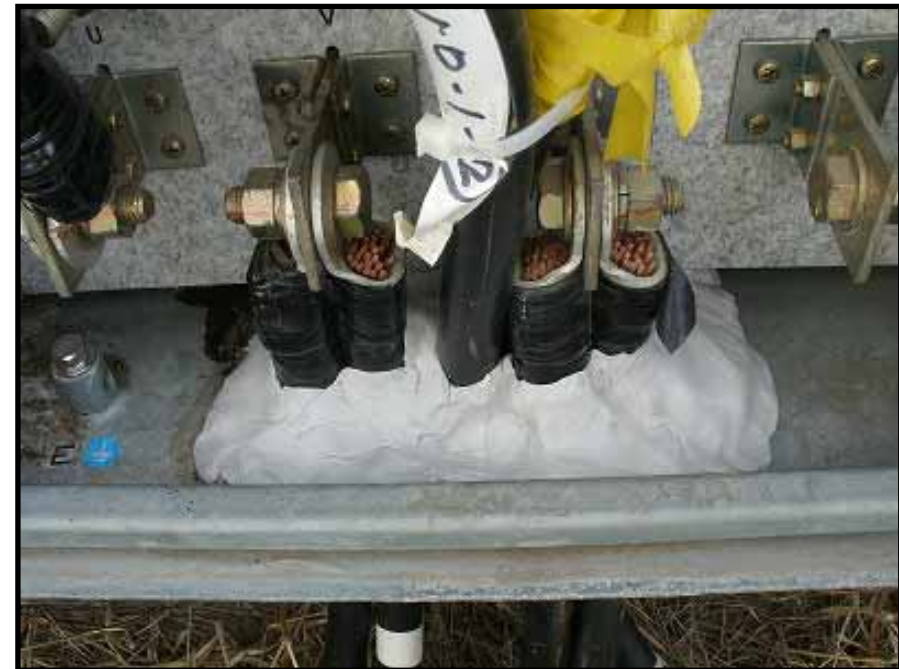
After seal was applied
