# Results of the Fifth Soundness Inspection of Unit 4 Reactor Building at Fukushima Daiichi Nuclear Power Station

May 29, 2013

Tokyo Electric Power Company

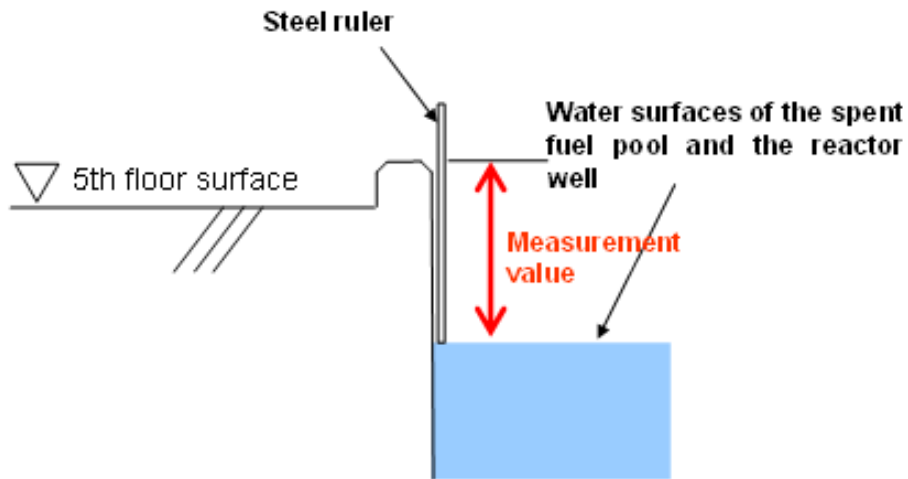
Considering that the water level measurement values on the four corners were about the same, it has been concluded that the 5th floor surface and the water surfaces of the spent fuel pool and the reactor well are parallel and the building is not tilted similarly to the past results.

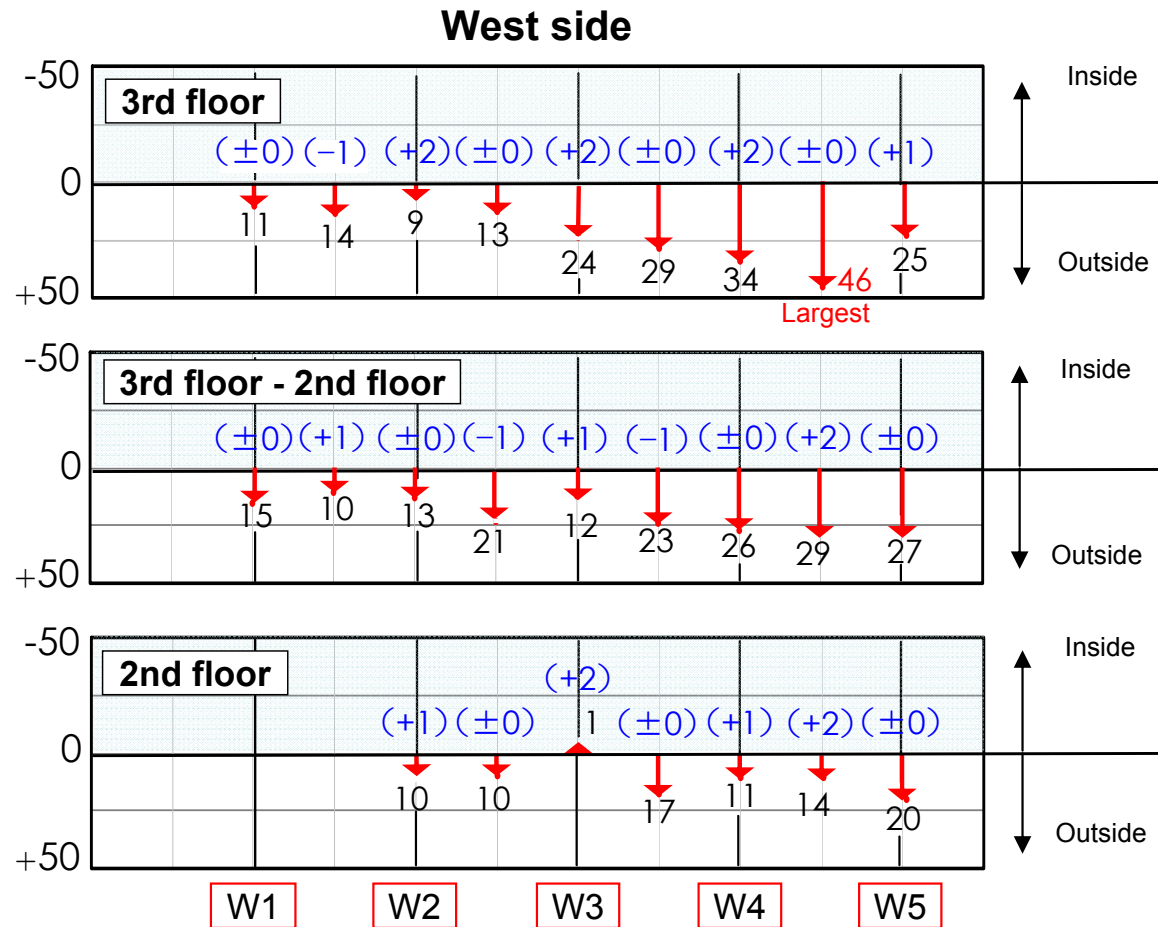
### Horizontal difference\*1 calculation results (Unit: mm)

- The horizontal differences measured this time were about the same as those in the first to fourth inspections, and the deformation characteristics on the measurement points were also similar.

- The small difference from the previous measurement results may be due to factors such as error of the optical equipment (Measurement error of  $\pm 2\text{mm}$  may cause approx. 4mm (Max.) error in horizontal difference) and thermal expansion of concrete (thermal expansion coefficient: Approx.  $7\text{-}13 \times 10^{-6}/^{\circ}\text{C}$ ) which may cause approx. 3-6mm error because of the difference of average monthly temperatures between February and May.

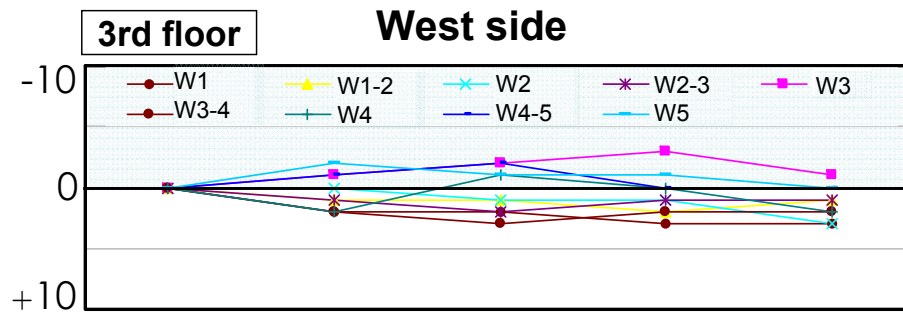
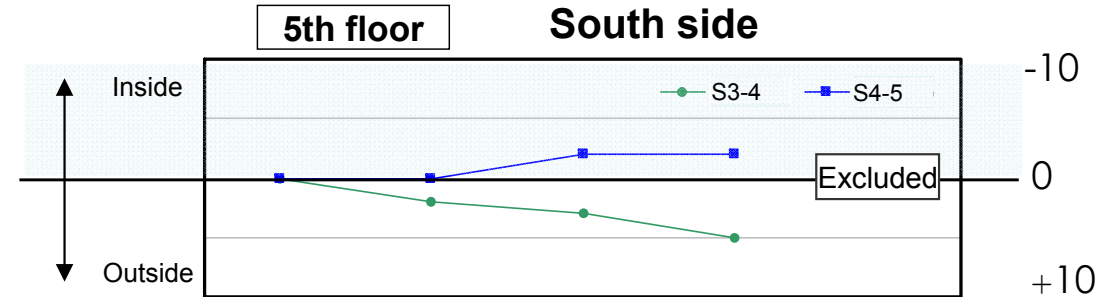
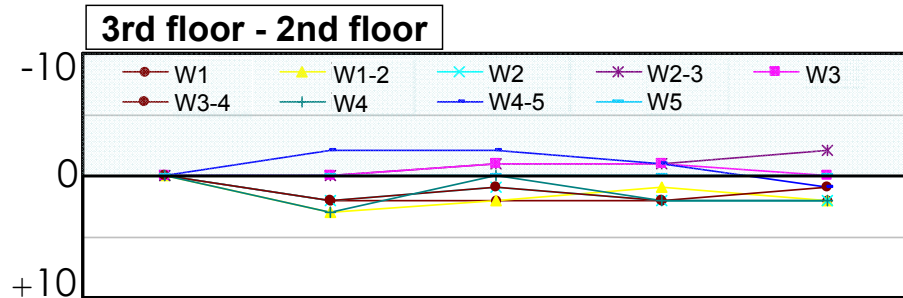
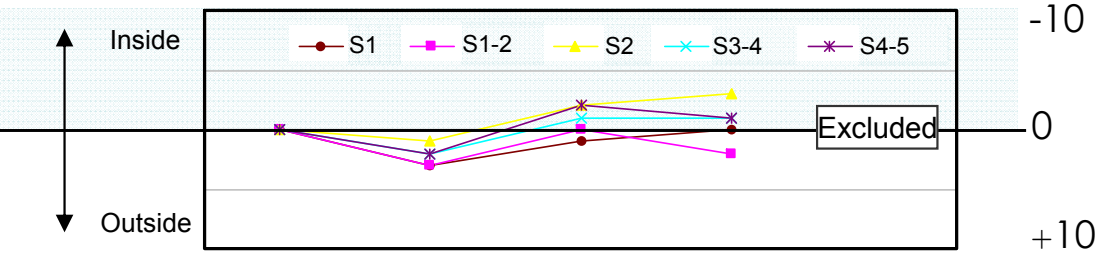
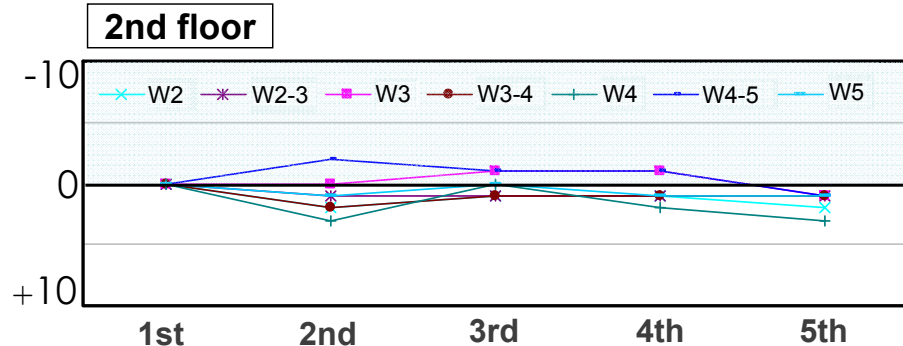
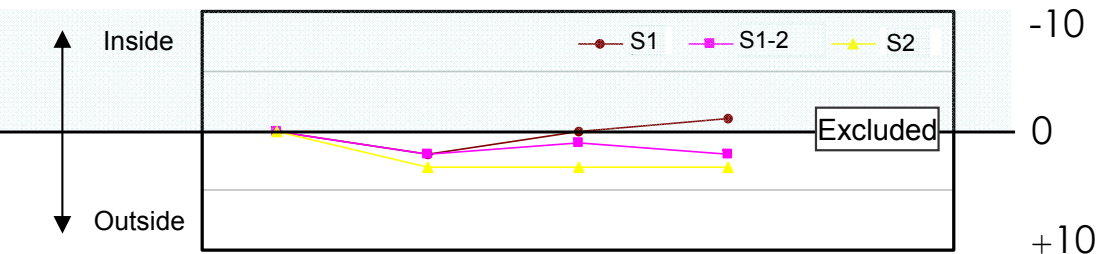
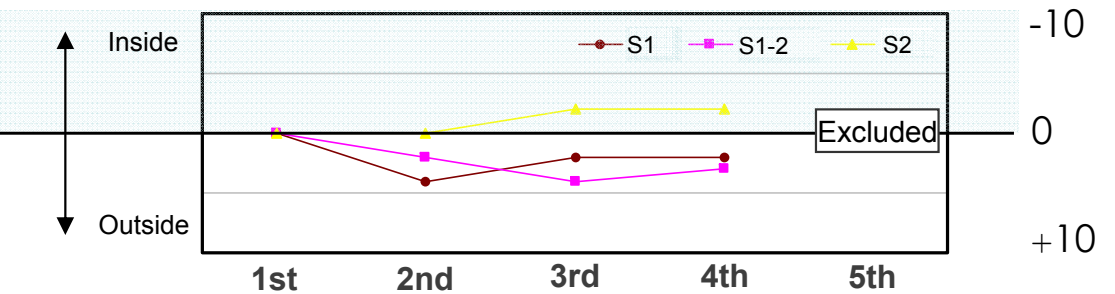
Changes in the horizontal difference over time (Unit: mm)

Based on the changes in the horizontal difference over time (from the first to fifth inspections), no tendency of building tilt was confirmed.

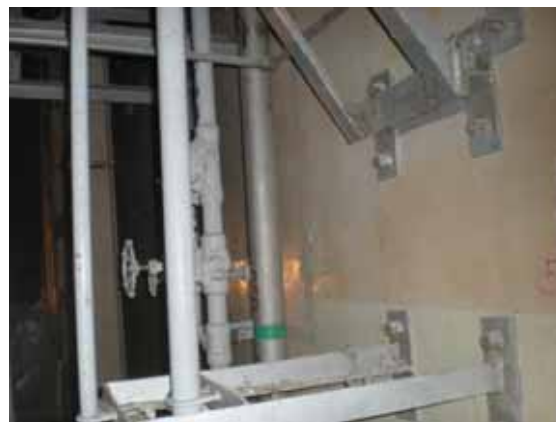
① West wall

Since no crack of a width of 1mm or more or with possible rebar corrosion was found as a result of visual inspection (similarly to the past results), it has been concluded that there is no hazardous deterioration of structural durability.

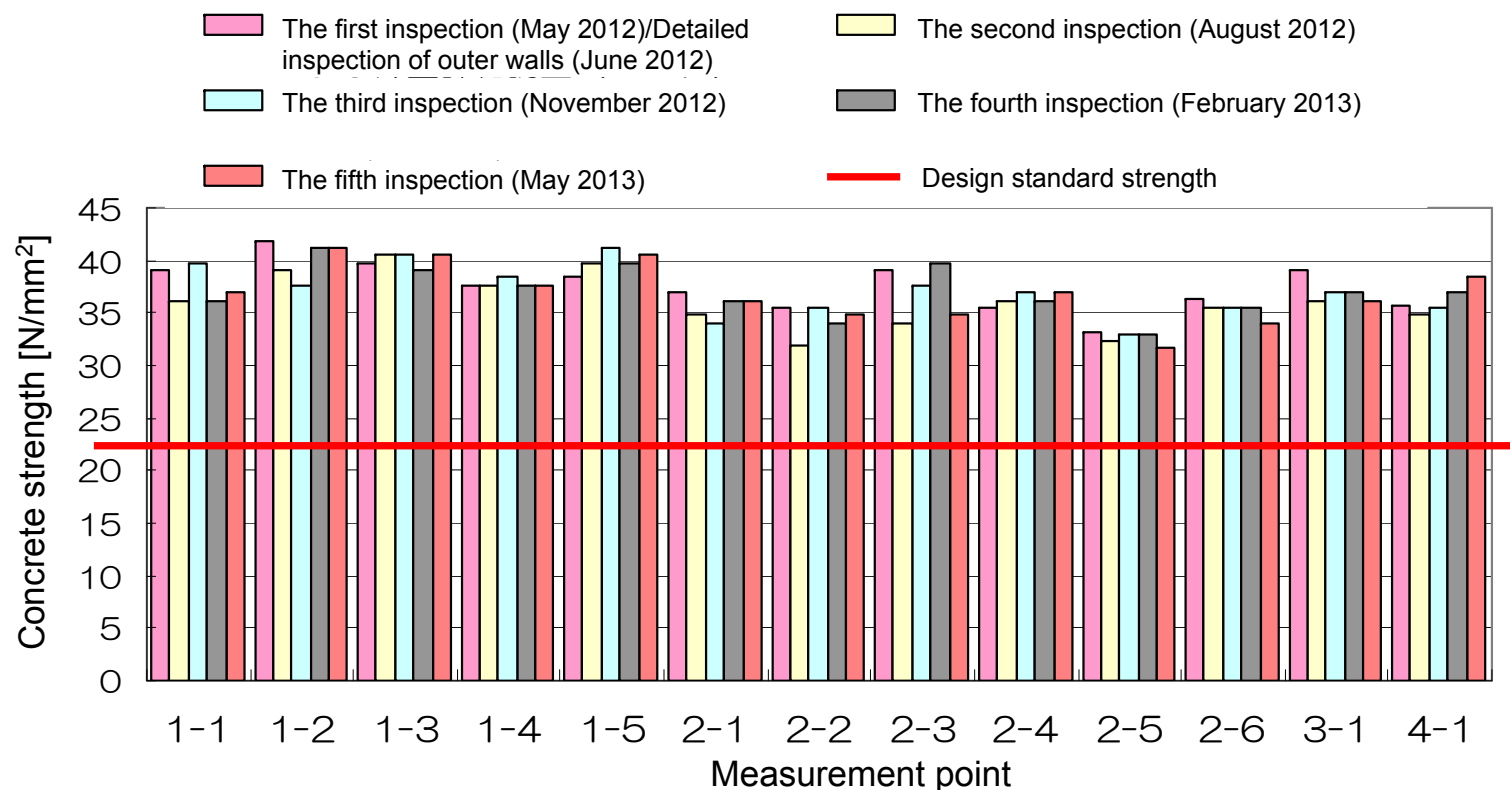
### Concrete strength evaluation results

As a result of measurement, the concrete strengths on all the measurement points were above the design standard (22.1N/mm<sup>2</sup>) similarly to the past results. The concrete strength is considered to be about the same as the past results taking into considerations the error of Schmidt Hammer\*<sup>1</sup> and that the measurement points were set at slightly different locations from the previous ones.
