# **Results of Groundwater Quality Survey at the East Side of the Turbine Building at Fukushima Daiichi NPS**

**June 19, 2013**

**Tokyo Electric Power Company**

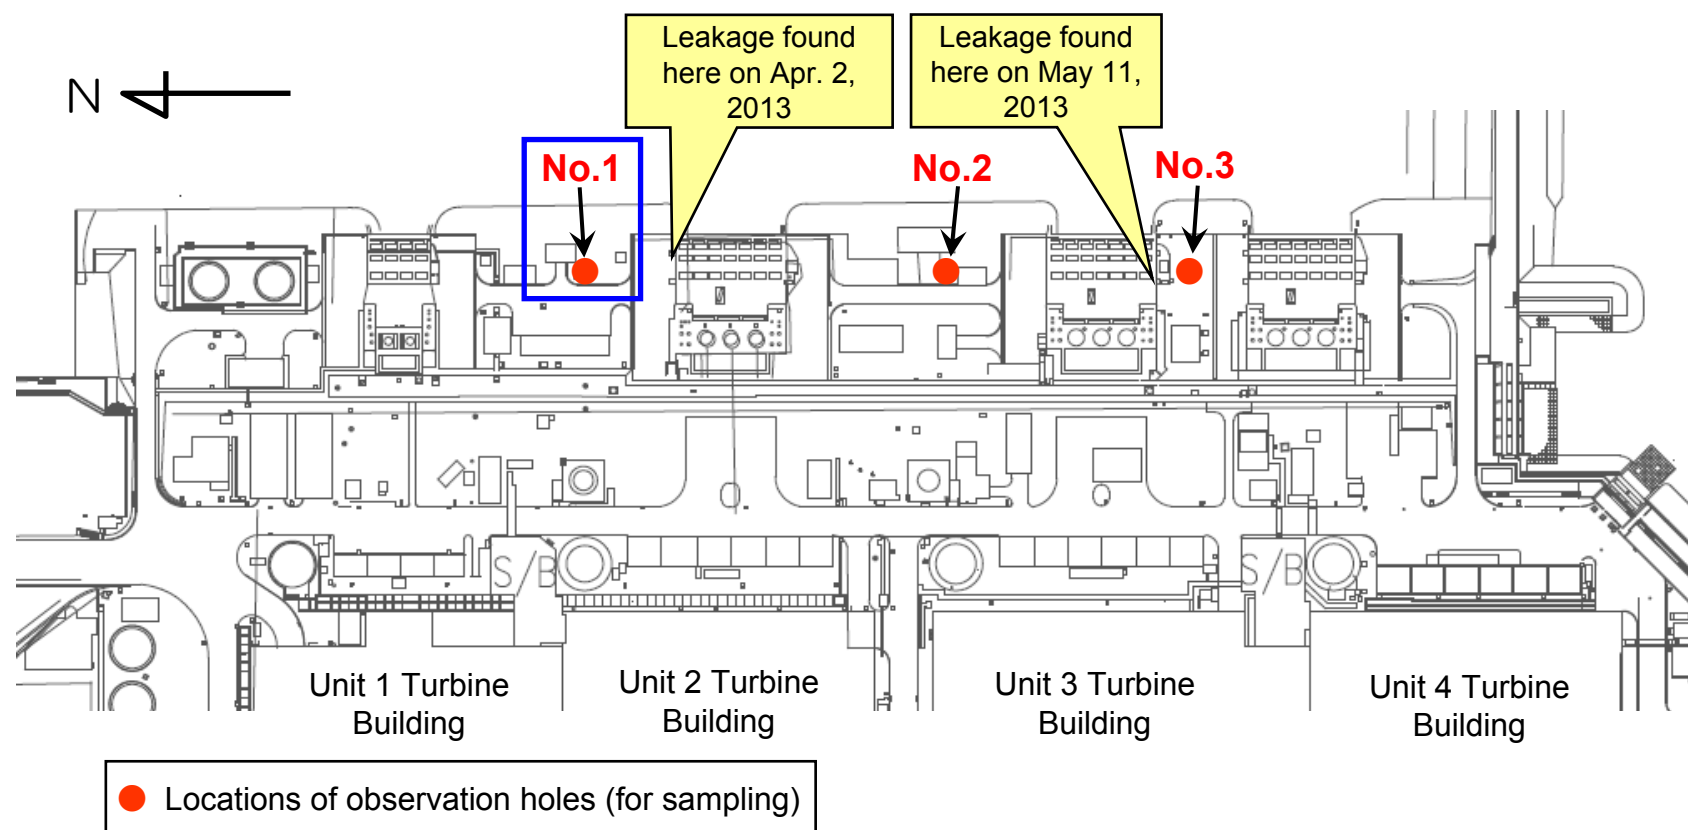
### Groundwater sampling locations east of the turbine buildings

- In order to confirm whether contaminated water currently still remains under the ground due to the leakage of accumulated water, observation holes (drilled to about -16m G.L.) were installed at 3 locations near the bank protection between the Unit 1-4 water intakes, and groundwater was sampled through the holes for measurement.

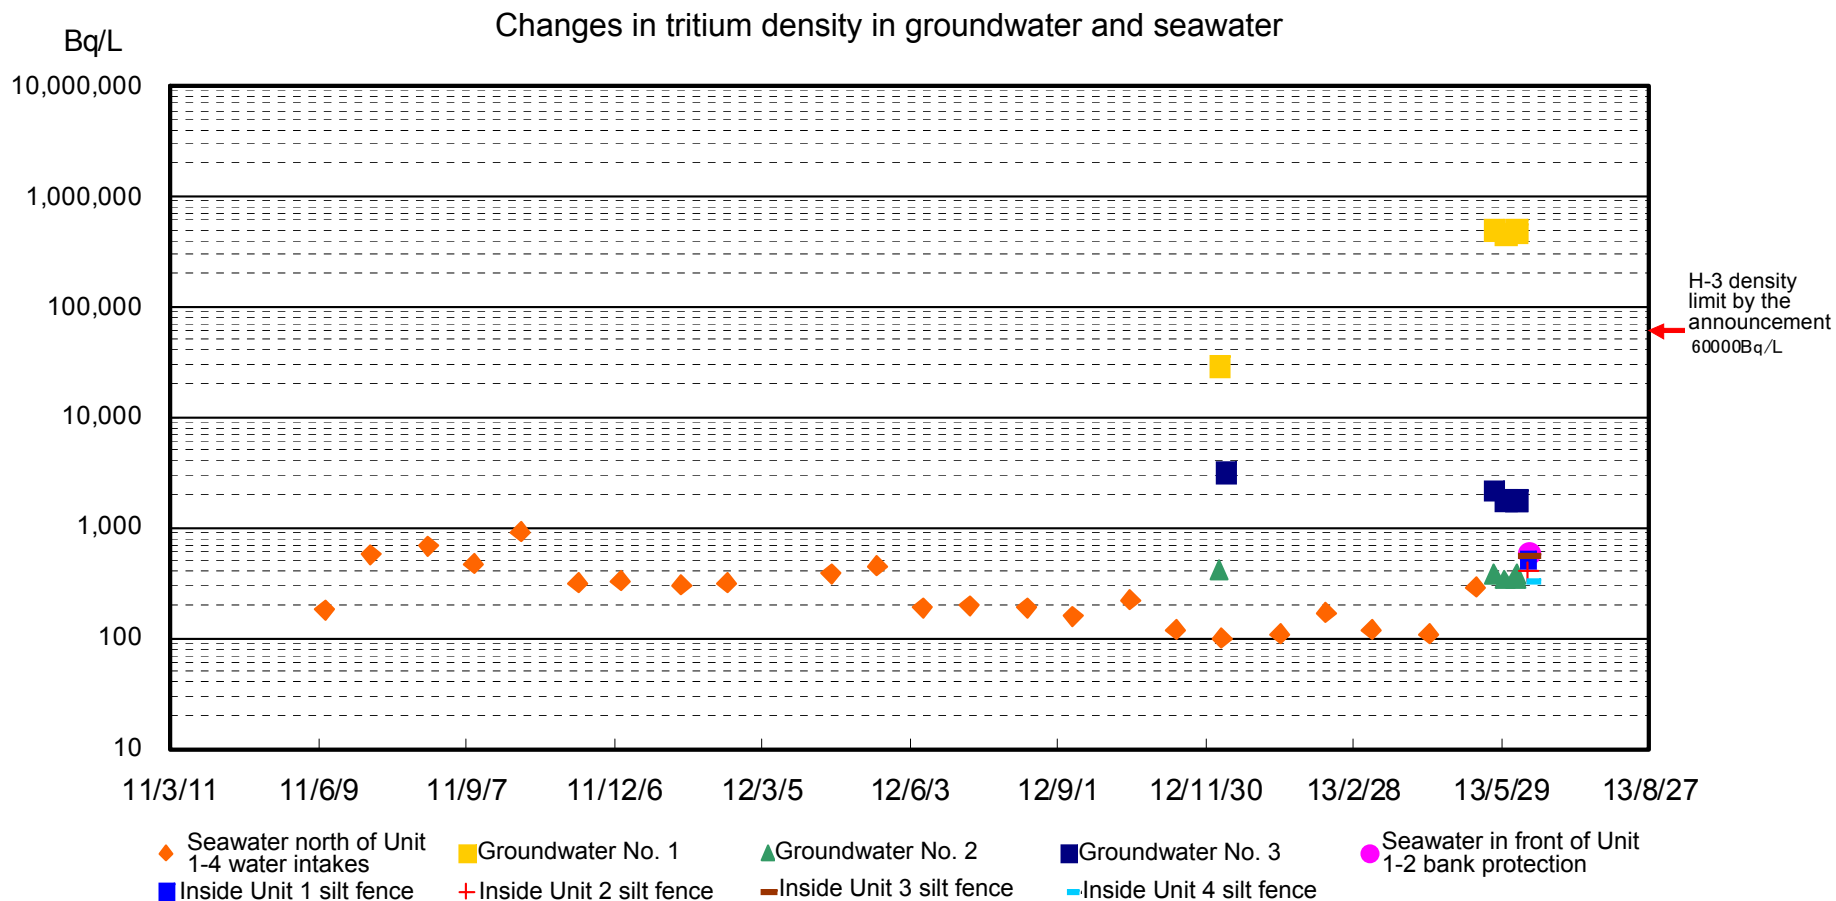
# Assessment through Comparison with Water Quality of Seawater in the Port (1/2)

○ No location showed a particularly high value as the tritium density in seawater in the port. We will continue monitoring seawater as well as groundwater.

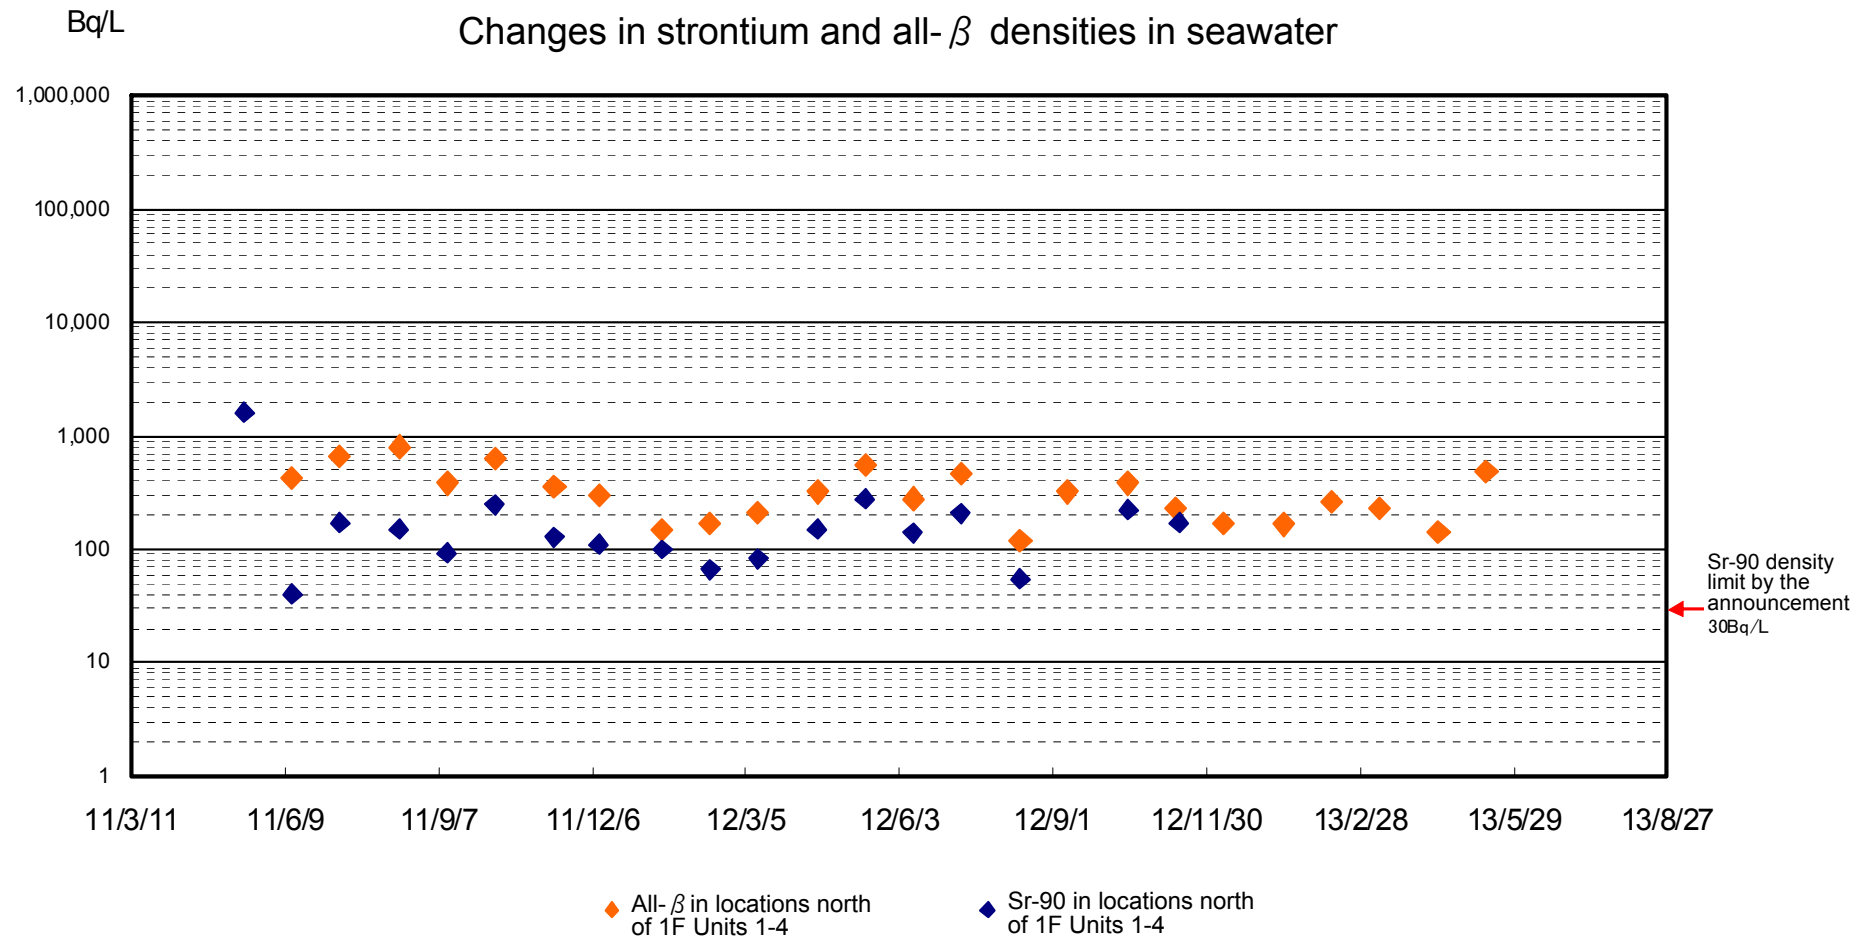
# Assessment through Comparison with Water Quality of Seawater in the Port (2/2)

○ No location showed a particularly high all-β density. We will continue monitoring.

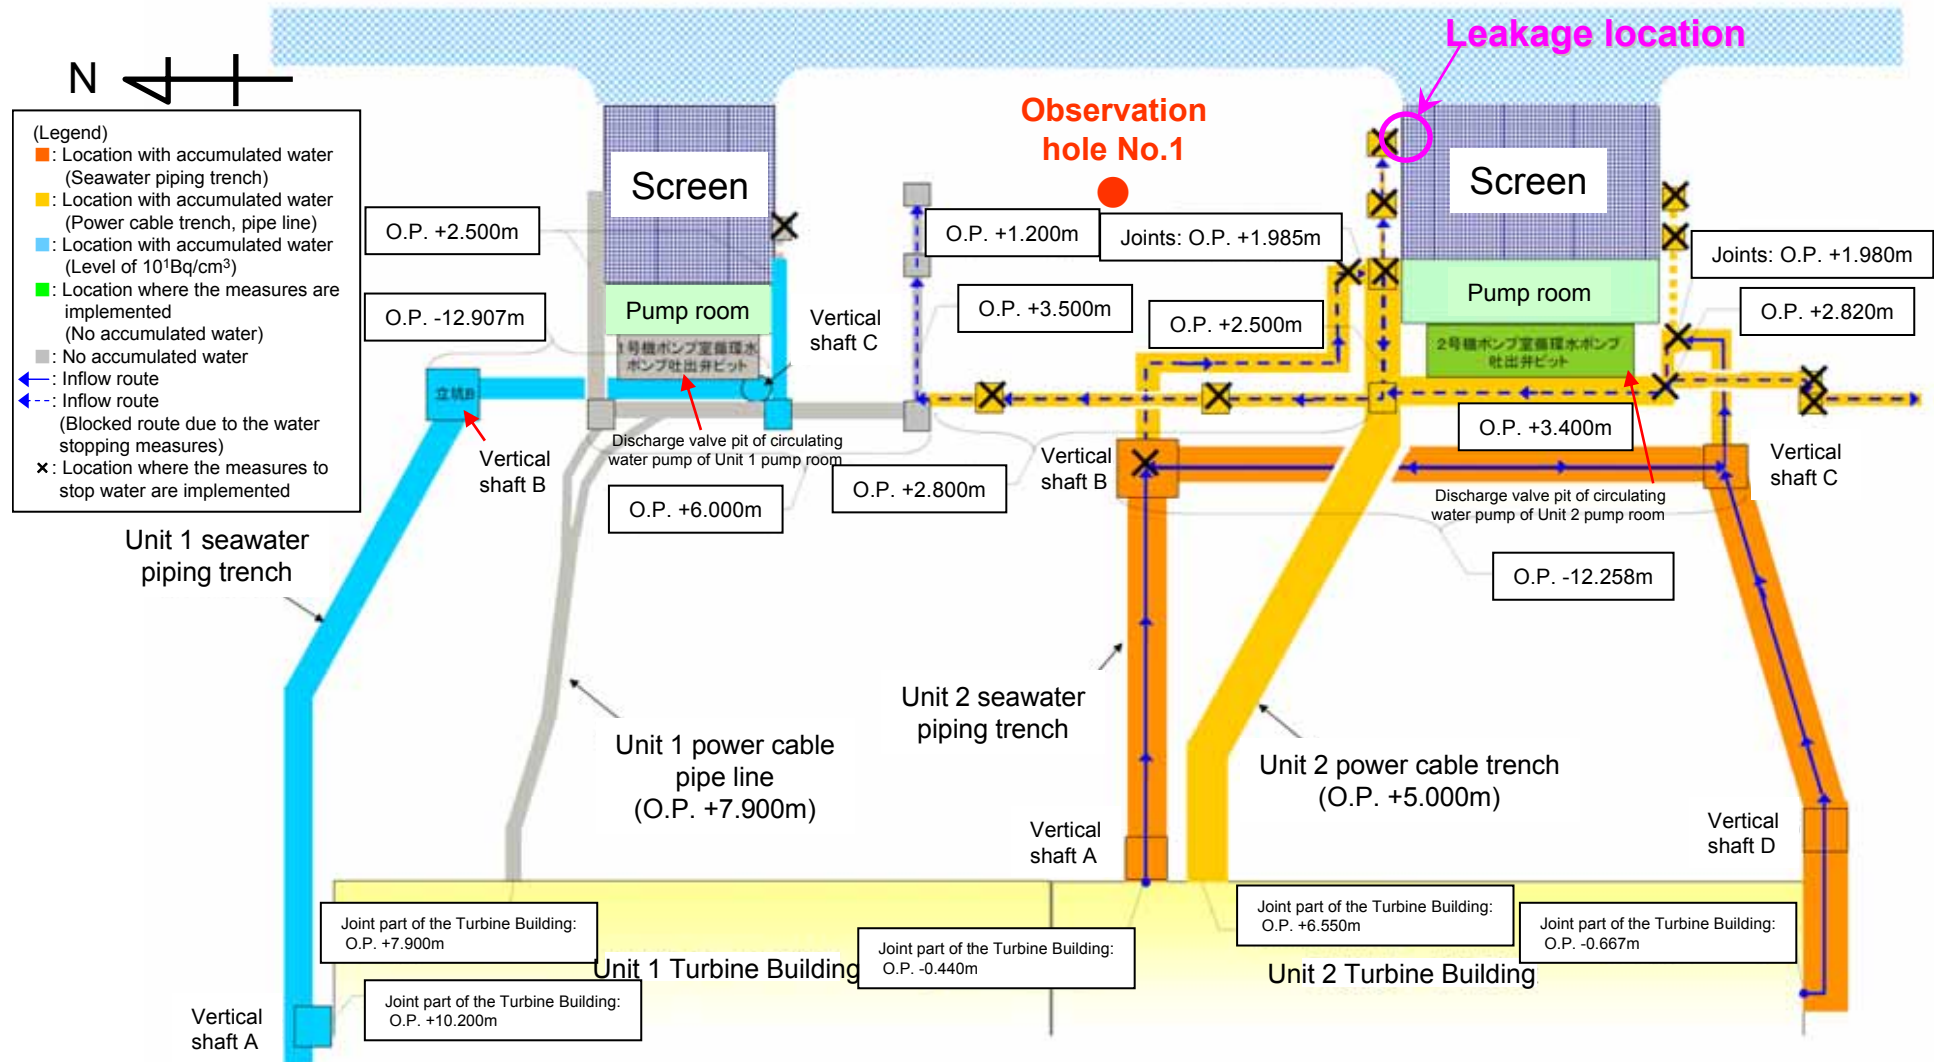
# Blocking of the Pit at the East Side of the Turbine Building (Units 1 and 2)

- The pit was basically blocked, so there is a possibility that contaminated water remains in the trench.

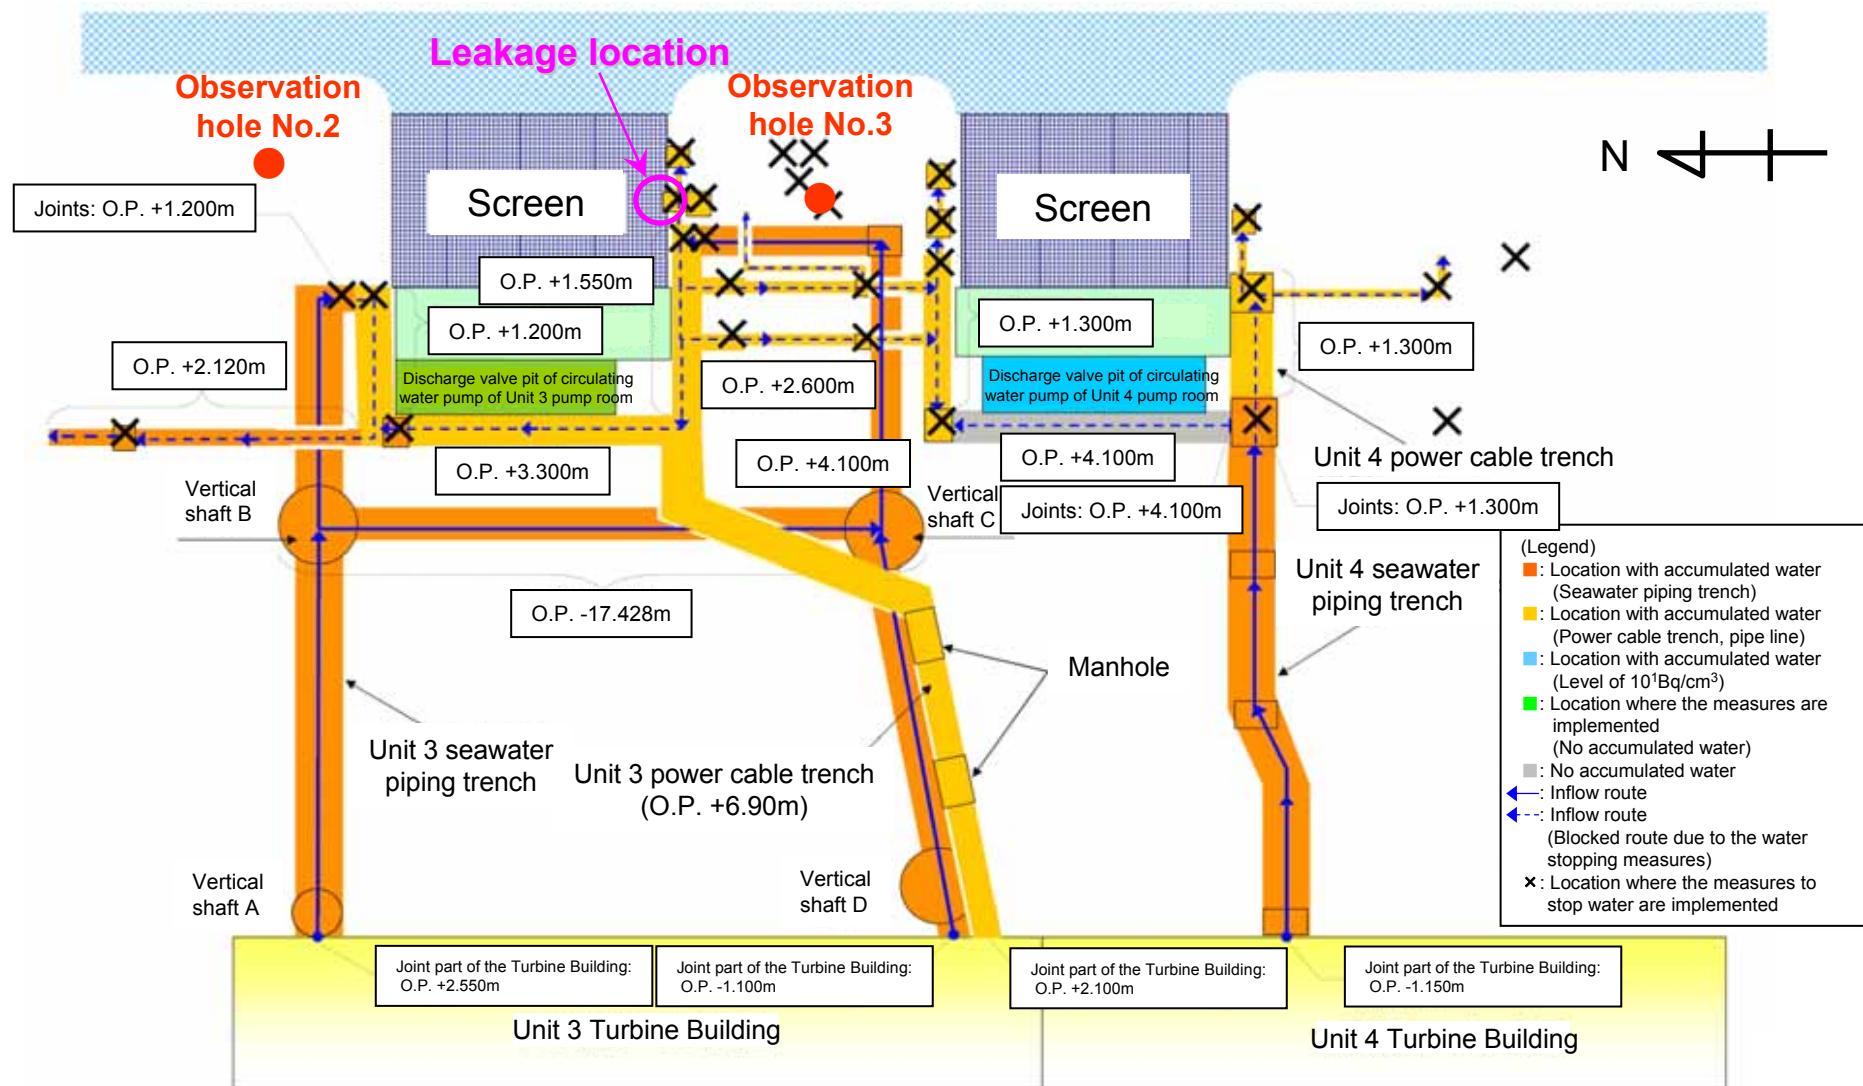
# Blocking of the Pit at the East Side of the Turbine Building (Units 3 and 4)

- The pit was basically blocked, so there is a possibility that contaminated water remains in the trench.
