# Results of Survey on Upper Space in 1st Floor of Fukushima Daiichi Nuclear Power Station Unit 2 Reactor Building

June 19, 2013

Tokyo Electric Power Company

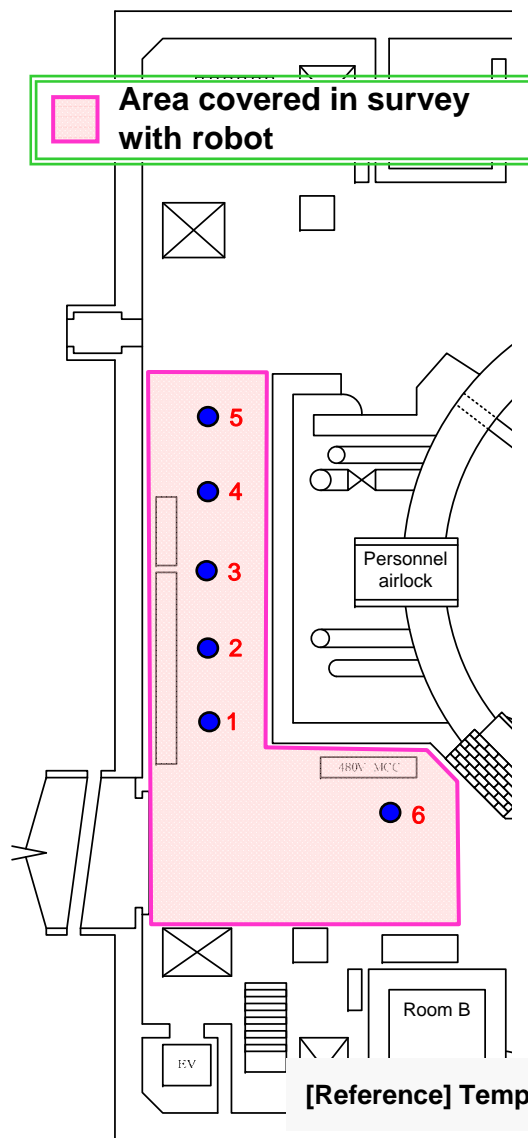
Measurement point	[Reference] National project survey (end of May 2012) 0.05m	[Reference] National project survey (end of May 2012) 1.5m	2.5m	3.5m	Maximum height reached	
					Dose rate	Height [m]
[1]	11	17	12	.	.	.
[2]	8	11	10	12	13	4.0
[3]	7	11	.	.	10	2.1
[4]	8	13	.	.	6	1.6
[5]	7	9	7	9	10	4.0
[6]	15	16	13	17	19	4.3

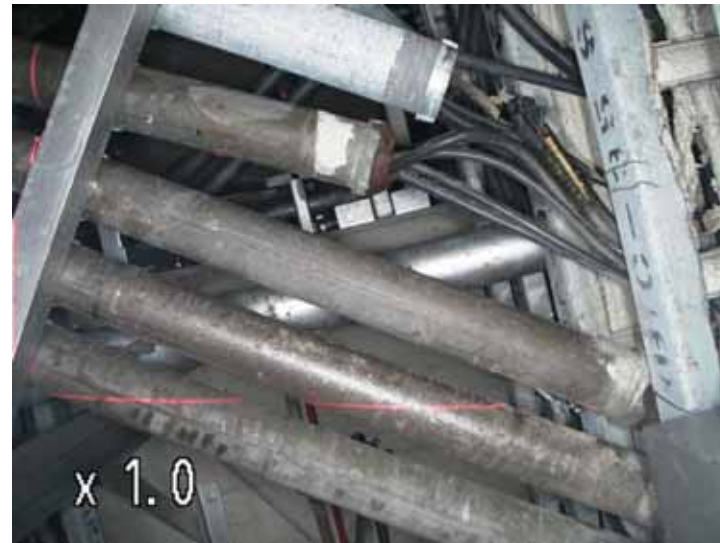
Picture point (1): Conditions of the ceiling

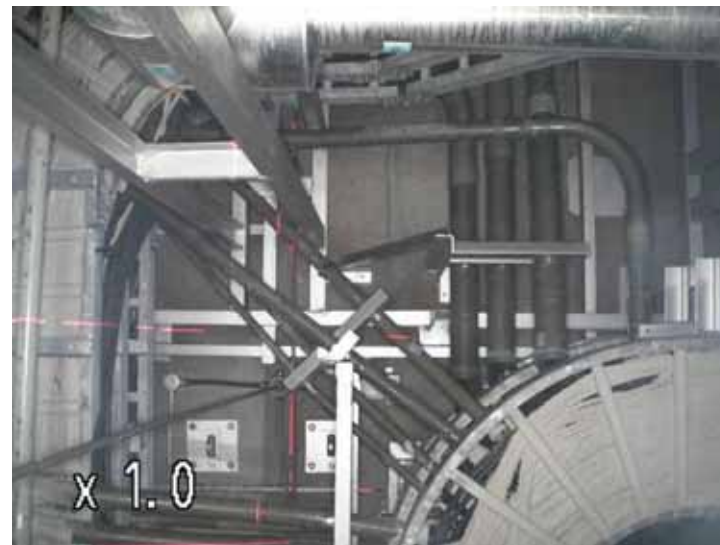
Picture point (2): Conditions of the ceiling

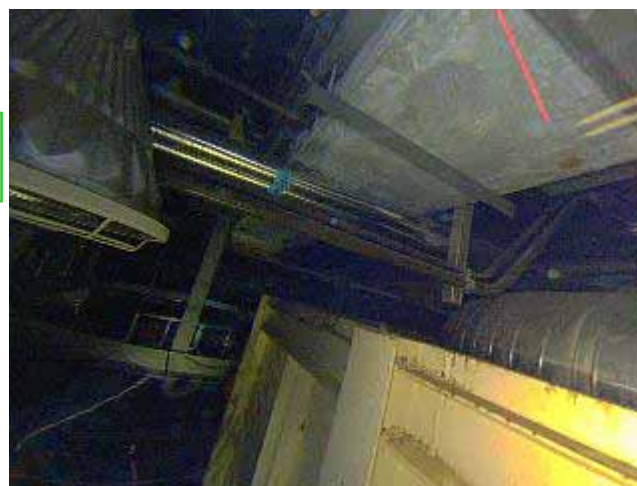
Picture point (3): Upper part at the wall surface side (4.0m from the floor)

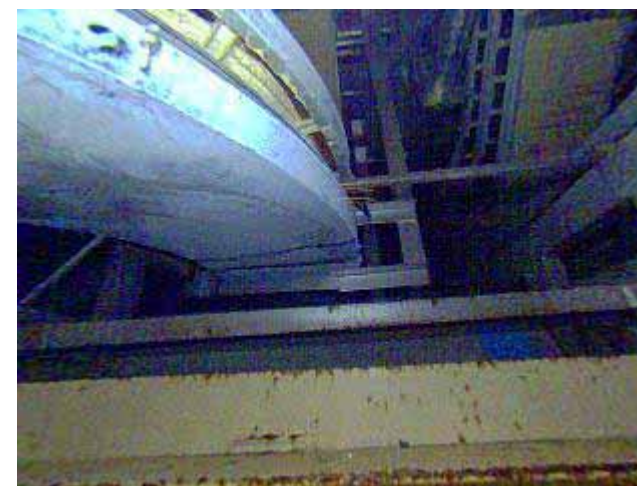
Picture point (4): Upper part at the wall surface side (4.0m from the floor)

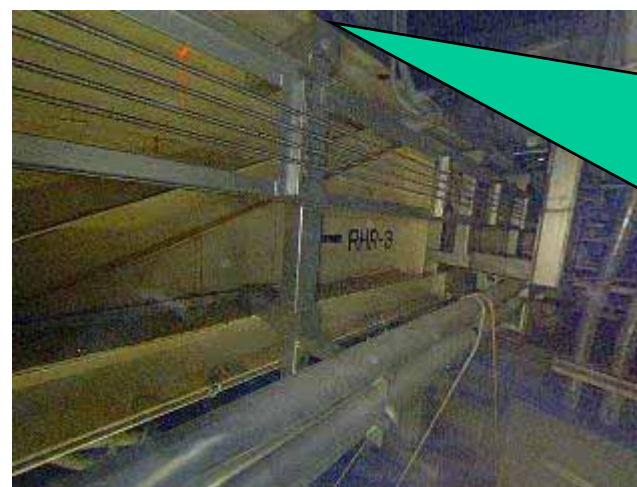
Picture point (5): Upper part at the wall surface side (3.5m from the floor)

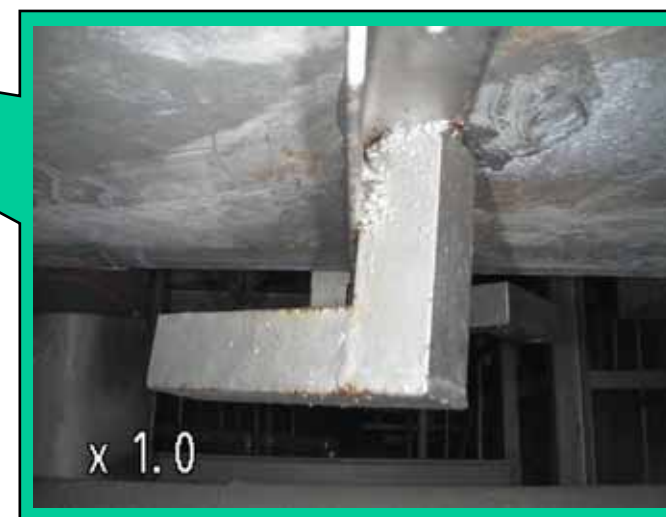
Picture point (5): Clearance in the upper part at the wall surface side (4.3m from the floor)
