Leakage from the Desalination System (RO3) at Fukushima Daiichi Nuclear Power Station

<Reference>
June 21, 2013
Tokyo Electric Power Company

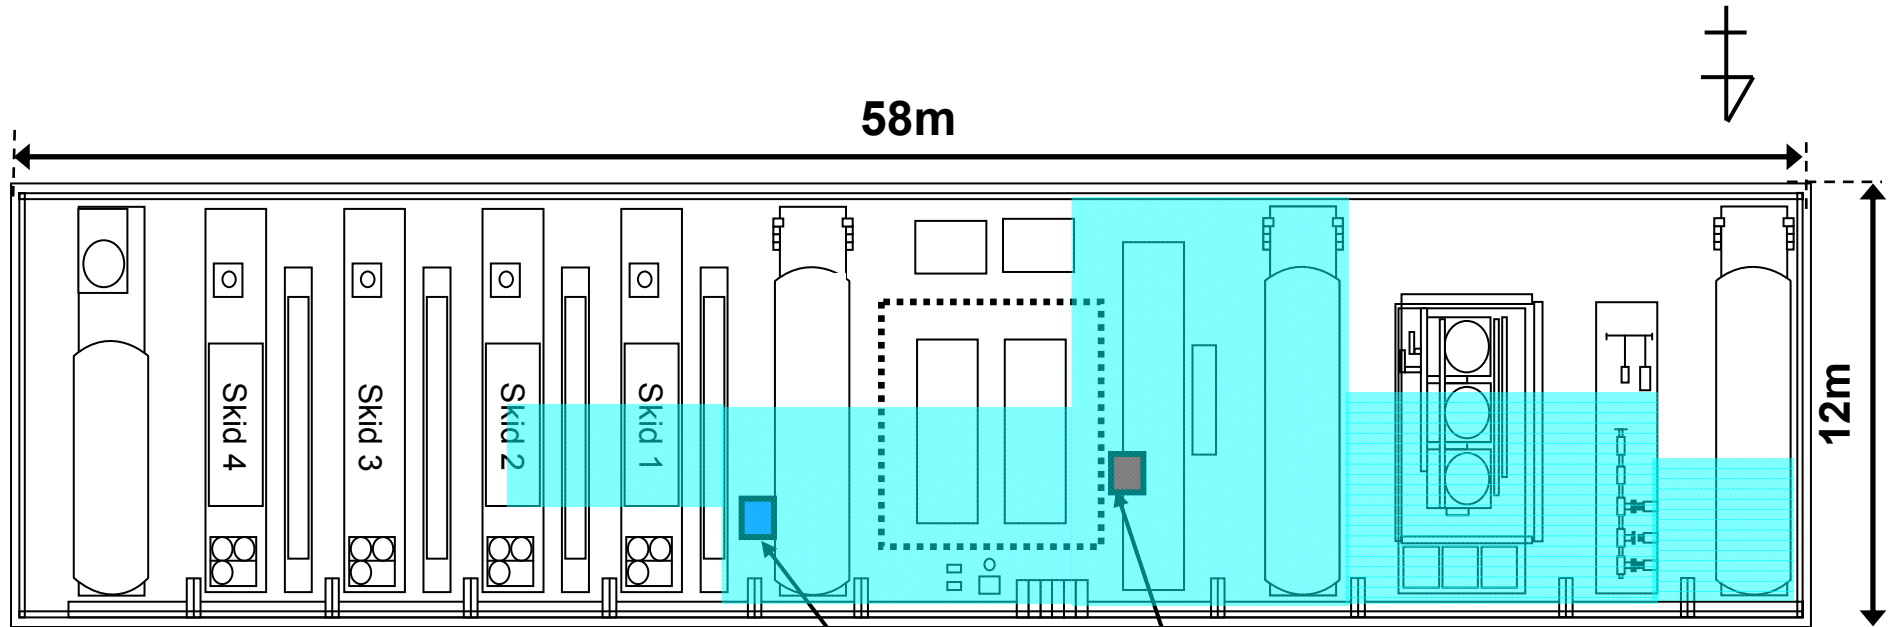
Leakage Situation in the Temporary Warehouse of the Desalination System (RO3)

: leaked area (250m²)

Estimated leakage amount: 250 liters
($\approx 250\text{m}^2 \times \text{depth } 1\text{mm}$)

Leak detector

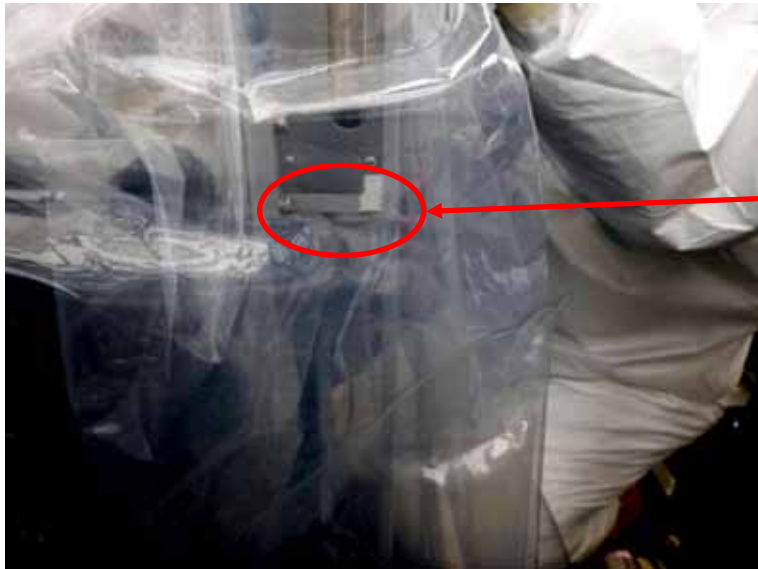
Identifying work of the leakage location

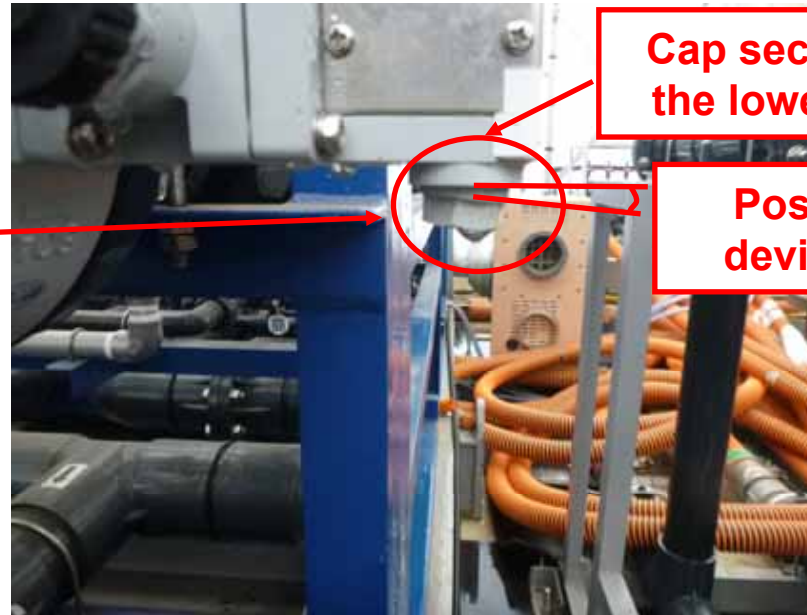
Before the identifying work of the leakage location

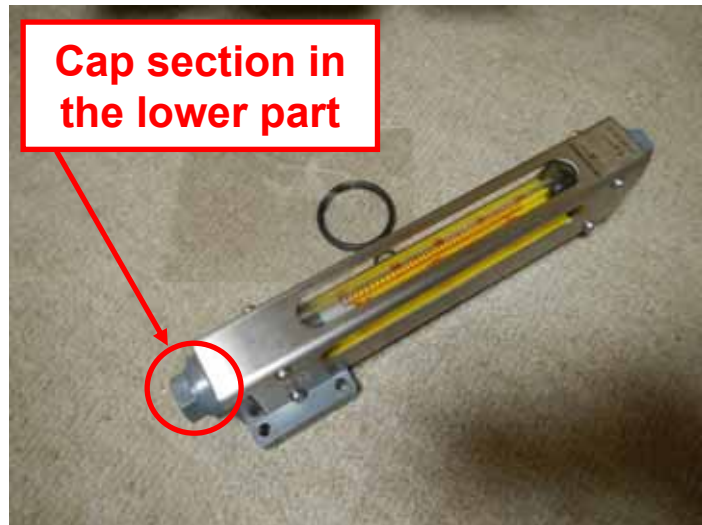
New flow meter

7. At around 3:00 PM, the flow meter was replaced to a new one.
- Estimated leakage amount: Approx. 250 liters
- Nuclide analysis results
 - Cs134: $5.7 \times 10^{-1} \text{Bq/cm}^3$, Cs137: $1.7 \times 10^0 \text{Bq/cm}^3$

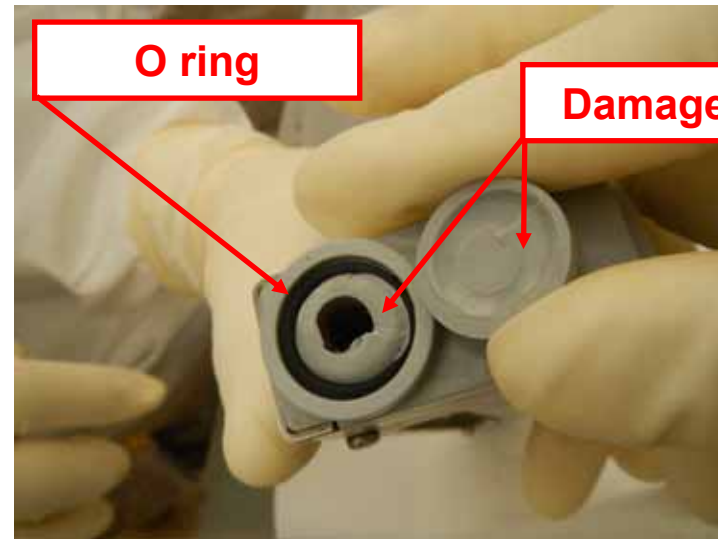
- All β : $2.6 \times 10^4 \text{Bq/cm}^3$
- Estimated cause: The cap section in the lower part of the flow meter was removed when the ultra filter was cleaned on June 20. The cause of the leakage is estimated to be cracks occurred at the neck part of the cap because the cap was tightened too much after the cleaning.

After the cap section in the lower part of the flow meter was removed (neck part of the cap was damaged)

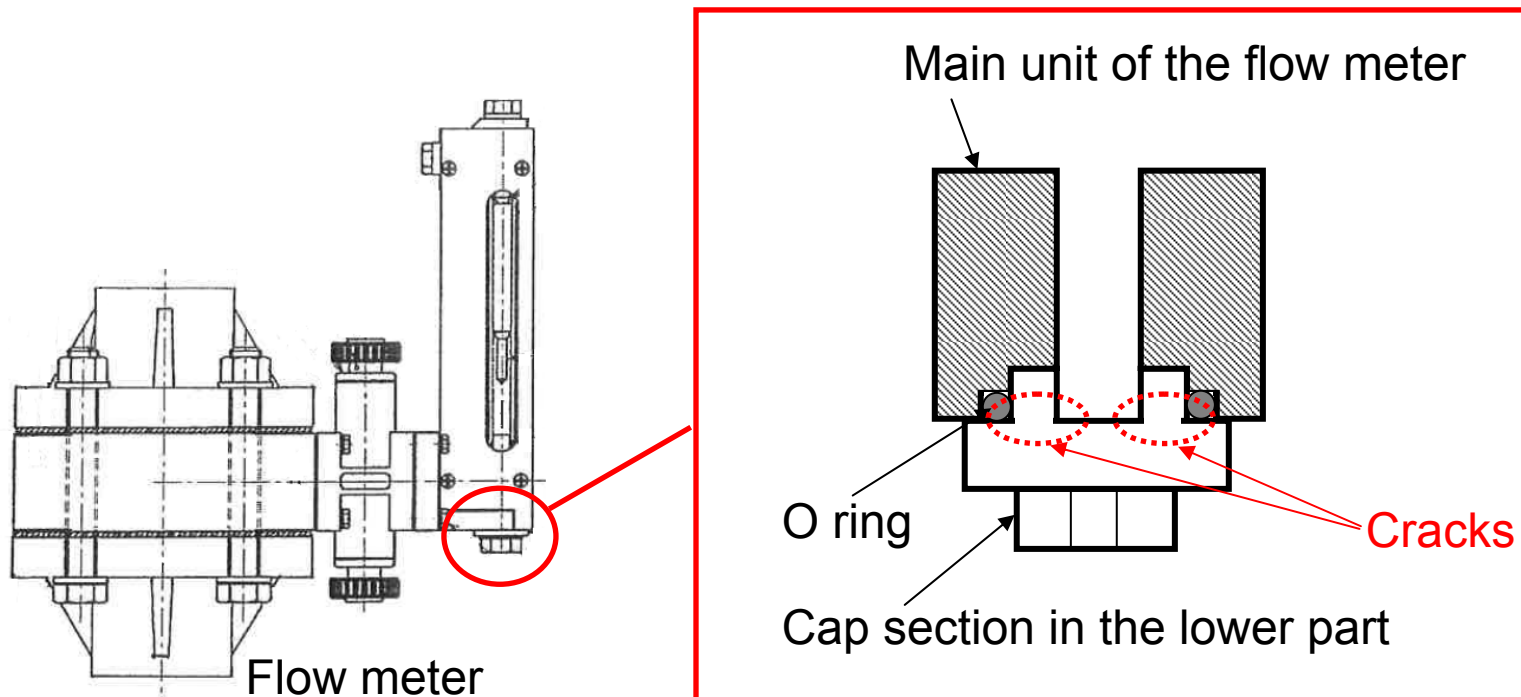
Estimated Leakage Mechanism

The cap section in the lower part of the flow meter was removed when the ultra filter was cleaned on June 20. The cause of the leakage is estimated to be cracks occurred at the neck part of the cap because the cap was tightened too much after the cleaning.

(No leakage was found at a leakage check utilizing pump operating pressure after the restoration work. Sealing performance of the flow meter is estimated to be maintained by the O rings at that moment.)
