Inspection Results of the Batch Treatment Tank 2A of Multi-nuclide Removal Equipment (ALPS) in Fukushima Daiichi Nuclear Power Station

<Reference>
July 2, 2013

Tokyo Electric Power Company

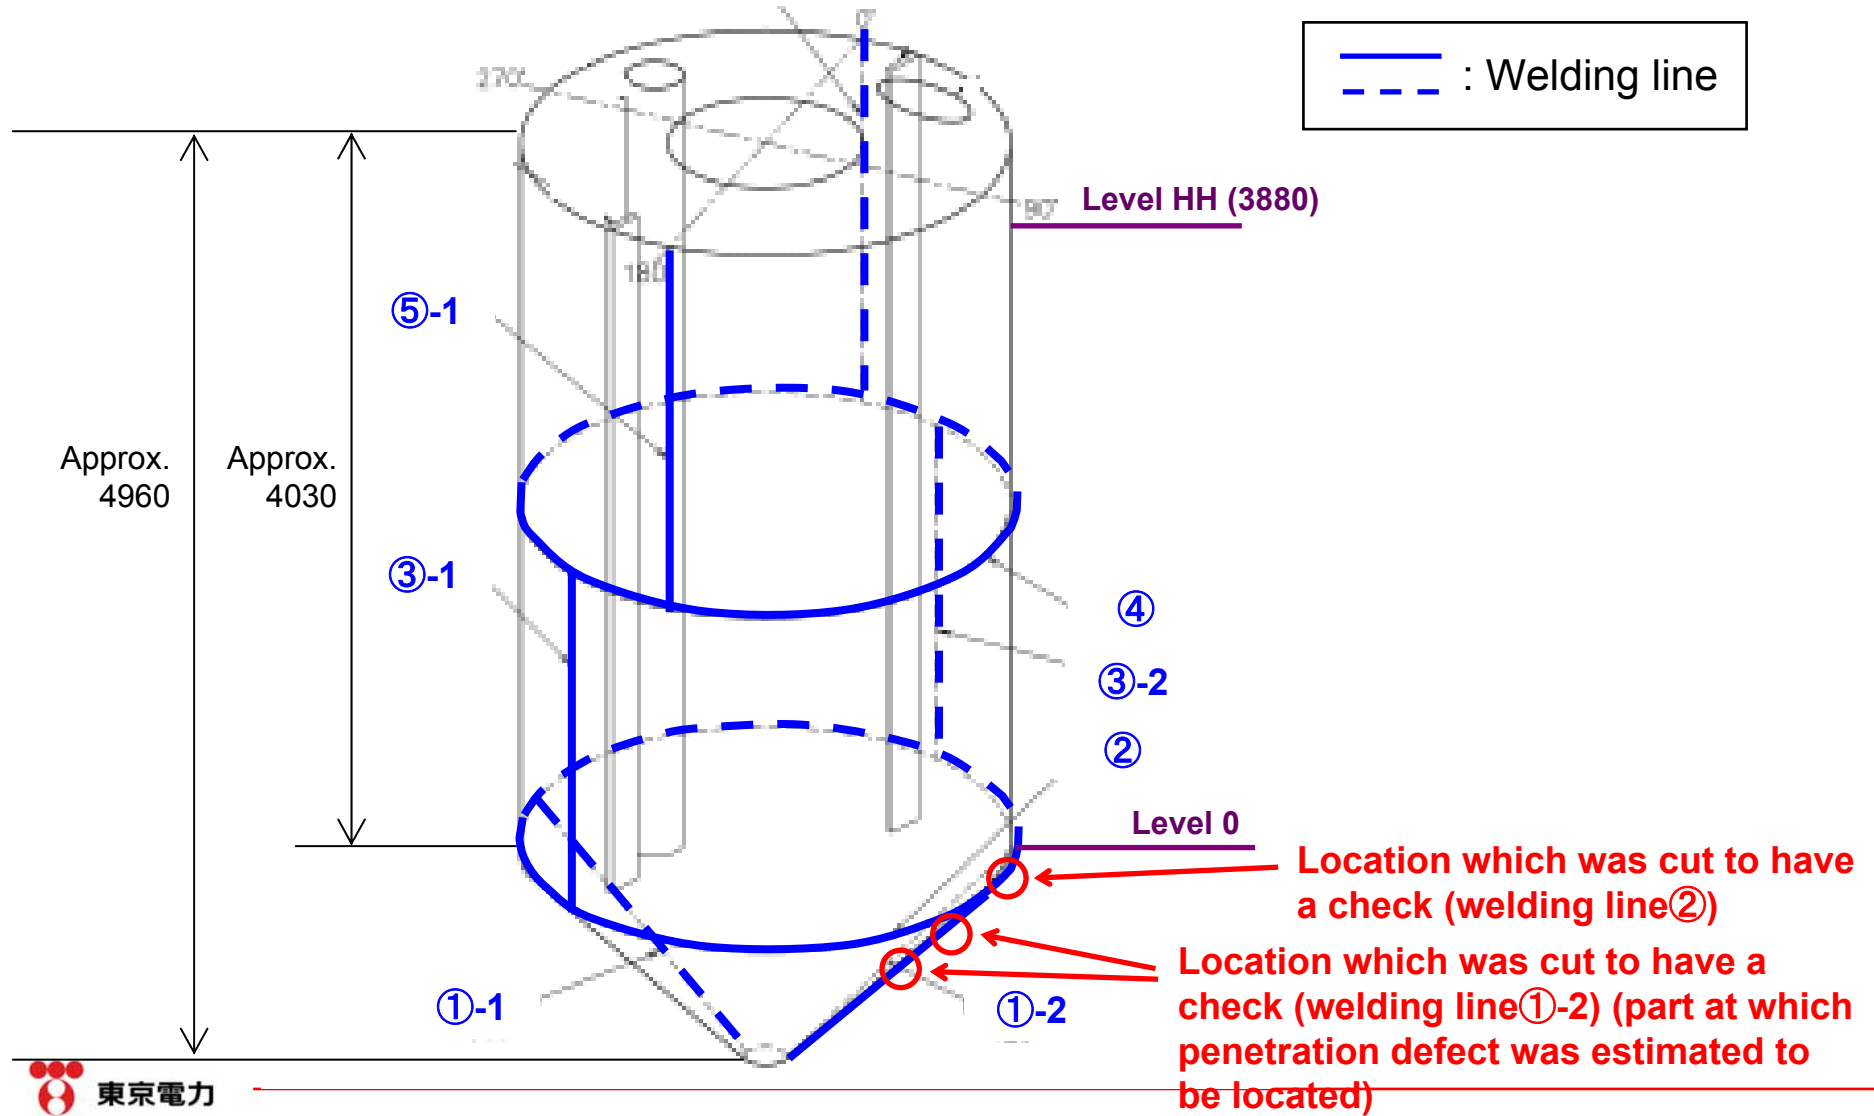
■ The bottom part of the batch treatment tank 2A, where penetrant testing (PT) was performed before, was cut in order to have a check.

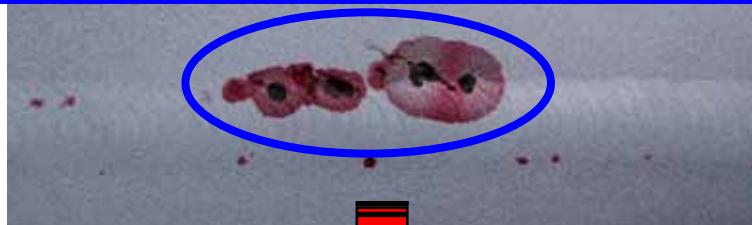
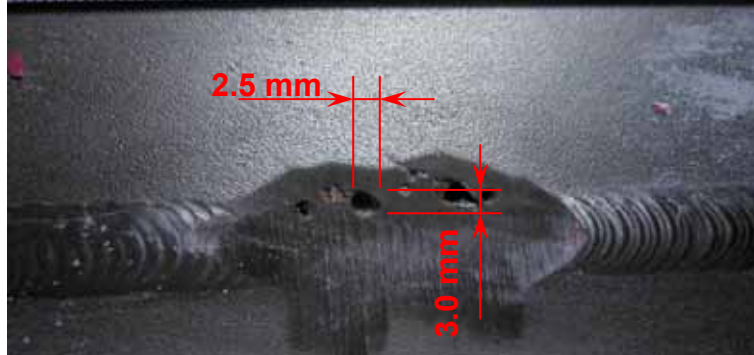
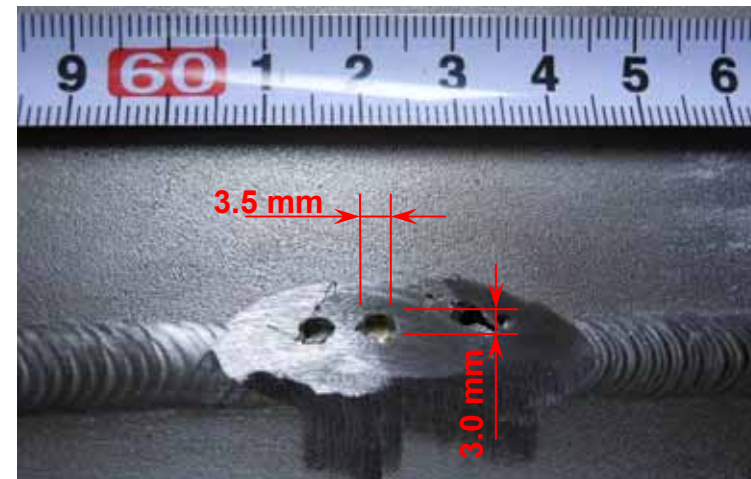
Parts at which penetration defect were estimated to be located by external surface penetrant testing (1)

- Parts at which penetration defects were estimated to be located by external surface penetrant testing at the batch treatment tank 2A was cut in order to have a check (1) (vertical welding line ①-2 at the conical part, approx. 70 cm from the lower edge).

↑ Cut length: 2.60mm

← Cut length: 2.40mm

Some defects were found vanishing, by a gradual cutting. However, bag-like defect was also found, which was gradually widening.

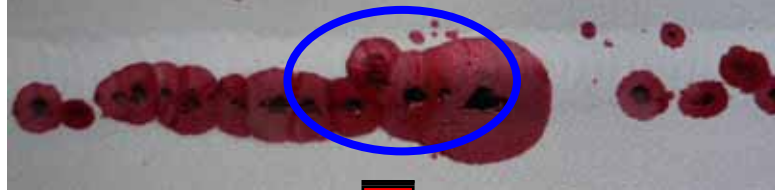
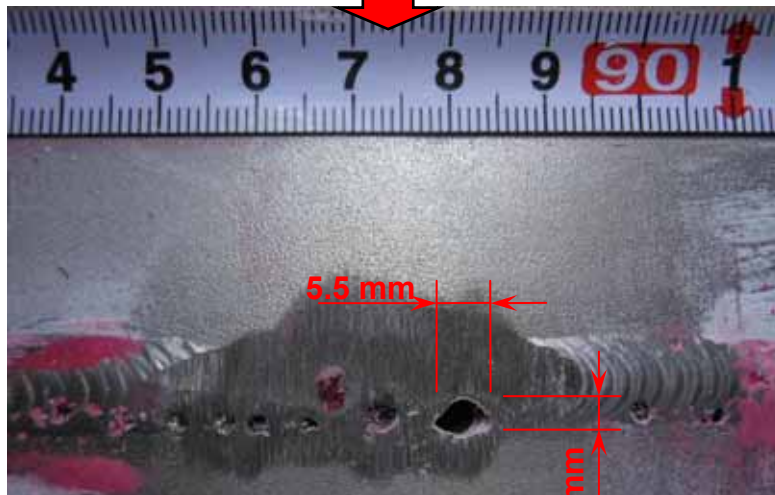
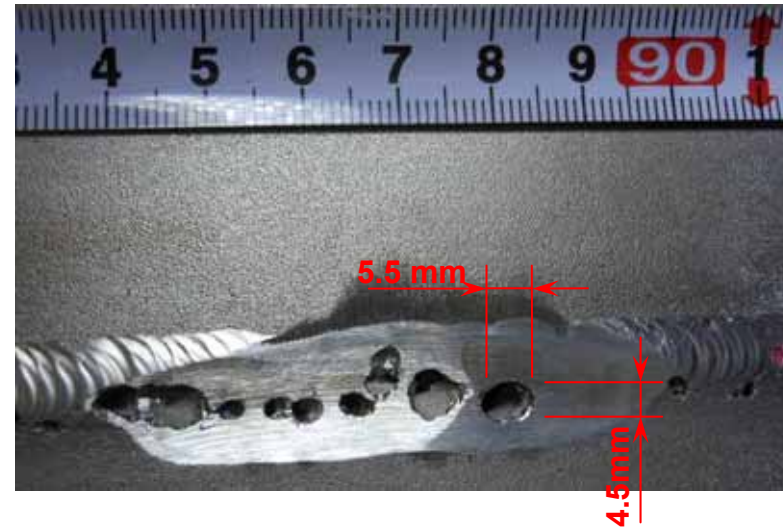
Parts at which penetration defect were estimated to be located by external surface penetrant testing (2)

- Parts at which penetration defects were estimated to be located by external surface penetrant testing at the batch treatment tank 2A was cut in order to have a check (2) (vertical welding line ①-2 at the conical part, approx. 100 cm from the lower edge).

↑ Cut length: 2.40mm

← Cut length: 1.70mm

Some defects were found vanishing, by a gradual cutting. However, bag-like defect was also found, which was gradually widening.

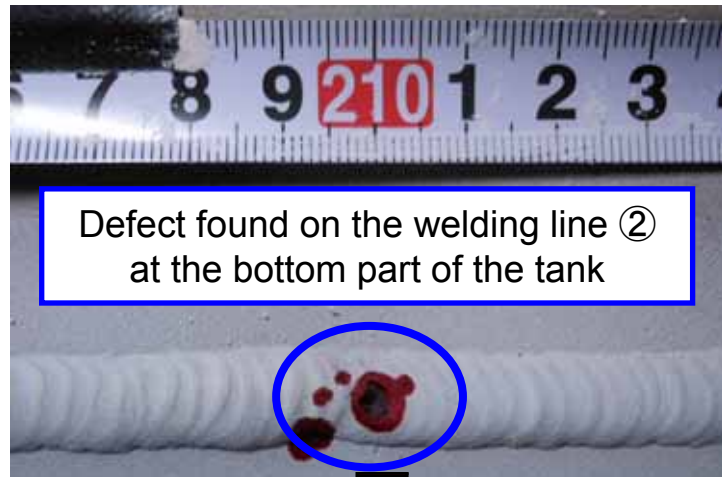
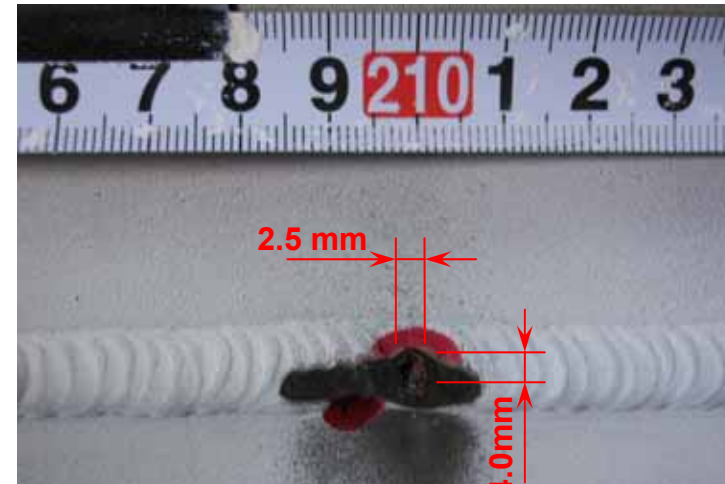
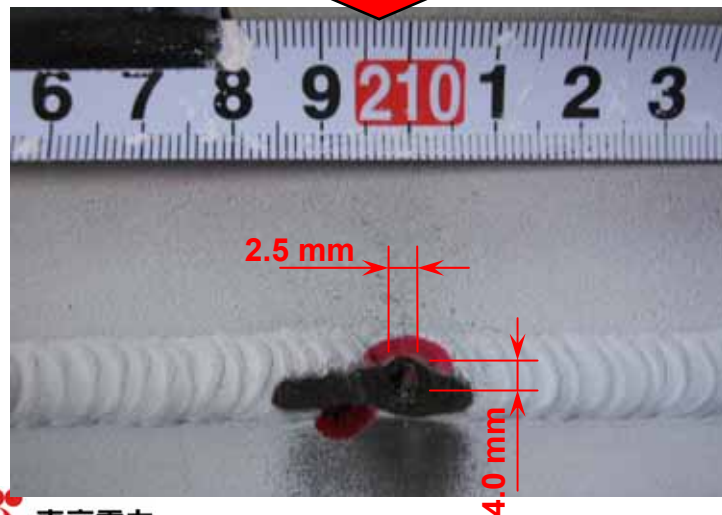
- Major parts at which penetration defects were estimated to be located by internal surface penetrant testing at the batch treatment tank 2A was cut in order to have a check (2) (welding line ② around the conical part).

↑ Cut length: 2.80mm

← Cut length: 0.13mm

Bag-like defect was found, which was gradually widening, by a gradual cutting.
