Results of Soundness Inspection of Unit 2 TIP Guide Pipe (4th Day)

July 11, 2013

Tokyo Electric Power Company

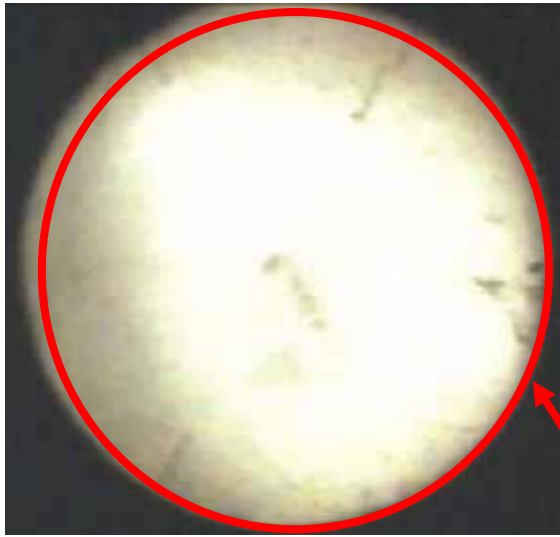
At the location near but short of the indexing device

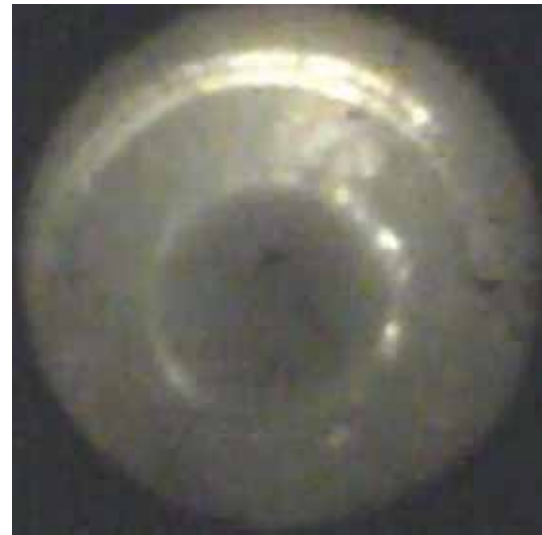
Near the location reached previously

Attached substances

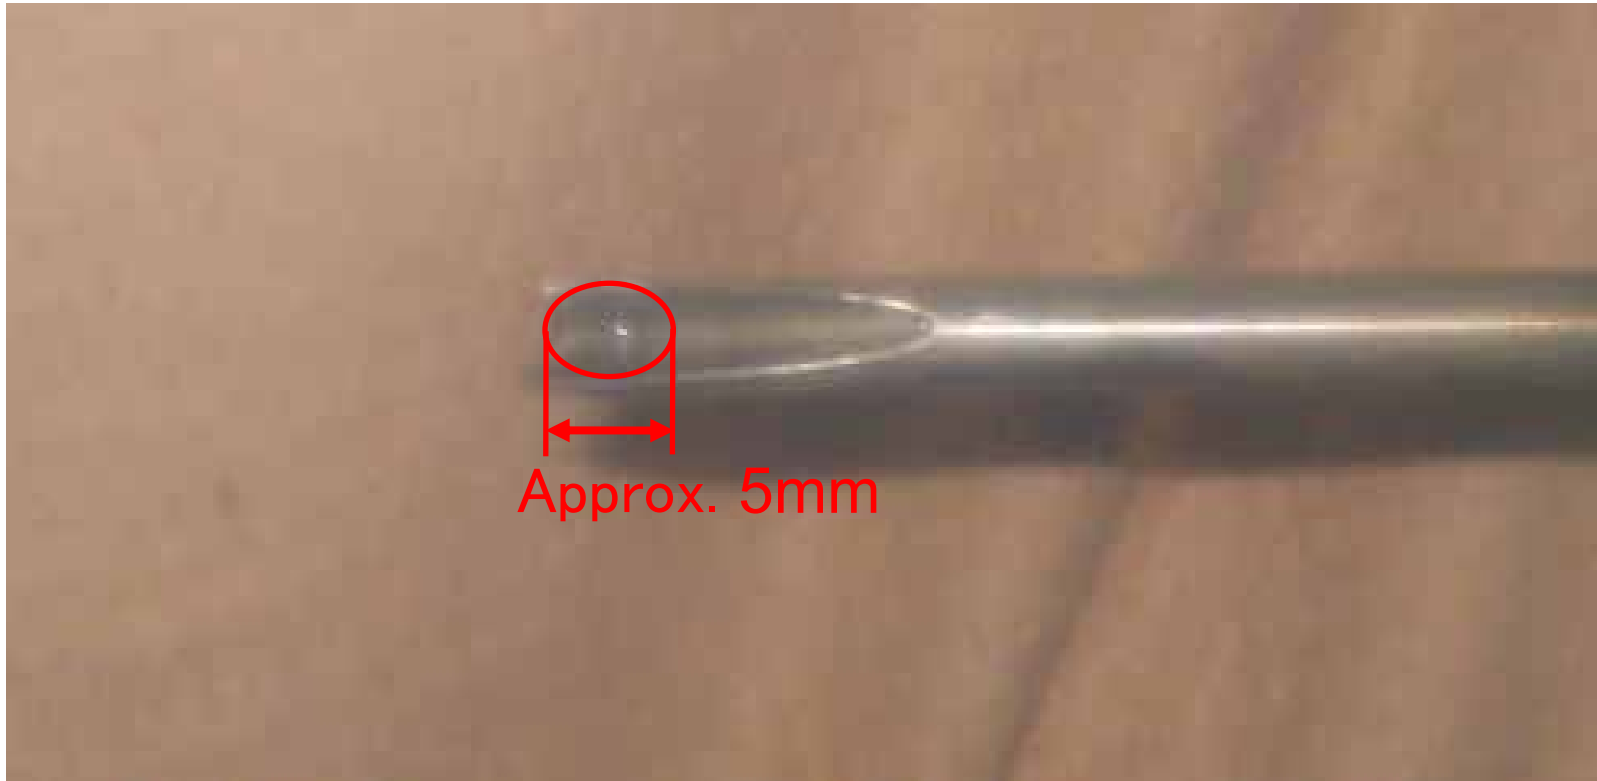
■ Dummy TIP cable head

- After the dummy TIP cable was pulled out, attached substances were found on the head.
 γ -ray: 17.0mSv/h, β - and γ -rays: 45.0mSv/h
