# Results of Survey on the PCV Penetration Vicinity at High Places in the 1st Floor of Unit 2 Reactor Building at Fukushima Daiichi Nuclear Power Station

July 24, 2013

Tokyo Electric Power Company

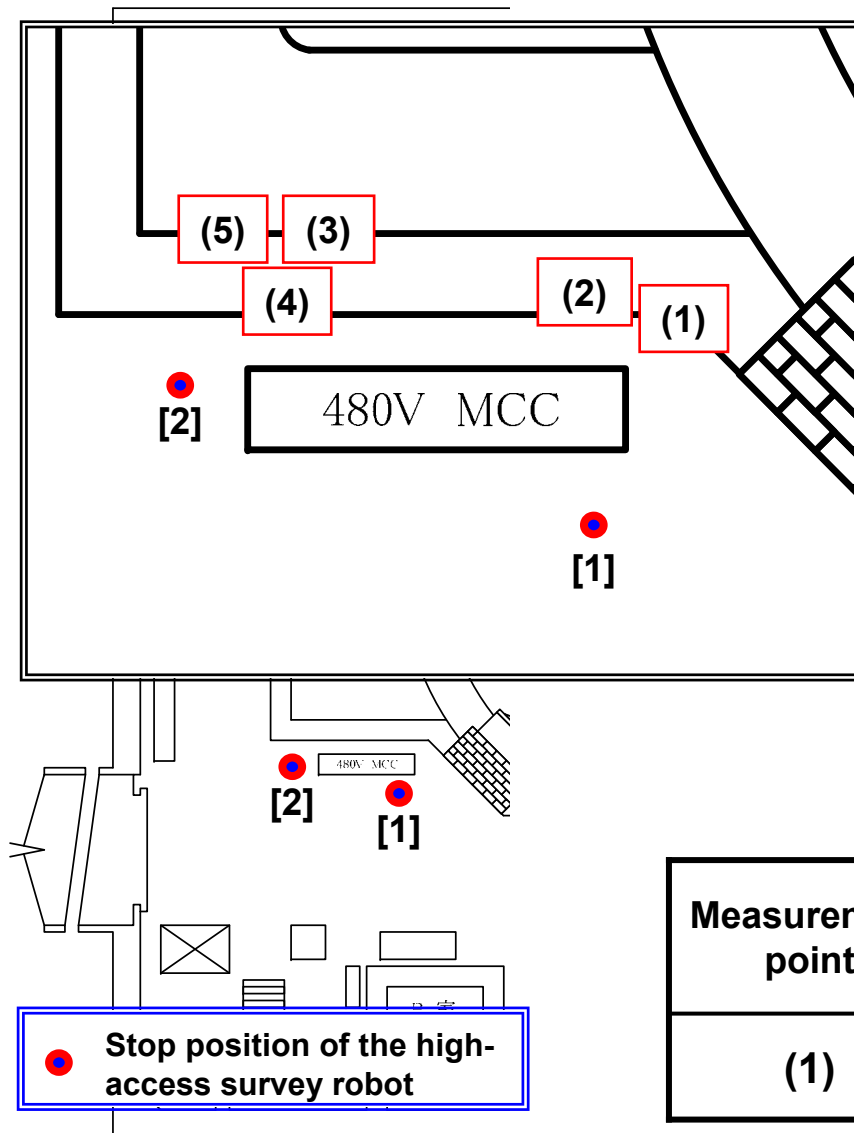
Measurement point	Measurement height [m]	Dose rate [mSv/h]
(1)	4.7	19.3
(2)	4.4	19.6
(3)	5.2	14.9
(4)	5.1	14.6
(5)	5.6	14.6

Measurement point	Measurement height [m]	Temperature [°C]	Humidity [%]
(1)	4.7	29.3	63
