Tokyo Electric Power Company

**Results of Additional Investigation
Based on Leakage from
Batch Treatment Tank of the
Multi-nuclide Removal Equipment
(Follow-up Information)**

Additional Investigation of Multi-nuclide Removal Equipment

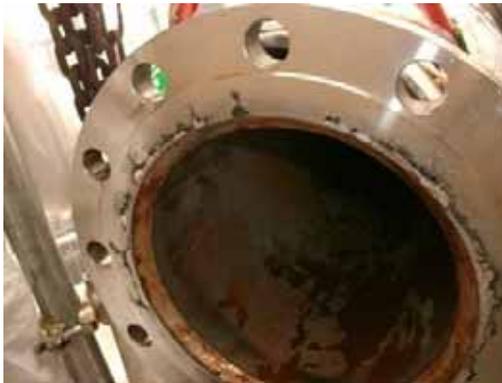
Return piping nozzle (location a) of the circulation tank

- An additional investigation was implemented mainly at welding line, where no corrosion was found at the previous horizontal development investigation. As a result, we found crevice corrosion on the flange surface of return piping nozzle (location a) of the circulation tank and inspection port nozzle (location c) of the adsorption tower 8A, 9A.

Crevice corrosion on the flange surface was found

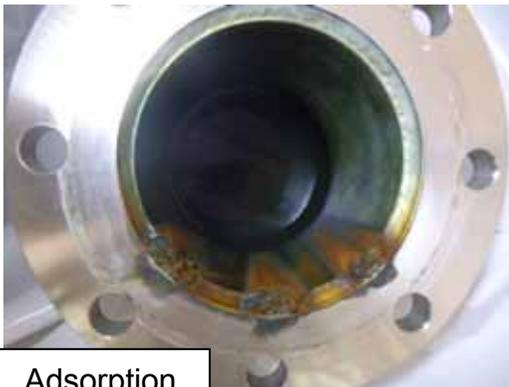
Adsorption tower 8A

Inspection port nozzle (location c) of the adsorption tower 8A, 9A

Crevice corrosion on the flange surface was found

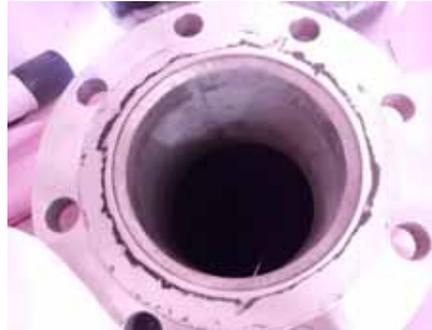
Flange surface (blank flange) of inspection port of the adsorption tower 1A

No crevice corrosion was found.

* Black part of the surface of flange sheet is remaining gasket.

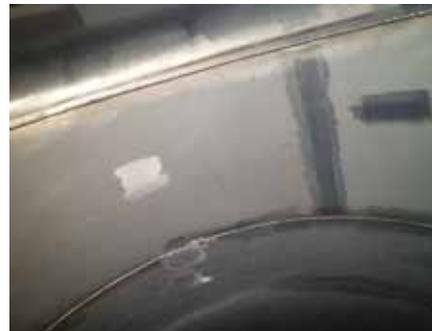
Inner surface of the adsorption tower 1A

No discoloration, etc. which is estimated to be corrosion was found at vicinity of welding line.

* Black part at the bottom is remaining adsorbent 1.

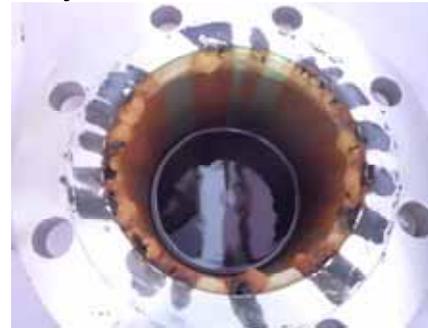
Flange surface (blank flange) of inspection port of the adsorption tower 6B

Crevice corrosion was found at the flange surface.

* Black part of the surface of flange sheet is powdered adsorbent 4.

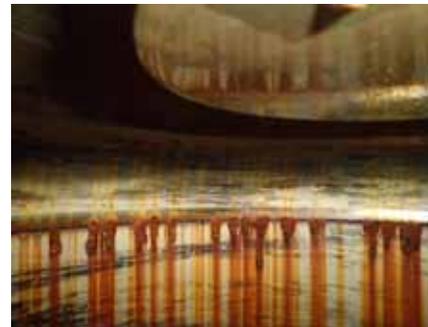
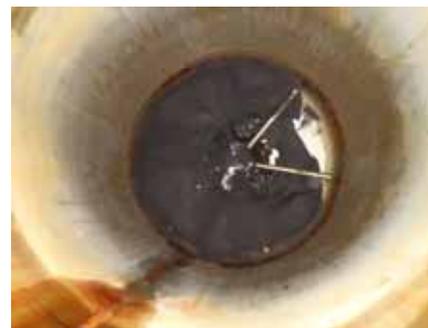
Inner surface of the adsorption tower 6B

Discoloration, which seems attributable to corrosion was found at vicinity of welding line.

* Black part at the bottom is remaining adsorbent 4.
