# Results of Full Check of the Bolt Fastening Tanks at Fukushima Daiichi Nuclear Power Station

<Reference>  
August 22, 2013  
Tokyo Electric Power Company

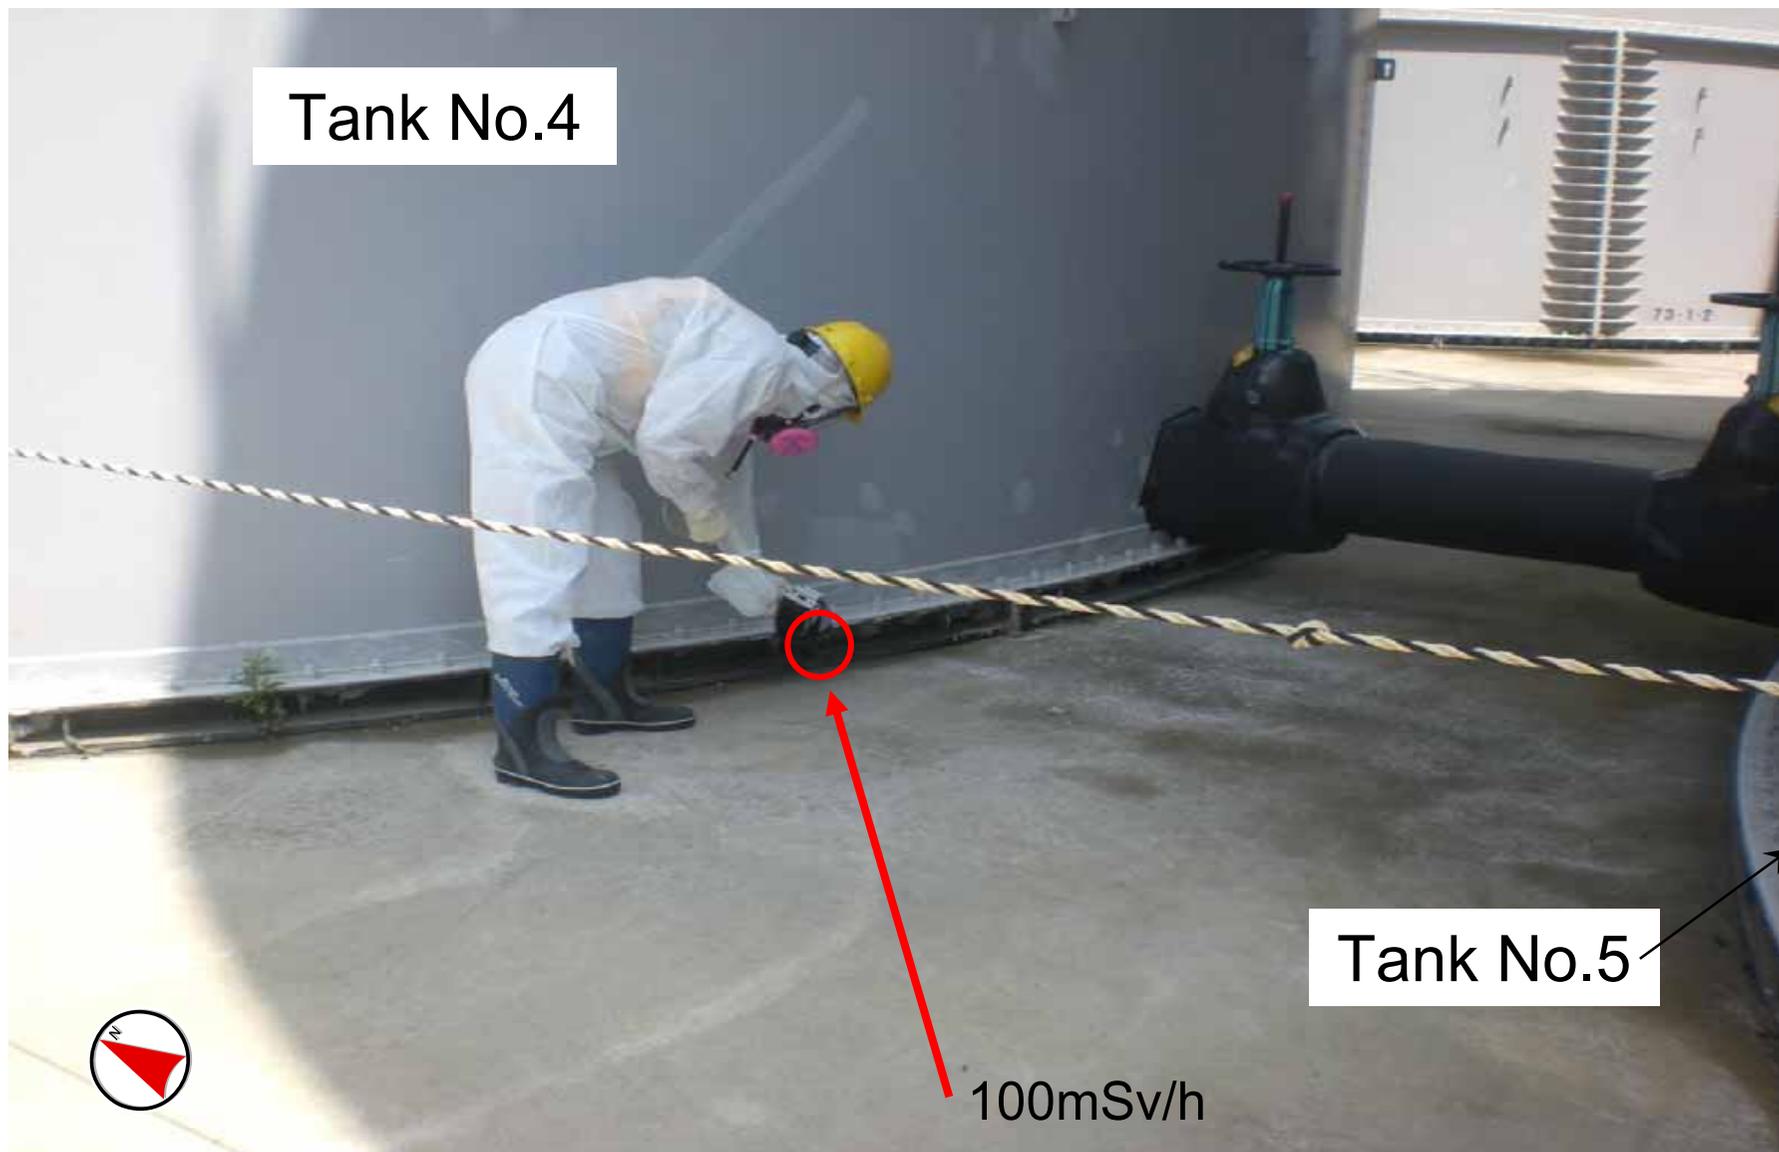
## Condition Near Flange at the Bottom of Tank No.4 at Group B in H3 Area

- Near flange at the bottom of tank No.4 at group B in H3 area: 100mSv/h
- Near flange at the bottom of tank No.10 at group A in H3 area: 70mSv/h

- Tank No.4 at group B in H3 area: Water level 97%
- Tank No.10 at group A in H3 area: Water level 95%

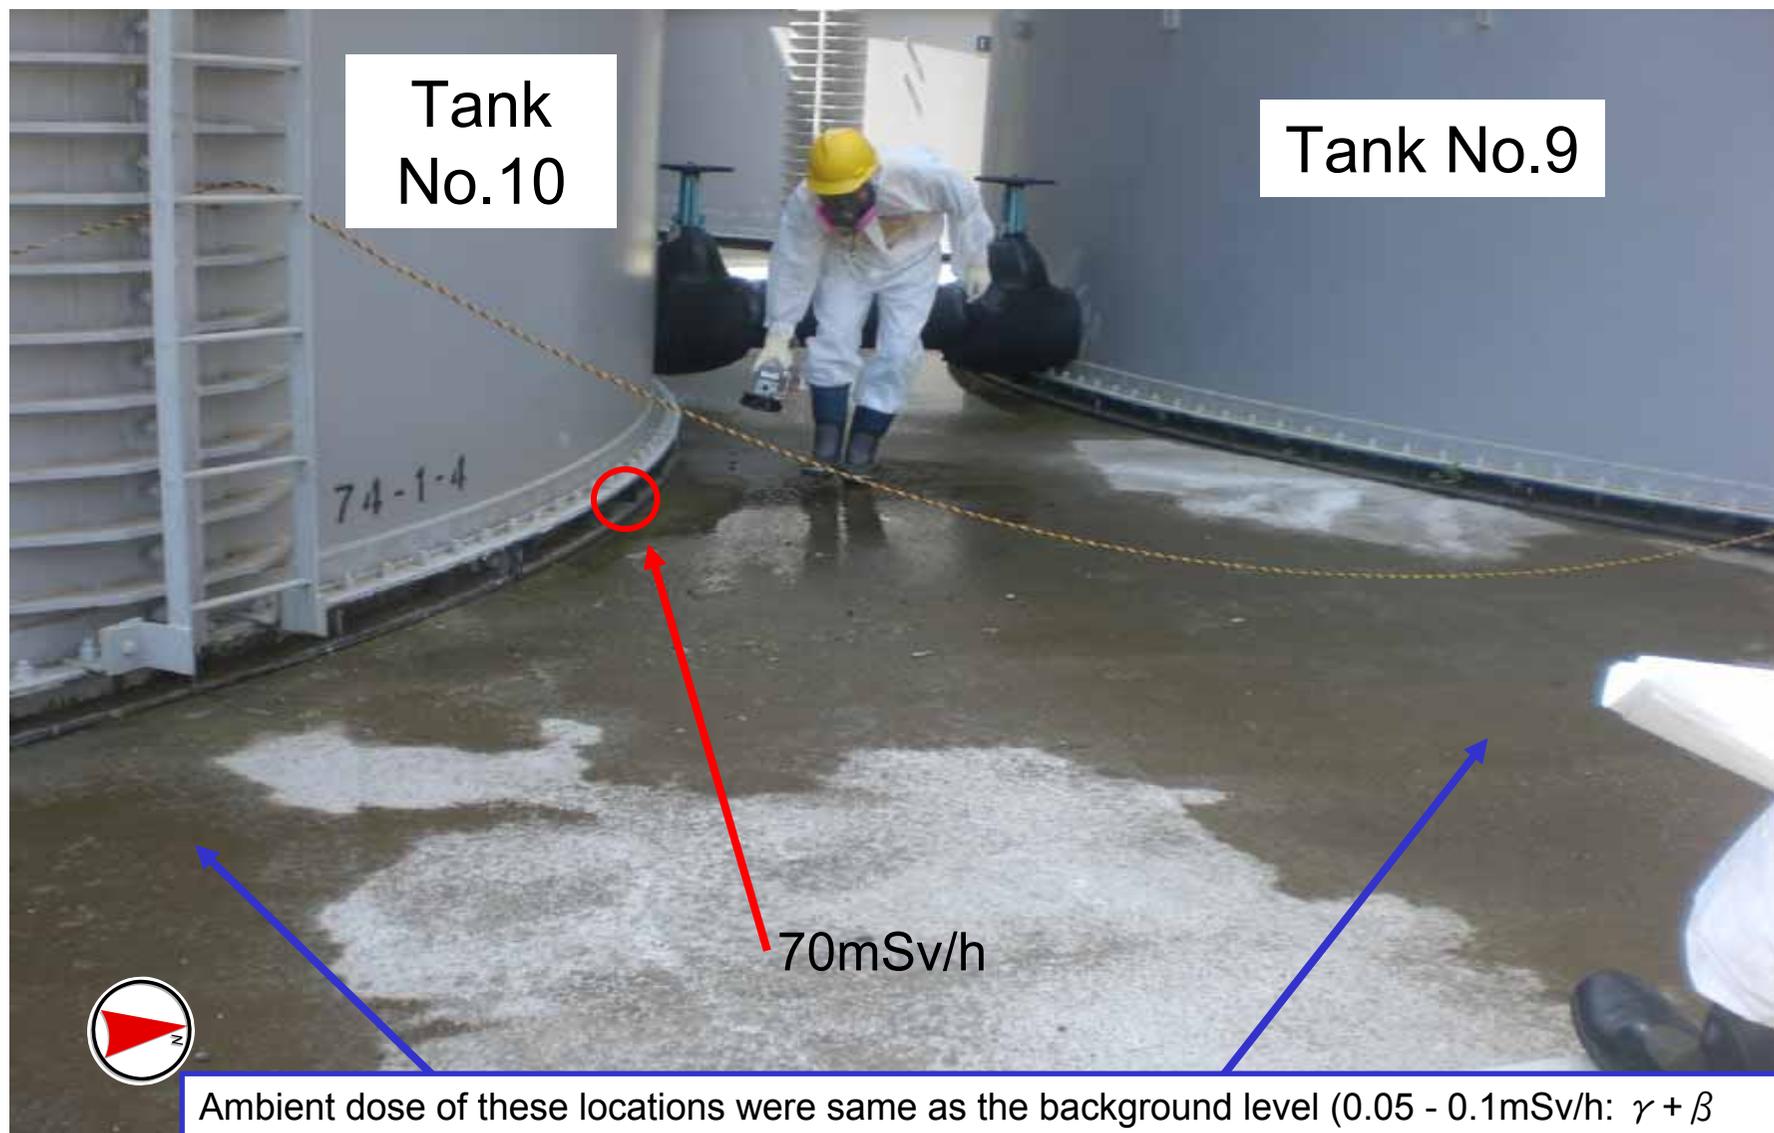
## Condition Near Flange at the Bottom of Tank No.10 at Group A in H3 Area

Ambient dose of these locations were same as the background level (0.05 - 0.1mSv/h:  $\gamma + \beta$  ray (dose equivalent rate measured within 70  $\mu$  m)), so they are considered to be rainwater.
