# Results of Tank Patrol at Fukushima Daiichi Nuclear Power Station

<Reference>  
September 2, 2013  
Tokyo Electric Power Company

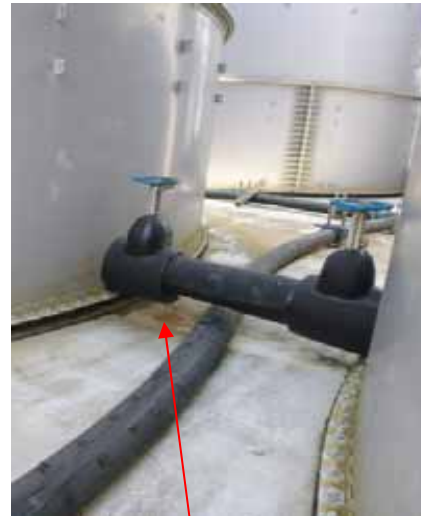
- Date of detection: August 31, 2013
- Location: Connecting pipe section between Tank No.5 and Tank No.6 in Group IV in the H5 area
- Situation: Discolored part was found above the floor surface under the outside flange of the entrance/exit valve of Tank No.5 in Group IV in the H5 area, and water was dripping one drop per approx. 90 seconds (dripping was found at around 11:10 PM on August 31).
- Countermeasures: After the bolts had been tightened up, the flange part was observed for 30 minutes, and we determined that no water leakage was occurring (at 2:20 PM on September 1). A drain receiving pan was installed under this valve, and monitoring will be continued for approx. 3 days. After that, we will reconfirm whether water leakage is occurring or not and will restore the heat retention function.

Discolored part

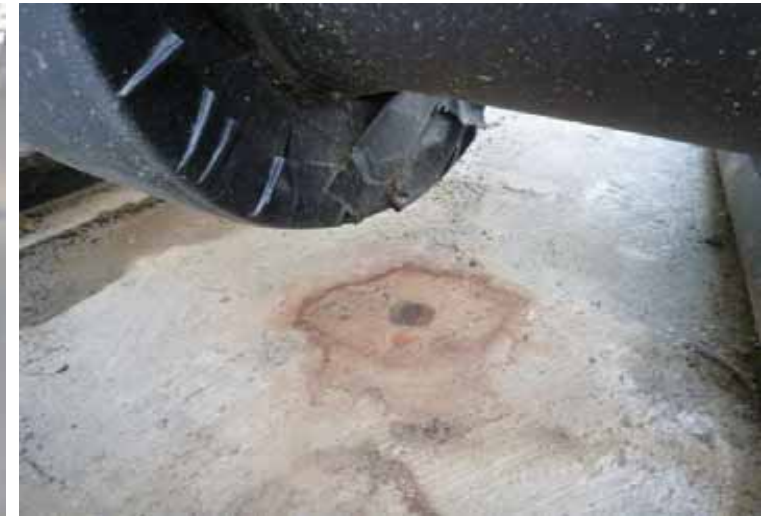
Discolored part (enlarged image)
