High Radiation Locations Found at the H3 Area Tank

<Reference>
September 2, 2013
Tokyo Electric Power Company

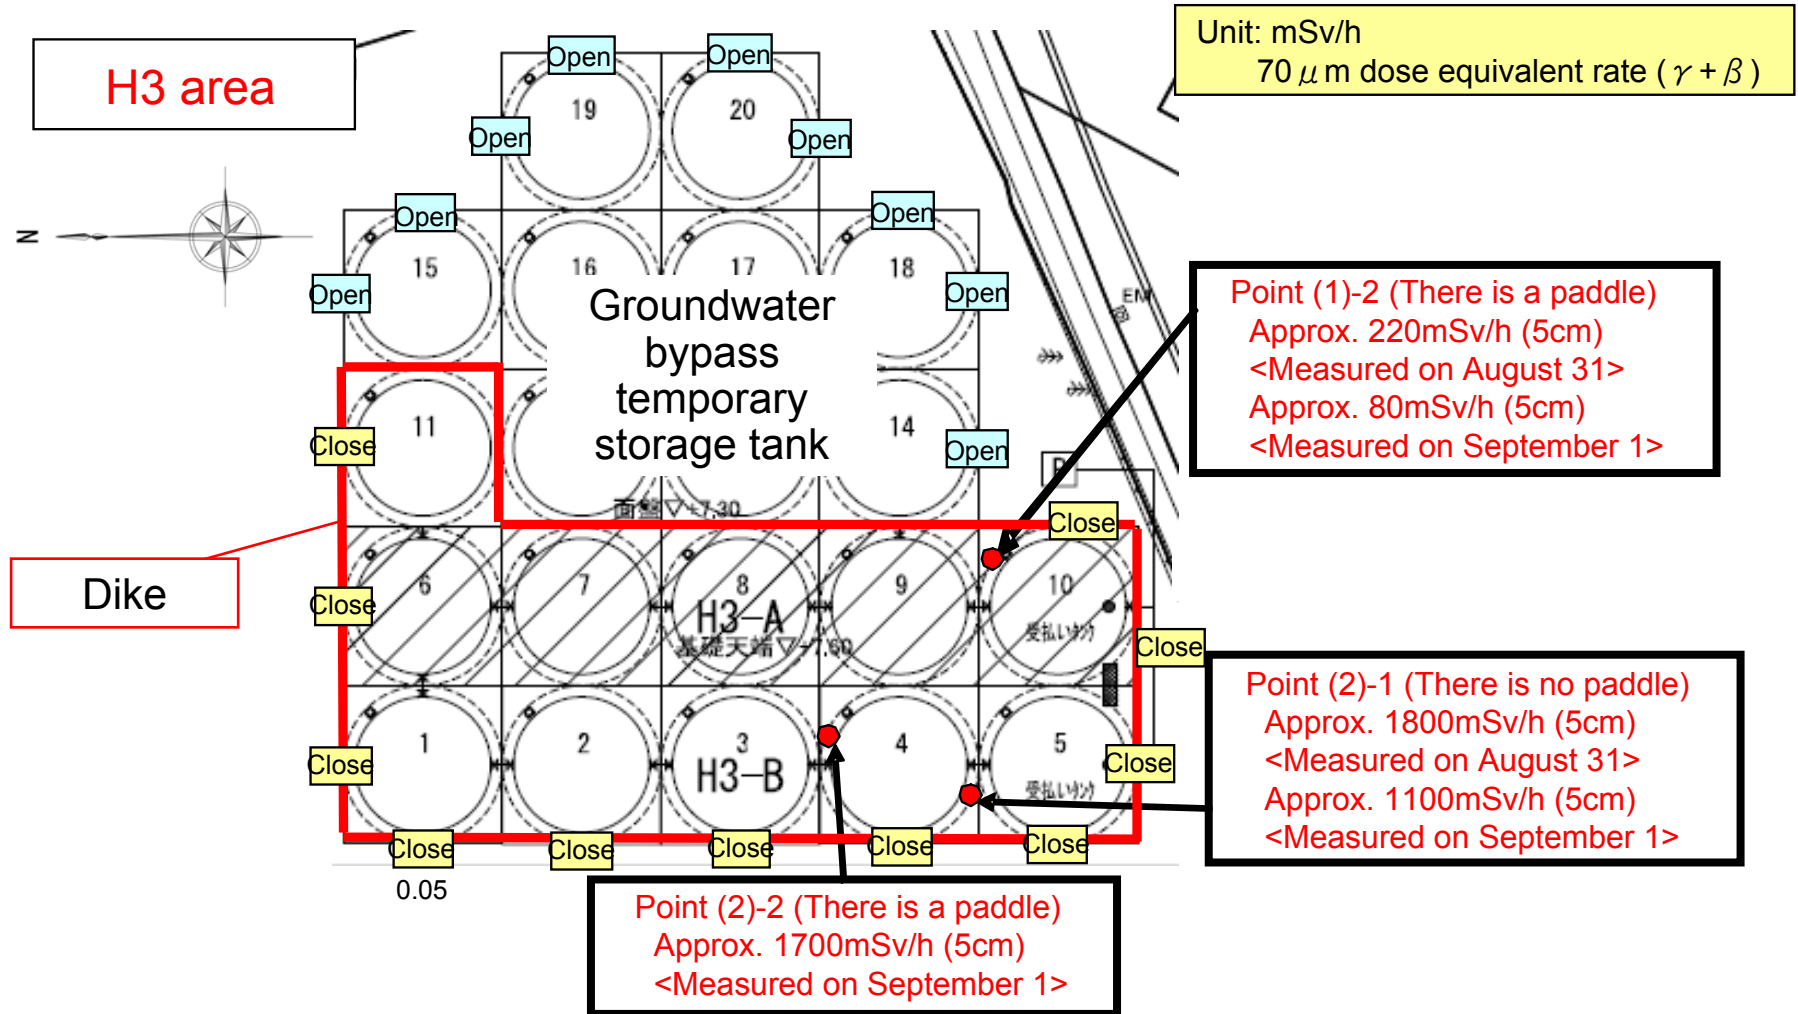
Results of Patrol at the H3 Area

- As for 3 high radiation locations found during a patrol conducted on August 31 and September 1, there was no suggestion of water leak since
 - (1) neither water dropping nor trace of leakage has been found and

- (2) radiation detected on the floor surface directly underneath the location was not high. We will continue to monitor the status closely and will investigate the cause of the high radiation in detail.

- All 3 high radiation locations were the flange parts of the bottom of the tanks (edge of a packing with water expansible water stop function).
- Aside from these 3 locations, there was a record that someone measured the bottom of the tank where radiation level was higher than the surrounding area. (Since the level detected was below the record standard (10mSv/h in the measurement conducted within 1m from the outer surface of the tank, at the height of 50cm), this record was voluntarily made). There is a possibility that this was also the flange part of the bottom of the tank, so we will implement a detailed investigation.

- There are 8 similar flange parts per each tank, so we will investigate flange parts of the other tanks.

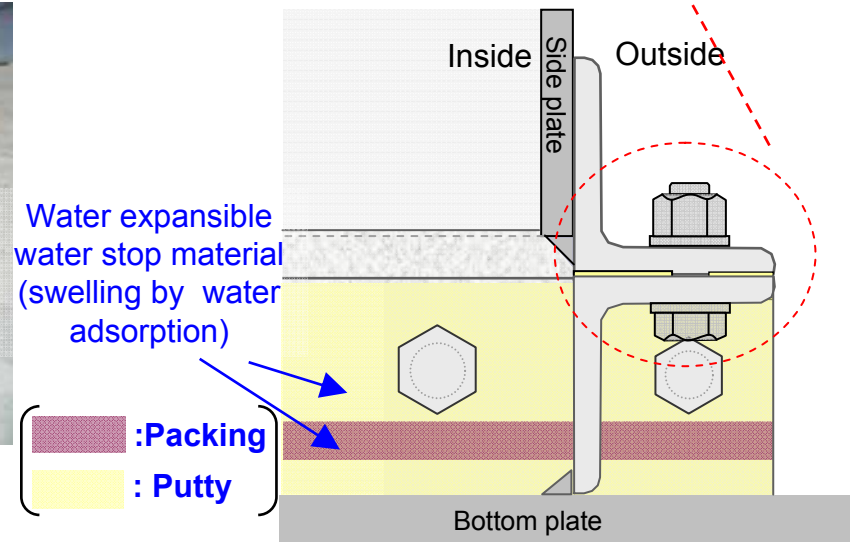
<Sectional view in A-A>

Water expansible water stop material (swelling by water adsorption)

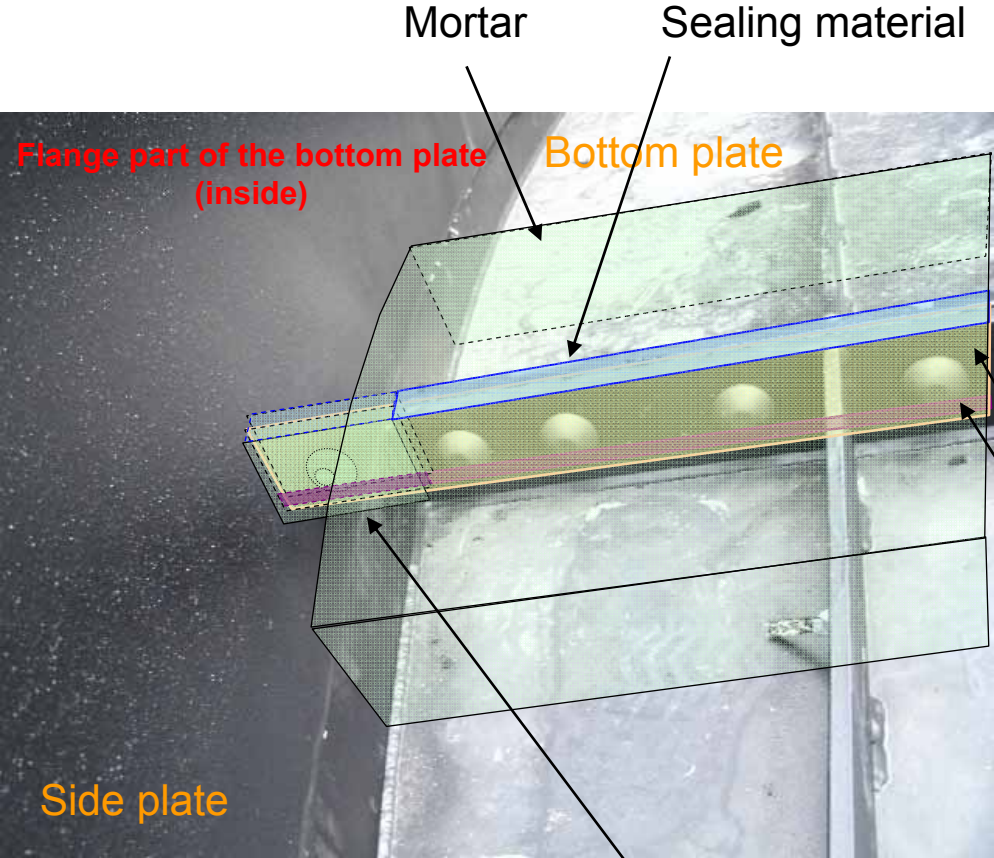
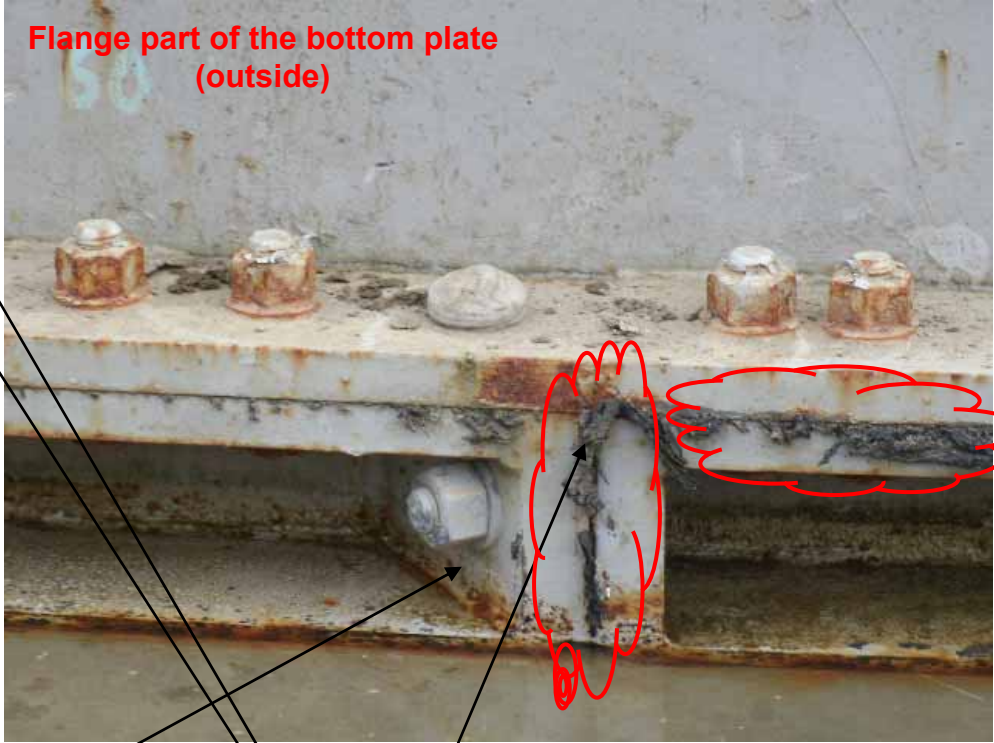
Photo of the joint part of flange at the bottom of the tank

Flange part of the bottom plate (outside)

Water expansible water stop material
