# Investigation into the inside of tank No.5 in H4 area

Revised edition  
(Revised on September 26)

<Reference>  
September 20, 2013  
Tokyo Electric Power Company

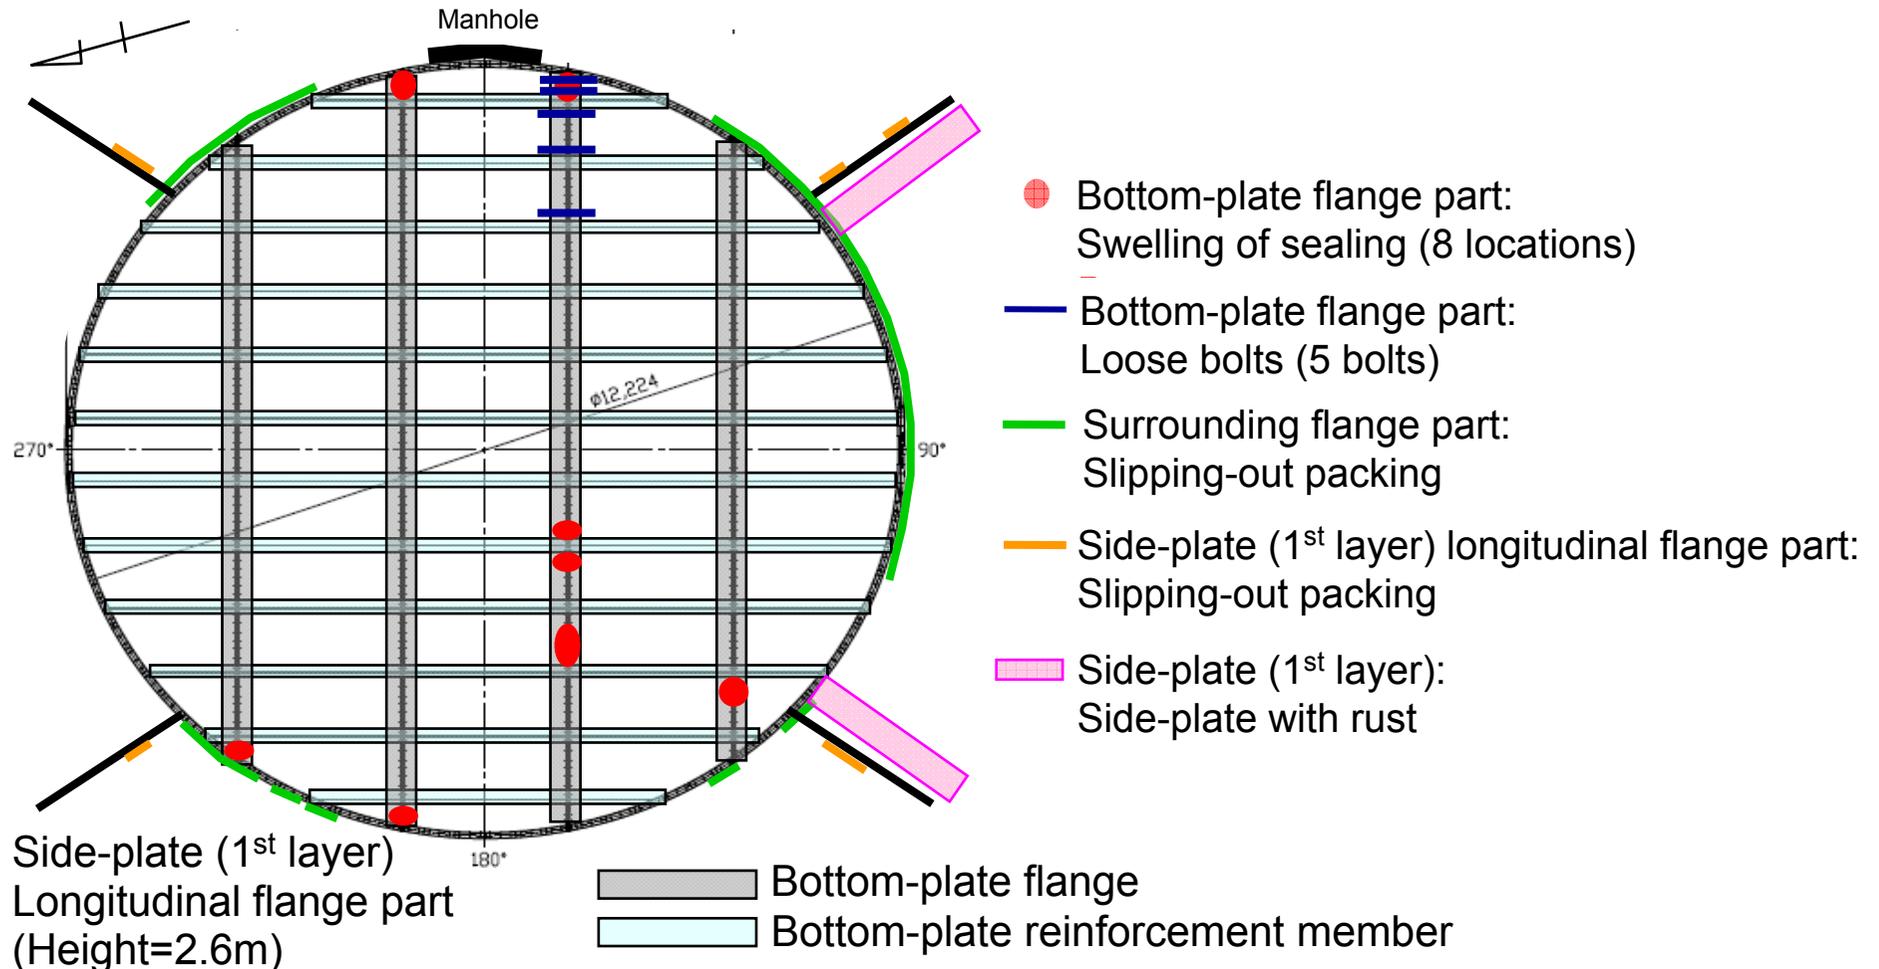
- We checked the inside of the tank with eyes, and found transformation and damage in sealing member between the lowest side-plate and the bottom-plate, and bottom-plate flange part.
- We checked the tightening of the bolts, and found 5 loose ones through percussion on the bolts etc.

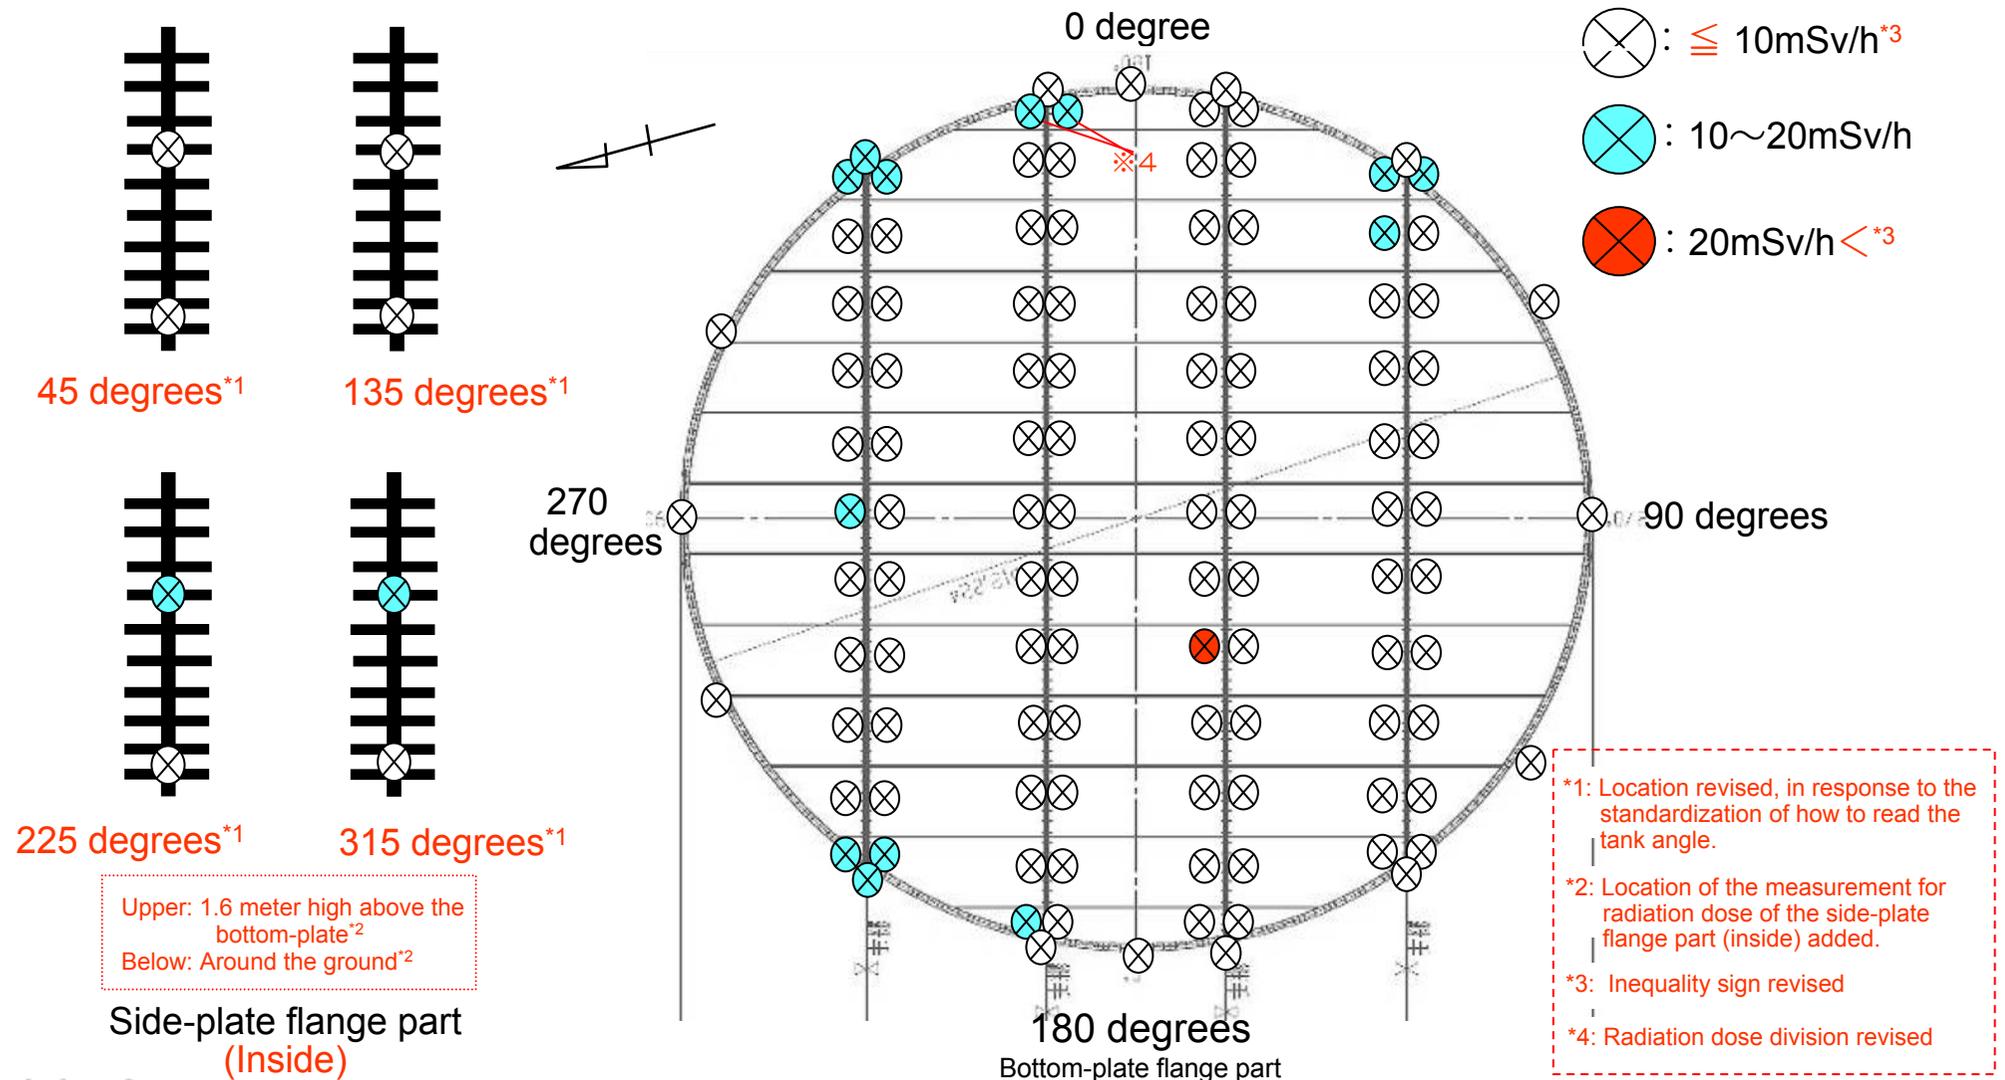
# Results for measurement of radiation dose on the flange part

- Measurement results at the flange part were below 10m Sv/h in general ( $\beta : 70 \mu\text{m}$  dose equivalent rate), at highest was 22mSv/h ( $\beta : 70 \mu\text{m}$  dose equivalent rate).

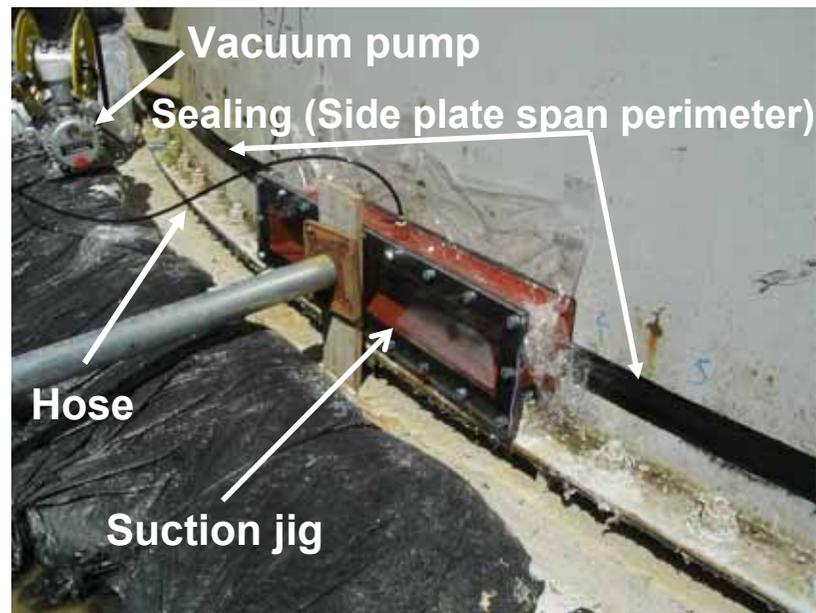
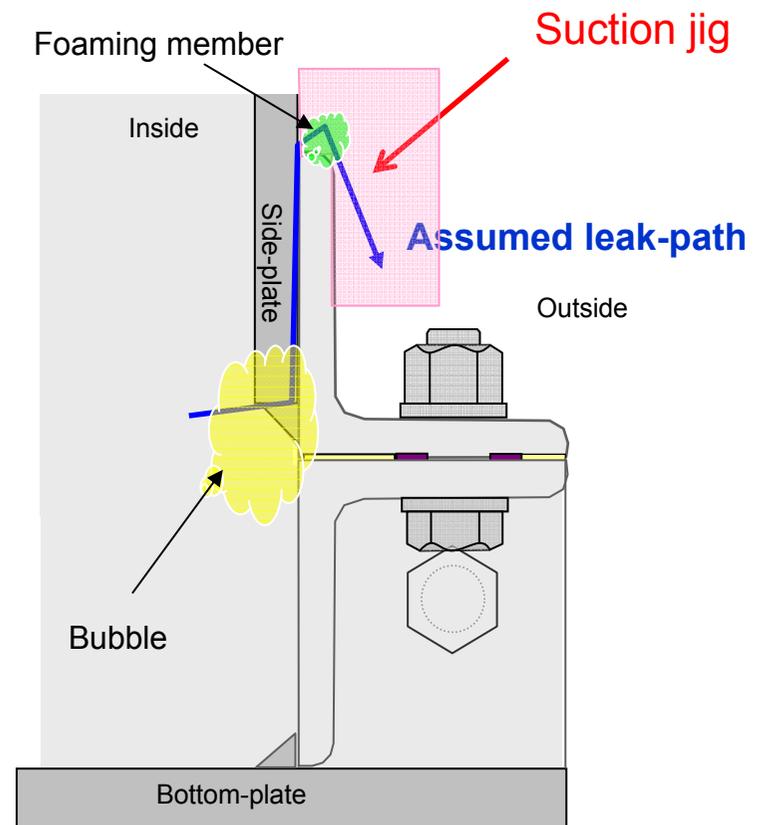
Side plate: Cross section of flange part

- We conducted local suction at the welded parts between side-plate of tank bottom and flange part, where relative high radiation dose was found (rust parts).
- We found no continuing foaming from the foaming member applied to the parts in question, and no bubbles inside the tank was vacuumed.

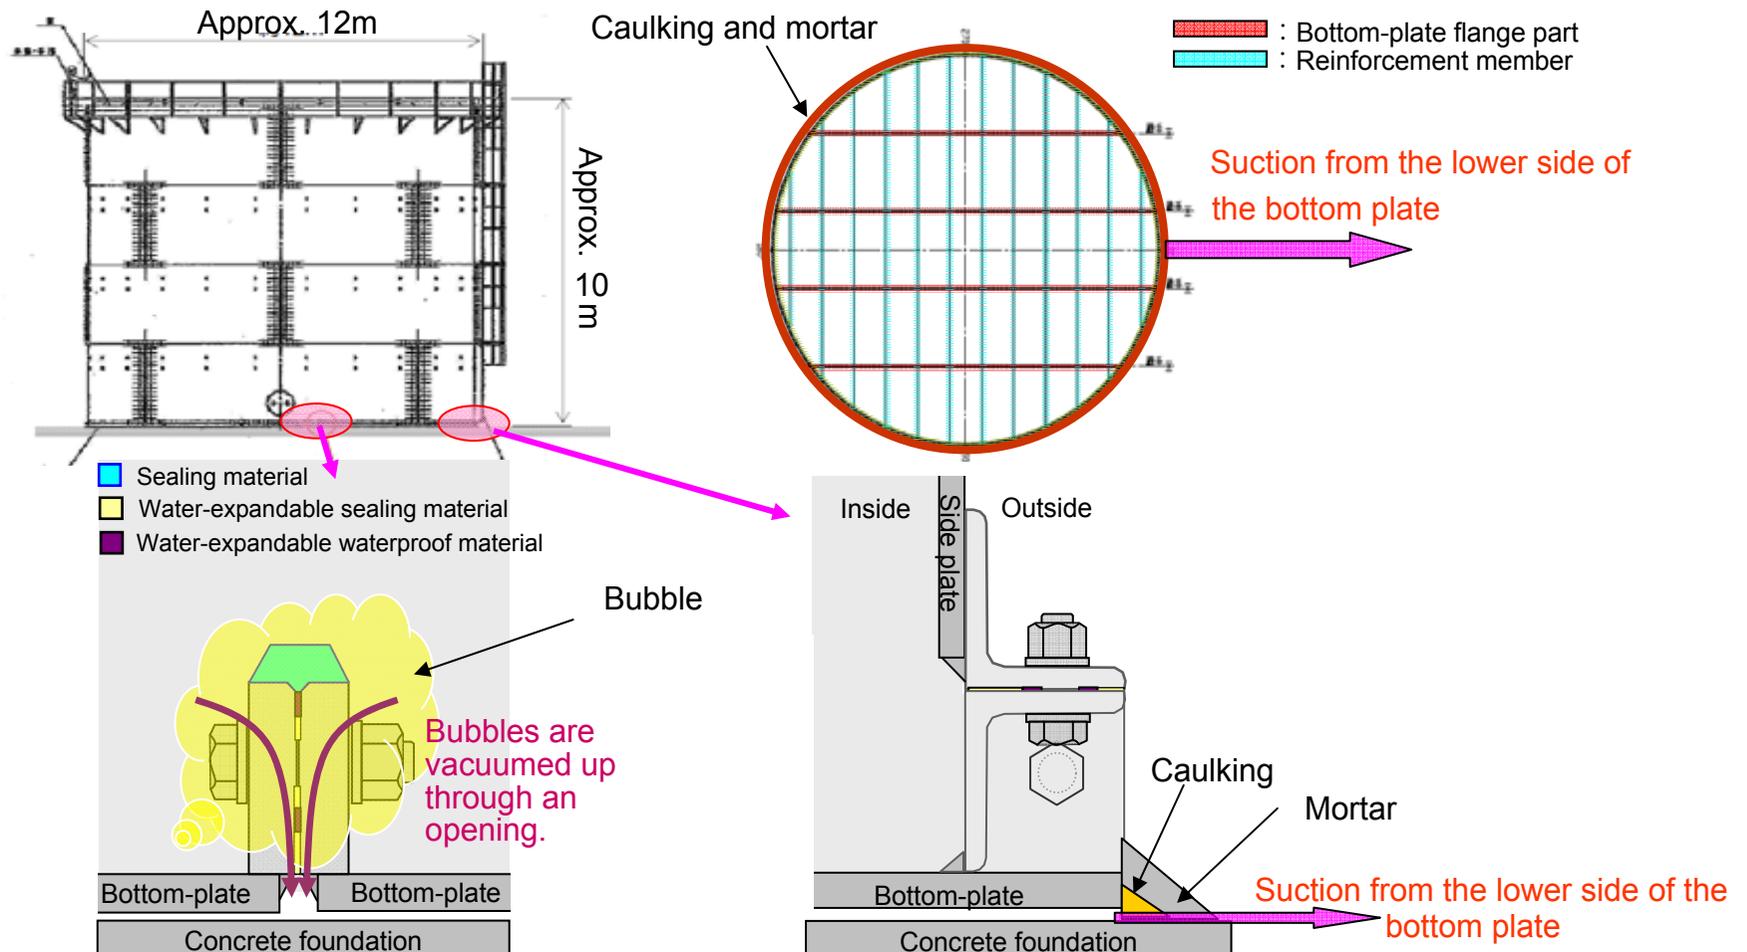
# The vacuum test for the tank bottom plate

- We apply bubbles to the flange parts etc. and conduct suction from the lower side of the bottom plate, in order to specify locations of opening parts through which bubbles are vacuumed up.

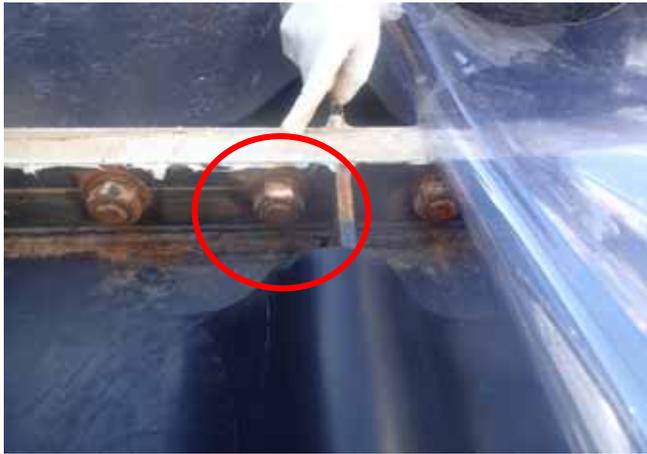
Loose bolt on the bottom-plate flange part  
(Photo taken on Sep. 19, 2013)

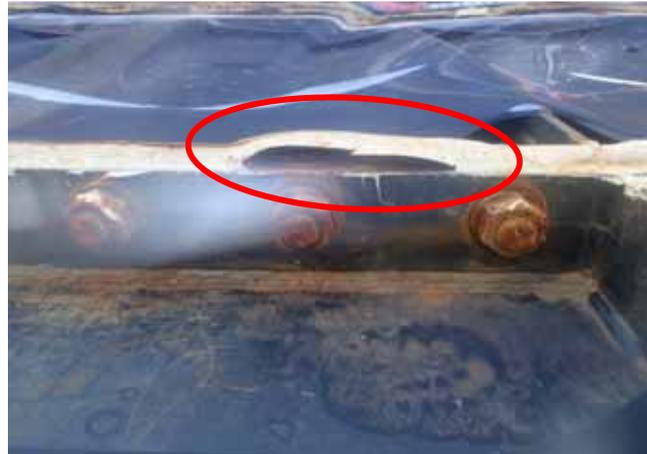
Swelling sealing member on the bottom-plate flange part  
(Photo taken on Sep. 19, 2013)

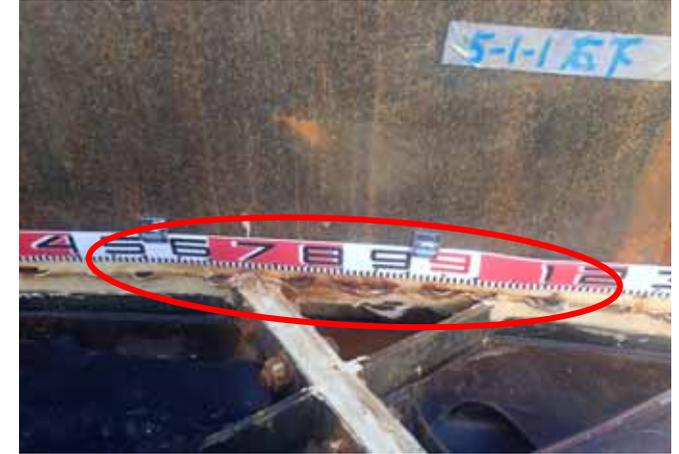
Packing slipping out on circumferential direction flange part  
(Photo taken on Sep. 19, 2013)

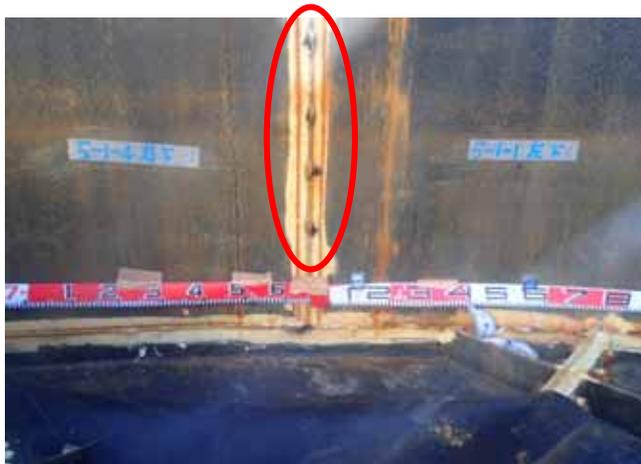
Packing slipping out on side-plate (1<sup>st</sup> layer) longitudinal flange part  
(Photo taken on Sep. 19, 2013)

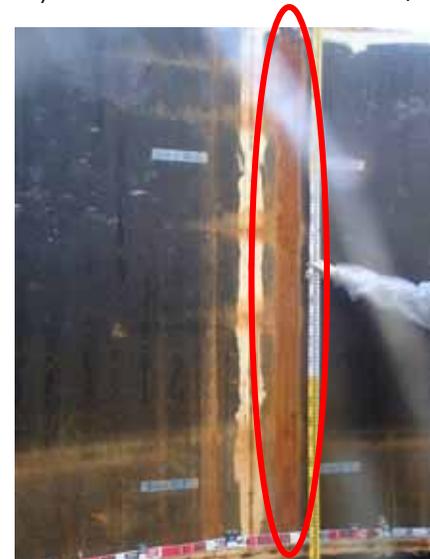
Rust generation on the side plate (1<sup>st</sup> layer)  
(Photo taken on Sep. 19, 2013)
