Regarding the Incident Where a Jib Mast at the Tip of a Remote-control Large Crane Was Bent Down [Cause and Countermeasures]

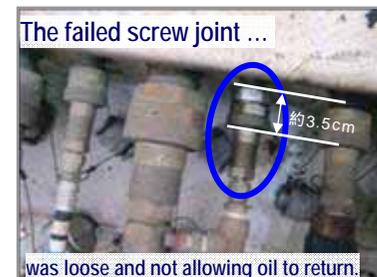
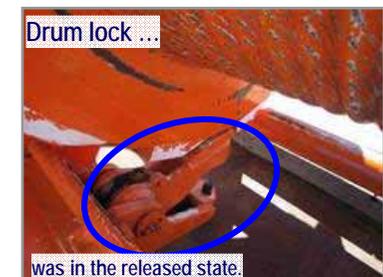
The drum lock of a winch to wind up a wire cable used for hoisting the tip jib mast is operated by hydraulic pressure. The joint section (a screw joint) of a hydraulic pressure hose used for that operation became loose, and the drum lock was released.

The failed part (a screw joint) and the released state of the lock

- (1) Replacement of the failed screw joint with a new one
- (2) Implementation of a procedure that requires a worker to confirm, before and after operating the crane each day, that the screw joint is tight and that the drum lock is in the locking state.
[Added as a monthly and a daily inspection item]
- (3) Installation of an indication light by which a worker can see whether the drum lock is in the locking state.

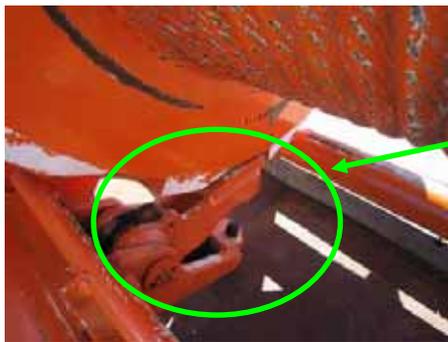
Drum lock

The drum lock* of the jib hoisting winch was released, and this caused the hoisting wire to relax, so that the tip jib mast was gradually bent down. Then, a load larger than expected acted on and caused a crack to the main mast.

- The drum lock* was released as the loosened assembly/disassembly screw joint, which was in used for the hydraulic hose of the drum lock, prohibited decrease in hydraulic pressure.
- The drum lock normally functions to unlock the winch as a result of increase in hydraulic pressure while the crane is operated, and to lock the winch as a result of decrease in hydraulic pressure while the crane is not operated.

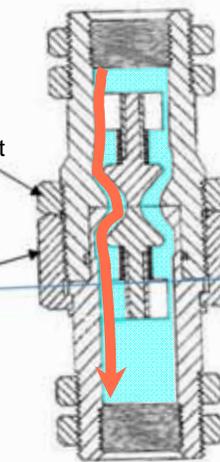
[When operating properly]

Oil goes back

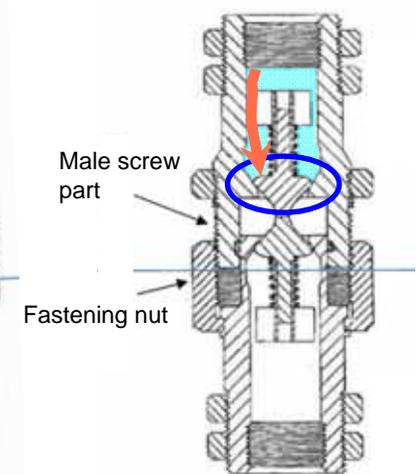
[When this incident occurred]

Oil was unable to go back blocked by the loosened screw
