# Leakage from B Area South Tank

October 3, 2013

Tokyo Electric Power Company

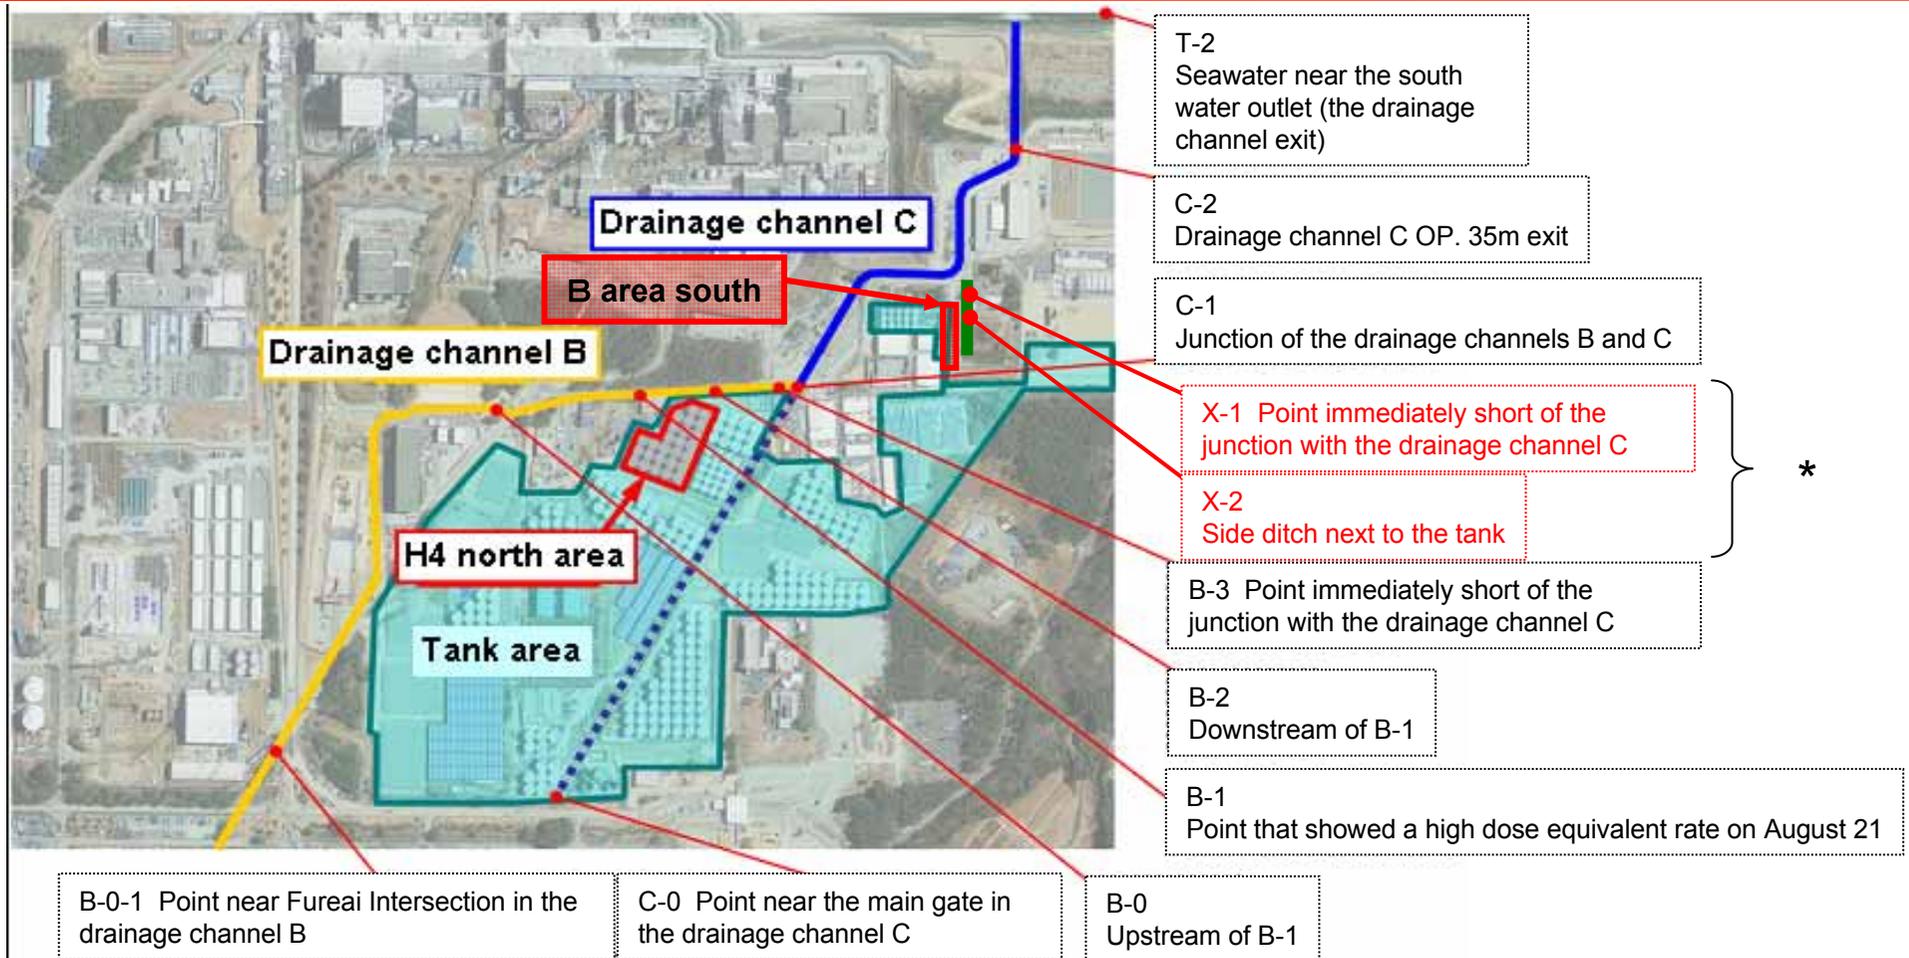
# Sampling Results Obtained in the Side Ditch Connected to the Drainage Channel

**Point immediately short of the junction of the side ditch near the tank and the drainage channel C (X-1)**  
 (Sampled at 11:10 PM on October 2)  
 All  $\beta$  : 15,000Bq/L  
 Cesium-134: 120Bq/L  
 Cesium-137: 310Bq/L

**Point where water stop work was performed by installing sandbags at the side ditch in front of the drainage channel (X-2)**  
 (Sampled at 11:00 PM on October 2)  
 All  $\beta$  : 5,200Bq/L  
 Cesium-134: 66Bq/L  
 Cesium-137: 170Bq/L

We piled sandbags in the side ditch (destination of water: drainage channel C) at the south of this area in order to prevent water from spreading to the outside of the area.

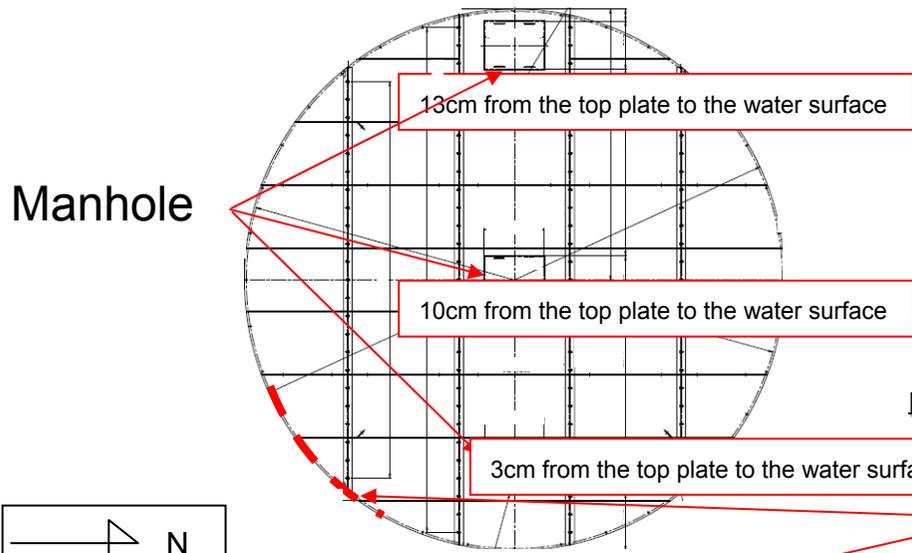
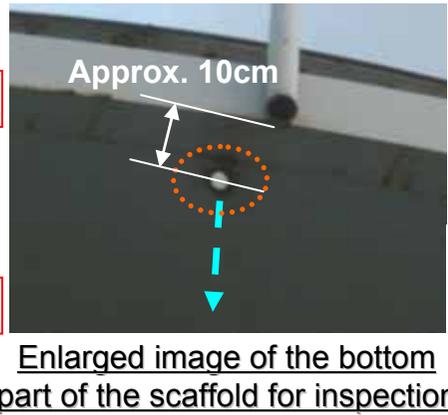
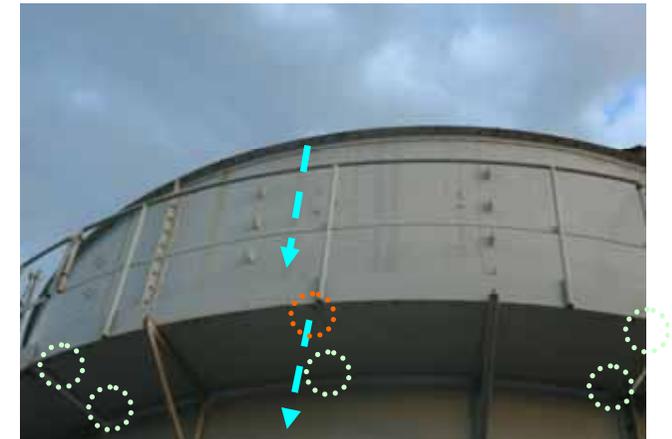
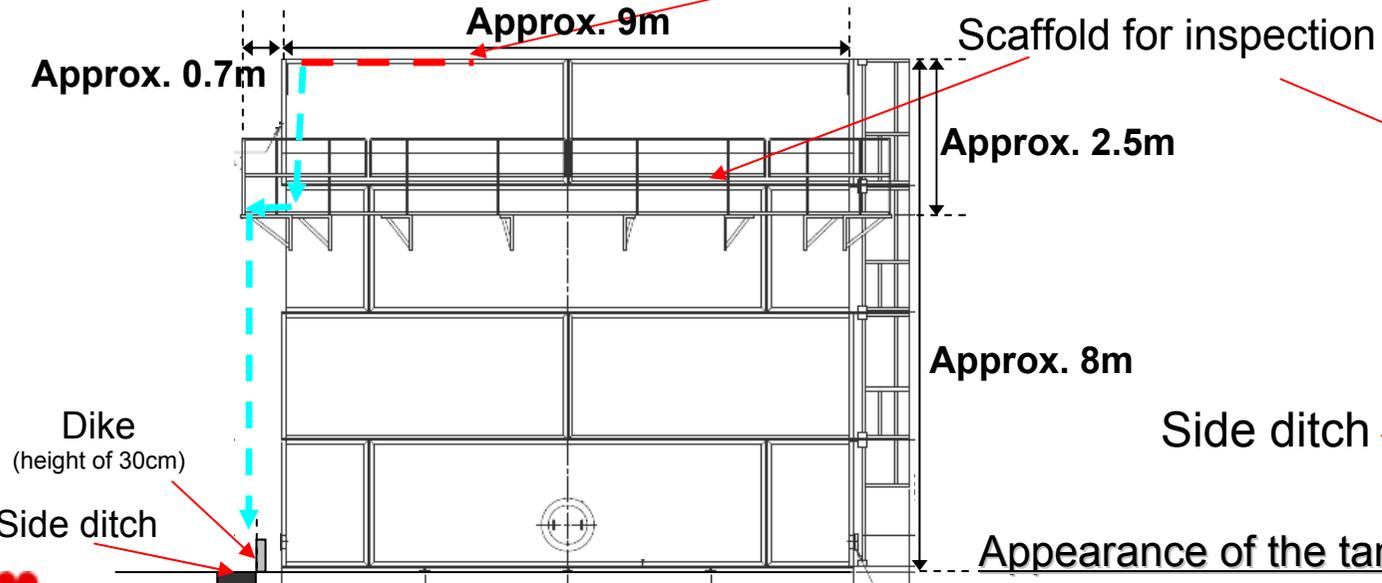
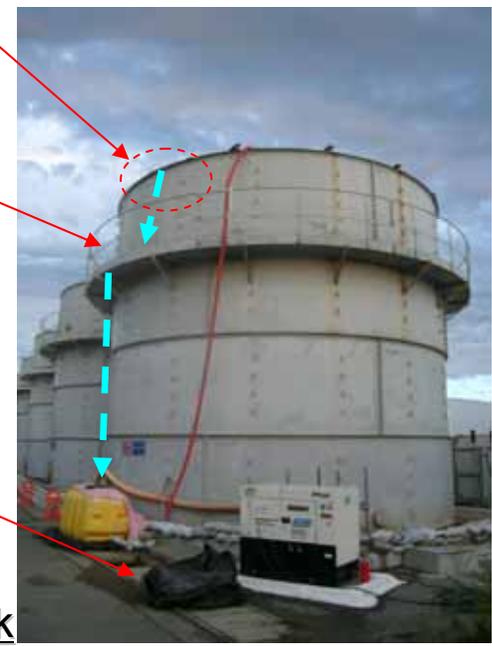
# Drawings of the Tank

- There are five tanks in the same area, connected to each other in series with connection pipes and separation valves. The ground level on which each tank stands differs, since there are slight downward slopes from the mountain side to the sea side (from West to East)
- Due to continuous rainfall, we transferred the water inside the dike to the tanks in which there were additional space to put water in, by pumps to prevent rainwater inside the dike from overflowing. On October 2, responding to the water level inside the dike, we conducted transferring twice. During this procedure, the tanks reached almost full capacity. Therefore, our presumption is, that water level inside the tank B-A5 which is located nearest to the sea side, installed at the lowest level, reached its top plate, leading to the water leakage from between the top plate and the side panel.

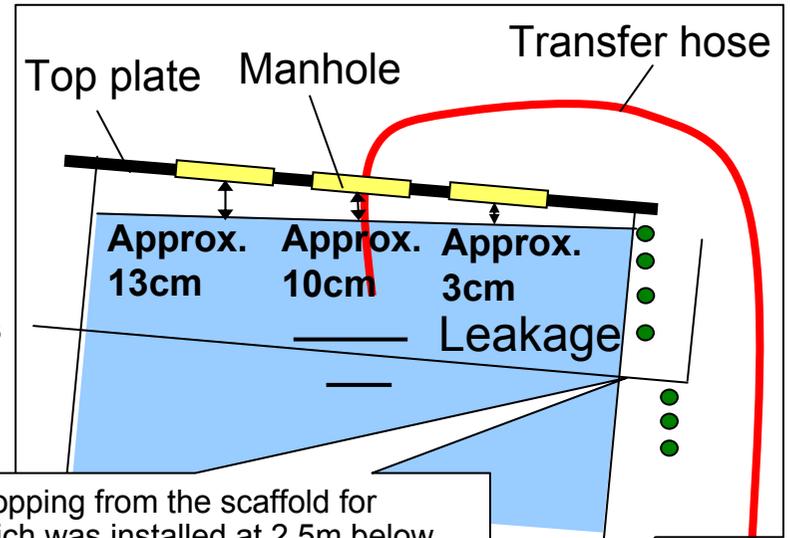
# Image of the Leakage from the Top Plate of the Tank

- Water level of the tank is being monitored by a water gauge installed in the west end tank (B-A1).
- As a target water level, tank was used at the maximum of 98% of the capacity (approx. 50cm from the top plate). (We have followed this target when we collected water for the first time. However, we have exceeded this target for the second time collection, since we had to pump up water from the dike urgently. As a result, there was no margin left to prevent water from leaking.)
- Water of the east end tank (B-A5) was reached to the top plate, since there is a slight slope.
- Leaked water from the tank was dripped to the outside of the dike via the scaffold for inspection, which was installed at the circumference of the tank.

Water gauge (tank was used at the maximum of 98% of the capacity as a indication)

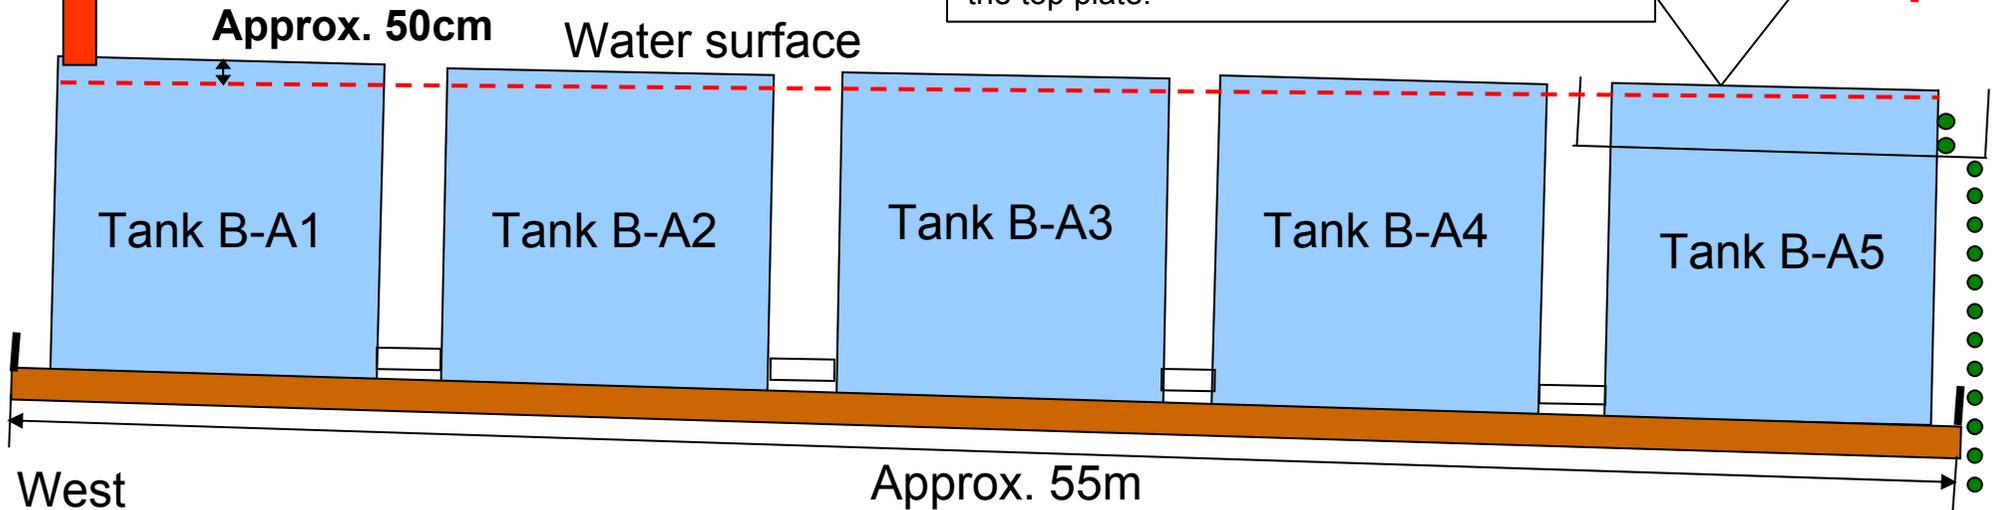
Water was dropping from the scaffold for inspection which was installed at 2.5m below the top plate.

There is a slight slope from west to east at the B area.
