Investigation into the Bottom Plate etc. of the Tank No.5 in H4 Area at Fukushima Daiichi NPS.

October 8, 2013

Tokyo Electric Power Company

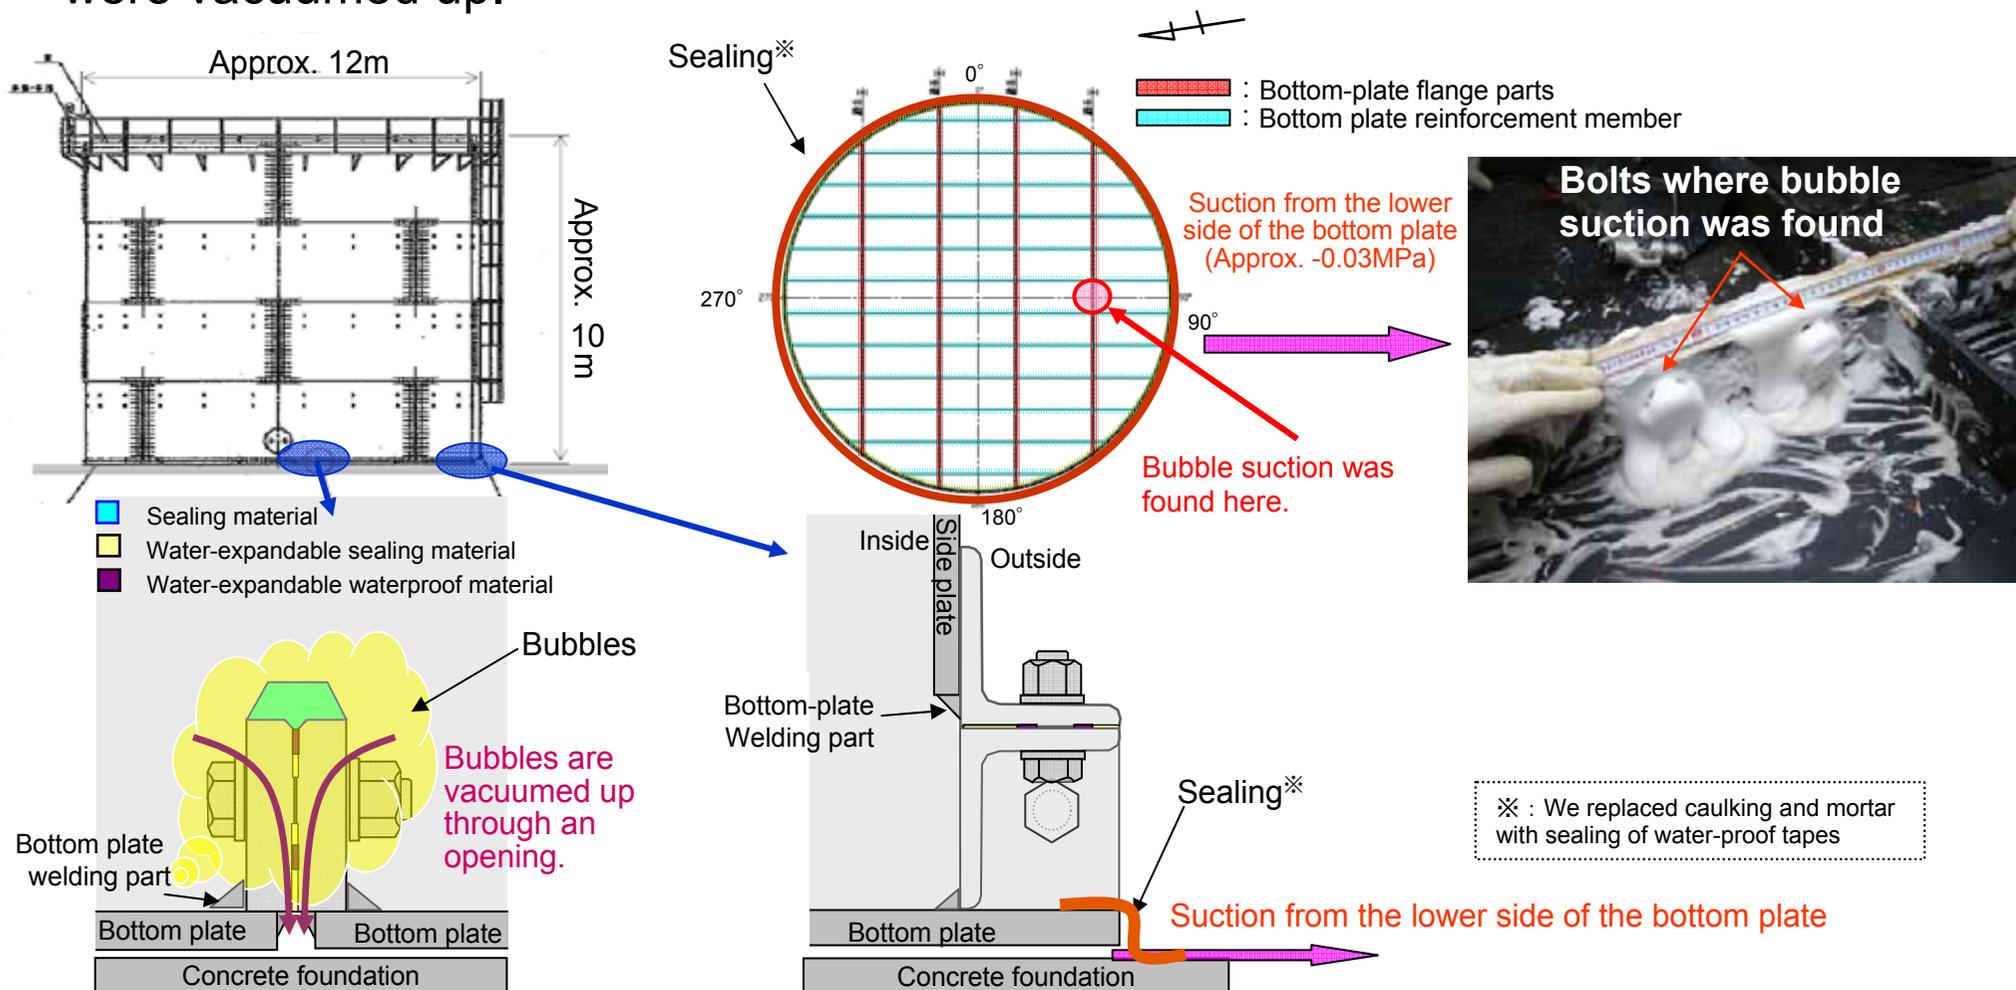
Results of the Vacuum Test for the Tank Bottom Plate (Previously Announced)

- We applied bubbles to the flange parts etc. and conducted suction from the lower side of the bottom plate. We found the two adjacent bolts through which bubbles were vacuumed up.

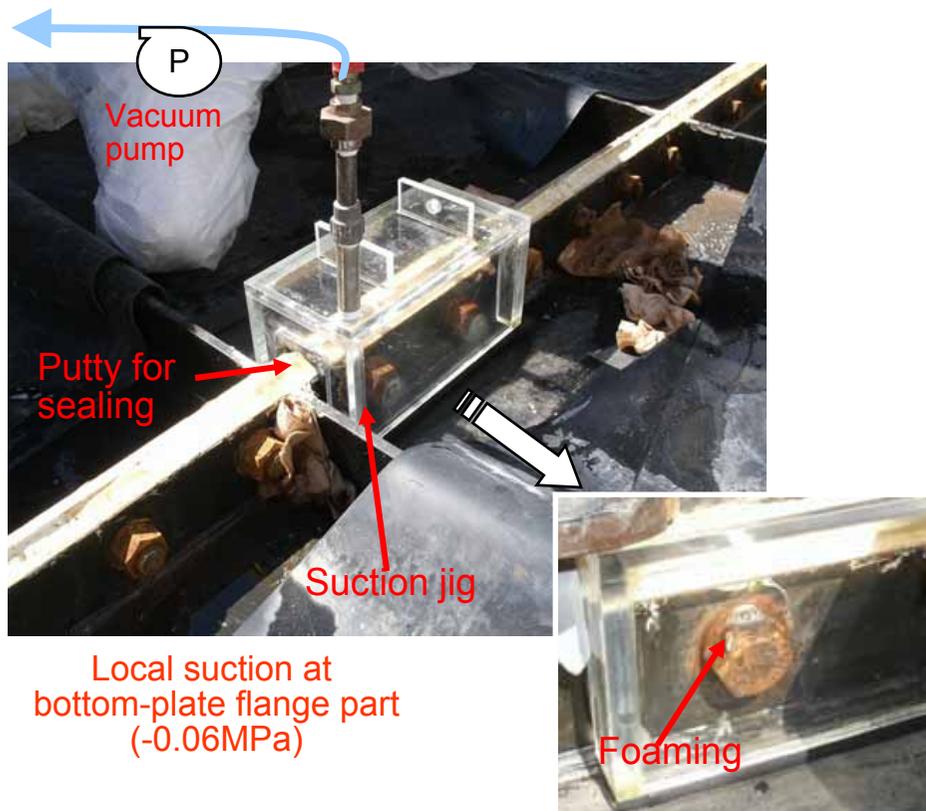
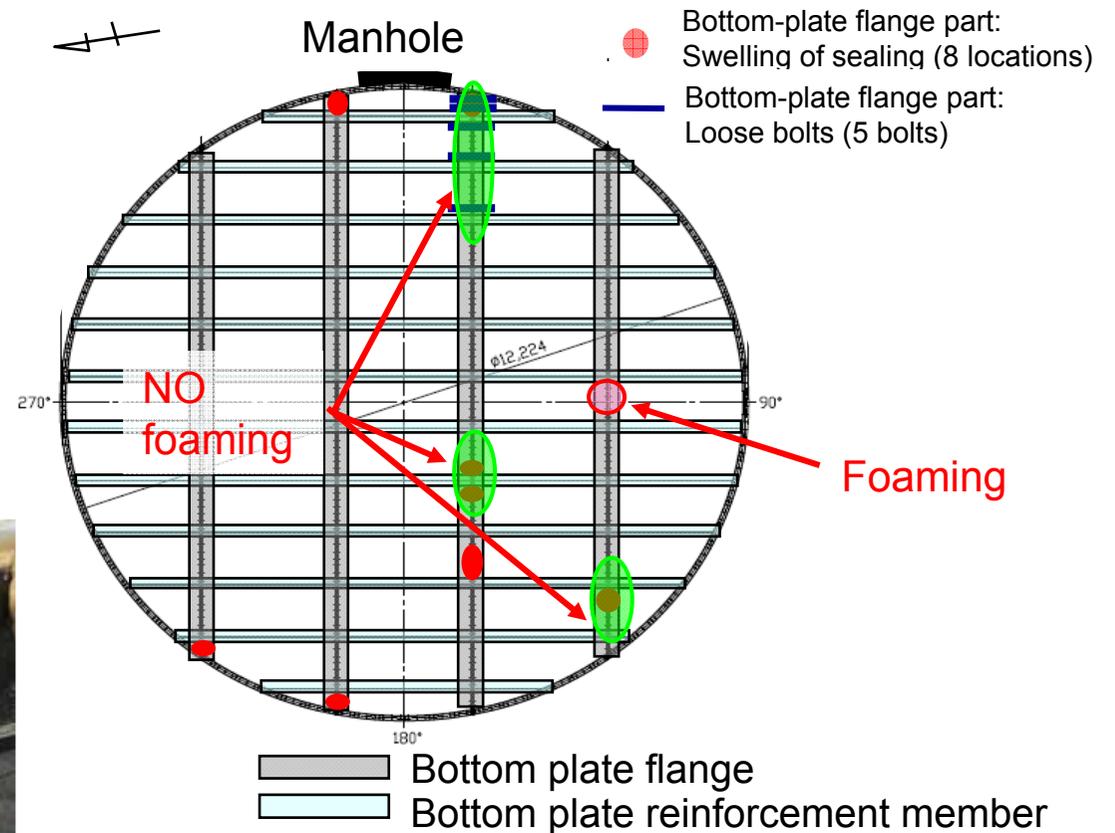
Results of the Local Vacuum Test for the Tank Bottom Plate (Previously Announced)

- We conducted the local vacuum test at the point(s) where 1) bubbles were vacuumed up in the vacuum test for the bottom-plate, 2) bolts were loose, and 3) swelling of sealing was found. As a result, we found foaming at the point 1), but NO foaming at the points 2) and 3).

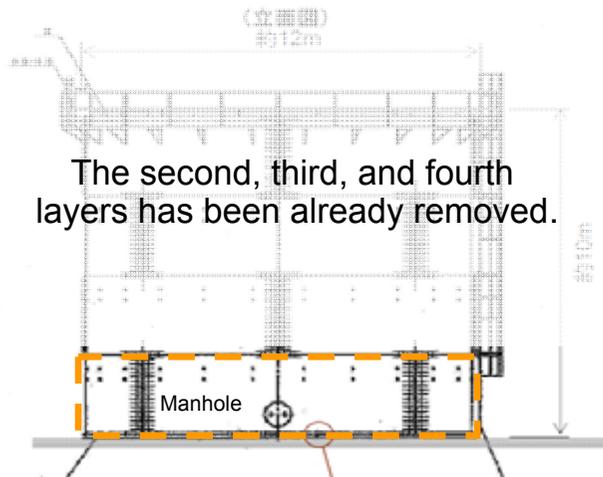
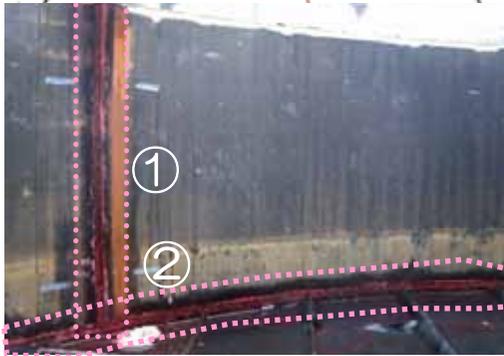
- In accordance with the side plate removal (the first layer), we applied PT agent (red-color liquid penetrant) to the flange part. We checked and searched for a path where water could have leaked.
- As far as we checked with eyes as the removal, we found no path for a leak.

PT agent applied on the side plate on the inner flange part

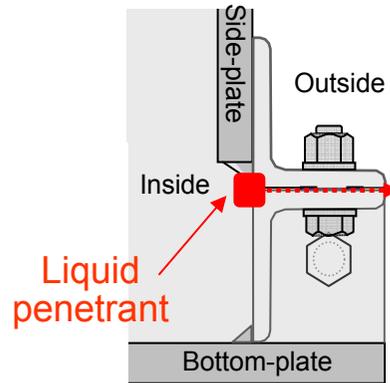
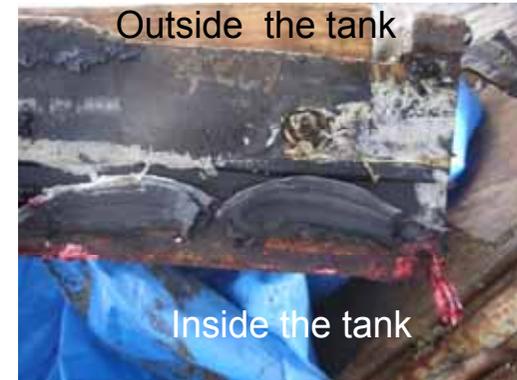
Under removal (Side-plate side near ②)

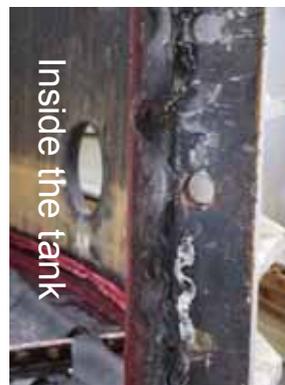
Under removal (Side plate near ①)

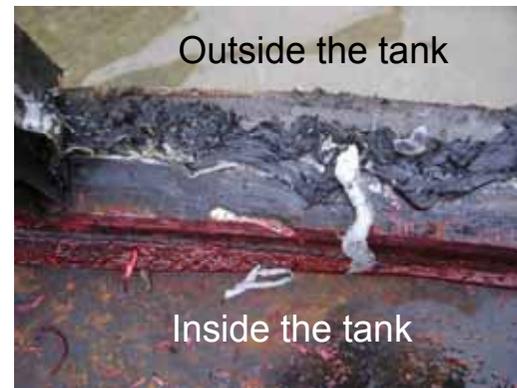
Under removal (Bottom-plate side near ②)

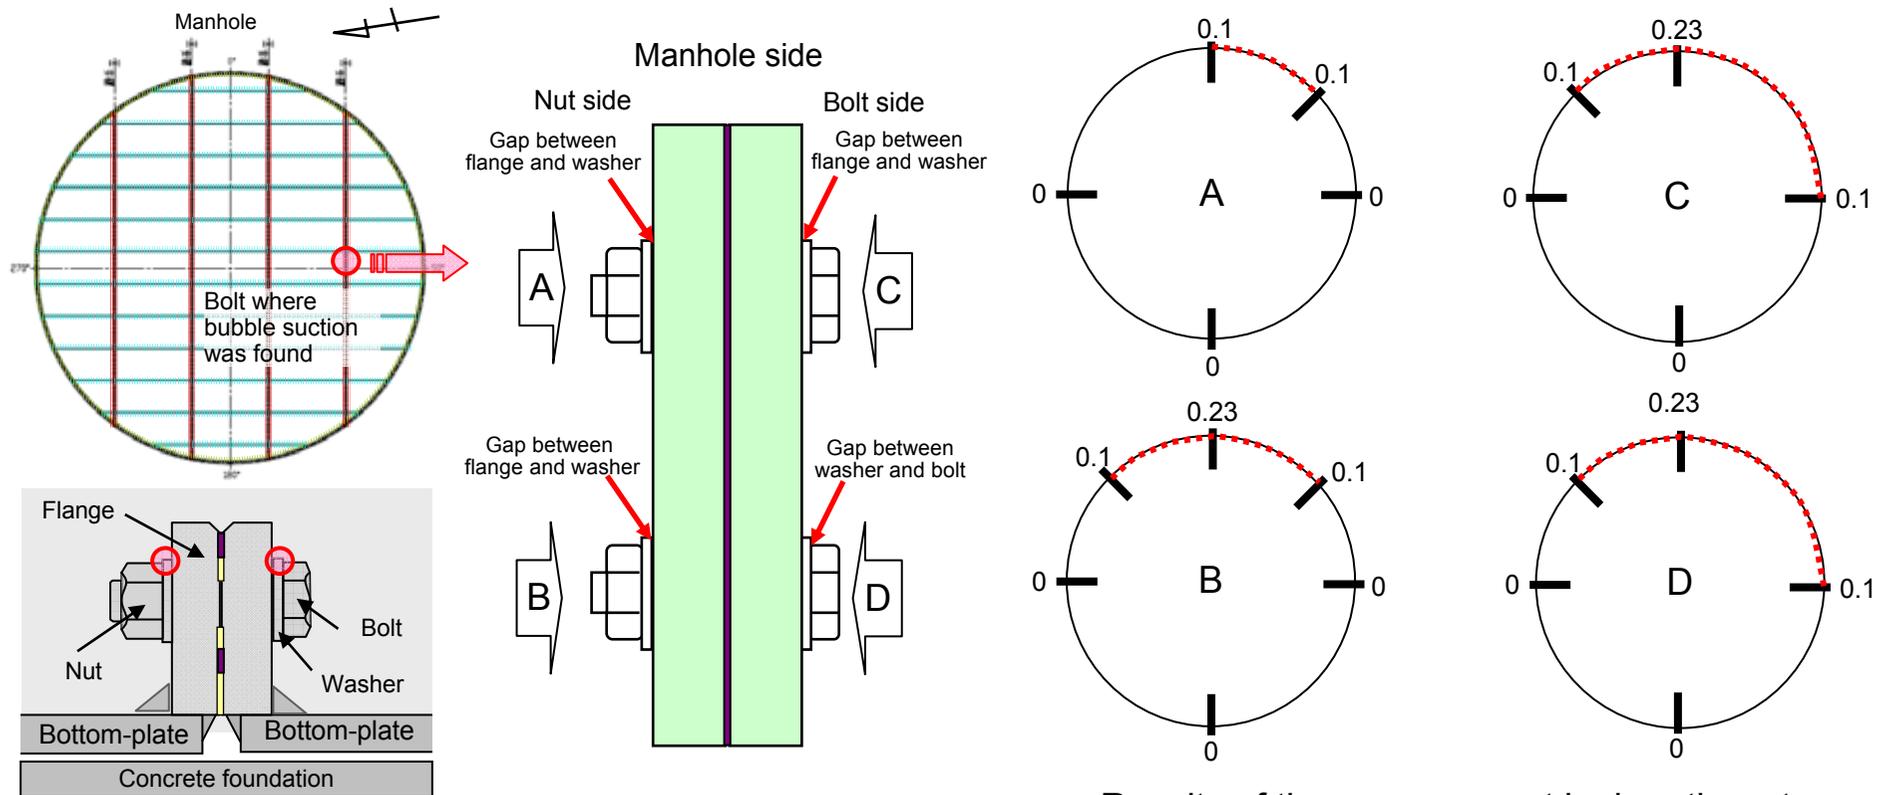
- We investigated further into the bolt parts which are suspected of leak, and measured the gaps (between a flange and washer/ a washer and bolt) with a gap gauge, and found, for instance, a maximum 0.23millimeter gap.

Results of the gap gauge at leak-path part
(Looking from the front in each bolt and nut)

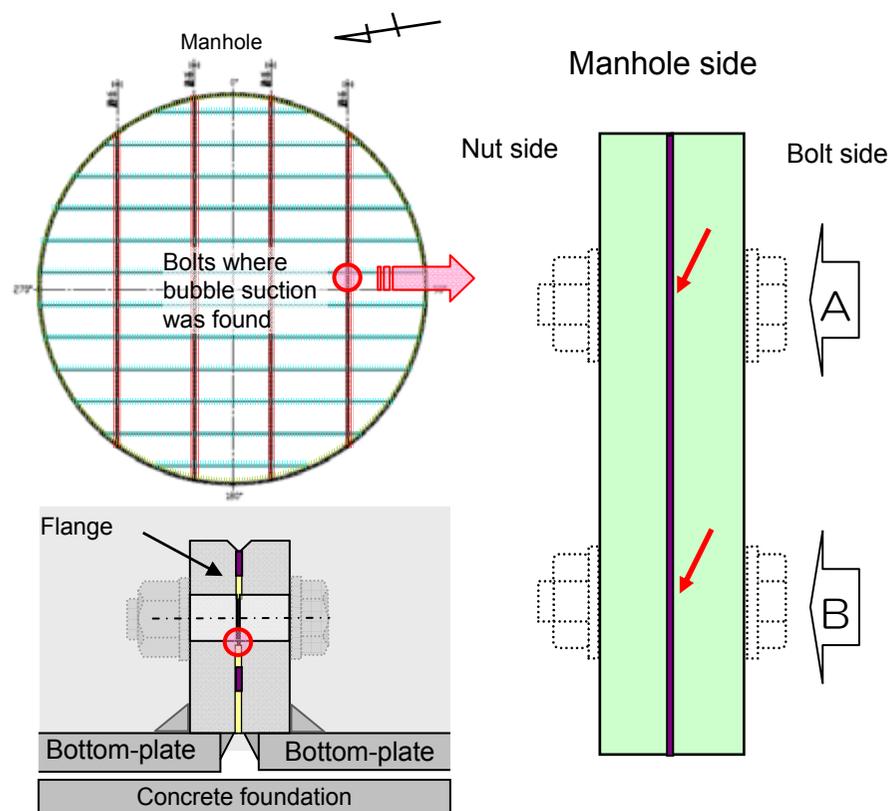
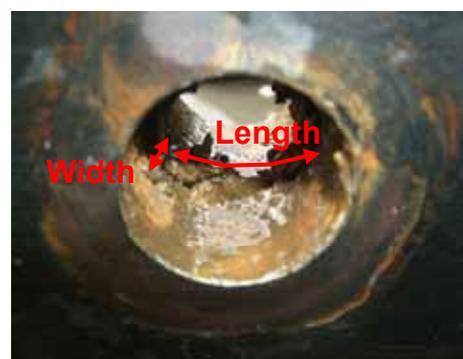
- We removed the two bolts on the bottom plate, and checked with eyes and conducted a vacuum test.
- As a result of checking with eyes, we found such openings as follows at the lower side of the bolts: Approx. 3mm (width) × 22mm (length) in the manhole side, and approx. 2-3mm (width) × 11mm (length) in the other side.
- As a result of the vacuum test, we found that bubbles were vacuumed up through the these openings.

Vacuum test (Looking from the direction A)

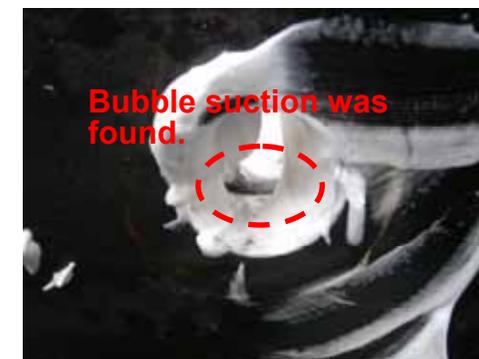
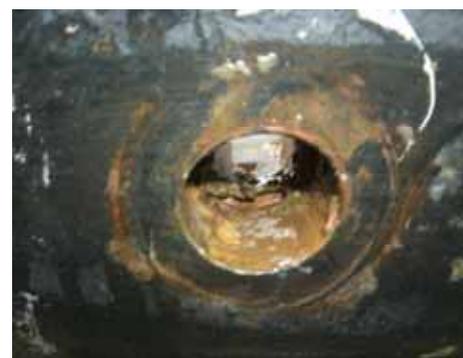
Vacuum test (Looking from the direction B)

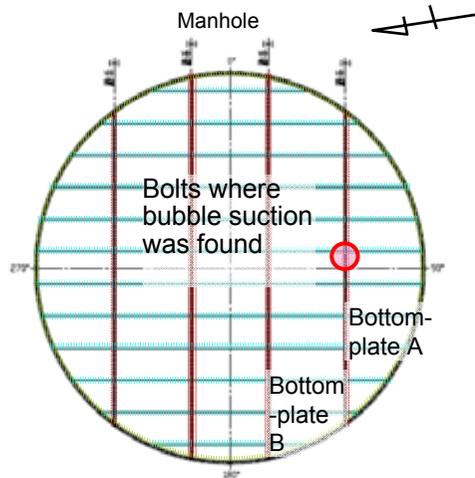
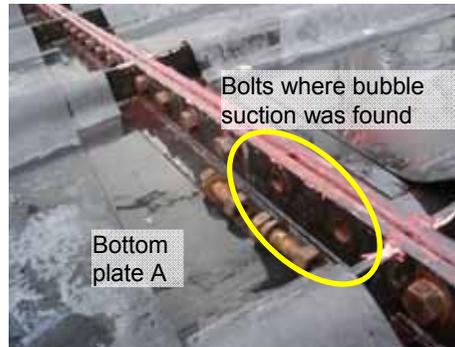
- In accordance with the bottom plate removal, we applied PT agent (red-color liquid penetrant) to the flange parts. We checked and searched for a path where water could have leaked.
- As a result of checking with eyes, we found no leak path other than the leak-path part which had been previously found.
- As for the leak-path part, we found a slipping-out packing, and rust on the flange.

PT-material applying to the inner flange part on the bottom plate

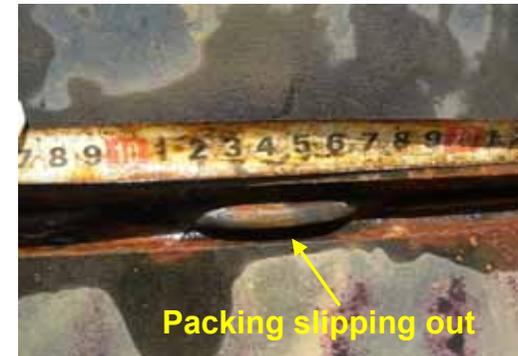
Leak path part on the backside the bottom plate before removal

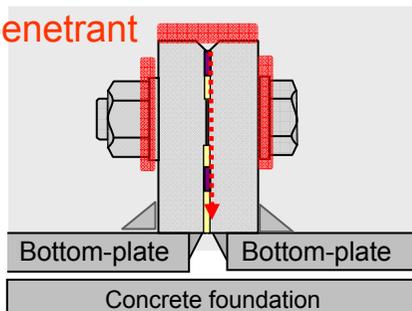
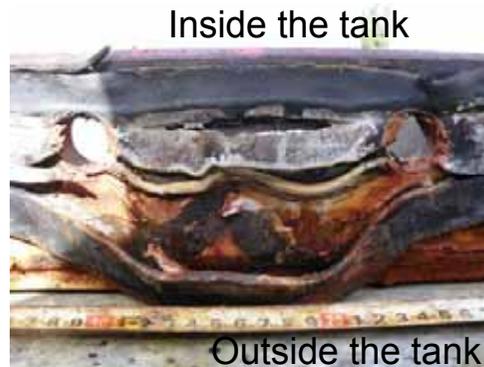
Under removal (Bottom plate B)

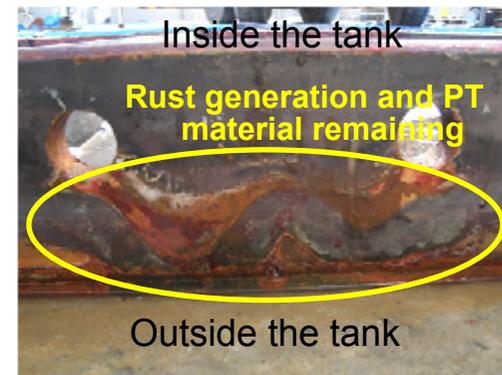
Under removal (Bottom plate A)
